Te Hiku

Te Paki Stream Pond No. 2 (Aupouri), NRC Lake No. 14B

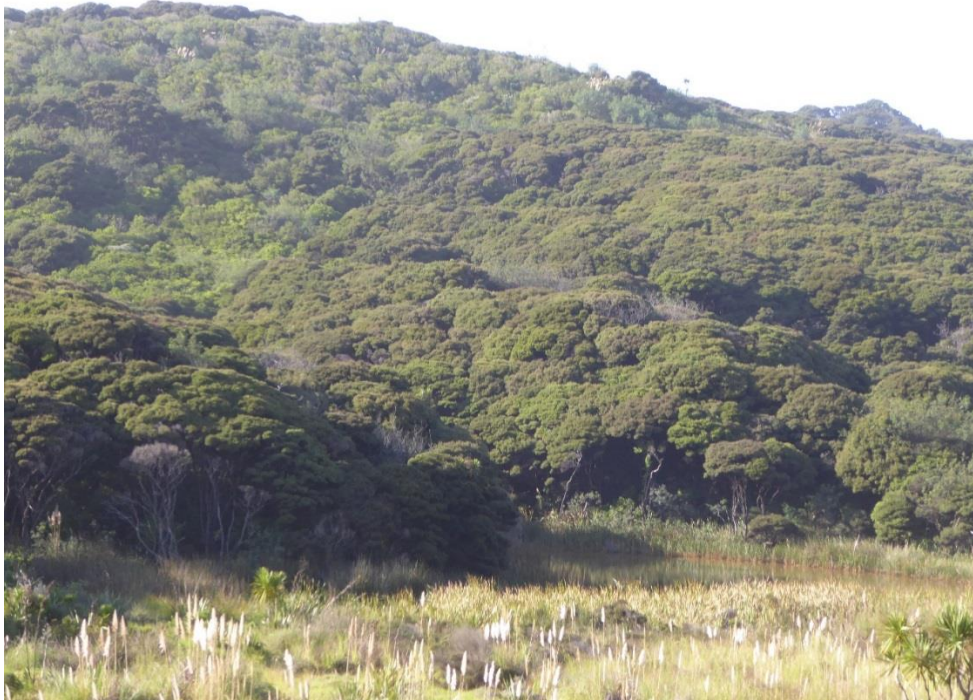
Te Paki Stream Pond No. 2, 2016.

Te Paki Stream Pond No. 2 (1579265E, 6179190N) is a small 0.5 ha waterbody with a narrow emergent fringe in a tributary of the Kauaeaparaoa (Te Paki) Stream. The catchment is in scrub. Access is from the Te Paki Road, off the stream.

The pond was surrounded by *Typha orientalis*, *Eleocharis sphacelata*, *Machaerina articulata*, *M. juncea*, *M. rubiginosa*, *Apodasmia sessilis* and *Schoenoplectus tabernaemontani*. Other indigenous wetland species seen included *Persicaria decipiens*, *Cyperus ustulatus*, *Isolepis prolifera*, *Carex secta* and *C. maorica*.

Submerged vegetation was absent although the invasive *Utricularia gibba* grew amongst emergent species. Underwater visibility was 0.6 m.

No monitoring.
