## 22 Tauranga Bay

### Coastal Erosion Hazard Assessment

Coastal Erosion Hazard Assessment

Tauranga Bay

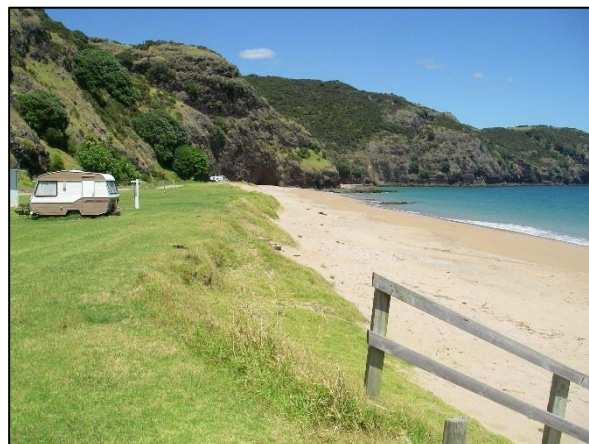
Site Photograph A (west)

Tauranga Bay is located on the east coast of Northland, approximately 30 km north of Kerikeri. The north-west facing shoreline is approximately 0.8 km long and is situated between Te Kahikatoa Point in the south and Te Ania Point in the north.

The site has a sandy beach comprising medium to coarse sand. The beach has a berm width of approximately 15–20 m above the high tide line.

The dune is well vegetated at the eastern end with spinifex. The dune vegetation is sparse over the eastern half of the site. The dune heights range from approximately RL 4 to 7 m along the site. A campground exists at the site which is well set back from the dune toe.

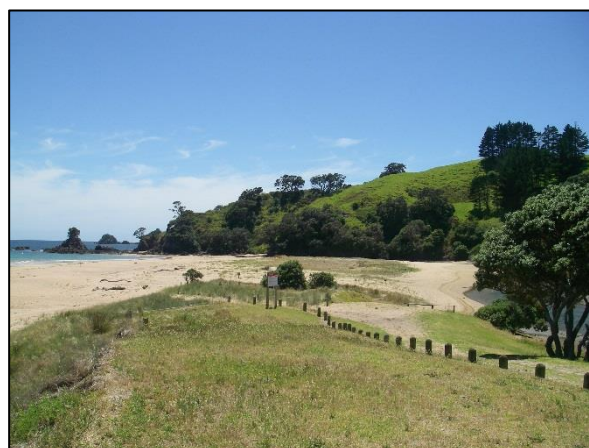
Site Photograph B (spit)

The Tauranga Stream mouth is located at the eastern end of the site. A relatively large intertidal spit has formed at this end of the beach, which forces the stream flow north along the base of Te Ania Point. Some erosion is evident on the inside of the spit shoreline.

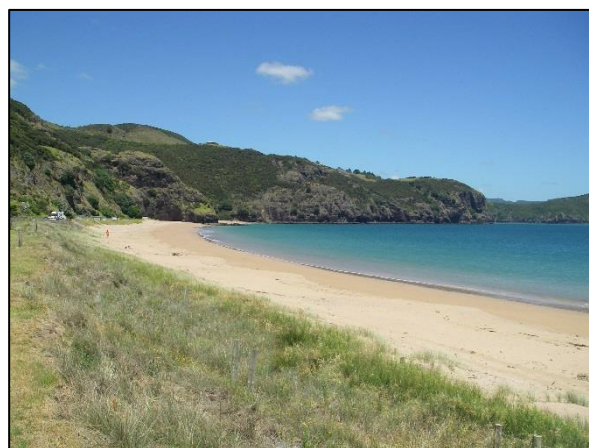
Site Photograph C (east)

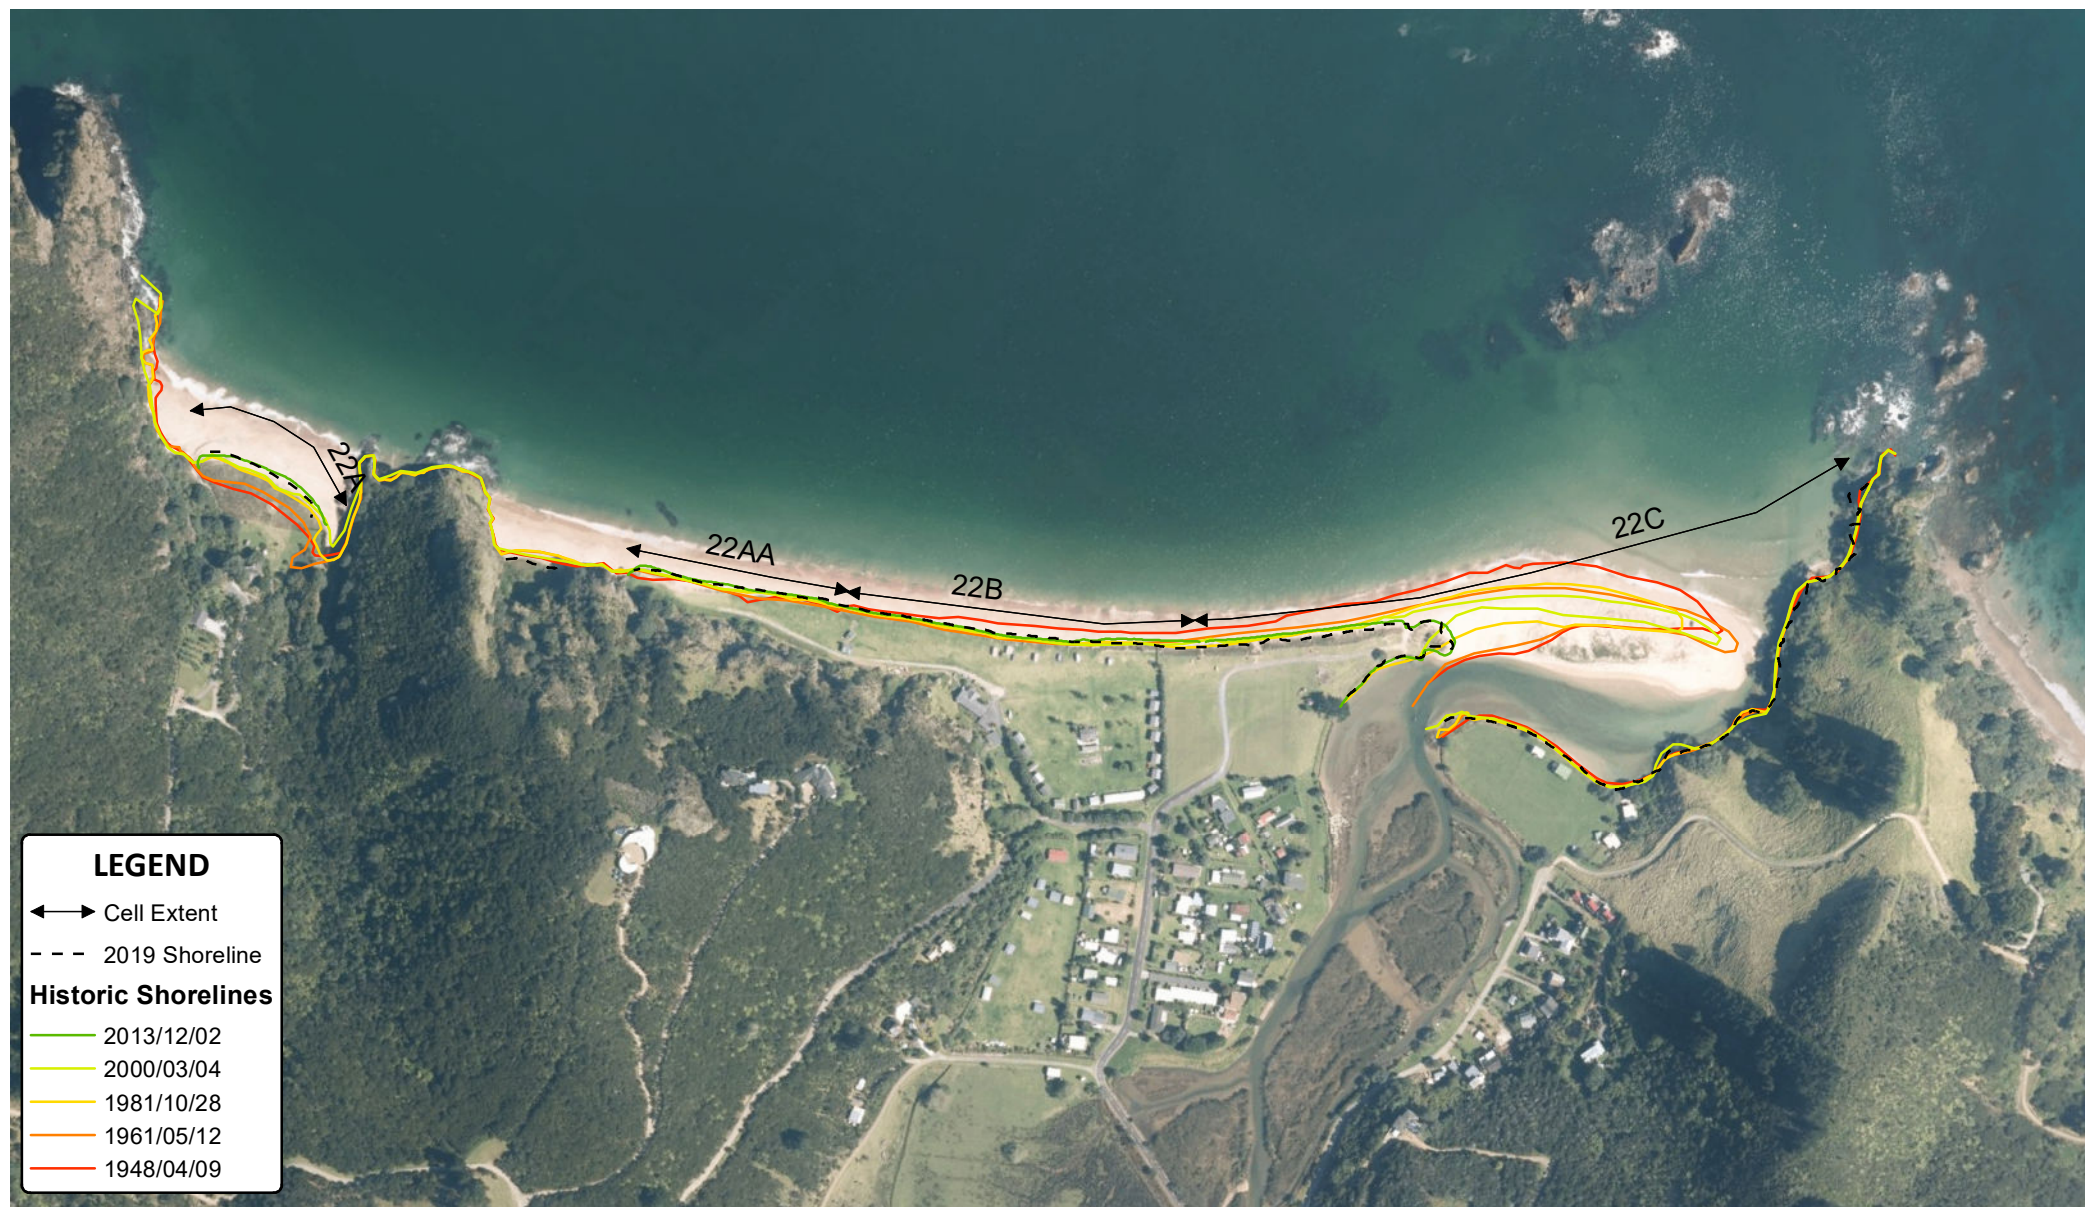
| FIGURE No. | Figure 22-6 | Rev. |

| Historic Shorelines | | |
| Tauranga Bay | | |

Figure 22-6 shows the available historic shorelines for Tauranga Bay.
