## North of Dargaville

Lake Taharoa, NRC Lake No. 229.

Summary	Lake Taharoa
<b>Surveyed:</b>	1985, 1987, 2001, 2005, 2007, 2011, 2014, 2018, 2023 and 2025.
<b>Overall ranking:</b>	<p><b>Outstanding:</b> A native submerged plant dominated lake, with nationally rare plants. It is recovering from a loss of vegetation in 2023. Water quality trends show this lake is improving over the past five years, classed as microtrophic in 2024/25.</p> <p>Prior to 2023, Lake Taharoa was reported as the best example of a clear-water lake in Northland, with the deepest recorded (27.5 m) submerged vegetation in the North Island.</p>
<b>Threats:</b>	<p>The lake has a high risk of pest plant introduction but currently the subsequent impact likely to be low, due to very low nutrient status and steep bathymetry. There is a risk of gold clam spreading from the Waikato. Koi carp may be present in this lake.</p> <p>Nutrient loading from the catchment is a major threat with potential sources from nitrogen-fixing woody vegetation, pine harvesting and livestock farming.</p>

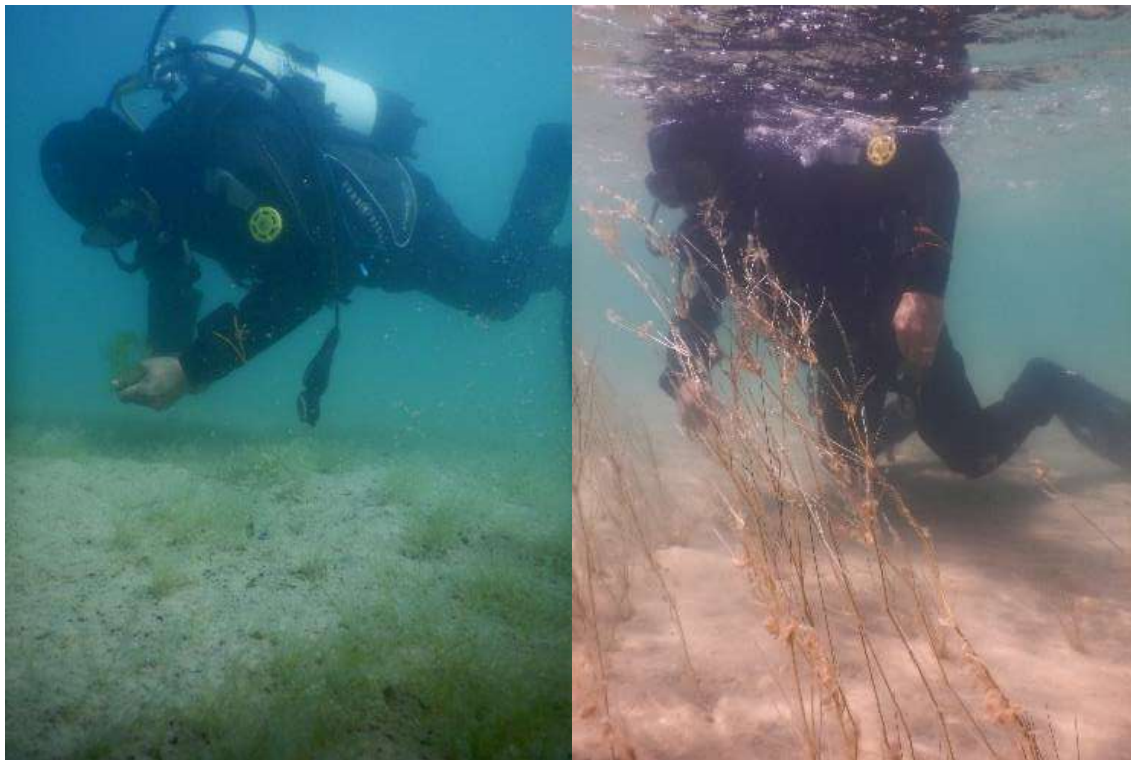
**Lake Taharoa:** Moderate covers of charophytes at 8 m depth (left), *Juncus bulbosus* at 1 m depth (right) (Mary de Winton 2025).

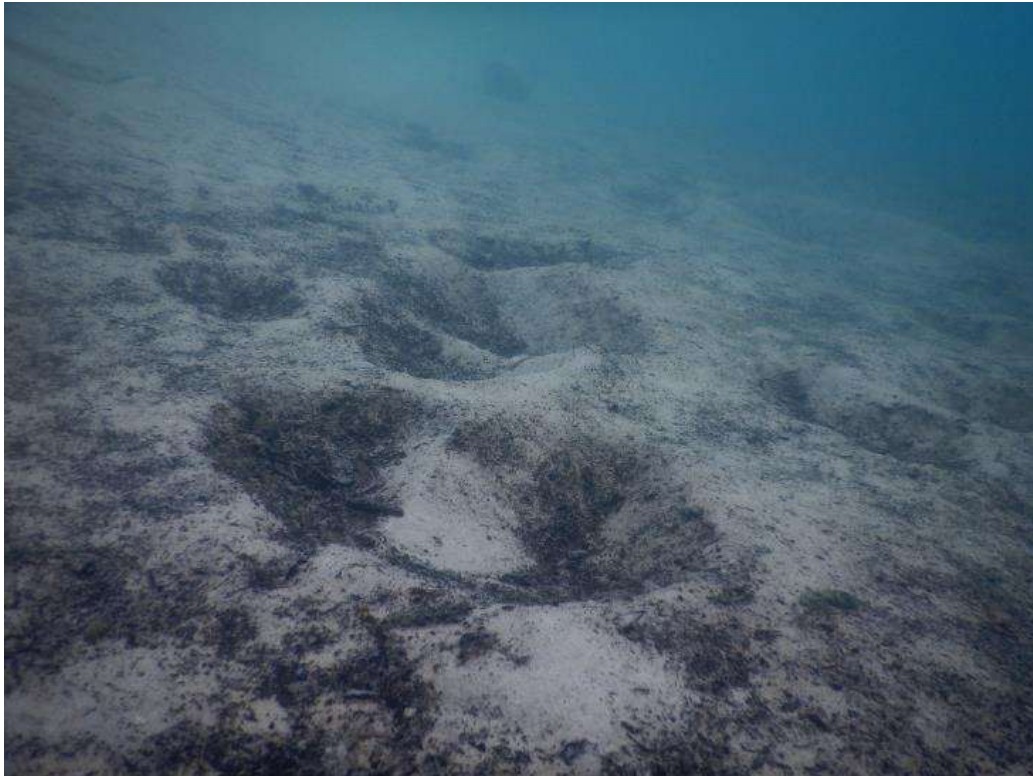
There was a report of a koi carp (*Cyprinus rubrofuscus*) being seen in Lake Taharoa in 2021 by a member of the public. No further observations of this species have been made. However, divers noted large depressions beyond 2 m depth at two sites, potentially caused by pest fish.

**Lake Taharoa:** Large depressions noted in bottom sediments at depths greater than 2 m (Mary de Winton, 2025)

A survey of Lake Taharoa fish and benthic invertebrates, targeting koi carp (*Cyprinus rubrofasciatus*) is advocated. A combination of gill, trammel and fyke nets is recommended by Collier and Grainger (2015).
