Northland Coastal Water Quality

Results from 2018-2020

Northland Regional Council

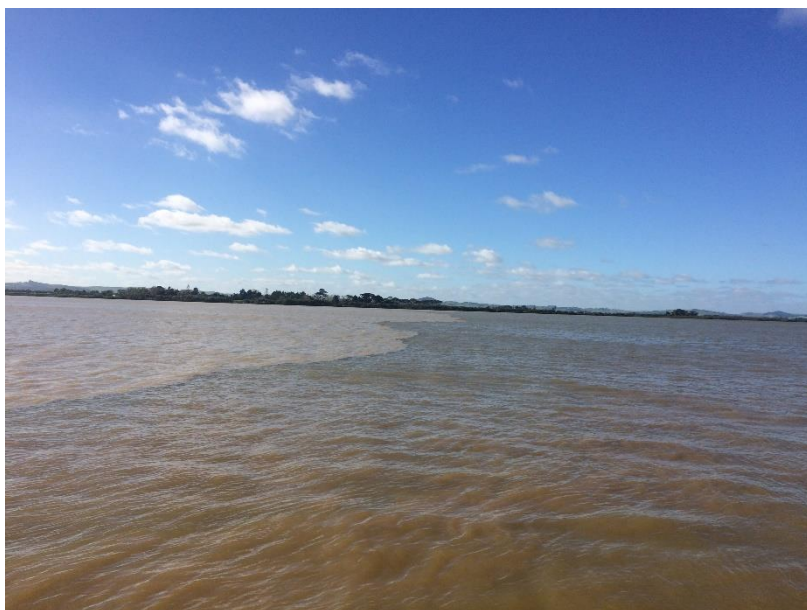
Plate 2. Photograph taken near the sampling site at the Wairoa River in the Kaipara Harbour.

The highest turbidity measurements were generally recorded after heavy rainfall events and catchment sources of sediment are undoubtedly responsible for some of the elevated turbidity results. This is particularly true of sites located in tidal creeks and estuarine sites located in either tidal lagoon or tidal river hydrosystems, such as Ruakaka Estuary, Waipū Estuary and Aurere Estuary. At the Wairoa River site, in the Kaipara Harbour, turbidity is particularly poor and is clearly caused by sediment laden inputs from the vast northern Wairoa catchment. On ebb tides sediment laden water can be seen advancing down the channel and tidal state is critical to how poor water clarity is at the time of sampling (Plate 2).

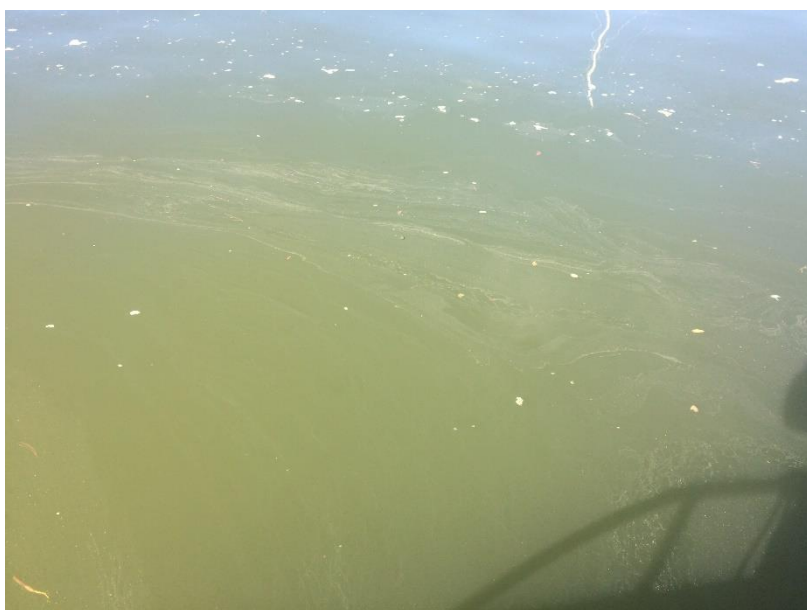
Plate 3. Poor water clarity caused by algae growth in the water column, in Whangārei Harbour.

Water clarity can also be affected by algae in the water column, and it is often obvious when collecting samples that the poor water clarity is caused by algae in the water (Plate 3). Although none of the sites had a seasonal pattern that was statistically significant, it was apparent at some sites that the highest turbidity was recorded in summer, when there is typically less rainfall but more algal growth, and that the lower turbidity was recorded in winter, when rainfall is typically higher but algae growth low.

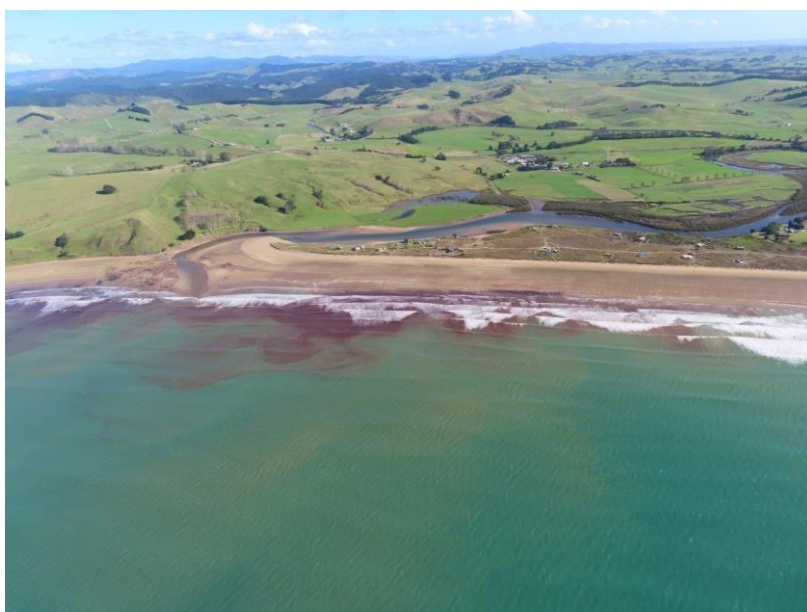
Plate 4. Algae observed outside the mouth of Aurere Estuary in Doubtless Bay, April 2021.

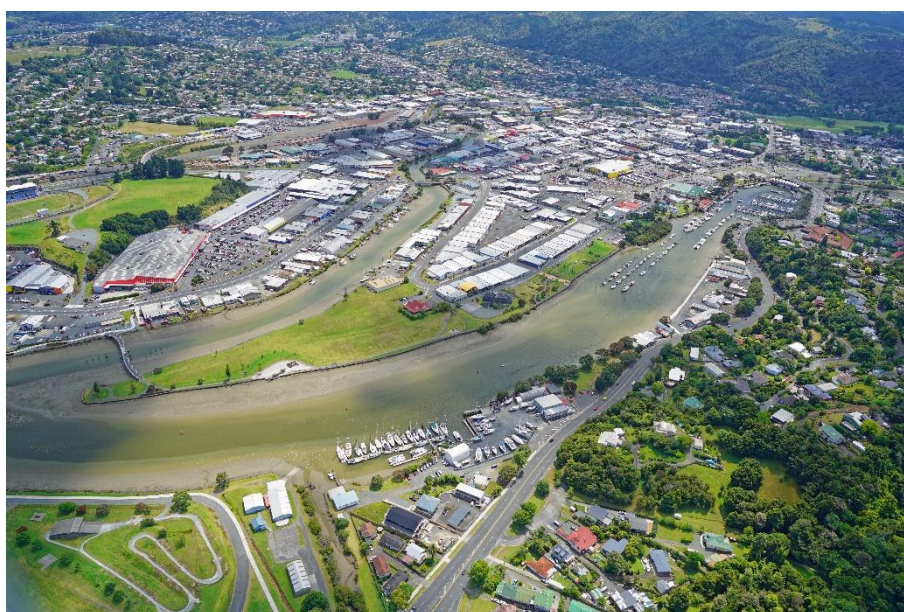
Plate 5. Confluence of the Waiarohia Canal and Hātea River, Whangārei (the Town Basin marina and mooring area is visible to the right of photograph).

The Hātea River is a tidal creek which flows through the city of Whangārei (Plate 5). Land cover in the catchment, has a relatively high proportion of urban use (19%) covering the catchment, with high producing grassland covering 29% and indigenous forest covering a further 26% (Figure 13). It receives road run-off and stormwater from Whangārei city and is the receiving environment for the Whangārei wastewater treatment plant and a number of industrial discharges. There is also a relatively high number of domestic on-site systems in the catchment (38). Much of the saltmarsh and mangrove habitat that would have flanked the river has been drained and reclaimed for urban and industrial land use and the shoreline has been significantly modified. There is also a marina at the Town Basin, a large mooring area at Kissing point and several boat maintenance facilities in the Hātea River.

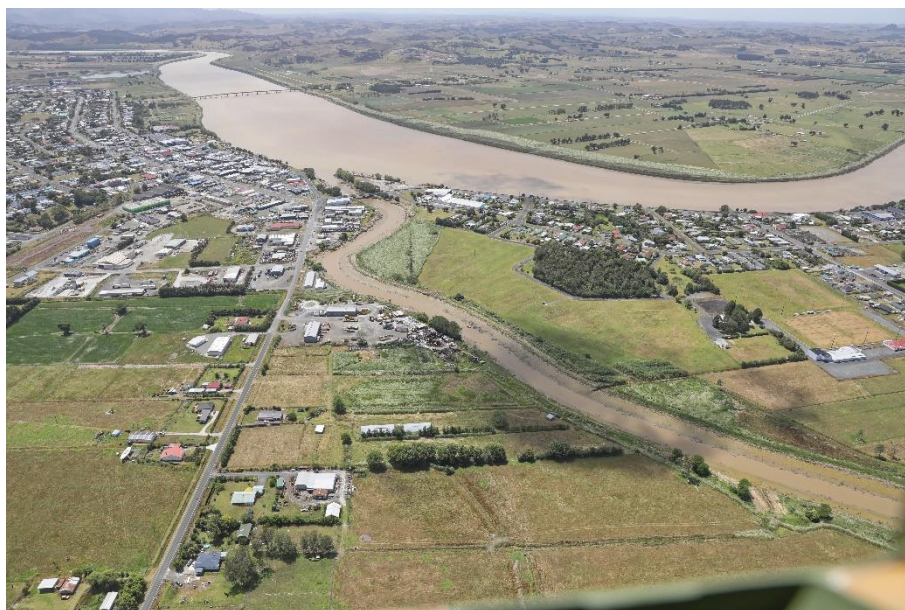
Plate 6. Sediment laden water from the Kaihu River and Northern Wairoa River at Dargaville.

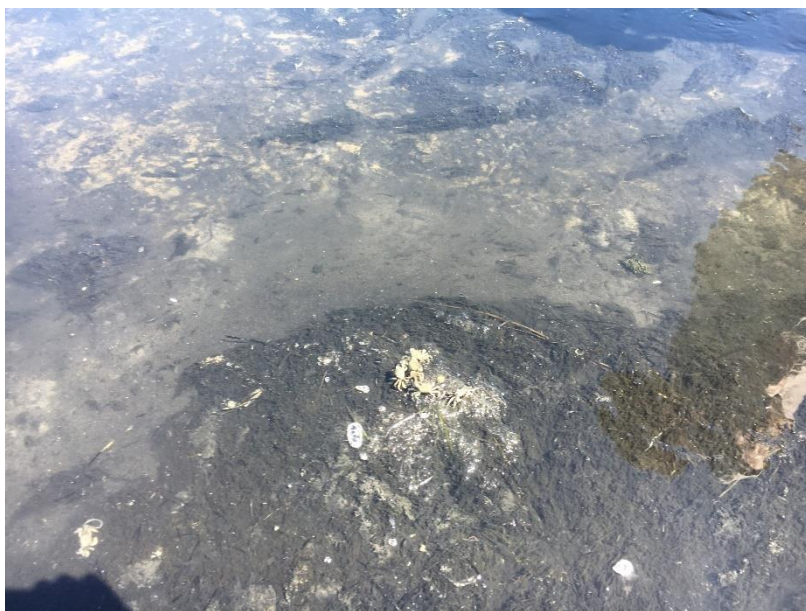
Plate 7. Nuisance macroalgae in Waipū Estuary, March 2021.

The nutrient concentrations in both estuaries will also contribute to nutrient concentrations in Bream Bay and there have been several large depositional events of macroalgae (Plate 8) in recent years that have resulted in a number of negative impacts including curtailing access to the beach and water for recreation, and producing unpleasant odours (Nelson, 2018).

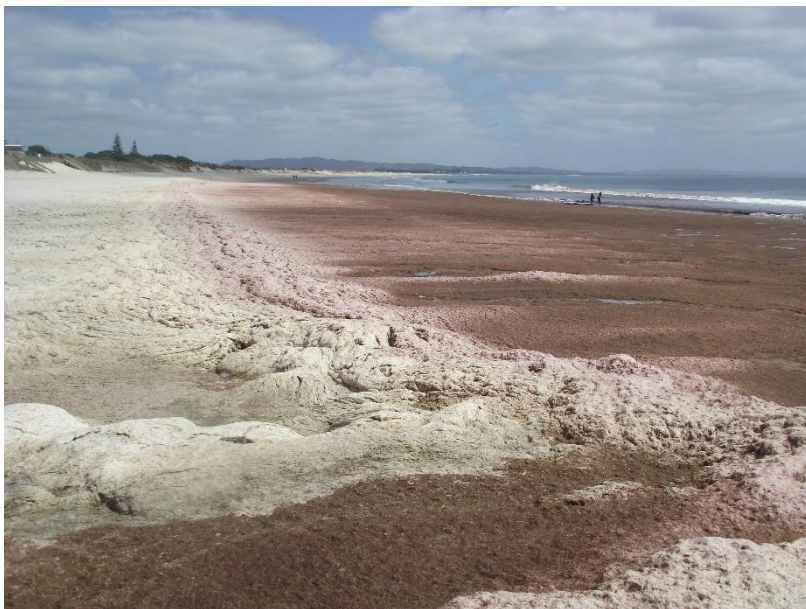
Plate 8. Nuisance algae at Waipū Cove, 2010.

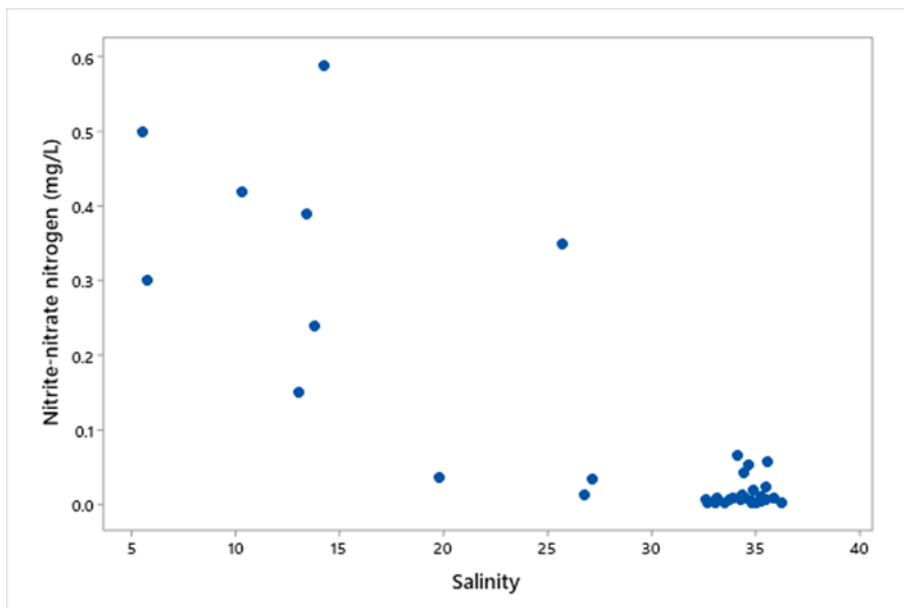
Figure 17. Salinity and nitrate-nitrite nitrogen at Waipū Estuary, 2018-2020.

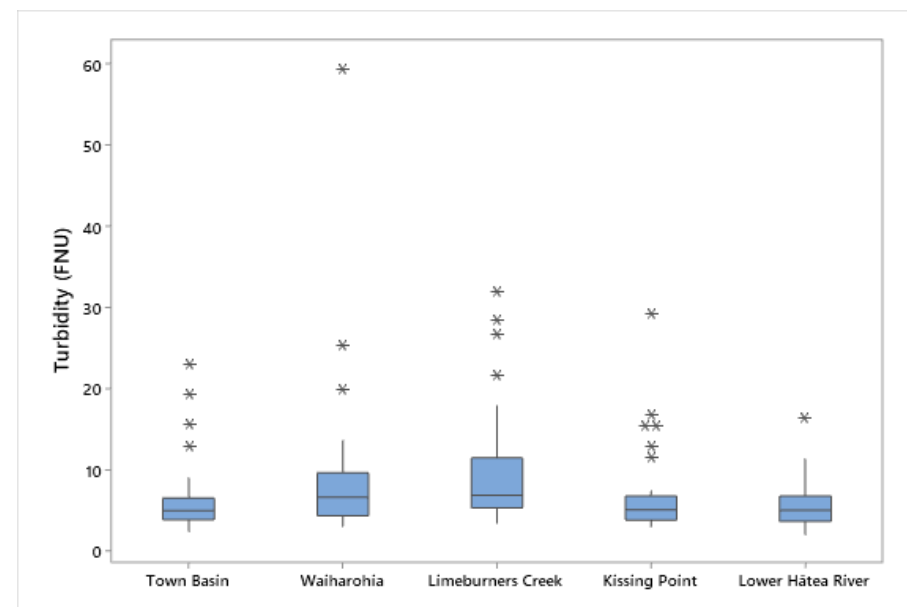
Figure D-3. Turbidity at open coast, estuarine, tidal creek, and Hātea River sites. Box plots show distributions for 2018-20, except for sites in the Kaipara (2020).
