## Poutō Peninsula

### Lake Egg (Poutō), NRC Lake No. 355A

Summary	Lake Egg
<b>Surveyed:</b>	Recce June and August 2020, marginal plant survey 2021
<b>Overall ranking:</b>	<b>Moderate to Low:</b> A small fenced off lake highly degraded by a near 100% submerged cover of the invasive plant pest hornwort growing almost to the surface in places. There is a continuous margin of reeds and the lake is in a pasture setting, fully fenced and with no stock access.
<b>Threats:</b>	<p>Nutrient inputs from land use in the catchment would have led to enrichment. However, thick covers of hornwort are currently supporting good water clarity.</p> <p>Lake collapse is possible if the hornwort is left to continue to fill the lake. As hornwort has been eradicated from Roto- otuauru, this lake is a risk to other high value lakes.</p>
<b>Management recommendations:</b>	<p>Eradication of hornwort is planned for 2021/2022 as this pest plant is a threat to other nearby waterbodies.</p> <p>No other monitoring.</p>

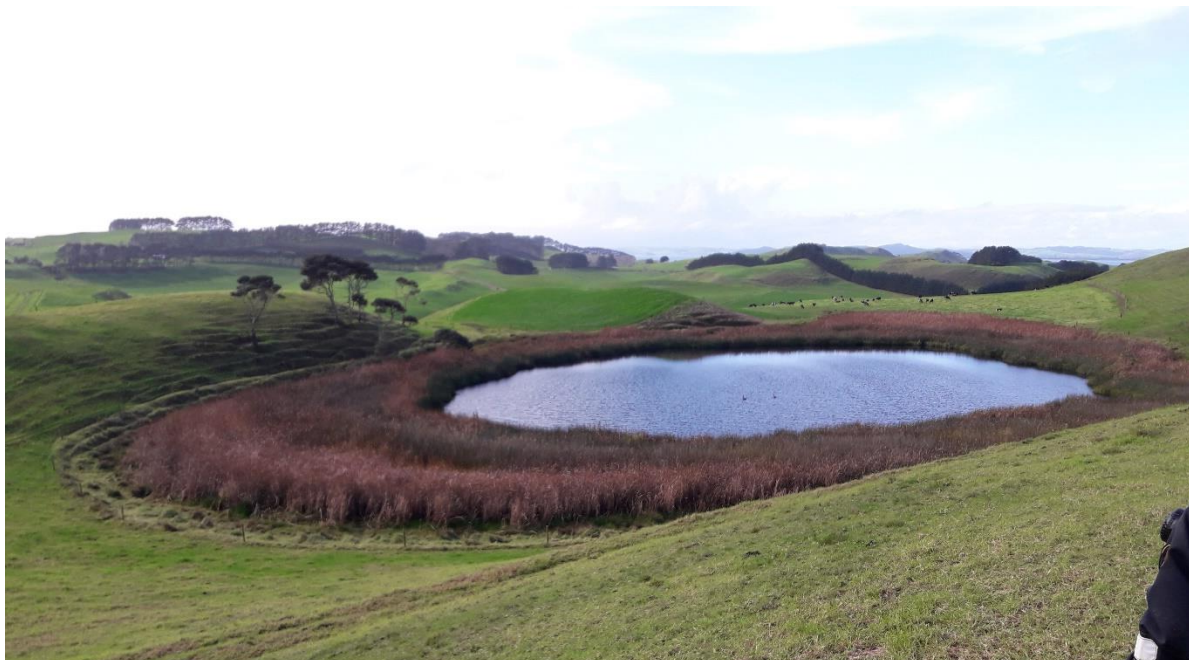
**Lake Egg.** Photo taken from the western side of the lake. (Photo: Nathan Arcus NRC, June 2020).

Submerged vegetation in Lake Egg is dominated by a near 100% cover of the invasive plant pest hornwort (*Ceratophyllum demersum*) covering the entire lake floor and growing up to near the surface in places. The entire lake margin was also snorkeled and searched for pest weeds especially for oxygen weeds with none recorded. *Utricularia gibba* was present in low densities. *Potamogeton ochreatus* was at low covers of less than 1% and a single plant of *P. cheesemanii* was seen. In the lake/reed bed margin *Ludwigia palustris*, *Landoltia punctata*, *Azolla pinnata* and *Myriophyllum propinquum* were recorded.

Eradication of hornwort in this lake is recommended and is planned for 2021/2022 using the herbicide endothall dipotassium.

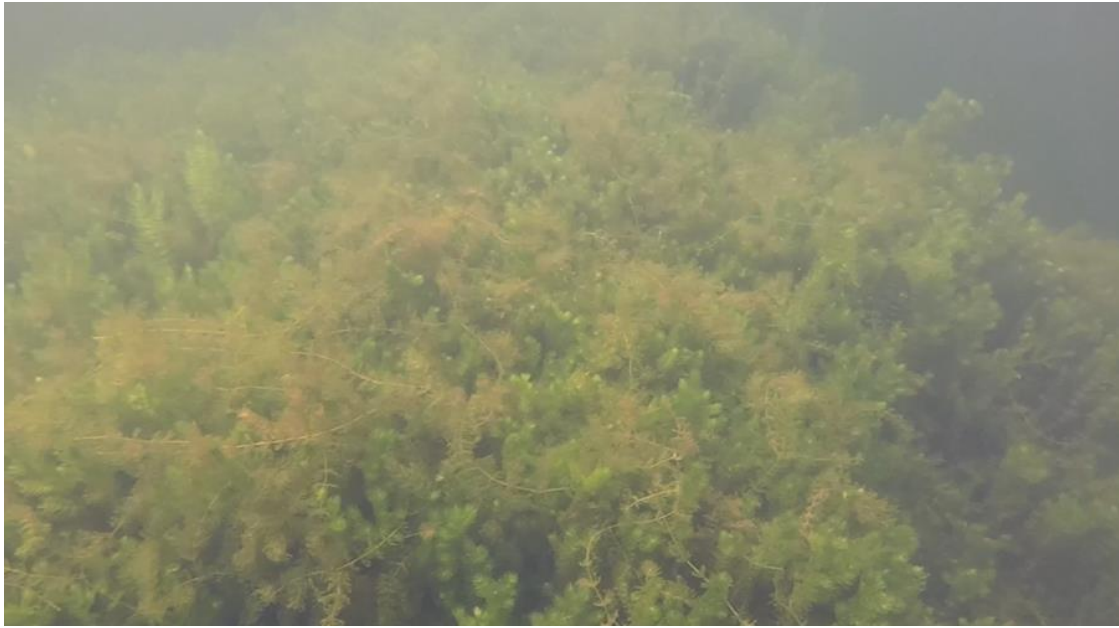
**Dense beds of the pest plant, hornwort in Lake Egg.** (Photo: From GoPro footage Lisa Forester NRC, June 2020)
