# **LAKE MONITORING**

# **Northland Lakes Assessment**

In the 2004-2005 financial year, Northland Regional Council engaged the National Institute of Water and Atmospheric Research (NIWA) to assist the council with gathering information to determine the status of 65 lakes throughout Northland. This included information on the extent and diversity of lake vegetation, the Lake SPI method of assessing lake condition, records of water birds, fish and invertebrates and water quality assessments.

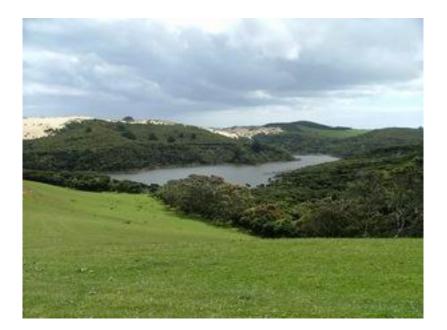
The photo below shows one of the Aupouri Peninsula dune lakes, which remains in a relatively pristine state with entirely indigenous aquatic vegetation and a riparian buffer strip of native shrub and dune vegetation.

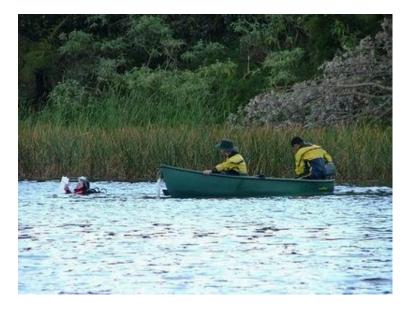
The photo below shows NIWA staff carrying out dive surveys of the lake vegetation in Lake Ngakapua on the Aupouri Peninsula

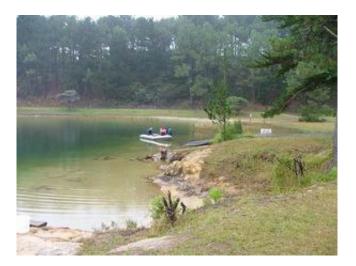
The photo below shows the green discolouration of the bottom water in Lake Waikere as a result of a higher algal biomass.

Secchi disk readings indicate moderate water clarity. The lake was stratified with moderate deoxygenation of bottom water and higher concentrations of nitrogen but not phosphorus in relation to the upper water column. The data suggests a mesotrophic to eutrophic status.

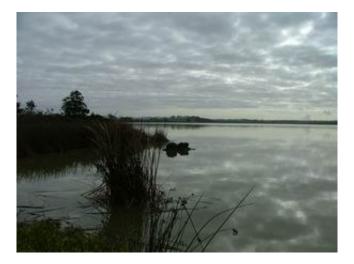
The results from September 2003 to June 2005 are summarised below. A full report is available on the Regional Council website.

Water quality in Lake Omapere from September 2003 to June 2005 has been very poor. Chlorophyll  $\alpha$ , total nitrogen, total phosphorus and secchi measurements are indicative of a lake in a hypertrophic state, meaning it is highly enriched with poor water clarity and frequent algal blooms and surface scums, as shown in the table below.
