Central and East Northland

Whau Dam (near Whangarei) NRC No. 206

Summary 2008

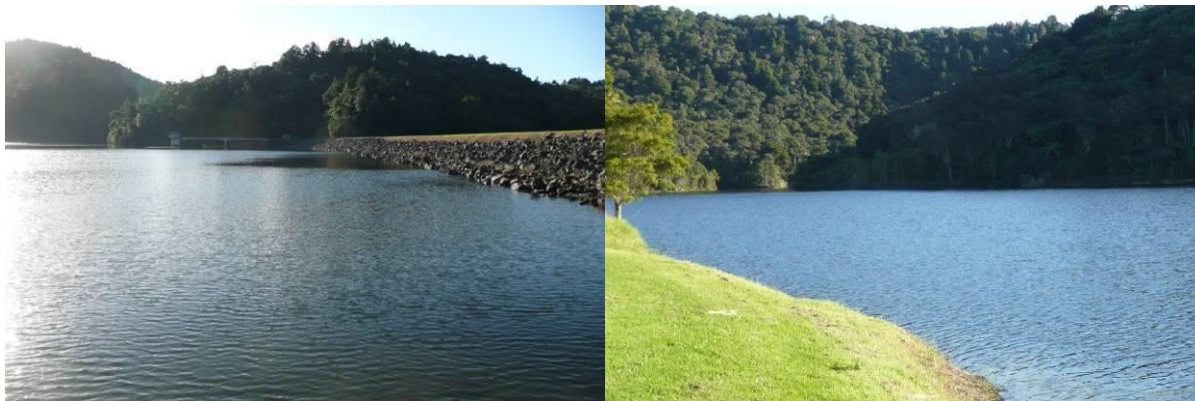
The Whau Dam (left) and looking away from the dam (right).

The Whau Dam (1716550E, 6047511N) was around 20 ha in area, a steep sided dam constructed for domestic water supply. The area was accessed by public road with gated access to the car park. The catchment was native bush.
