# Application for a Resource Consent – Resource Management Act 1991

**Scheme Plan and Engineering Plans**

**Integrated Three Waters Report**

# Stormwater Pond Drawings for 67 Dip Road, Kamo Whangarei

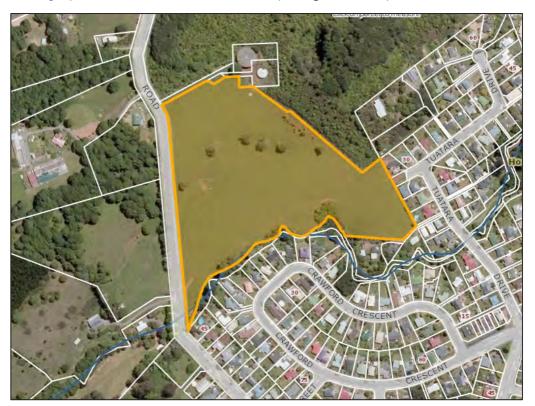
The 6.8ha subject site is comprised of on a single allotment (legally defined as Section 1 SO 65970), fronting Dip Road, with access to Tuatara Drive (see **Figure 1** below).

Figure 1: Locality plan – see full scale version in Appendix 2.

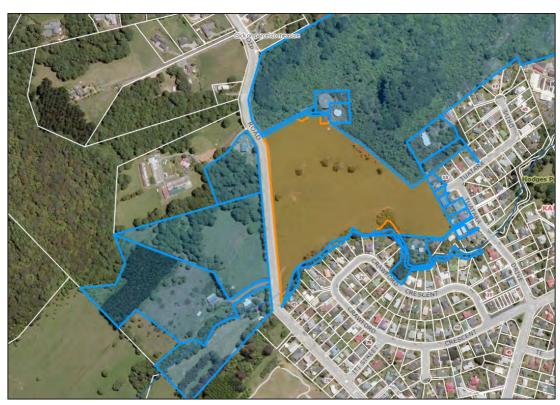
The adjacent properties to be considered in the limited notification assessment under section 95B and 95E are shown in **Figure 2** below, and include:

- Onoke Reserve (North west);
- 28 Tuatara Drive (East);
- 26B Tuatara Drive (East);
- 24 Tuatara Drive (East);
- 22 Tuatara Drive (East);
- 20 Tuatara Drive (South);
- Waitaua Stream Esplanade (South);
- 50 Dip Road (West);
- 54 Dip Road (West);
- 66 Dip Road (West);
- 86 Dip Road (West); and
- WDC Water Reservoir (North).

Figure 2: Adjacent properties in relation to subject site. (Source: Emaps)

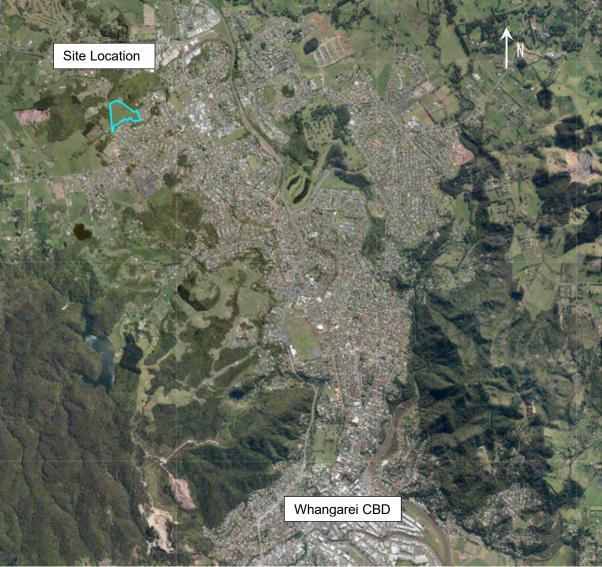
Figure 1 - Site location plan, outlined in blue. Sourced from Whangarei District Council (WDC) GIS.

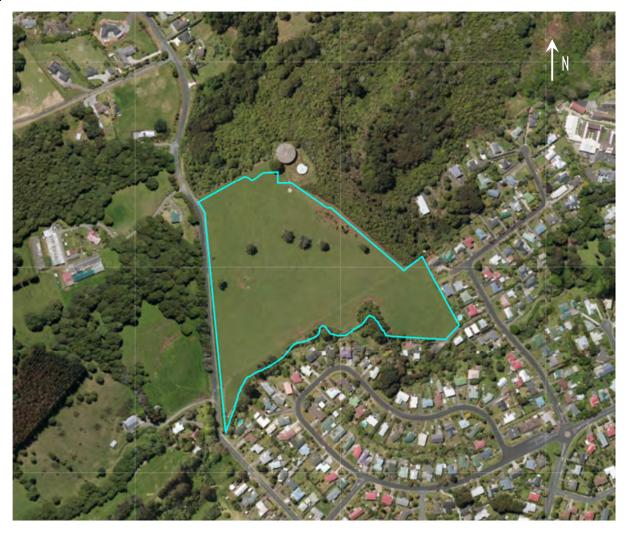
The subject site, shown in the aerial photo in Figure 2, has an area of approximately 6.9ha which is currently covered in grass with trees. The northern half of the site comprises of a converging south facing slope of up to 11 degrees. The southern part of the site comprises of waning slopes towards the stream on the southern end of the subject site.

Figure 2 - Aerial photo of site indicated in blue. Sourced WDC GIS.

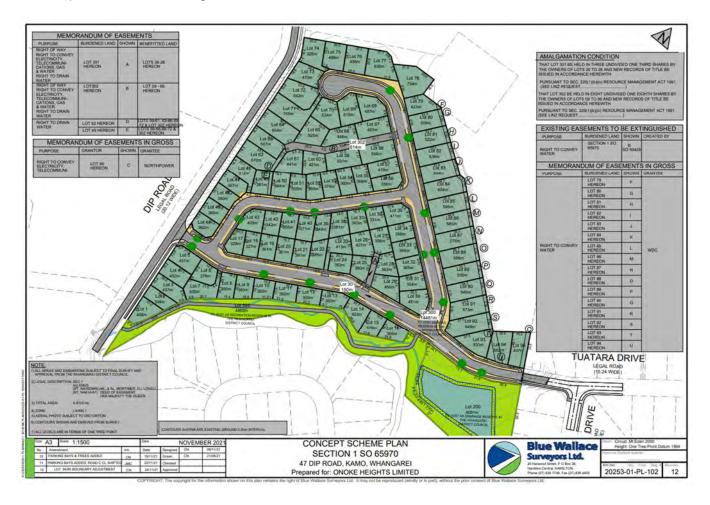
It is proposed to subdivide the site creating 95 new residential lots with majority of the areas between 340m<sup>2</sup> and 1050m<sup>2</sup>. The lots are proposed to be accessed via an extension of Tuatara Road to Dip Road. The proposed scheme plan can be seen in Figure 3 below.

Figure 3 - Proposed scheme plan provided by Blue Wallace Surveyors Ltd.

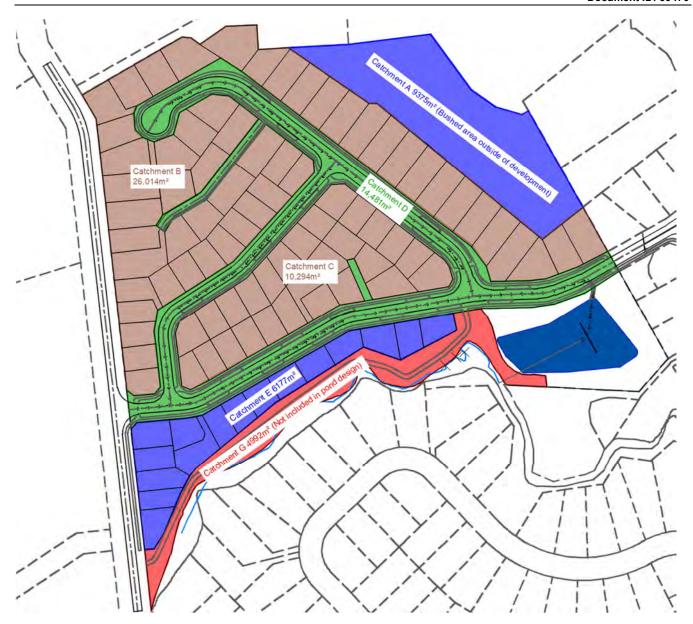
The proposed lots have been divided into impervious and pervious components with 60% of the lot area being nominated as impervious and the remaining 40% pervious. The road reserve area was nominated a curve number of 90 based on a weighted average between the road, footpaths and berms. Refer to Figure 4 below for catchment areas and pond location.

Figure 4 – Catchment areas and pond location.

It is proposed to construct a stormwater pond within the south-eastern end of the subdivision to provide attenuation and water quality treatment for runoff from the development. To achieve this, the pond has been designed to meet the requirements of Auckland Council's GD01.

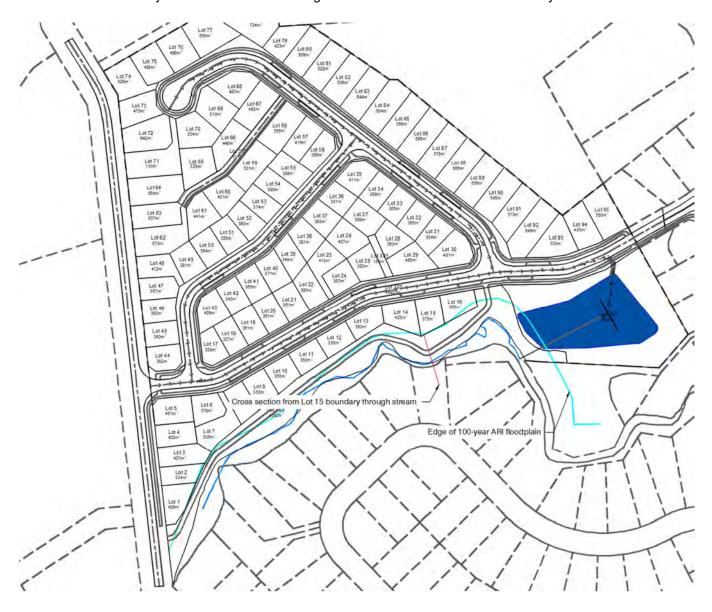
Figure 5. Cross section analysed from Lot 15 across stream.

A retaining wall is proposed on the southern boundaries of Lots 14,15 and 16 of the subject site which will sit on the edge of the 100-year flood plain outlined on WDC GIS Flood Hazard map and in Figure 5 below. A cross section was taken from the edge of the Lot 15 boundary to the adjacent side of the stream to model the peak water level for the 100-year ARI storm. Refer to Figure 5 below for location of section analysed.

Hydraflow Express software modelling of the stream was used to determine the peak water levels in proximity of the site. The stations and elevations of the stream were input into the user defined model to model the shape of the stream channel based on WDC GIS contours as well as the survey completed of the base of the stream.

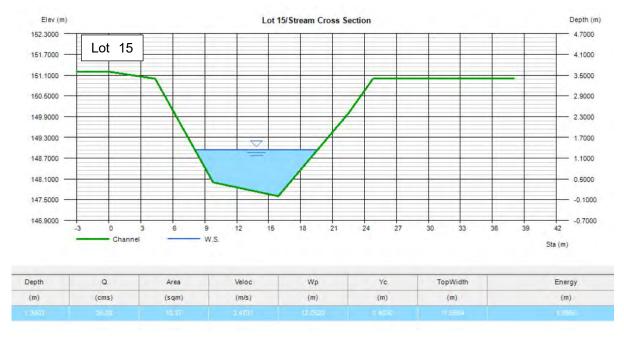
The subject stream is assumed to have a peak flow of approximately 36m³/s during a 100-year ARI storm (assuming an SCS type 1a storm distribution) with a catchment area of slightly less than 180 hectares with a time of concentration of 31mins. Based on the results we can see that the peak water level during a 100-year ARI storm is at RL 148.9 which is approximately 2.1m lower than the Lot 15 boundary at RL151.0 and as such, we can deem that the construction of the proposed retaining walls which will raise the platform level up to approximately RL154 along the boundaries will have no impact on the flood levels. Refer to Figure 6 below for the peak water level during a 100-year ARI storm. Note the stream channel cross section has a flow capacity well in excess of 100m3/s through this area without affecting either of the existing lots.

Figure 6. Hydraflow Express Stream model adjacent to Lot 15 existing ground levels.

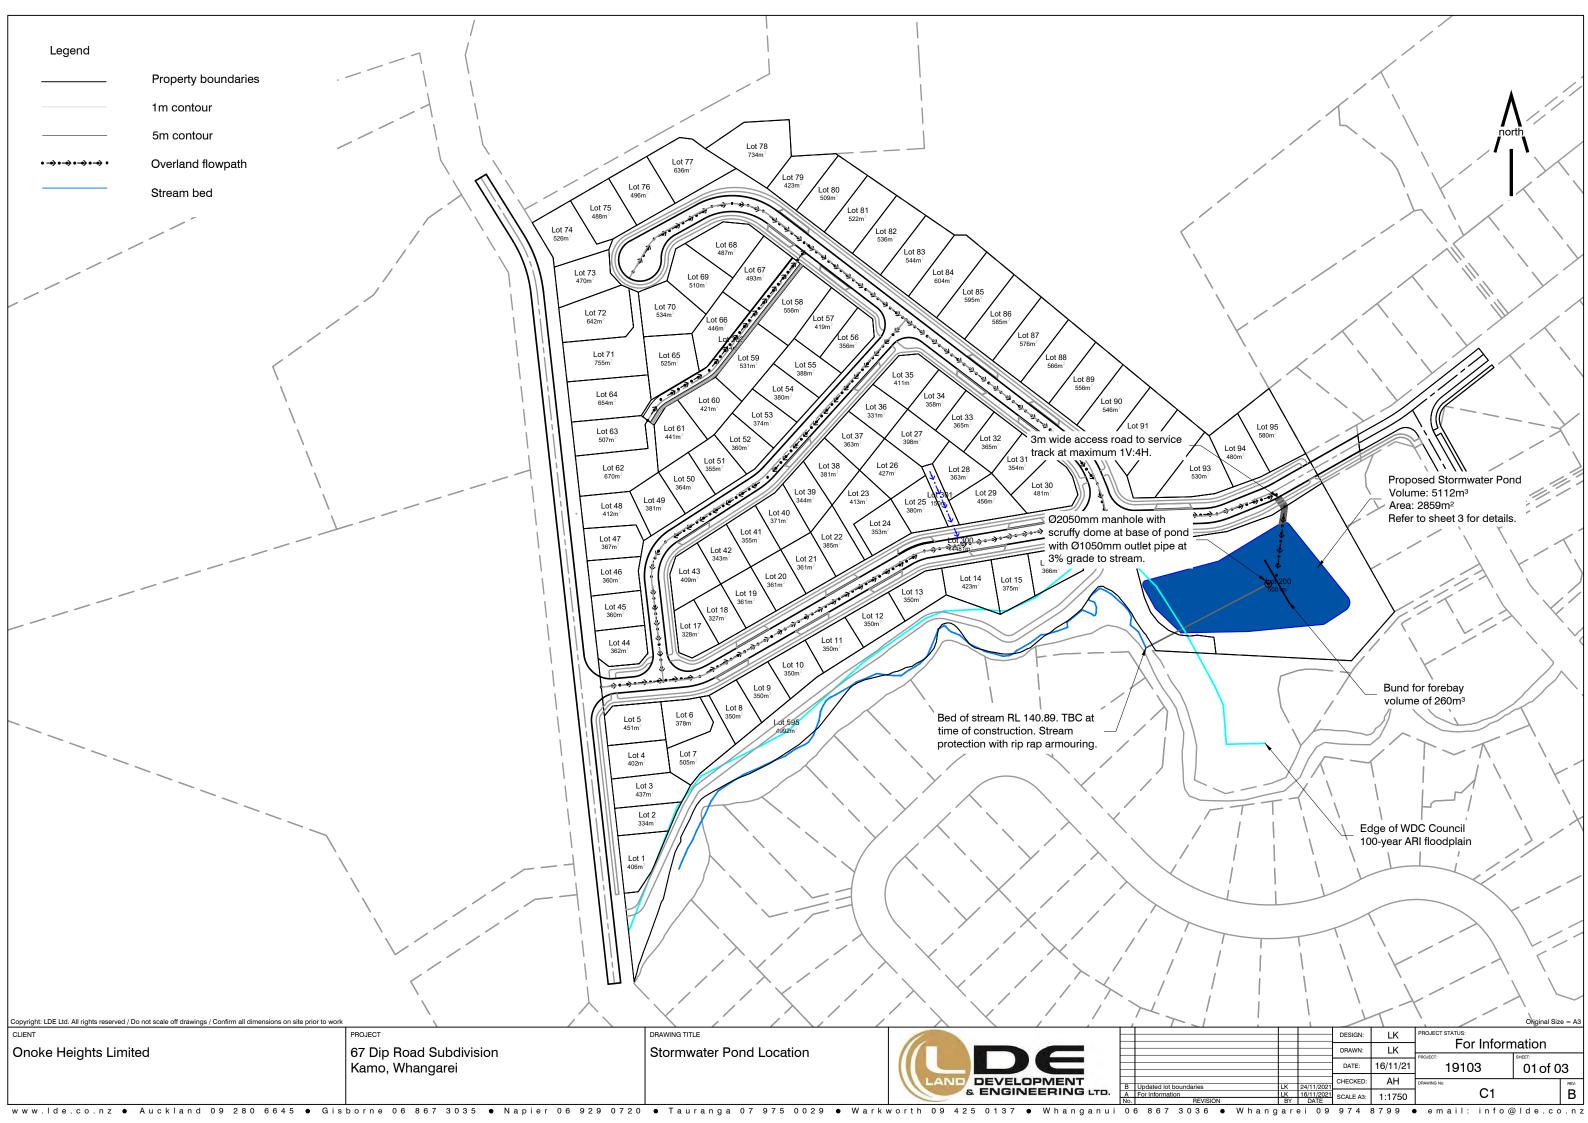
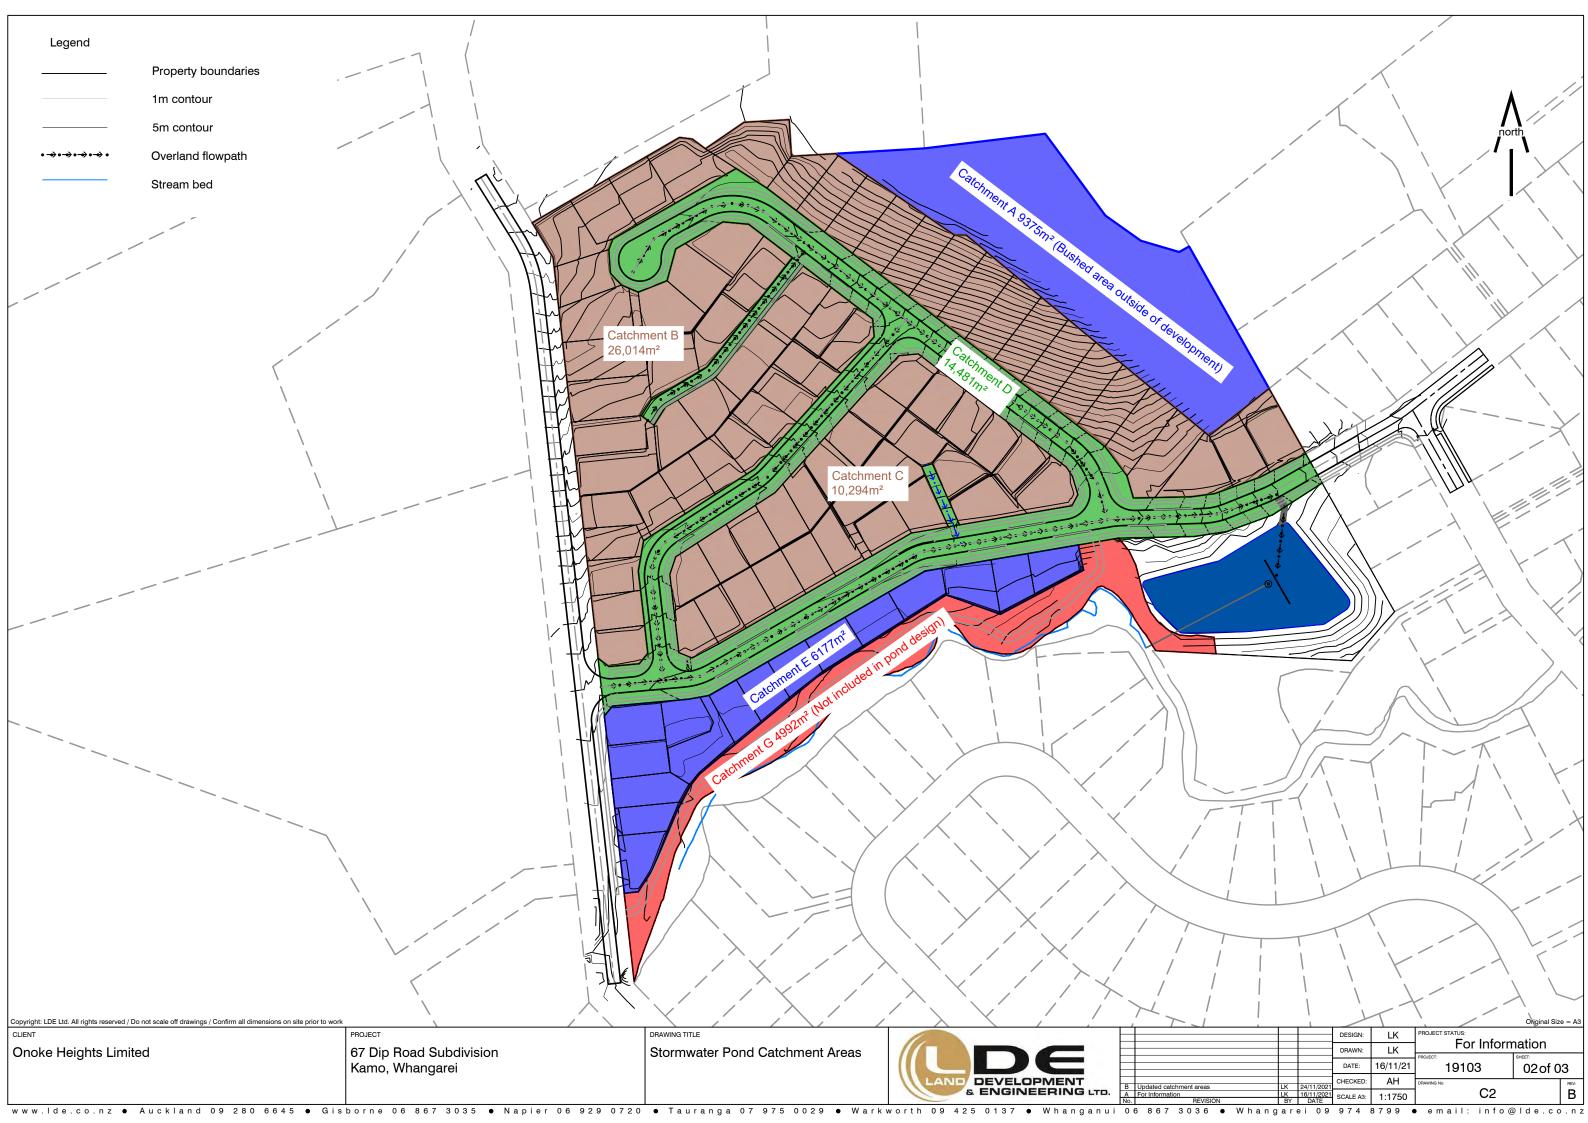
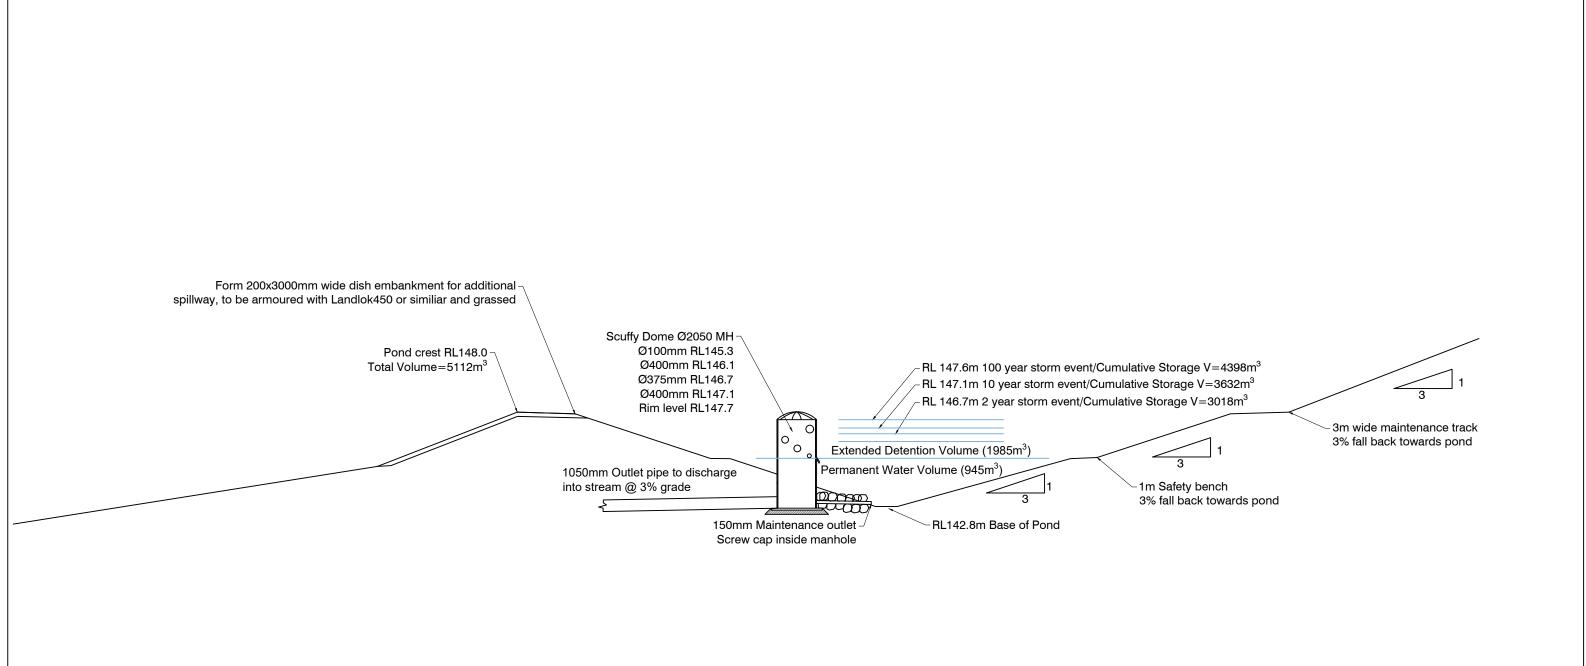
CONTENTS							
SHEET	DESCRIPTION	ISSUE DATE	STATUS	REVISION				
1	Stormwater Pond Location	24/11/2021	For Information	В				
2	Stormwater Pond Catchment Areas	24/11/2021	For Information	В				
3	Stormwater Pond Section	16/11/2021	For Information	Α

The proposed stormwater system has been designed by LDE and is detailed in Three Waters Design Report (Appendix 4). This report concludes that the proposal will improve the potential flood hazard risk for adjacent properties and downstream because:

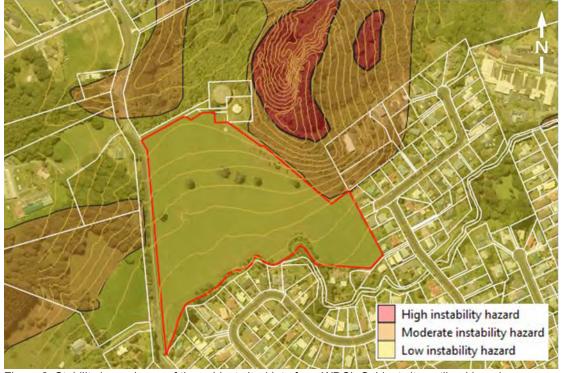
Figure 2: Stability hazard map of the subject site (data from WDC). Subject site outlined in red.

The site is mapped entirely as low instability hazard on the Whangarei District Council Hazard Maps. The slopes to the northeast of the site are mapped as moderate instability hazard. The only high hazard area identified in the vicinity of the site is a large, narrow gully landform to the northeast of the site as shown on Figure 2.

Notably, a clear track is present leading into the gully feature (high instability hazard area indicated on Figure 2) directly from the railway line to the northeast. The gully itself is in scrub and the track appears overgrown. This appears to indicate that the gully is more likely a disused scoria quarry. Given the age at state of this feature by 1942, it is inferred that this was likely used in the early 1900s and was perhaps a borrow area for the construction of the North Auckland railway line.

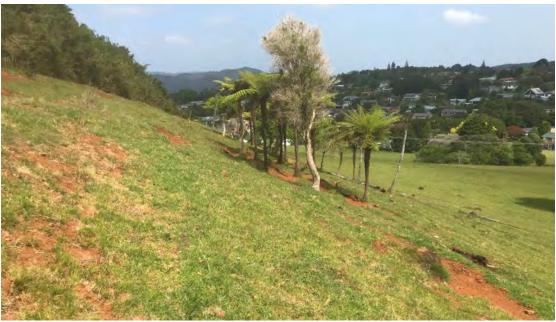
The north-eastern edge of the site borders the mapped scoria cone, with the side slope of this feature forming a steep bank at the boundary, with slopes up to approximately 1V:2H (27°) (Figure 4). A rough track is cut along of the top of this slope, appearing to follow the alignment of the watermains which pass through the site.

Figure 5: Photo showing the steep slope at the north-eastern boundary.

Qualitative assessment of the stability hazard through theses areas has been undertaken based on the findings of the subsurface investigation, laboratory testing, and geomorphic study. These areas are photographed in Figure 5 and 6 respectively, and are broadly delineated by the white dashed line on Figure 4.

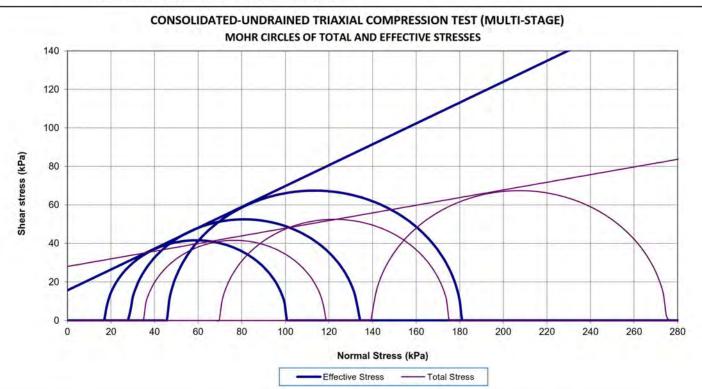
Test method used: ISO 17892-9:2018 Part 9 Isotropic consolidated-undrained triaxial compression test on water saturated soils (CIU)

General Sample Parameters						
Initial Sample Height:	175.03	mm	Initial Water Content:	96.0	%	
Initial Sample Diameter:	85.64	mm	Initial Bulk Density:	1.34	t/m³	
Initial B Value:	30	%	Initial Dry Density:	0.68	t/m³	
B Value before Consolidation:	94	%	Final Water Content:	101	%

Test Res	ults					
At the End of Consolidation Stage						Failure Values						F
	Effective	e Stress	Back	Volu	metric	<b>Deviator Stress</b>	Vertical	Effective Stress		Corrections (kPa)		Т
	Horizontal σ <sub>h</sub> '(kPa)			Strain (%)	Rate (%/hr)	(σ <sub>v</sub> ' - σ <sub>h</sub> ') (kPa)	Strain ε (%)	Vertical σ <sub>v</sub> ! (kPa)	Horizontal σ <sub>h</sub> '(kPa)	Membrane $(\Delta \sigma_v)_m$	Filter P $(\Delta \sigma_v)_{fp}$	
Stage 1	35	36	500	0.40	0.00	83.24	1.91	100.64	17.40	0.38	2.80	
Stage 2	70	71	500	1.16	0.00	105.04	1.34	133.64	28.60	0.26	1.96	
	100 30							A. Calantin and				1
