Poutō Peninsula

Waingata (Poutō), NRC Lake No. 371.

Summary	Waingata
Surveyed:	2005, 2010, 2018 (reconnaissance) and 2021
Overall ranking:	Moderate : Mostly de-vegetated by grass carp, but emergent vegetation starting to reestablish in fenced areas indicating grass carp numbers have declined below the threshold where grazing pressure can suppress plant growth. Freshwater mussels present.
Threats:	Low risk of introduction and establishment of invasive weeds. Water quality poor.
Management recommendations:	No regular lake native biodiversity value monitoring until grass carp numbers are insufficient to prevent submerged vegetation reestablishment.

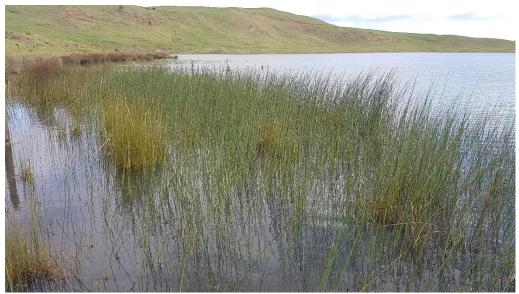
Figure Error! No text of specified style in document.-1: Waingata. Photo showing the re-establishment of emergent vegetation within the fenced area (Photo: Paul Champion 19 September 2018).

Emergent species were noted in 2018, for the first time since grass carp were stocked, within an area where stock were excluded by fencing. Species included *Schoenoplectus tabernaemontani*, *Eleocharis acuta*, oioi (*Apodasmia similis*) and *Juncus pallidus*. The pest plant alligator weed (*Alternanthera philoxeroides*) was well established around the lake in 2001 and has continued to proliferate.

No regular lake native biodiversity value monitoring is advocated until grass carp numbers are insufficient to prevent submerged vegetation reestablishment.

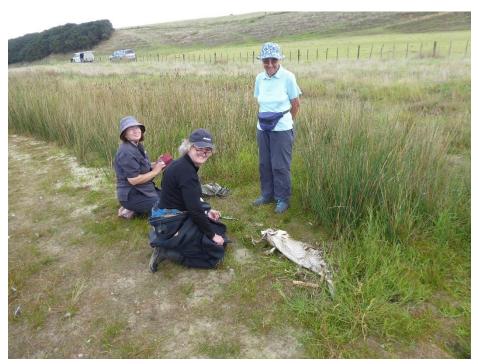
The lake was stocked with rainbow trout (*Oncorhynchus mykiss*) in the 1950's until 1980 but have since died out. Īnanga (*Galaxias maculatus*) was present in the lake and was recorded as abundant in 1997. Common bully (*Gobiomorphus cotidianus*) were the only other fish present in Waingata until 67 grass carp (*Ctenopharyngodon idella*) were introduced in 1995 to eradicate the pest plant elodea (*Elodea canadensis*). There are very few, if any, grass carp remaining in the lake with two dead fish (~75 cm long) seen on the lake shore. Bullies were common in 2021.

Dead grass carp on the margin of Waingata (Paul Champion 2021)
