Poutō Peninsula

Black Lake North (Poutō), NRC Lake No. 349

Summary	Black Lake North
Surveyed:	Recce 2022
Overall ranking:	Moderate: A small lake with highly stained water, native submerged and emergent vegetation.
Threats:	Nutrient inputs from land use in the catchment may have led to an enriched water quality causing algal blooms and loss of freshwater mussels and dense submerged vegetation. Submerged weed invasion is unlikely due to the lake's isolation but hornwort is present in several lakes to the north.
Management recommendations:	Limited further monitoring, e.g., surveillance for submerged weeds every five years.

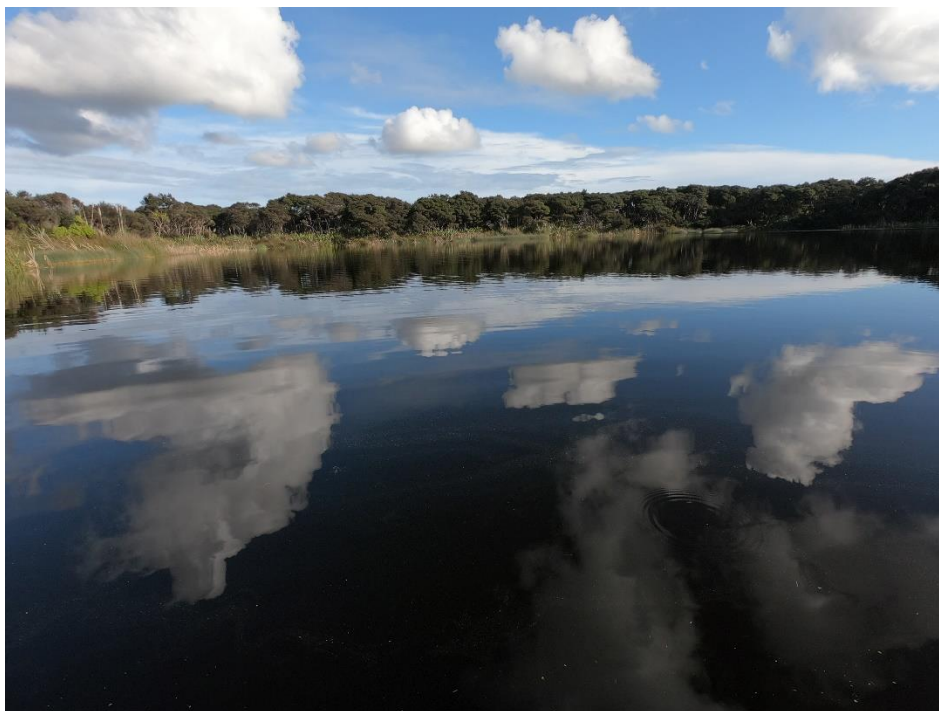
Figure: Black Lake North. Photo taken from the centre of the lake looking north, showing dark tea-stained water and high covers of marginal emergent species. (Photo: Daniel Clements, 10 August 2022).

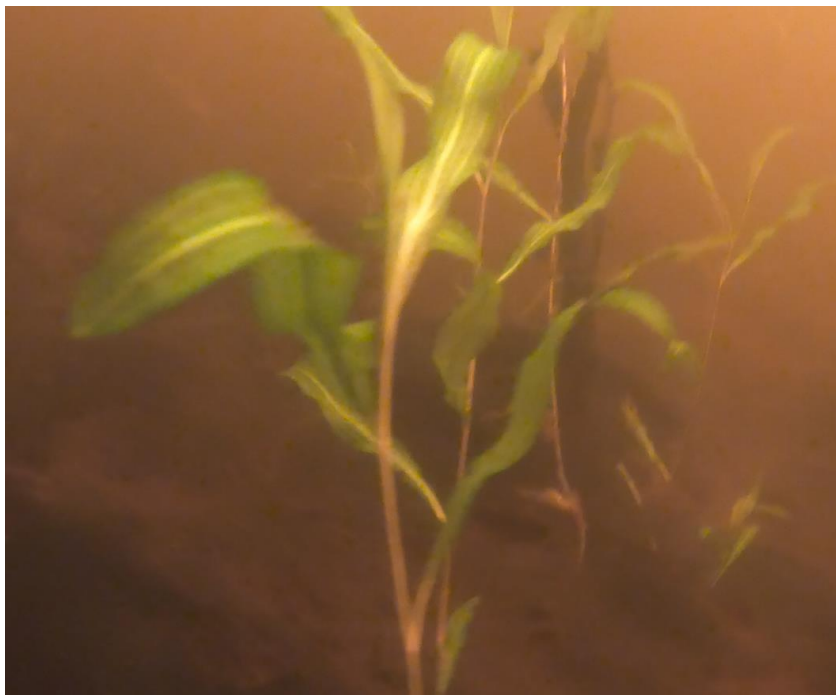
In 2022, the submerged vegetation was surveyed using snorkel, rake and sonar. Underwater visibility was poor, estimated at 1 m, mostly due to heavy brown staining but also with floccy material from a recent algal bloom. Native species formed low covers, with the pondweed *Potamogeton cheesemanii* and the charophyte *Chara australis*. They were found at a maximum depth of 3.6 m with an average cover of < 5% on the four transect sites. The invasive weed *Utricularia gibba* was found at low covers amongst marginal emergent vegetation.

***Potamogeton cheesemanii* in Black Lake North** (Photo: Daniel Clements 10 August 2022)

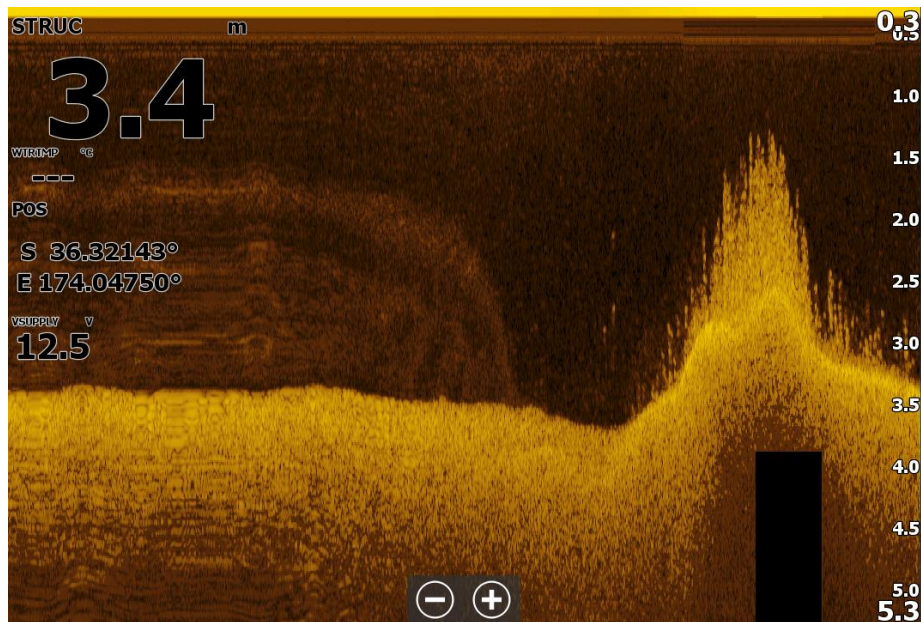
Local high cover of *Potamogeton cheesemanii* (right of sonar scan) in Black Lake North.
