# **Water quality investigation Raumanga catchment 2021-2022**

Northland Regional Council, Natural Resources Science Report No: TR2023/ FWQlty/01  
Report Date: August 2023  
Project Number (IRIS regime #): REG.852690.01

Chakraborty, M. 2023. Water quality investigation Raumanga catchment 2021-2022. Northland Regional Council, Whangārei, New Zealand.

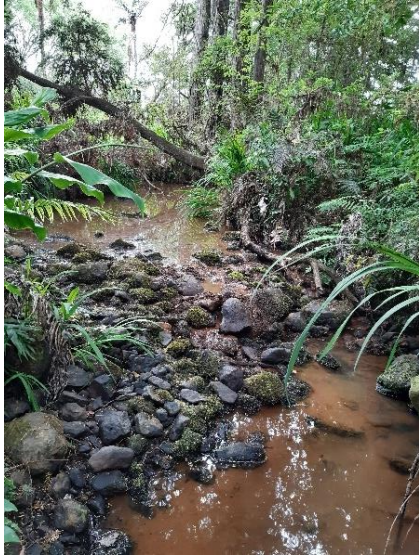
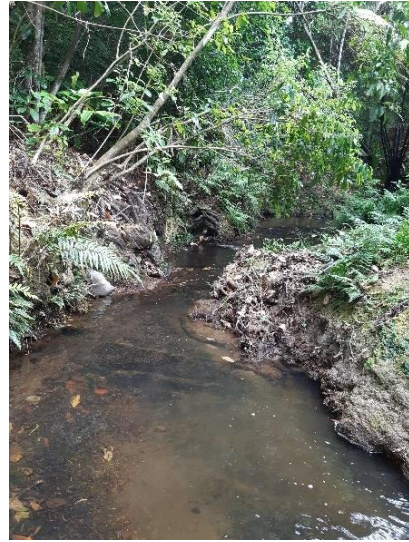
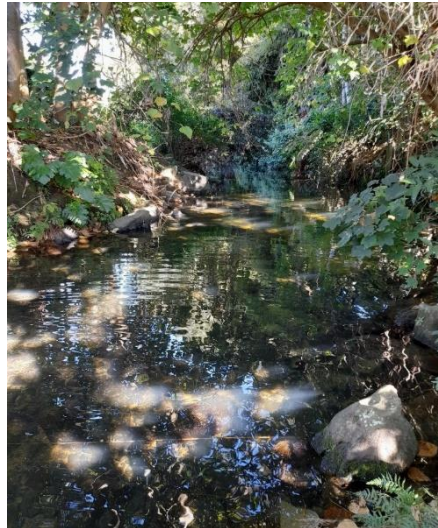
(a) Nihotetea Stream (to the left) and its unnamed tributary (to the right) at Austin Road.

(b) Nihotetea Stream upstream of Waiponamu Stream confluence at Kotuku Street Dam.

(c) Waiponamu Stream upstream of Nihotetea Stream confluence at Kotuku Street Dam.

(d) Te Hihi Stream at Highfield Way.

(e) Raumanga at Bernard Street

Figure 3: Photos of the water quality monitoring sites (in upstream to downstream order) that were selected for water quality investigation in the Raumanga catchment.

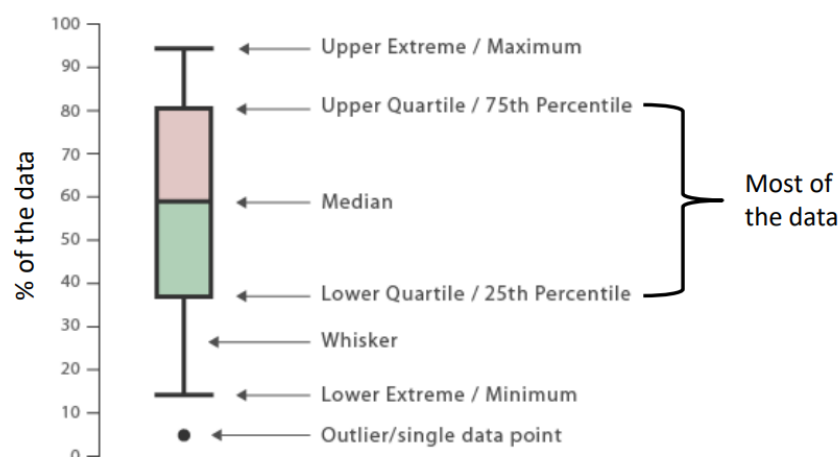
Figure 4: Explaining box plot.

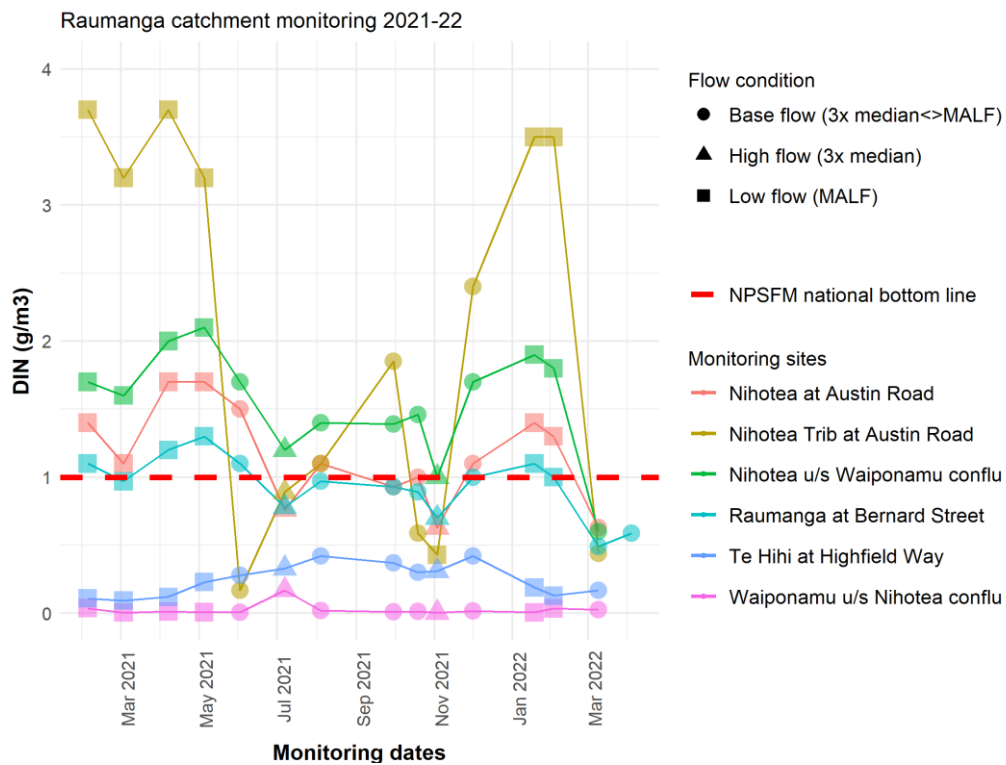
Figure 6: Comparing monthly results of Dissolved inorganic nitrogen (DIN) concentrations categorised by flow conditions across the monitoring sites over the whole monitoring period. Red hashed line = NPS-FM bottom line for annual median concentration. Flow categories are based on hydrological data at Raumanga site.

It was noticed, a major proportion of the total nitrogen (Total N) concentrations in the Nihotetea and Raumanga Stream sites was comprised of inorganic nitrogen (DIN) as opposed to the Waiponamu Stream which had a very low proportion of DIN (Figure 7) mainly because of its high proportion of Total Kjeldahl Nitrogen (TKN) or organic nitrogen influenced by its moderately poor soil drainage properties and reducing (low oxidising potential) catchment geology.

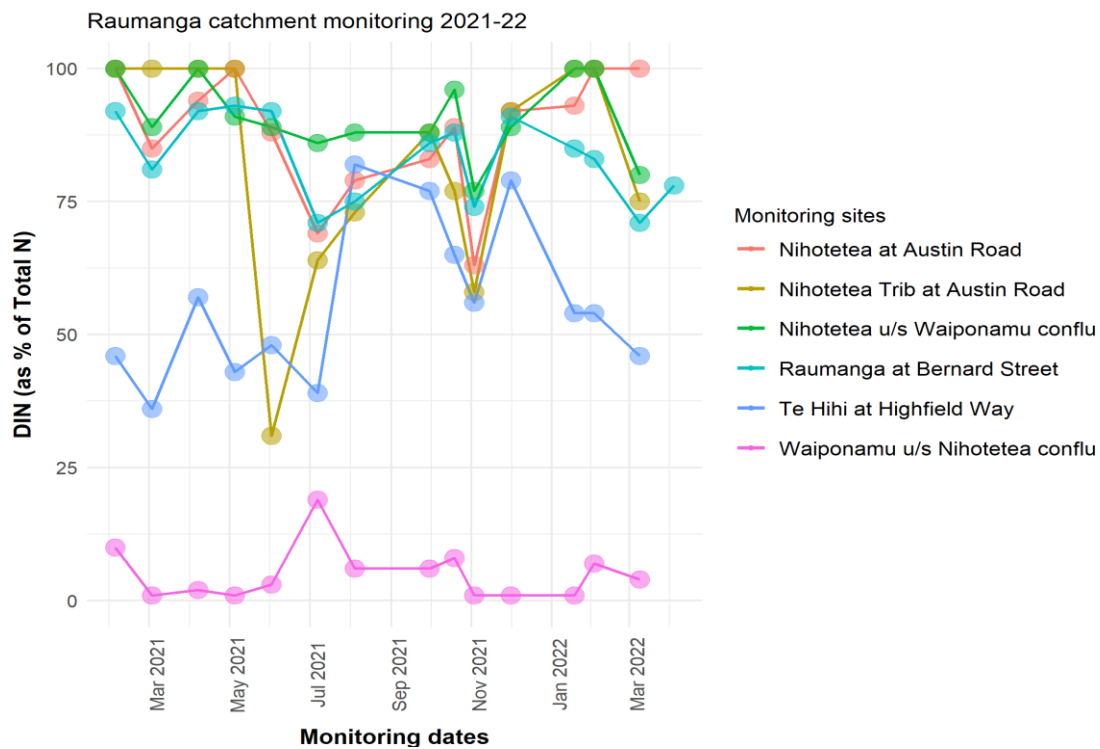
Figure 7: Comparing monthly results of Dissolved inorganic nitrogen (DIN) concentrations as proportion of total nitrogen (Total N) across the monitoring sites over the whole monitoring period.

On the other hand, a seasonal pattern was observed for Te Hihi Stream site where DIN as proportion of Total N was higher during winter wet months (perhaps due to surface run off and oxygen rich water)

and comparatively low during summer low flows (perhaps due to decomposition of organic matter and moderately reducing environment, therefore less denitrification process). A recent study by Land & Water Science (Rissmann and Pearson 2020) on physiographic control over Northland's river water quality found organic nitrogen (TKN) together with NH<sub>4</sub>-N constituting the bulk of nitrogen loads at most of our rivers. This finding by Rissmann and Pearson 2020 did not match with the water quality results for Nihotetea Stream catchment for obvious variation in physiographic properties and their complex control on water quality process together with unknown land management practices at smaller sub-catchment scale.

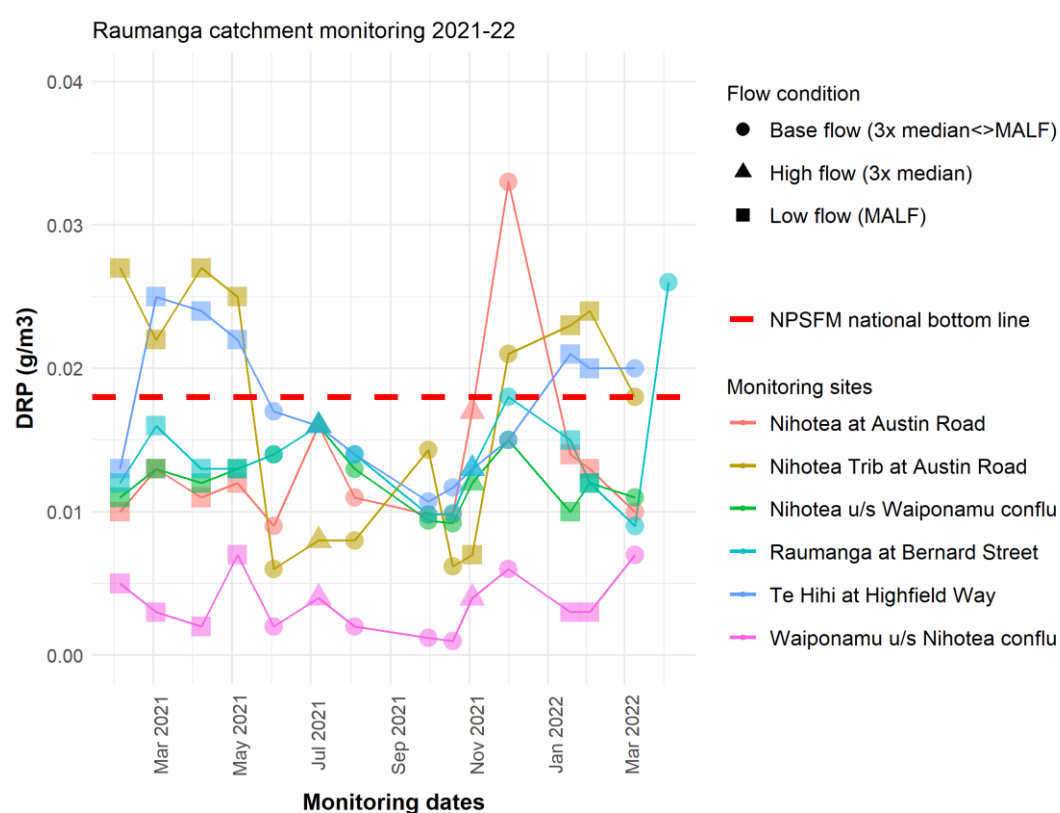
*Figure 8: Comparing monthly results of Dissolved reactive phosphorus (DRP) concentrations categorised by flow conditions across the monitoring sites over the whole monitoring period. Red hashed line = NPS-FM bottom line for annual median concentration. Flow categories are based on hydrological data at Raumanga site.*

Annual median concentrations of the Dissolved reactive phosphorus (DRP) were less than the NPS-FM national bottom line at most of the sites except at Nihotetea Trib at Austin Road (Table 4). The median DRP at Te Hihi Stream site, although did not breach, but was still close to the national bottom line (Figure 5c). The DRP concentrations at all sites satisfied the national bottom line for 95<sup>th</sup> percentile as well as the Northland objective value. While high DRP concentrations in Northland rivers are mostly associated with Basalt rocks from Tangihua Volcanic Complex and terrain ruggedness, the volcanic rocks from Kerikeri Volcanic Group unit, which is also found in Raumanga catchment, are less implicated in DRP generation (Rissmann and Pearson 2020). On the other hand, the Tauranga Group peat sediments in lowland floodplains (such as), particularly in developed lands, are also associated with high DRP generation, which could explain the high DRP in Te Hihi Stream and Nihotetea Trib at Austin Road. The monthly water quality results show that these high DRP concentrations in Te Hihi Stream and Nihotetea Trib at Austin Road mostly occur during summer low flow and base flow conditions, but not in winter months because of dilution effect.

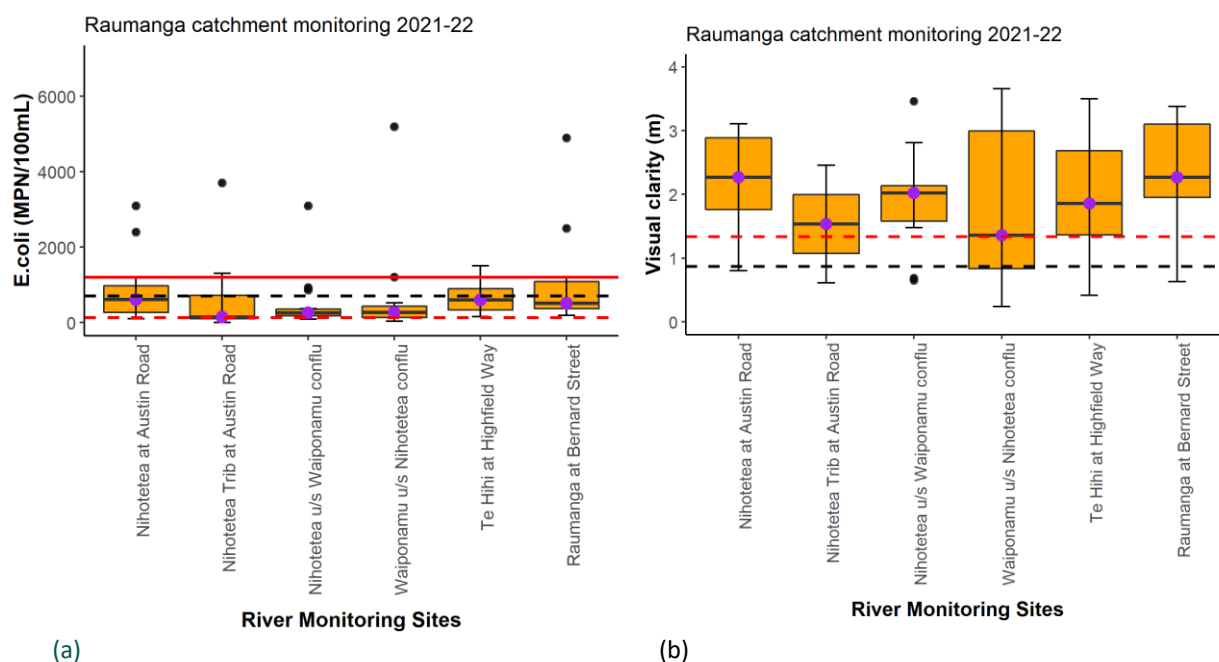
Figure 9: Box plots showing the distribution of *E. coli* (a), and visual clarity (b). Purple dots = median, Red solid line = NPS-FM national bottom line for annual 95<sup>th</sup> percentile concentration, Red hashed line = NPS-FM bottom line for annual median concentration, Black hashed line = Northland objective value.

*E. coli* numbers (both annual median and 95<sup>th</sup> percentile) were much higher than the national bottom line values at all sites, however none of the median concentrations breached the Northland objective value of 703 MPN/100ml (Table 4, Figure 8a). This means still 50 percent of the time *E. coli* numbers were lower than the worst results observed in some of the regional reference sites. This trend of exceptionally high *E. coli* concentrations is quite similar throughout Northland rivers except in catchments with high natural state condition such as Waipoua Forest and Punaruku at Russell Road (Muirhead et al. 2023). Distribution of *E. coli* results from the box plots showed comparatively high *E. coli* concentrations in Nihotetea at Austin Road and Te Hihi Stream, which could be partially related to runoff from developed pastoral land-use, as well as the faecal pathogens from animal pests and wildfowls. Further downstream in Raumanga mainstem the faecal pathogen can also be related to old sewage and stormwater systems and lifestyle blocks. Even if there was no clear association between river flow conditions (as well as rainfall events) and high *E. coli* concentrations, most of the samples collected during low flow and base flow conditions satisfied the Northland objective value, while some of the high concentrations were particularly related to high flow conditions indicating the diffuse source of microbial contamination (Figure 9). Diffuse pollution source has been identified as a major source of microbial contamination in Northland's waterways by Muirhead et al. (2023). Previously, microbial source tracking results indicated that the primary source of contamination within the Whangārei Harbour catchment is ruminant but human markers have also been detected on several occasions at the Raumanga at Bernard Street site.

None of the sites failed the NPS-FM visual clarity standards, however the annual median black disk readings (measure of horizontal visibility through water column) were close to the national bottom line at the two sites - Waiponamu Stream and Nihotetea Trib at Austin Road site. Annual medians of visual clarity were also higher than the Northland objective value for all sites monitored. Low visual clarity is mainly influenced by elevated suspended sediments in the water column because of large rainfall

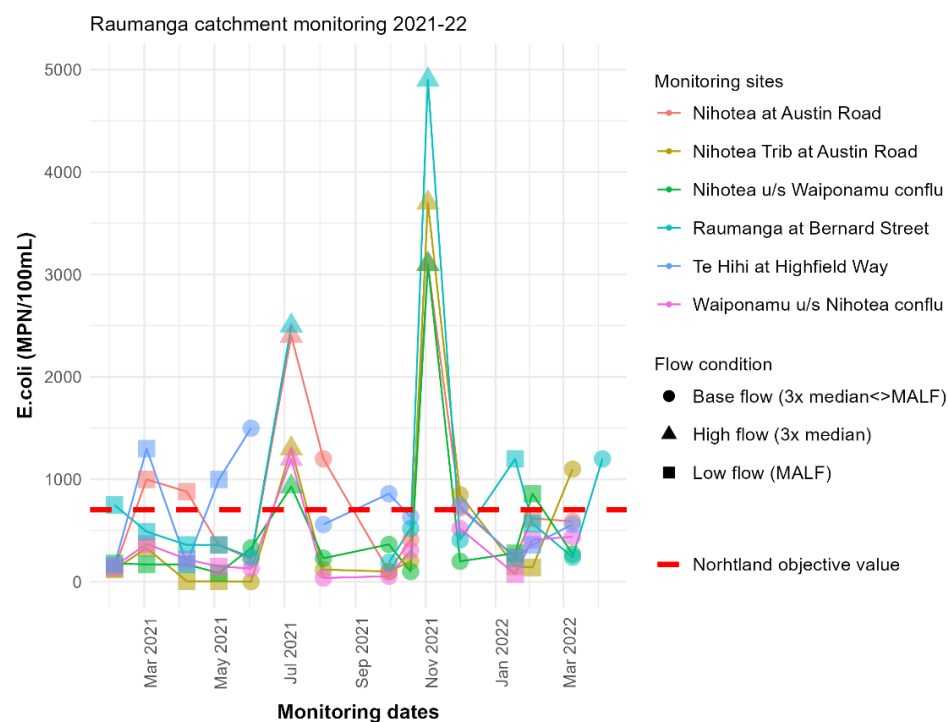
Figure 10: Comparing monthly results of *E. coli* concentrations among sites over the whole monitoring period. Here **Red hashed line** = Northland objective value. Flow categories are based on hydrological data at Raumanga site.

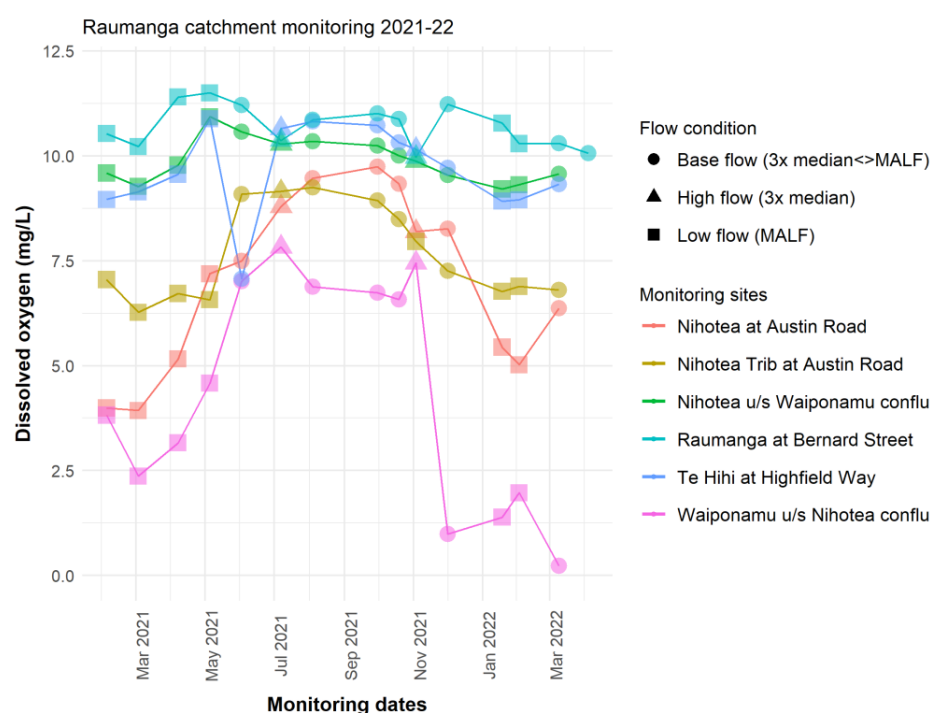
Figure 12: Comparing monthly results of dissolved oxygen (mg/L) among sites over the whole monitoring period. Flow categories are based on hydrological data at Raumanga site.

Dissolved oxygen (DO) is an important water quality attribute, which provides life supporting capacity value to fish and freshwater invertebrates. The seasonal and diurnal (day vs night-time) fluctuation in DO level is generally influenced by water temperature, stream characteristics, in-stream biological activities and atmospheric pressure. Biological activities include photosynthesis and respiration by aquatic plants and algae and decomposition of organic matter such as sewage effluent, decaying vegetation and animal manures. Therefore, high fluctuation in DO maxima and minima, particularly during summer months, often indicate poor river water quality and imbalanced biological activities. The DO concentrations (min., median and 5<sup>th</sup> percentiles) observed at Nihotetea Stream upstream of Waiponamu confluence, Te Hihi Stream at Highfield Way and Raumanga Stream at Bernard Street were indicative of healthy ecosystem. However, the DO values were exceptionally low at Waiponamu Stream (min. = 0.2 mg/L, median = 4.2 mg/L, 5<sup>th</sup> percentile = 0.7 mg/L) and Nihotetea Stream at Austin Road (min. = 3.9 mg/L, median = 7.3 mg/L, 5<sup>th</sup> percentile = 4 mg/L) (Appendix 1). The low DO values at Waiponamu Stream and Nihotetea Stream at Austin Road, mostly during summertime (Figure 12), could be linked to deoxygenated groundwater movements constituting the bulk of their base flows as well as macrophyte growth in a very slow-moving channel.

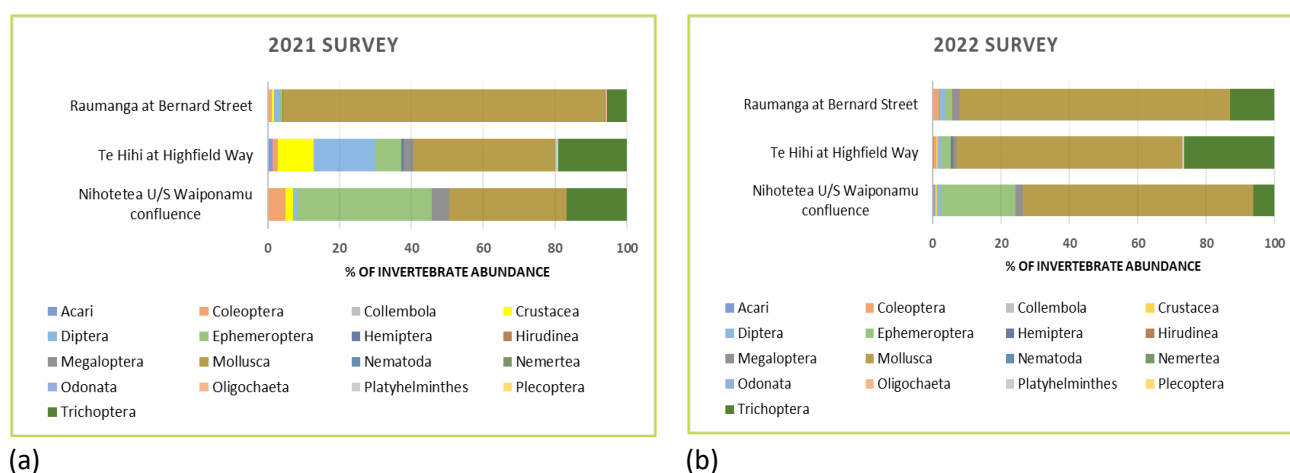
Figure 13: Various insect groups as percentage of macroinvertebrate community abundance observed at the three Raumanga catchment investigation sites during 2021 (a) and 2022 (b) annual invertebrate survey.

From the analysis of macroinvertebrate community structures at these sites it was obvious that the presence of abundant high scoring (MCI tolerance value) mayfly species (Ephemeroptera) such as *Austroclima*, *Deleatidium*, *Nesameletus*, *Zephlebia*, and *Coloburiscus* (a sensitive species adapted to forested streams) at the Nihotetea mainstem site contributed to its good macroinvertebrate scores compared to the other sites. On the other hand, caddisflies were abundant at the Te Hihi Stream site, which was mainly dominated by *Aoteapsyche*, a low scoring EPT tolerant to moderate pollution. However, the absence of stonefly species (Plecoptera) and abundance of pollution tolerant snail species (insect group - Mollusca) *Potamopyrgus* was noticeable at all sites, indicating degraded water quality in the catchment (Figure 13).
