Te Hiku

Te Urungi o Ngati Kuri Dam (Aupouri), NRC Lake No. 49A.

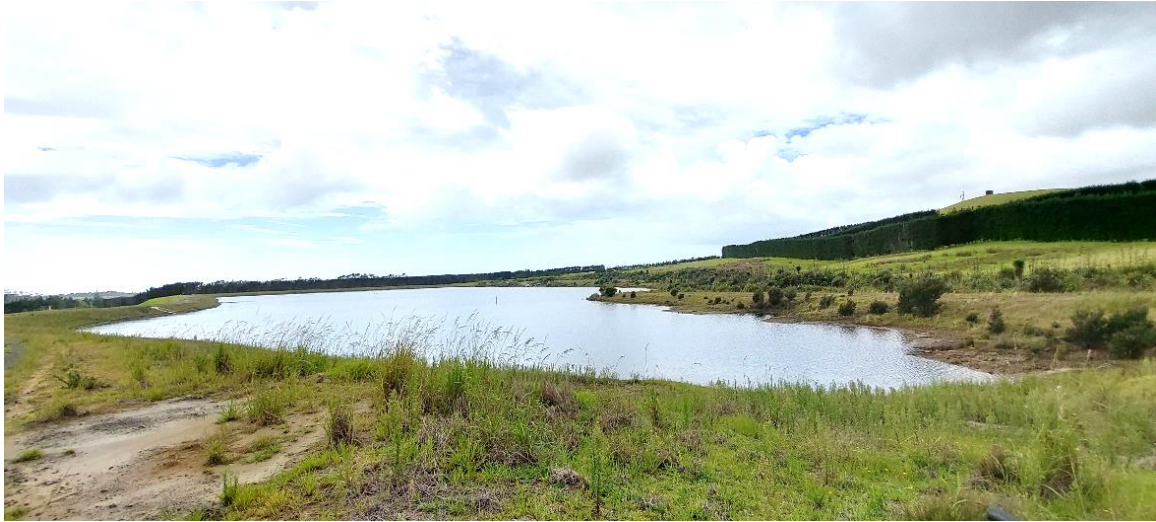
Te Urungi o Ngati Kuri Dam viewed from the western end, with a rank grass or bare substrate surrounding the water body (Aleki Taumoepeau 2023).
