26 Cable Bay

Coastal Erosion Hazard Assessment

NORTHLAND REGIONAL COUNCIL

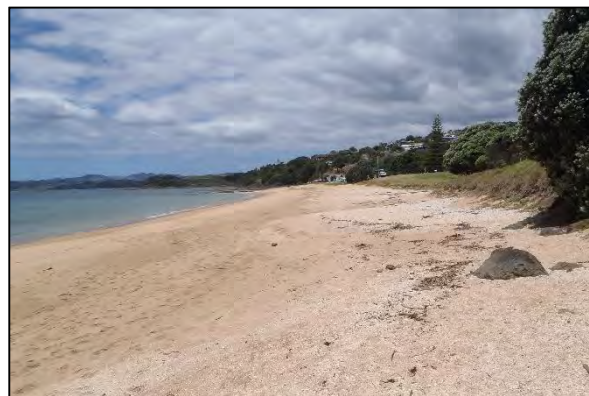
Site Photograph A (looking east)

The site has a relatively steep sandy beach comprising medium to coarse sand with a shell component. The beach has a berm width of approximately 5 – 15 m above the high tide line. The berm width is widest at the eastern end.

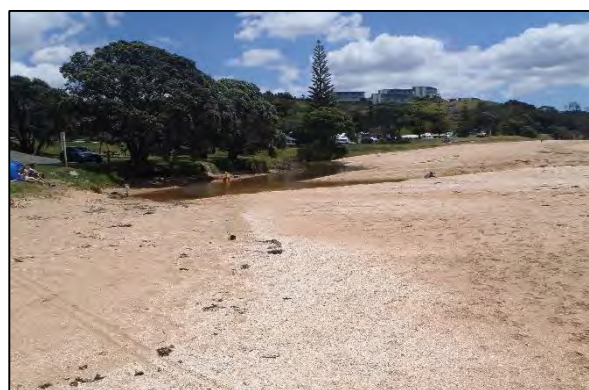
Site Photograph B (Opoi Stream mouth)

Opoi Stream mouth is located approximately 200 m from the eastern extent of the site and has a localised effect on the shoreline position. The stream meanders east along the backshore for approximately 80 m forming a small lagoon before cutting through the beach. There is erosion along the backshore edge of the stream.

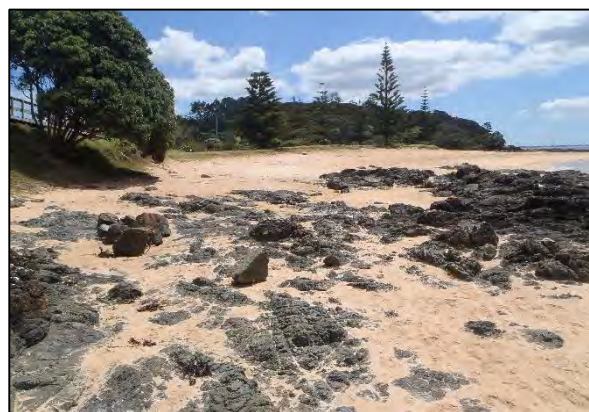
Site Photograph C (reef at western end)

The site morphology changes at the location of the nearshore reef situated approximately 200 m west of the Opoi Stream mouth (cell 26D). The backshore rises in elevation up to RL 8 m and comprises weakly consolidated colluvium material. The basalt reef extends through the beach up to the backshore area under the colluvium material. The rock reef has a width of approximately 200 m (Photograph C).

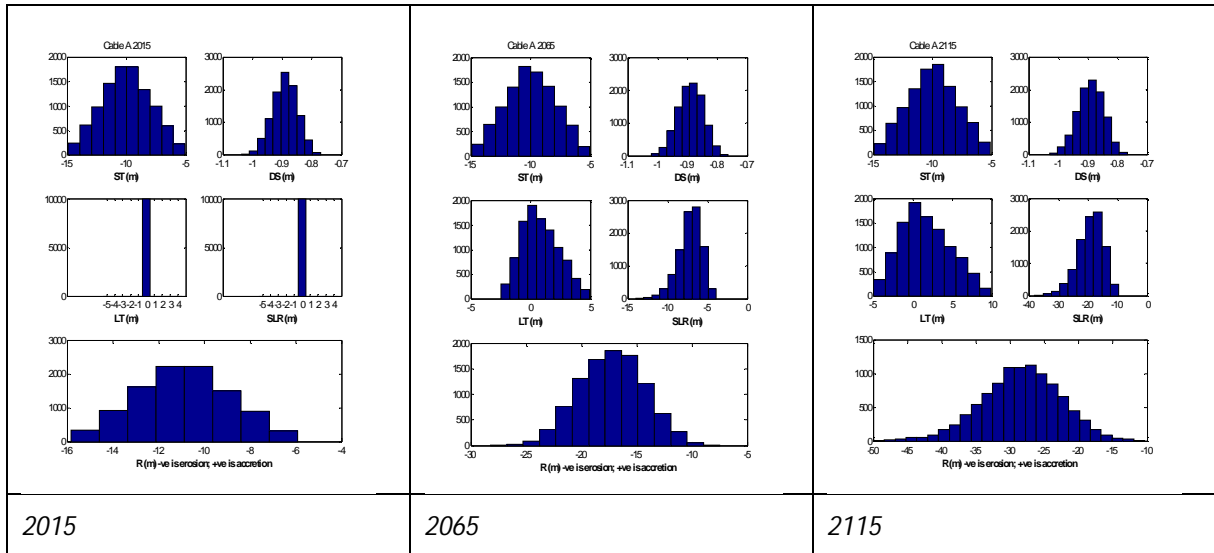
Figure 26-1 Histograms of parameter samples and the resultant shoreline distances for 2015, 2065 and 2115 timeframes for cell 26A

Histograms of individual components and resultant CEHZ distances using a Monte Carlo technique are shown in Figure 26-1 to figure 26-4.

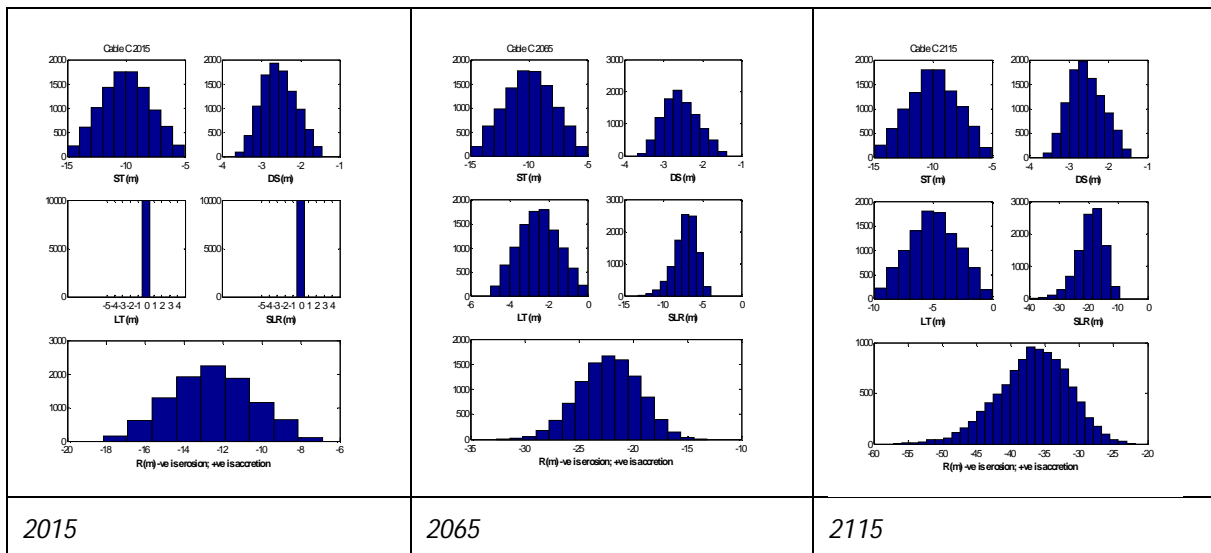
Figure 26-3 Histograms of parameter samples and the resultant shoreline distances for 2015, 2065 and 2115 timeframes for cell 26C

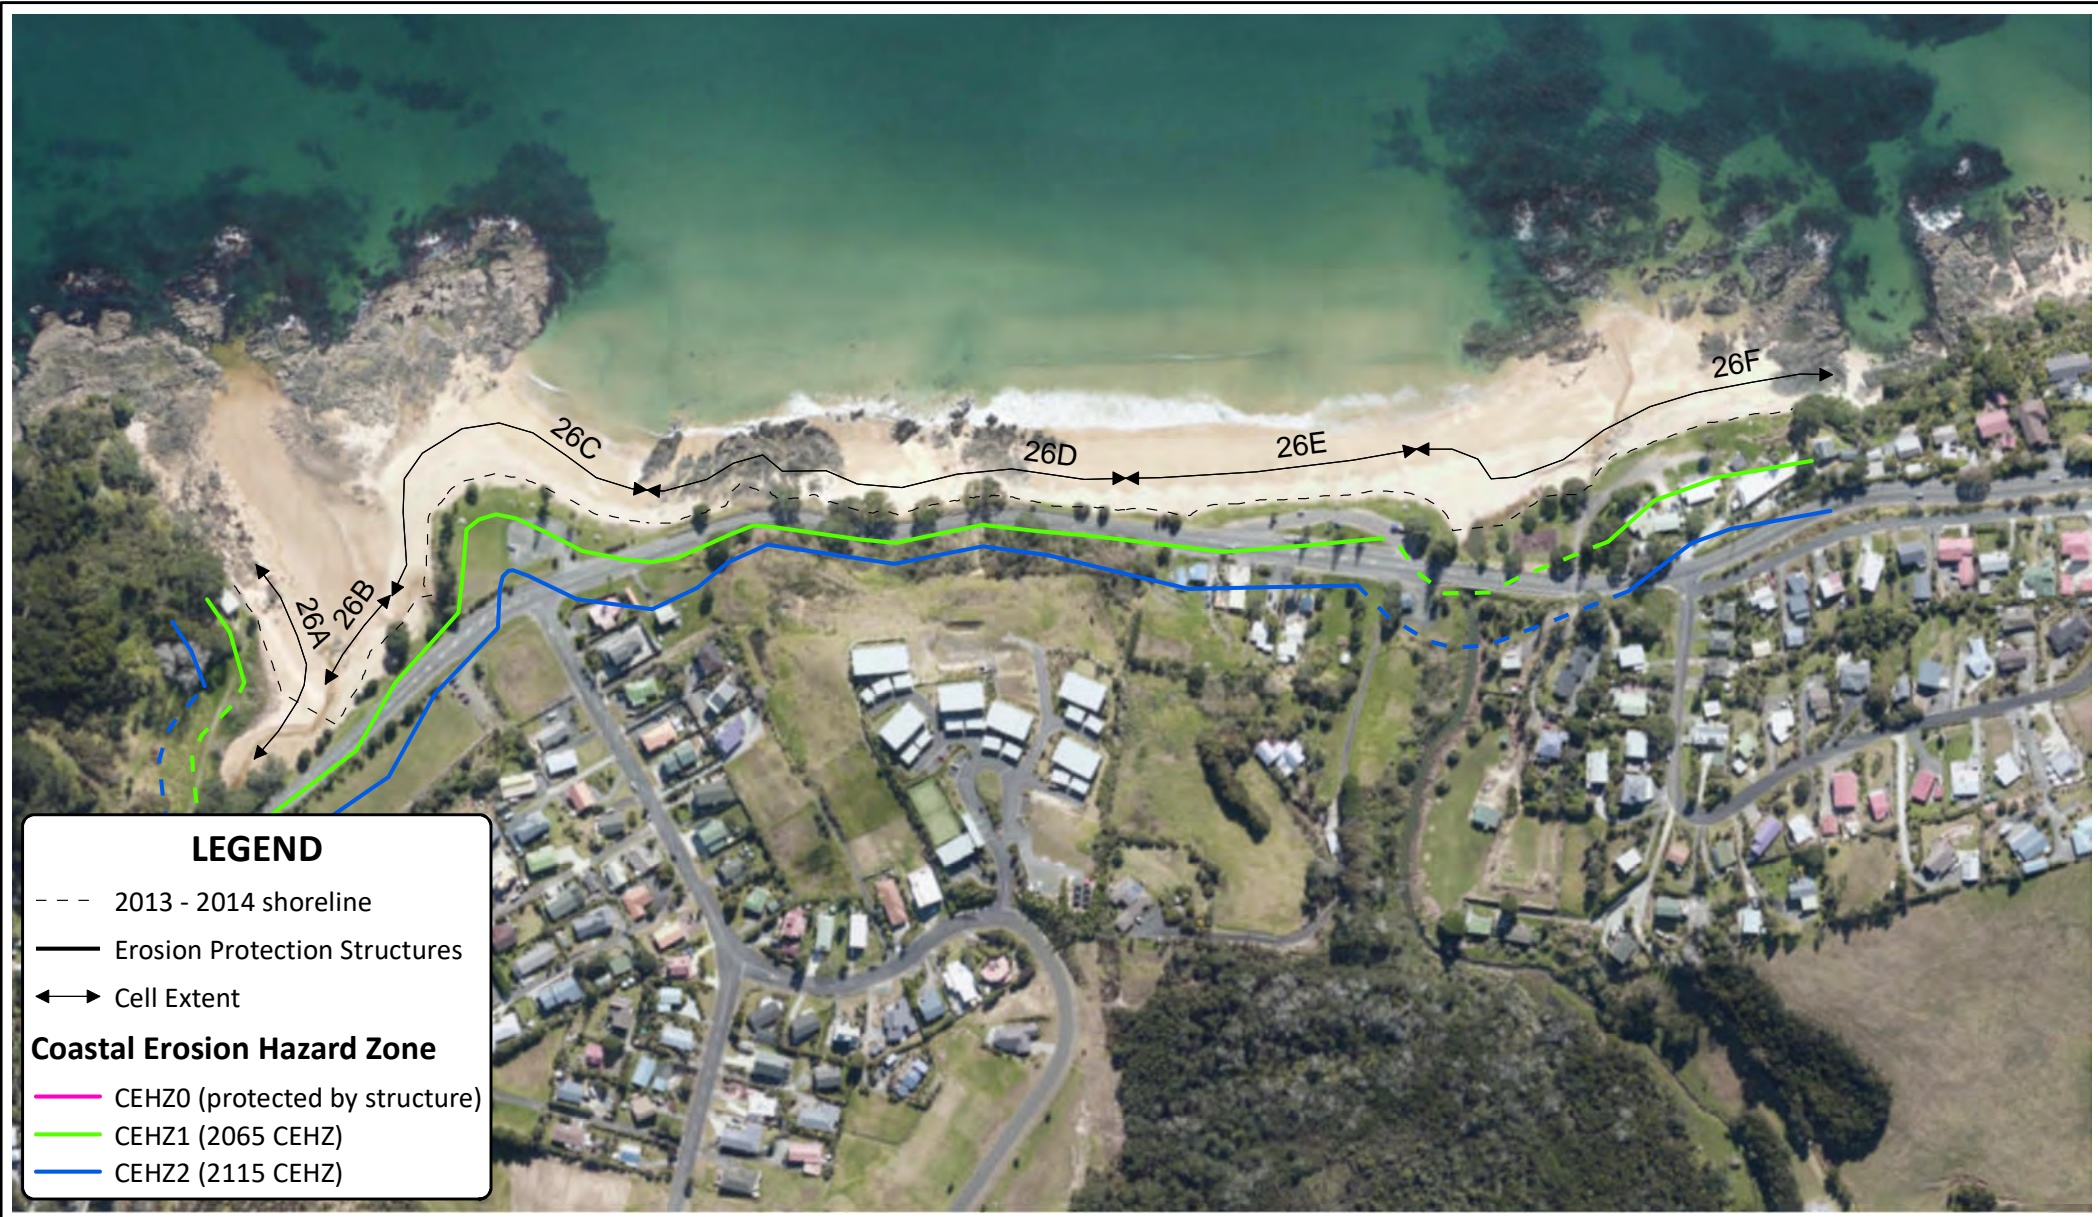
FIGURE No. Figure 26-7

Notes: Dashed CEHZ indicates greater uncertainty around stream mouths and backshore topography. Northland 0.1m Rural Aerial Photos (2014-2015).

Coastal Erosion Hazard Zone widths are presented within Table 26-2 and Figure 26-5.

CEHZ's have been mapped in agreement with the calculated values, although lines have been dashed around stream entrances to reflect the increased uncertainty due to fluvial processes.

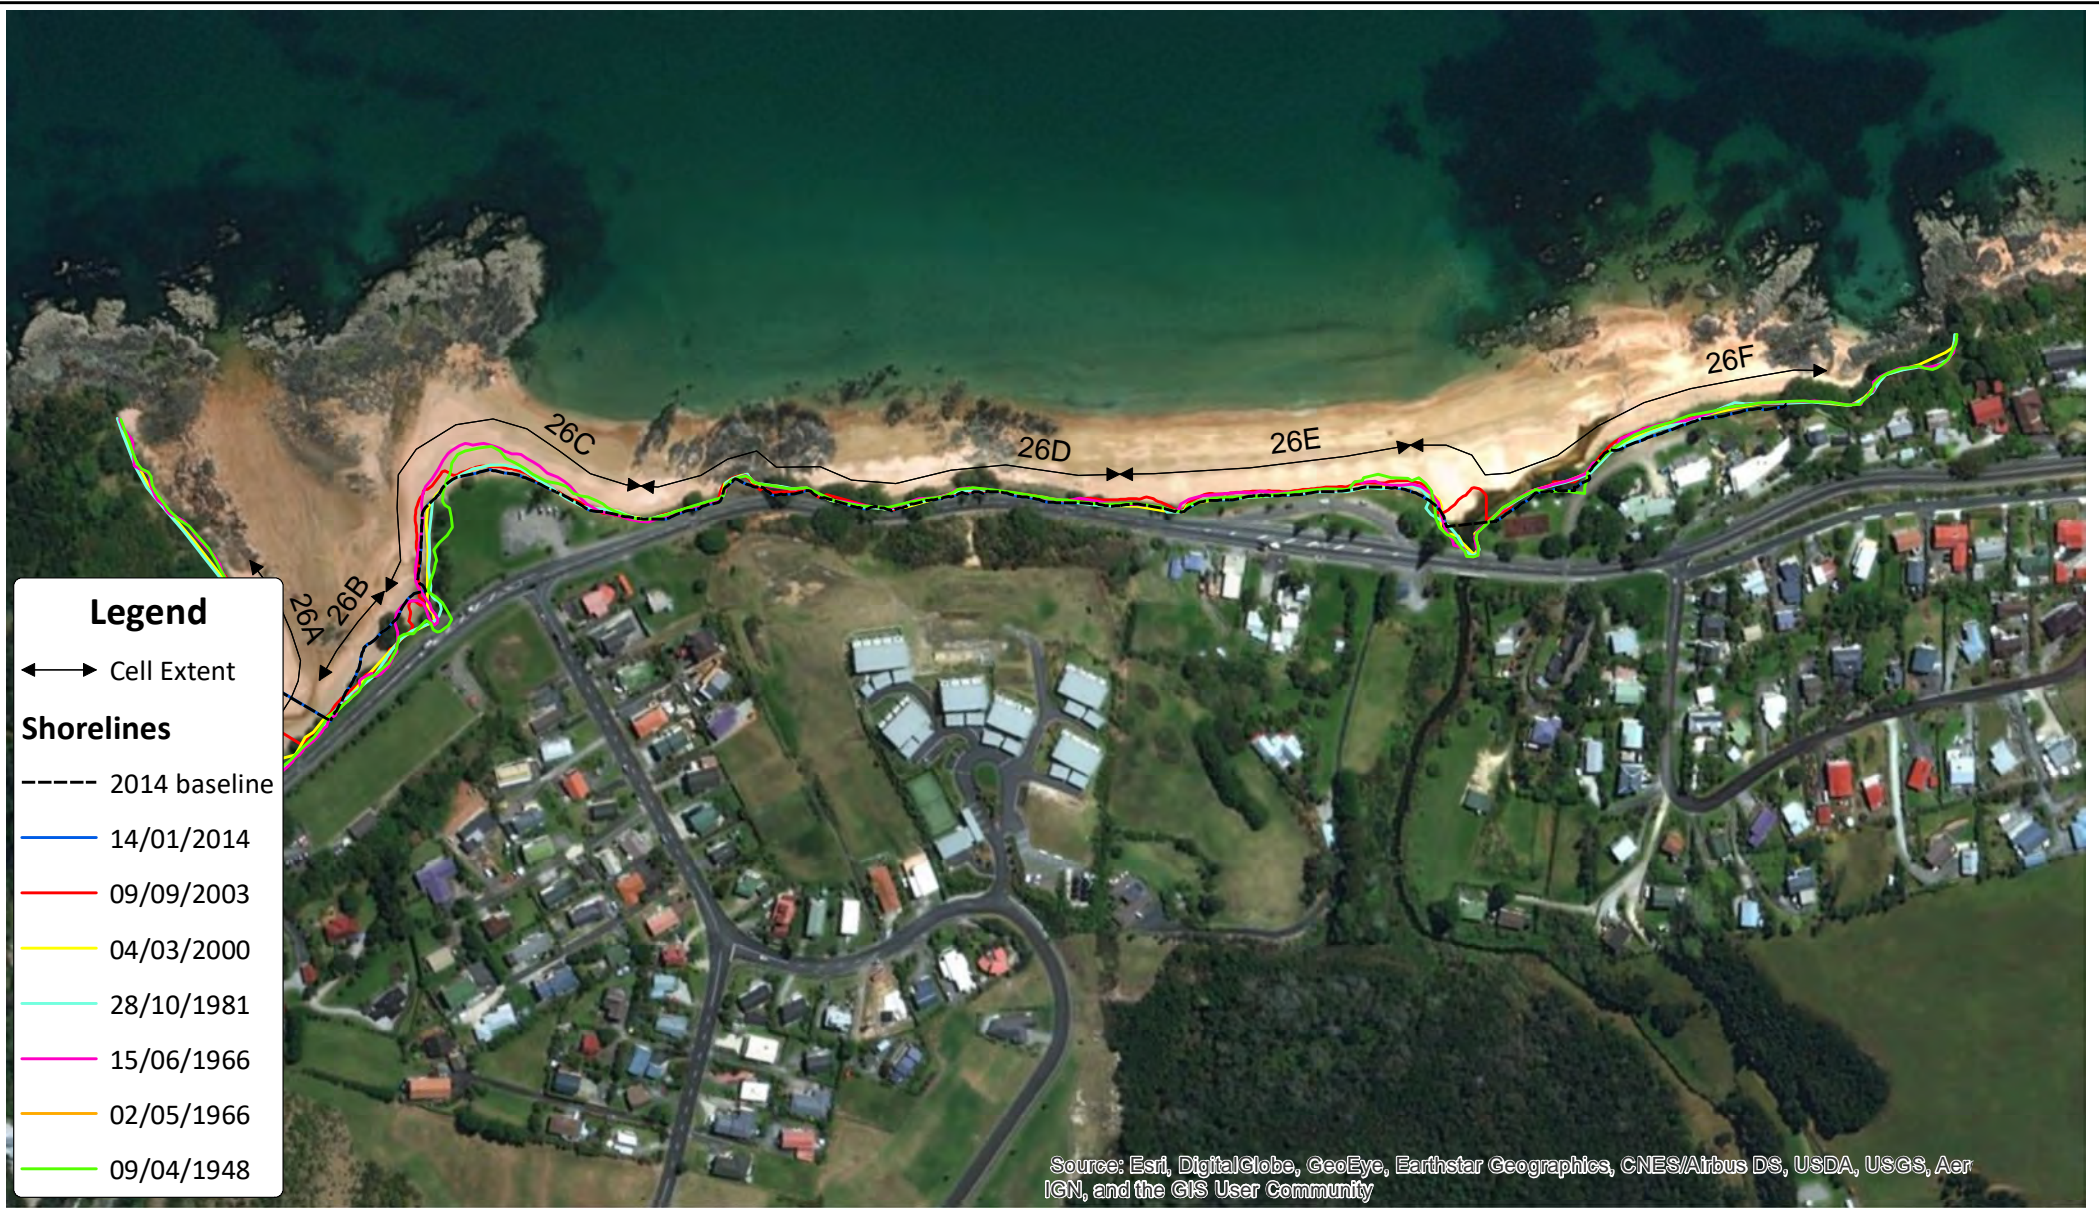
FIGURE No. Figure 26-8

Historic shorelines

Figure 26-6 shows the available historic shorelines for Cable Bay.
