## Te Hiku

Morehu (formerly Morehurehu) (Aupouri), NRC Lake No. 32.

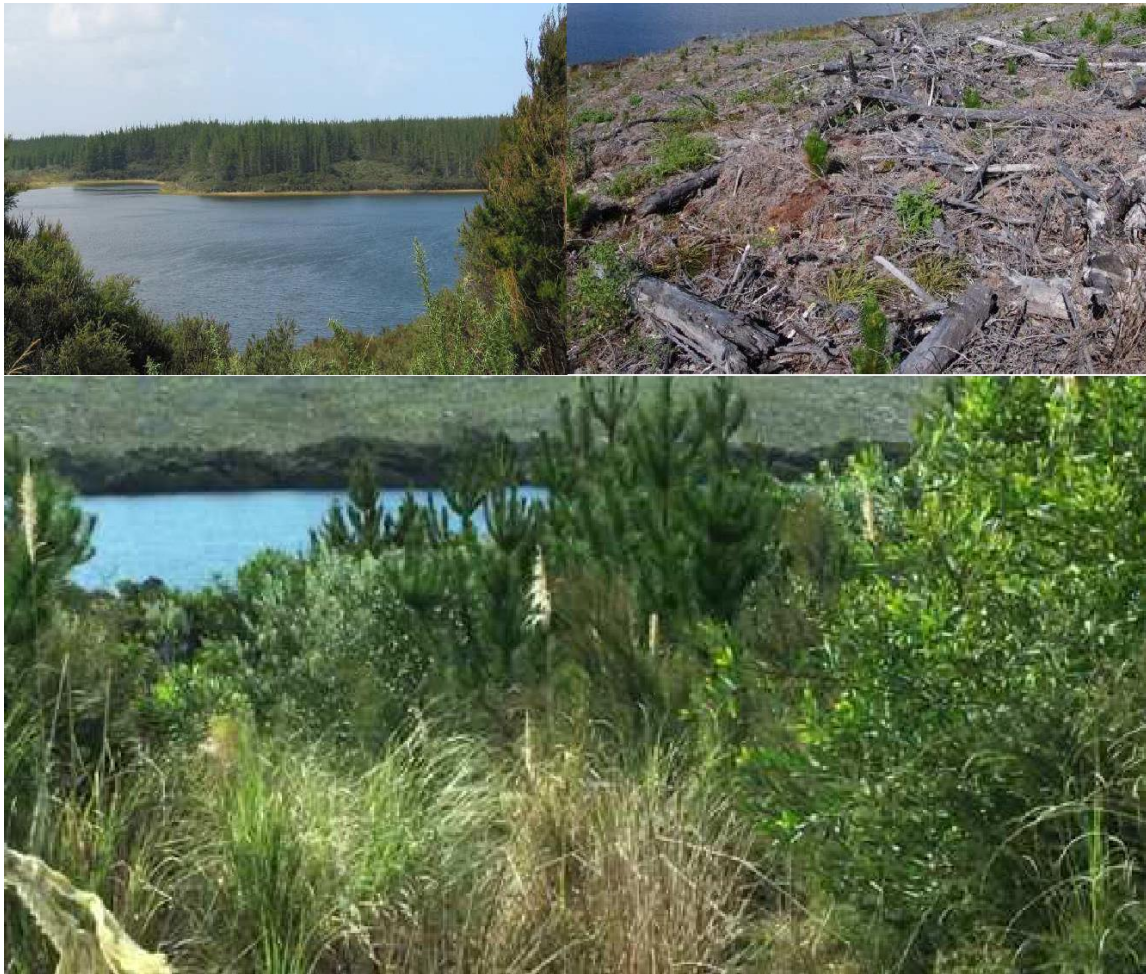
**Morehu** catchment has recently undergone significant change following the first harvest of mature plantation pine (top left 2009), with subsequent re-planting (top right 2013) and growth of young trees (below in 2016).

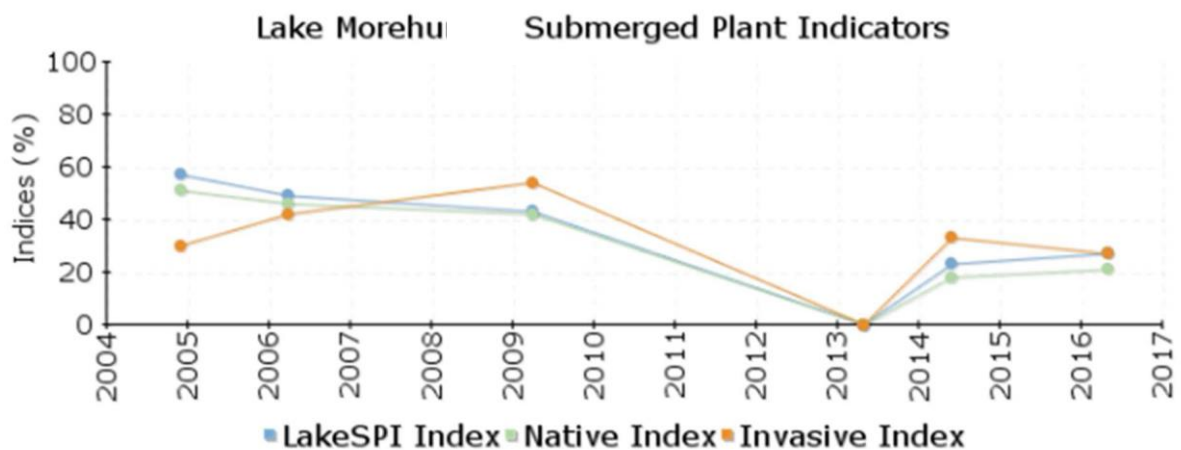
**LakeSPI for Morehu.** Six LakeSPI surveys are recorded. 2013 scored 0% due to very low abundance of submerged vegetation, followed by minor recovery in 2014 and 2016.

A decrease in LakeSPI score from 57% in 2004 to 27% in 2016 was a result of a decrease in submerged vegetation relating to a decline in water quality that occurred around 2013. This also resulted in a decrease of both the Native Condition Index and the Invasive Impact Index (invasive impact from *U. gibba*).

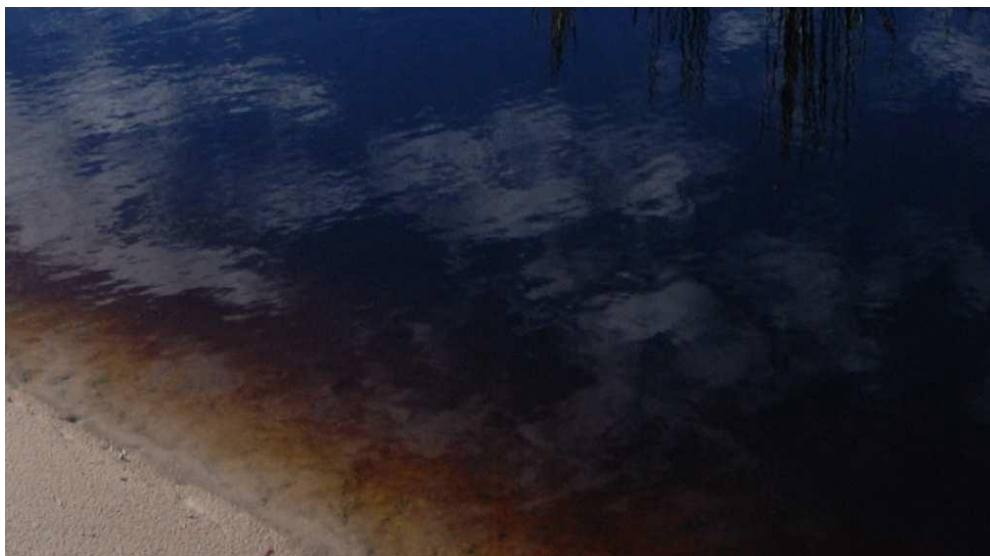
A 1988 vegetation survey recorded similar submerged vegetation to the 2009 description although *Chara australis* was more abundant and extended to a maximum depth of 9.5 m. *U. gibba* was not recorded. The lake has changed from being relatively clear when visited in 2009 to having a dark brown / red stain with less than 1 m in water visibility since 2013. The impact of the invasive

**Morehu.** This picture illustrates the stained water.

The marked change in water clarity and total nitrogen concentration was significant and its causes not clearly understood. This is of concern with regard to restoration and preventing this impact re-occurring in the future. Light is a major determinant of submerged vegetation. Such a marked change in water clarity could account for the loss of submerged vegetation. The recent harvesting of the pine plantation likely caused the change in water quality as similar changes were noted in other water bodies in the area (Te Kahika and Morehu South). The event may have been much wider with a local reporting that the Parengarenga Harbour became heavily coloured making channels impossible to follow after an extended period of heavy rain (Kevin Mathews, local conservationist, pers. comm.).

Another hypothesis is that pine tree transpiration had been keeping water levels lower in the soil profile for decades. Felling of the trees stopped water loss from transpiration and water logging of pine debris is likely to have occurred following heavy rainfall events occurring post-harvest. Removal of the pine canopy allows rain direct access to a broken soil layer. Quartz sands in the catchment have no ionic binding (M. Gibbs, NIWA, pers. comm.), which may have led to leaching of tannic substances through the sands.

Lake monitoring every three to five years will enable impacts to be documented and potential recovery rates tracked. A study of the possible causes of this major ecological impact should be undertaken and if related to human activity then it may be possible to mitigate ongoing impacts and avoid a re-occurrence in the future.
