Northland Lakes - Annual Report 2012

Prepared for Northland Regional Council

NIWA Client Report No: HAM2012-069
Report date: June 2012
NIWA Project: NRC12205

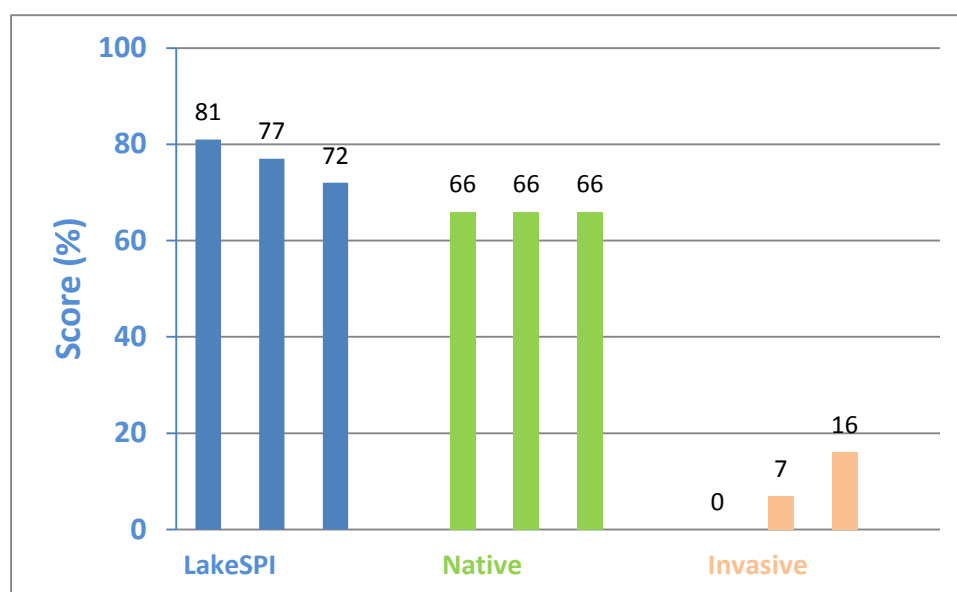
Figure 3-1: LakeSPI Index as % of potential score for Lake Humuhumu with Native Condition Index, and Invasive Impact Index for 2005; 2007 and 2012 from left to right.

The most recent LakeSPI Index (Table 2-1; Figure 3-1) shows a lake in high ecological condition with a LakeSPI index of 72%. This reflects the extent of native submerged vegetation present in the lake with charophyte meadows growing down to a maximum depth of 9.1 m. However the presence of *Utricularia gibba* for the first time at 3 of the 5 LakeSPI sites, has seen the Invasive Impact Index more than double since the 2007 survey and impact negatively on LakeSPI values.

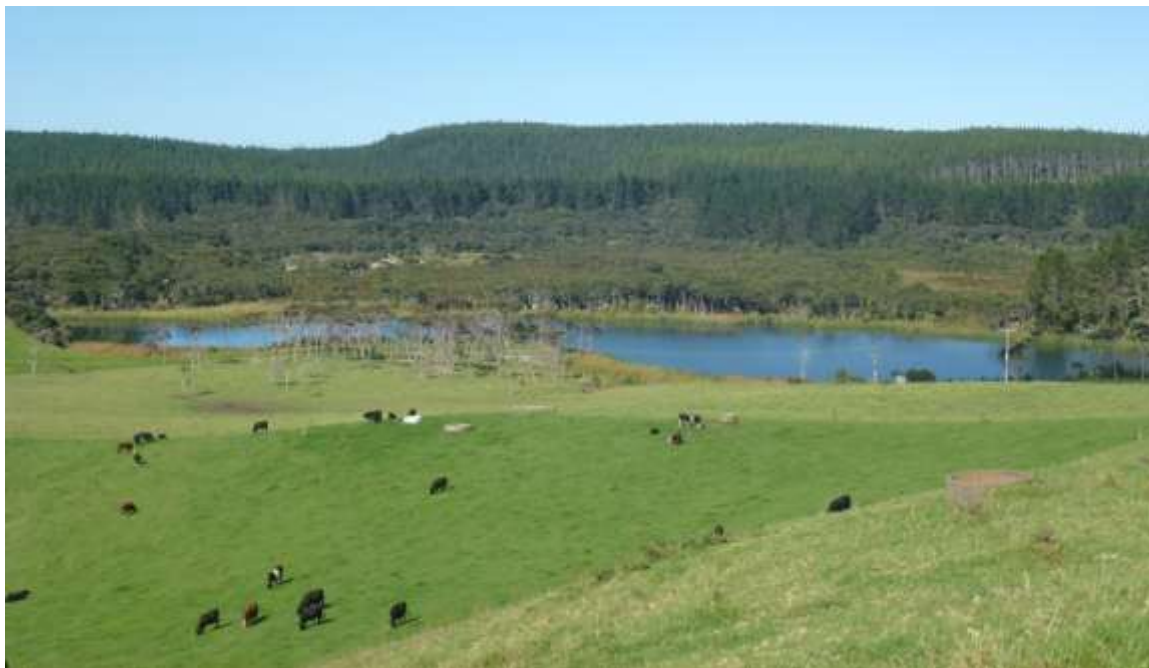
Plate: Lake Kahuparere showing pasture foreground, and pine forest on sand dunes to the rear.

The relatively poor visibility and presence of filamentous algae covering the submerged vegetation indicated nutrient enrichment. Cattle access to the east shoreline not only has damaged the marginal vegetation through grazing and trampling, but can also lead to direct addition of nutrients to the lake by defecation and urine. Fencing of the margin was noted in 2009, with a corresponding decline in the abundance of filamentous algae.

Lake native biodiversity value monitoring every 5 years.

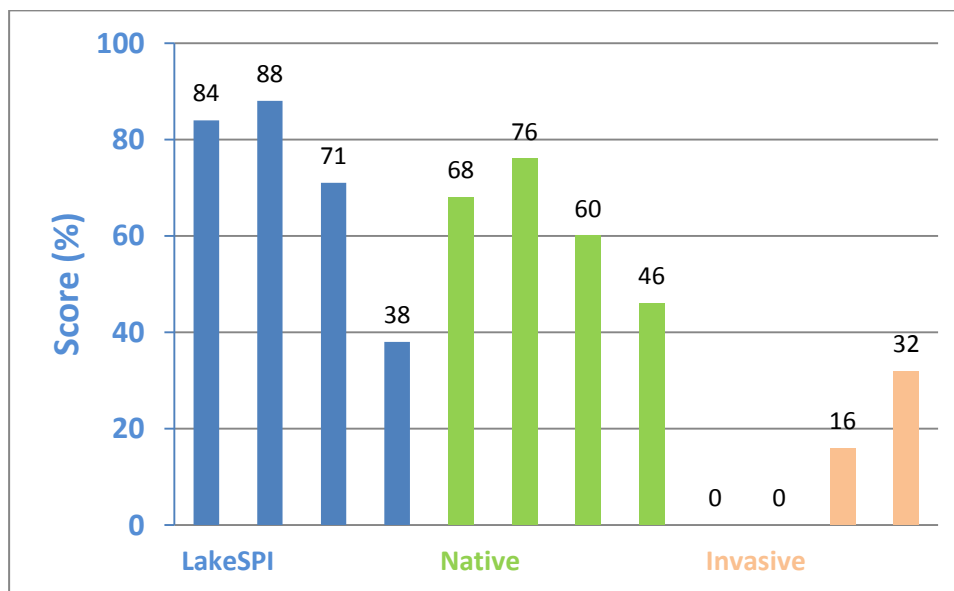
Figure: LakeSPI Index as % of potential score, Native Condition Index, and Invasive Impact Index (from left to right) with 2001, 2005, 2007, 2012, values shown respectively.

The LakeSPI score of 38% was low due to one of the 3 profiles having no submerged vegetation present. Otherwise indicators were good with a slightly deeper bottom limit and an increase in charophyte meadows. *U. gibba* invasive impact has increased further but is not displacing native vegetation. It is now categorised by LakeSPI as being in a moderate ecological condition with a LakeSPI index of 37%.

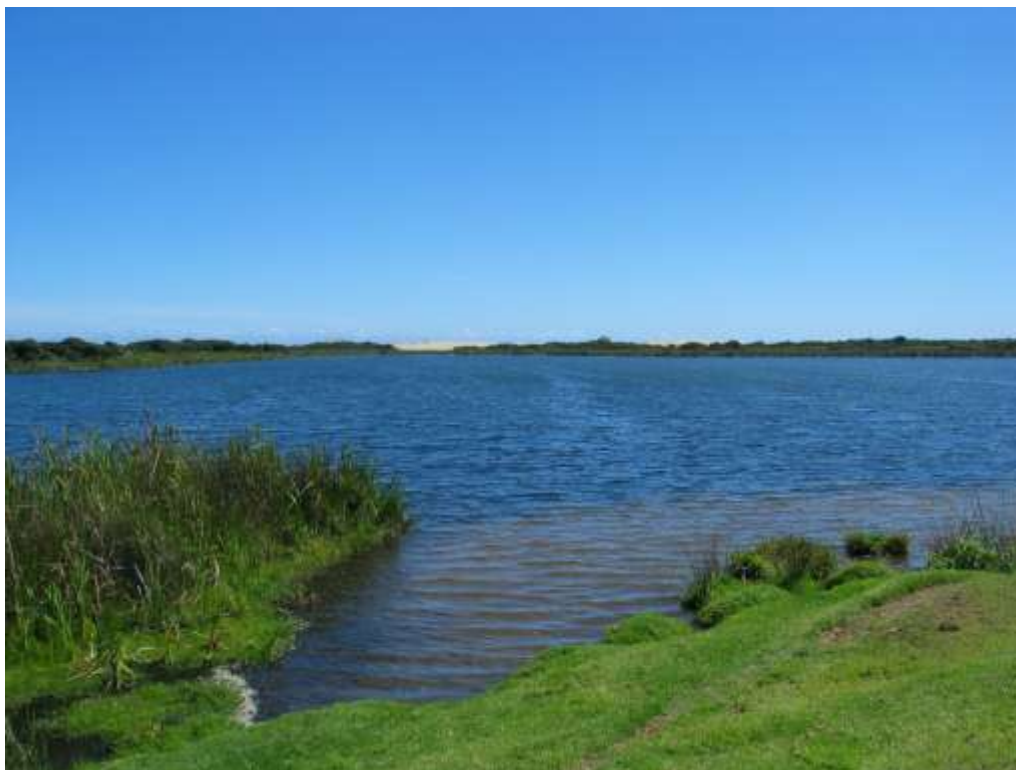
Plate: Lake Karaka viewed from the access point showing pasture to the lake edge. The remainder of the lake margin is wetland.

Relative isolation and difficulty of access makes risk of introduction of pest species low. However, should these be introduced they would displace or significantly impact indigenous biota. Nutrient enrichment from farming and forestry may be the cause of algal blooms noted and charophytes in poor health.

Advocate fencing off the eastern shoreline to prevent cattle access to the lake. A consideration of nutrient sources might reveal why this lake is so eutrophic and mitigations measures might be self-evident.

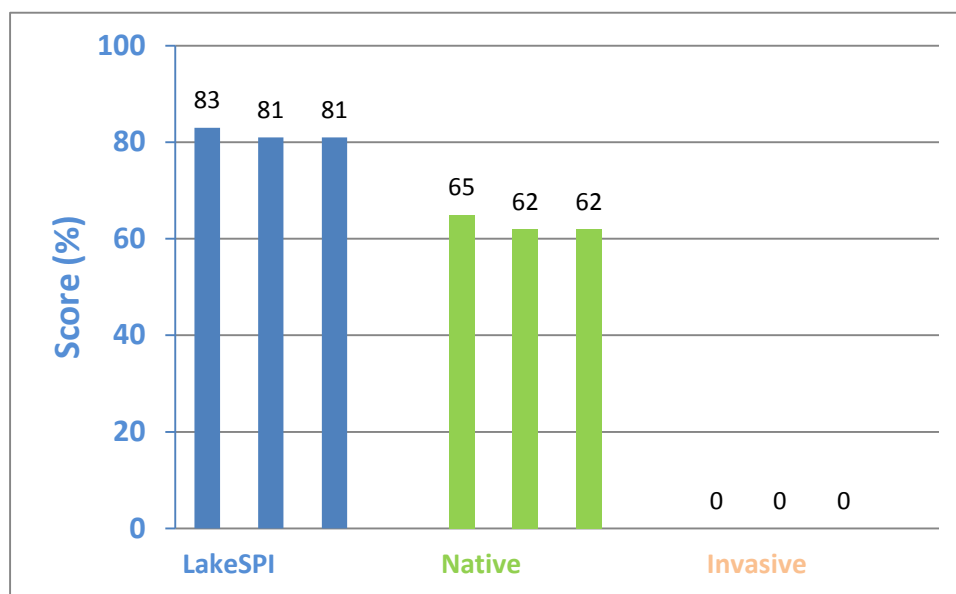
Figure 4-1: LakeSPI Index as % of potential score for Lake Karaka with Native Condition Index, and Invasive Impact Index 2005; 2007; 2012 (from left to right).

Lake Karaka is in 'excellent' ecological condition as categorised by LakeSPI (Table 4-1, Figure 4-1). Its high LakeSPI index of 81% reflects its extensive charophyte meadows and a lack of invasive species.

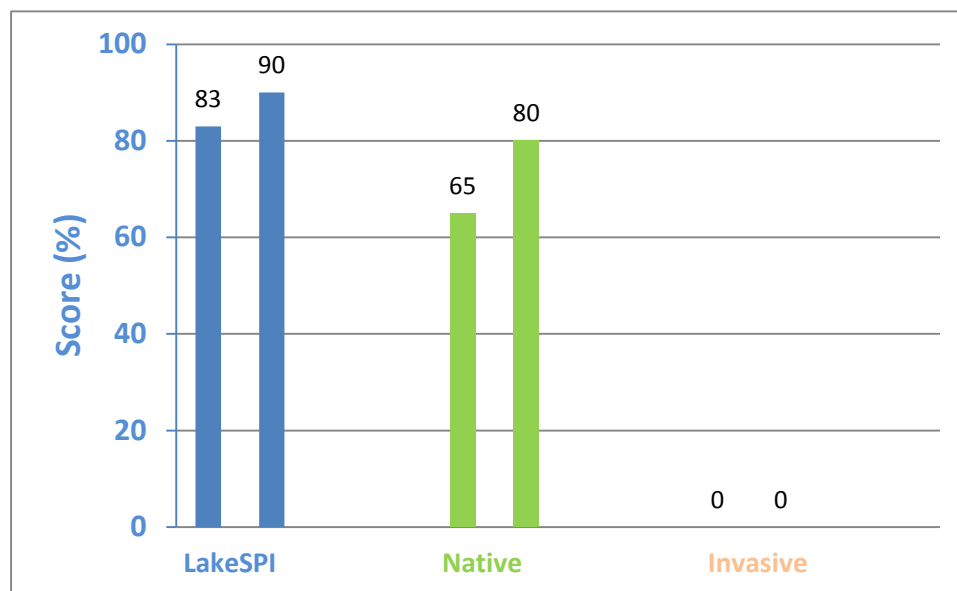
Figure 4-2: LakeSPI Index as % of potential score for Lake Mokeno with Native Condition Index, and Invasive Impact Index shown for 2005; 2007 (from left to right).

Lake Mokeno was in 'excellent' ecological condition as categorised by LakeSPI (Table 4-2, Figure 4-2) during the 2007 survey. Its high LakeSPI index of 90% reflected the quality of native submerged vegetation and lack of invasive species. Due to poor clarity a LakeSPI Index could not be generated in 2012.

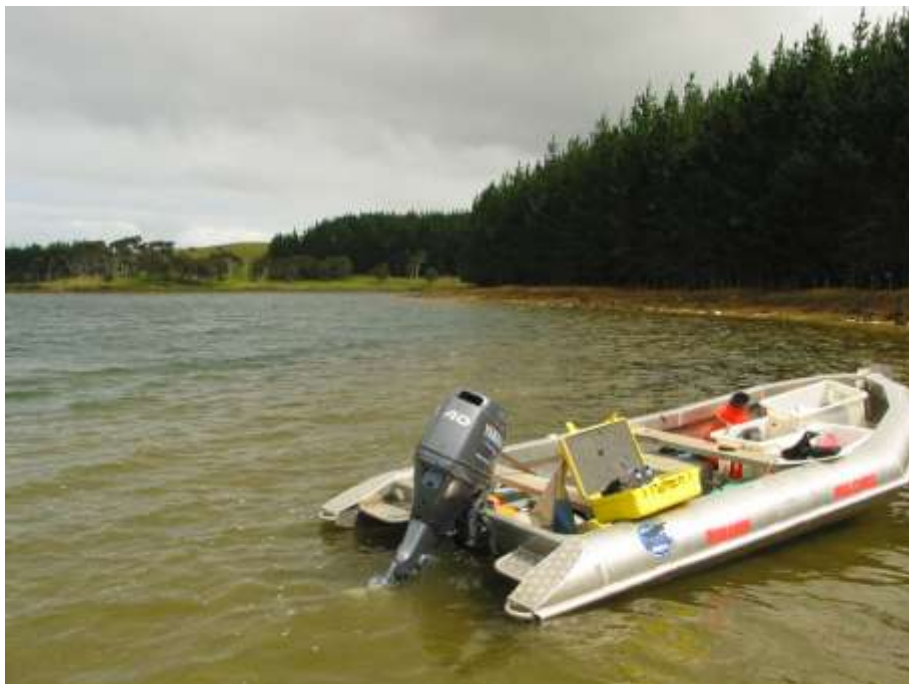
Plate: Lake Rotokawau showing the exposed north east shoreline with few emergent species.

Poor access to the lake reduces the risk of weed incursion so weed surveillance monitoring has been suspended. Lake ecological assessment every 5 years.

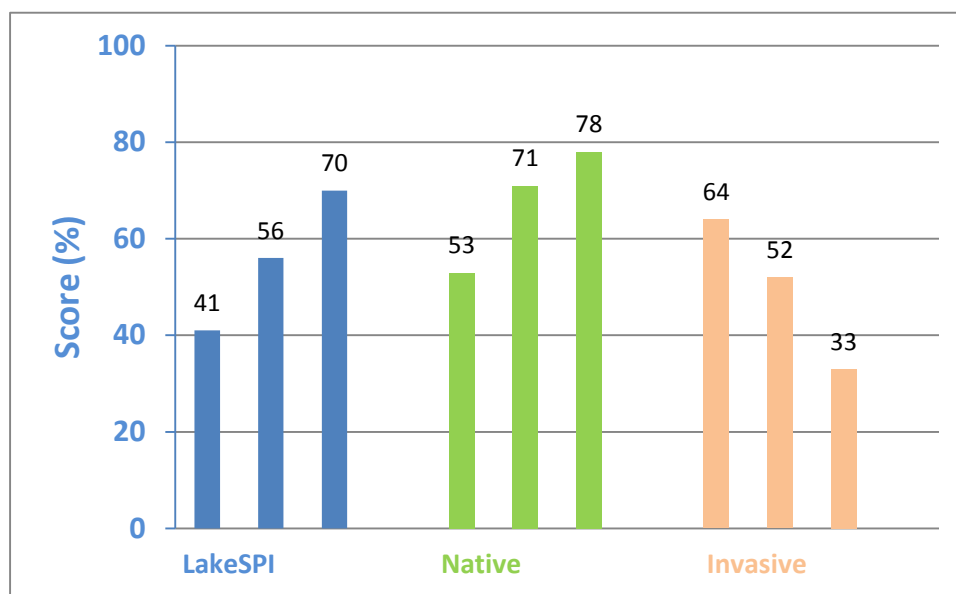
Figure 4-3: LakeSPI Index as % of potential score in Lake Rotokawau with Native Condition Index, and Invasive Impact Index for 2005; 2007; 2012 (from left to right).

Lake Rotokawau is currently categorised by LakeSPI as being in high ecological condition with a LakeSPI index of 70% (Table 4-3, Figure 4-3). The LakeSPI index for this lake has notably improved since the 2007 survey as a result of a reduction in the invasive impact scores. *E. densa* and *U. gibba* while still present during the 2012 survey did not exceed a 10% cover at any of the baseline sites. It is also likely improved water clarity (excess of 5 m during the 2012 survey) has contributed to the growth of native charophyte meadows down to 11.1 m, the maximum depth found at the time.

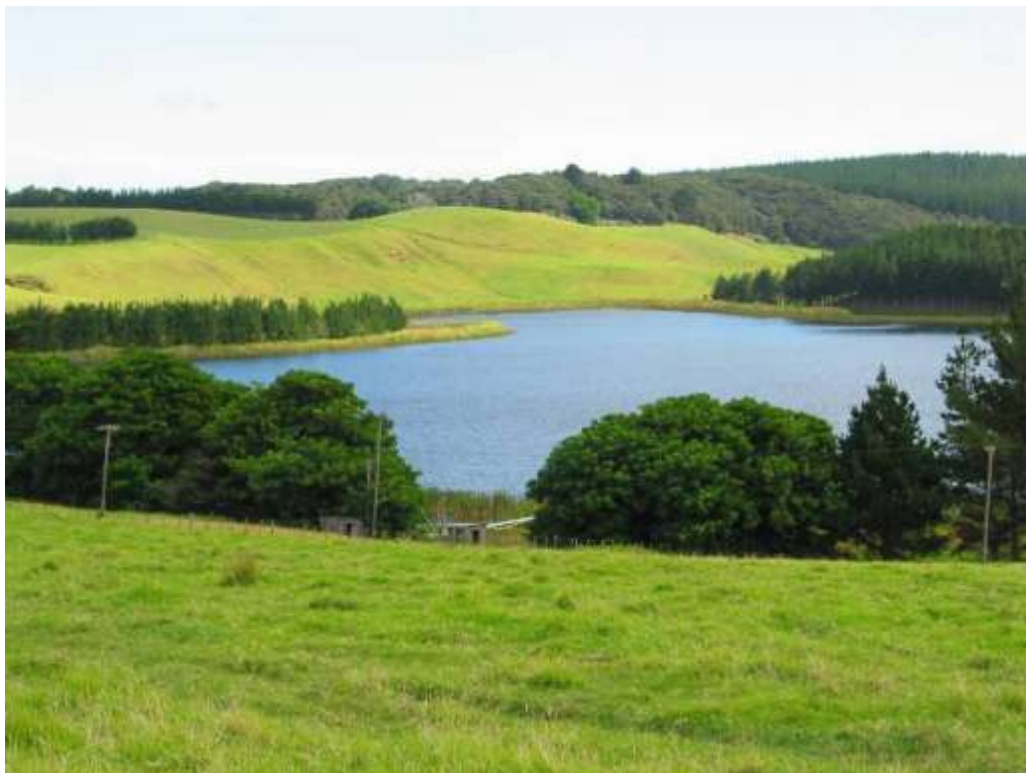
Plate: Lake Roto-otuauru (Swan) showing access (centre foreground gap in trees) and the lake catchment.

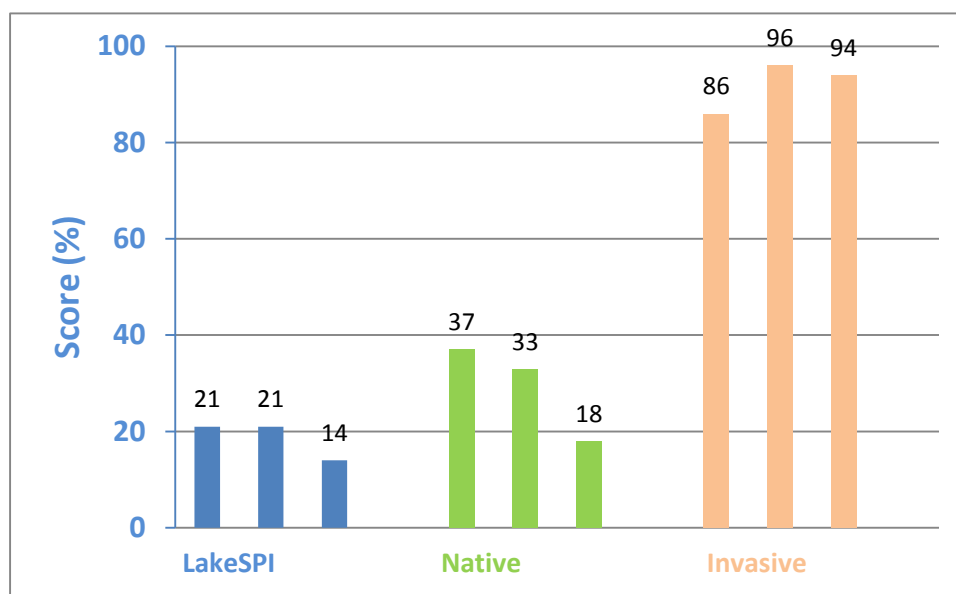
Figure 4-4: LakeSPI Index as % of potential score for Lake Roto-otua with Native Condition Index, and Invasive Impact Index shown from 2005, 2009 and 2010 (from left to right). Note grass carp directly affect LakeSPI metrics and currently the default score is zero with no submerged macrophytes found.

A very low LakeSPI score of 14% was recorded in 2010 as *E. densa* and *C. demersum* have greatly reduced native values in the lake (Figure 4-4). By 2011 grass carp had removed all the submerged vegetation so it scored 0% (Non-vegetated), as in 2012 but as grass carp directly affect the LakeSPI metrics the value of LakeSPI in monitoring ecological condition is markedly reduced. When grass carp grazing pressure is removed LakeSPI is expected to improve markedly with an all-native submerged vegetation restored from the seed bank.

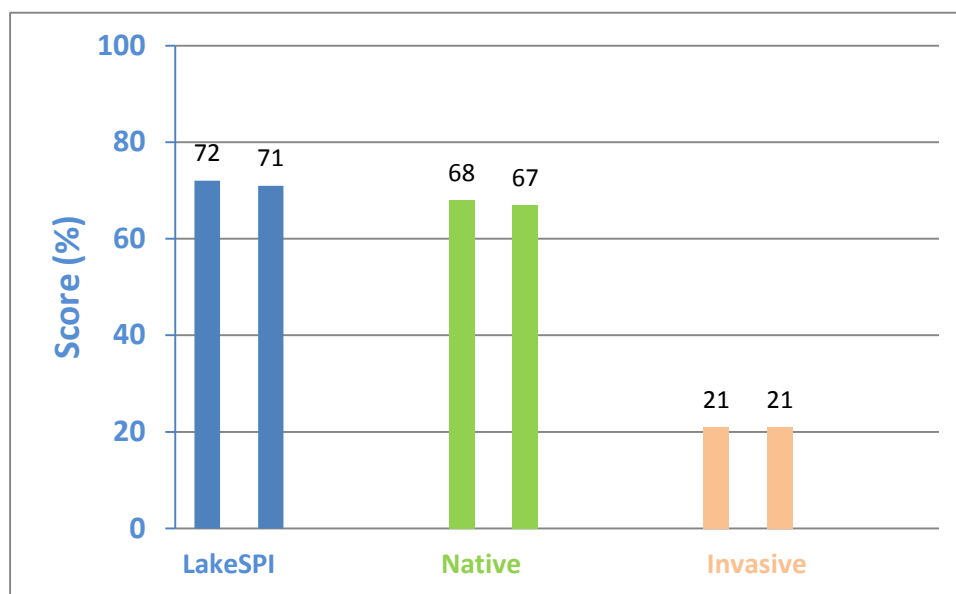
Figure 4-5: LakeSPI Index as % of potential score for lake Rotopouua with Native Condition Index and Invasive Impact Index for 2008 and 2012 shown (from left to right).

Lake Rotopouua is in 'high' ecological condition as categorised by LakeSPI (Table 4-4, Figure 4-5).

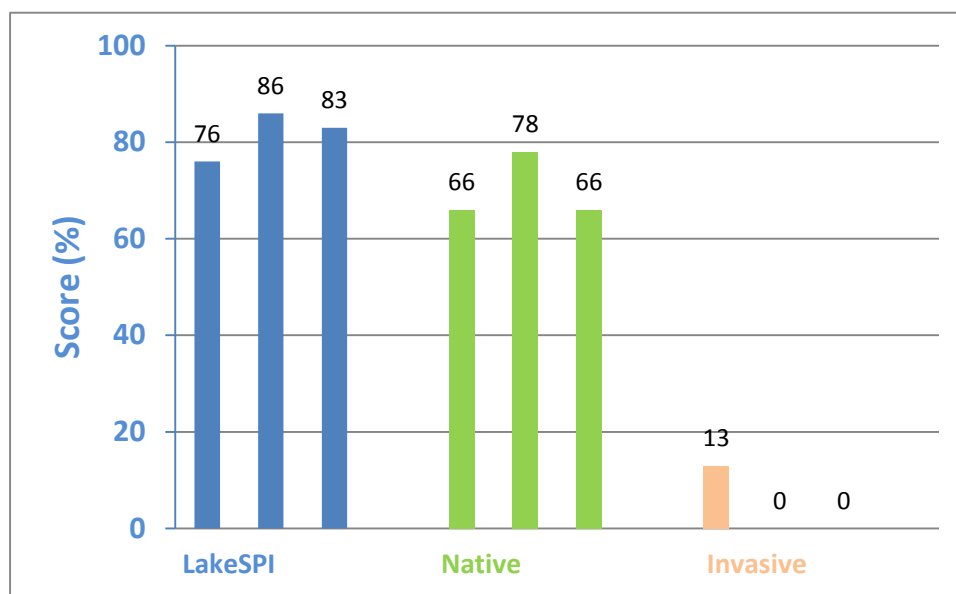
Figure 4-6: LakeSPI Index as % of potential score for Lake Rototuna with Native Condition Index, and Invasive Impact Index shown for 2005; 2007; 2012 (from left to right).

Lake Rototuna is categorised as being in 'excellent' ecological condition with a high LakeSPI index of 83% (Table 4-5, Figure 4-6). LakeSPI values for this lake have remained stable since surveys begun in 2001 with only a small change noted in the invasive impact scores during the 2001 and 2005 surveys on account of *Potamogeton crispus* and *Juncus bulbosus* being present at that time.

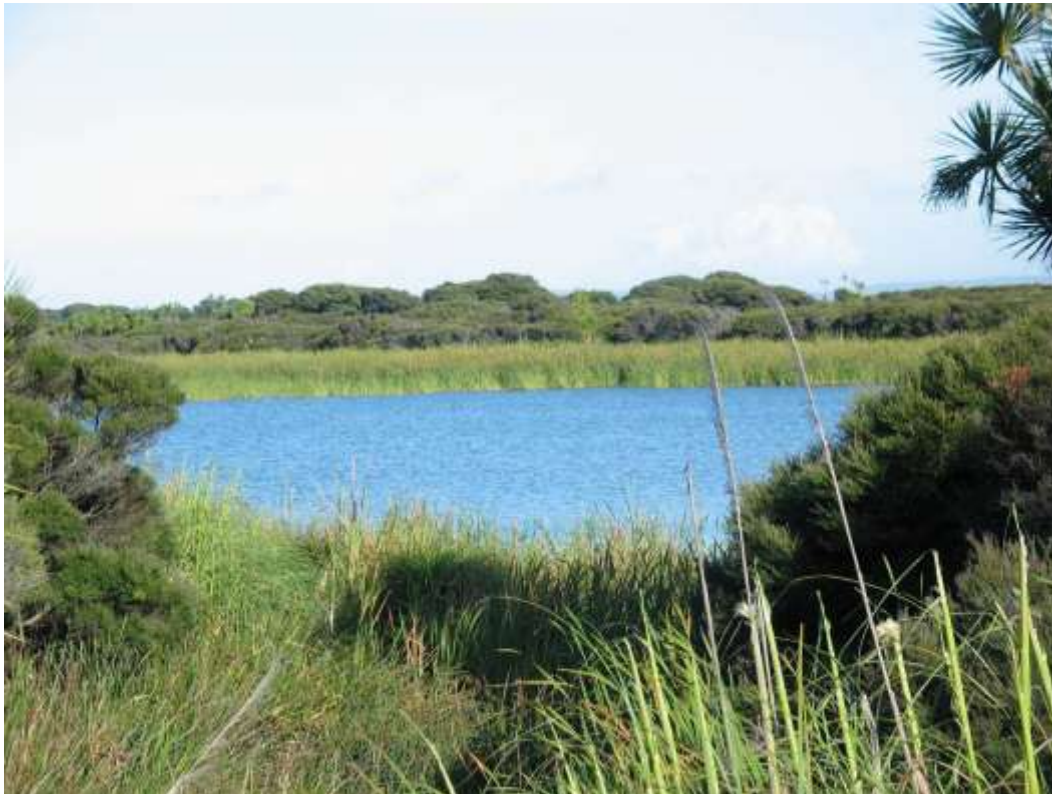
Plate: Lake Whakaneke surrounded by manuka scrub with dense emergent vegetation dominated by *Typha orientalis* and *Schoenoplectus tabernaemontani*.

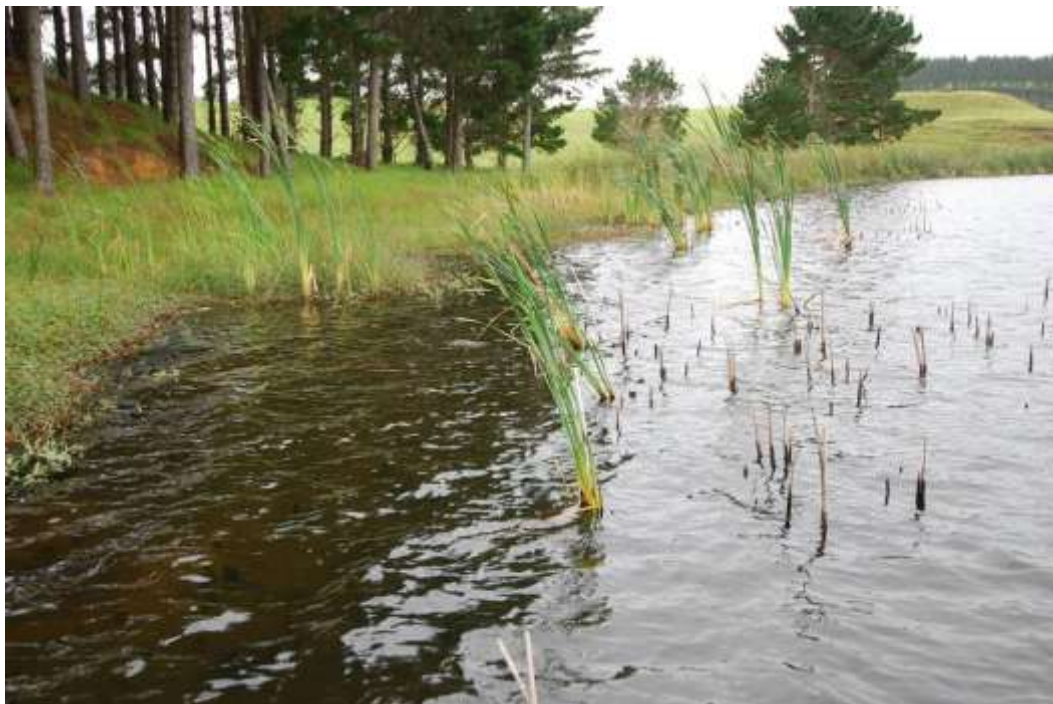
Figure 6-2: Lake Swan margins. Grass carp were introduced in May 2009 and by 2011 had removed much of the *T. orientalis* (raupo) from the margins.

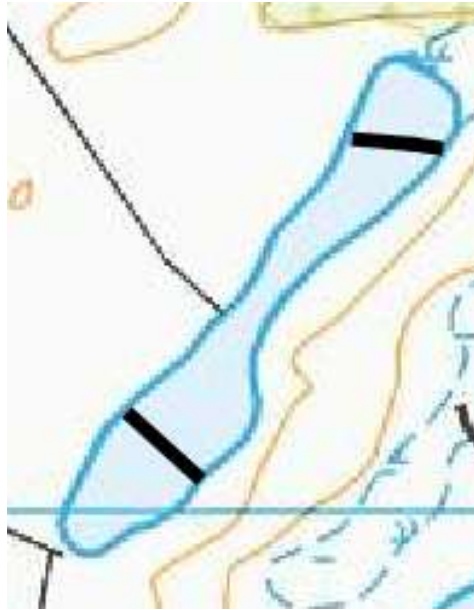
The two baseline profiles recorded prior to grass carp release in 2010 were repeated in 2011 and 2012 (Figure 6-3).

Figure 6-3: Lake Heather showing the location of the 2 profiles monitored, with one in each basin.

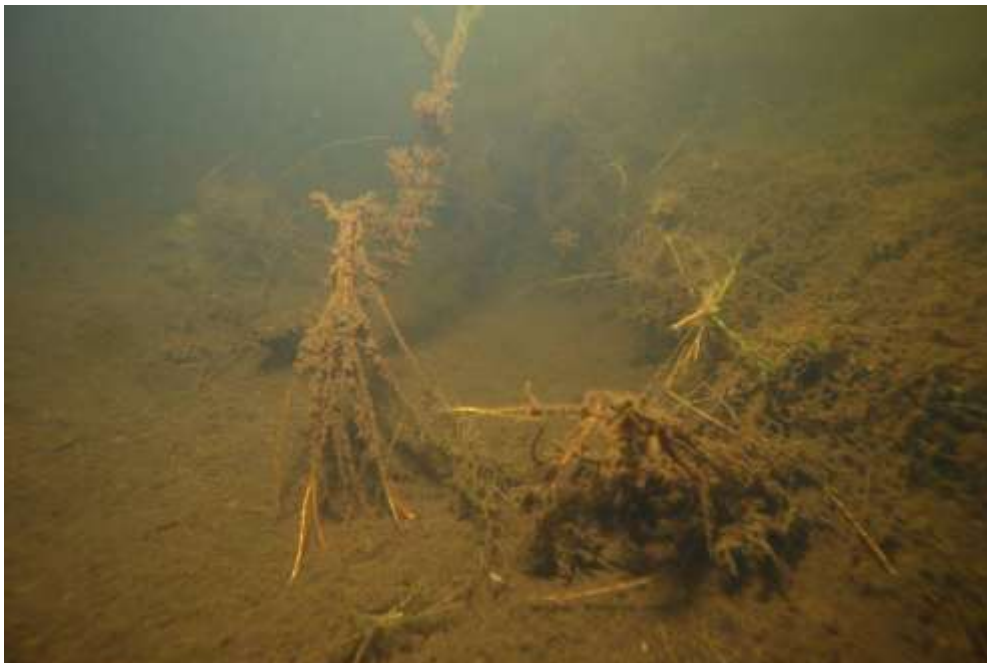
In 2011 the *E. densa* had been heavily grazed but little damage was noted on the *C. demersum*. In 2012 the *E. densa* had been heavily grazed and reduced to basal stalks (Figure 6-4) but only about 50% of the *C. demersum* has been removed. Most of the *C. demersum* was still recorded up to 2.2 m tall. The rate of progress for grass carp in removing the weed beds is slower than in Lake Swan, but they are making steady progress.

Figure 6-4: *E. densa* remnants in Lake Heather at 2.6 m deep heavily grazed by grass carp.
