43 McLeod Bay

43.1 Description and geomorphology

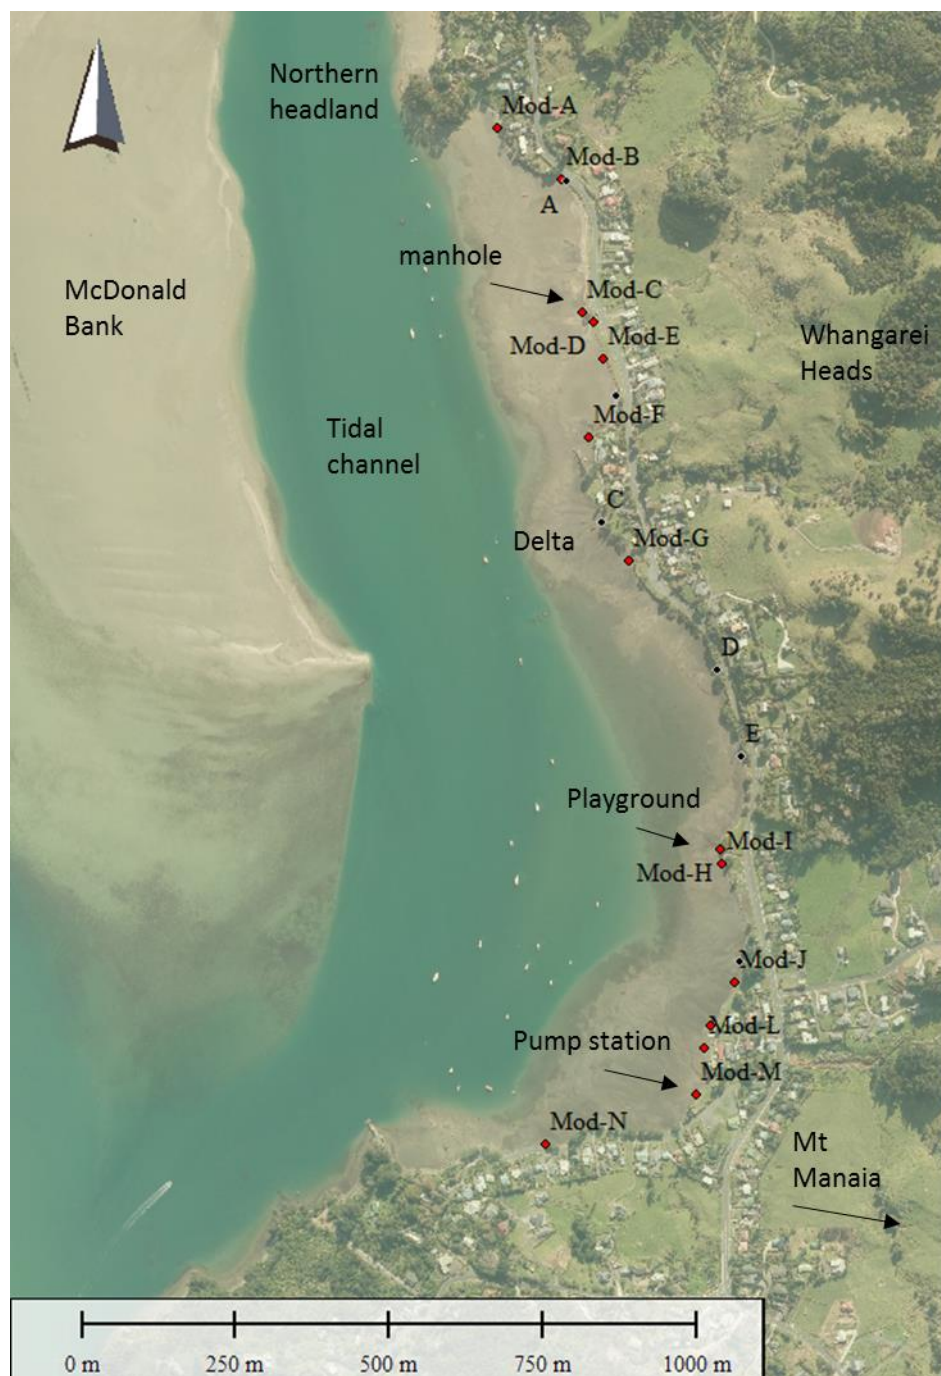
McLeod Bay sits at the base of Whangarei Heads, with volcanic slopes of Mt Manai to the east and Mt Aubrey to the south (Figure 43.1). Four small streams flow form these hillslopes into the McLeod Bay, transporting fluvial and landslide material towards the coast. The north end of the site is defined by a small headland formed from historic landslide material that extends into the harbour. The majority of the coastal edge is defined by a low elevation shoreline terrace that was deposited by river and coastal processes during the Holocene. The shoreline terrace width varies alongshore between 50-150 m and is locally influence by streams.

Figure 43.1: Map of McLeod Bay showing coastal features and the location of site setting photos (black dots) and shoreline modification photos (red dots)

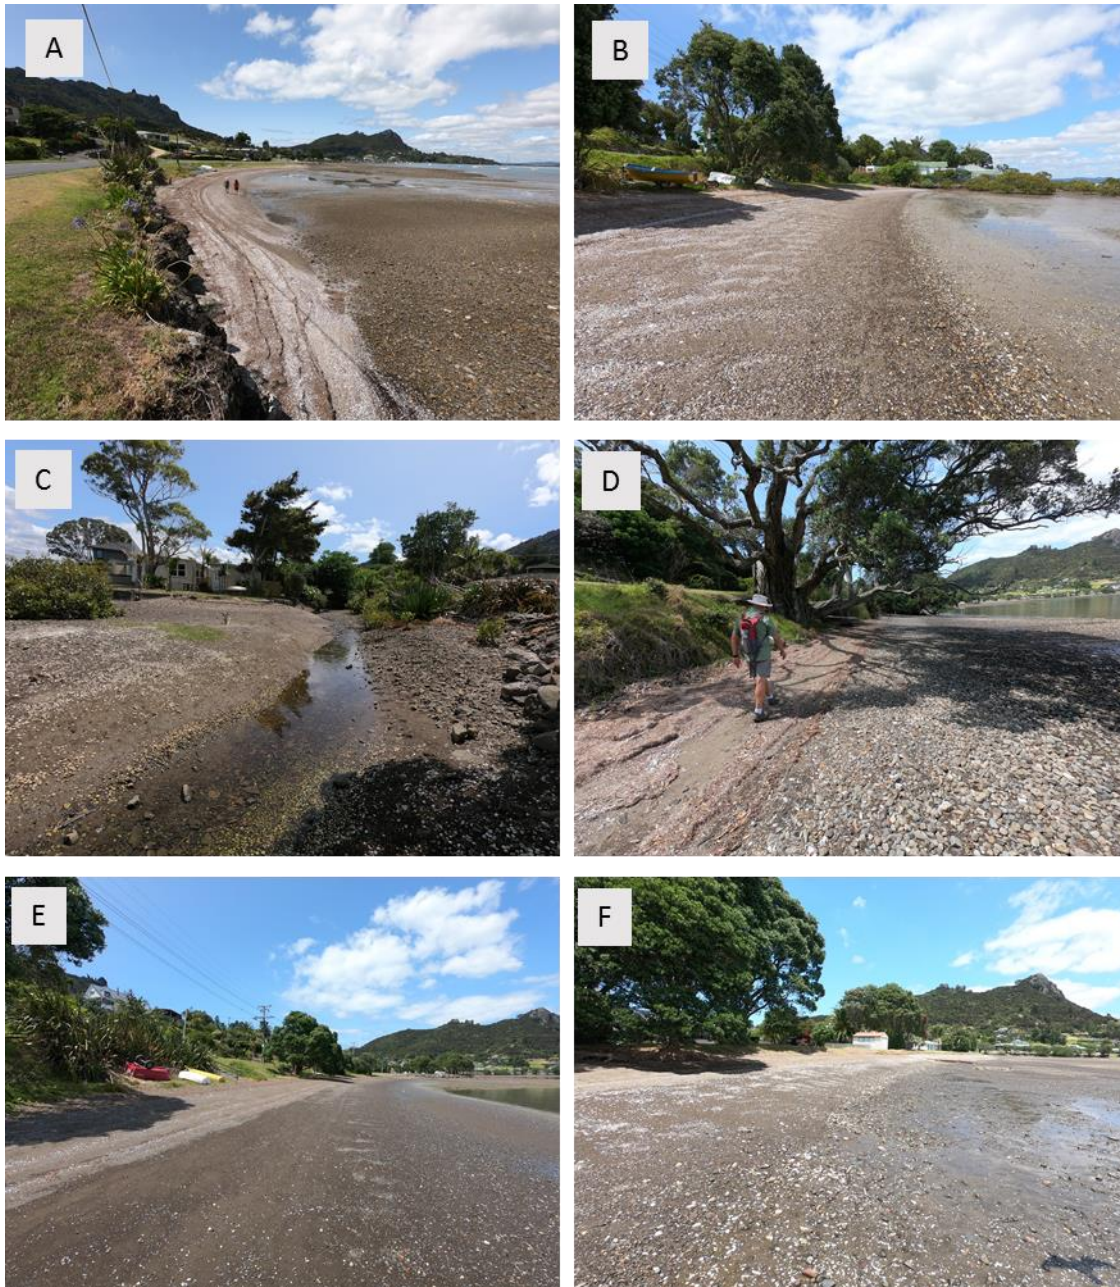
Whangarei Heads Road follows the coast for the length of the site. In places, the road centreline is located within 10 m of the shoreline (Figure 43.2A). Houses are located seaward of the road in small clusters at the north end, centre and south end, with a grass reserve space is located between the road and coast for most of the site. Houses are located landward of the road for the length of the site. Houses located seaward of the road at the north end are positioned on the headland formed by historic landslide deposits and houses at the centre are located on a low-lying delta that has formed from stream deposition. Sections of beach with reserve space and parking are located to the north and south of the delta, with a playground located at the southern beach.

The beach at McLeod Bay are characterised by a mixture of sand, shell and gravel that forms a narrow strip between the vegetated terrace and a tidal flat. The tidal flat is comprised of fine grain sand, is exposed at low tide and extends for 100-200 m before the tidal channel that is constrained by McDonald Bank on the harbour side. The shallow tidal flats prevent wave energy from reaching the shoreline during lower tidal stages. At high tide stages, wind wave energy generated inside the harbour can interact with the shoreline and drive coastal change. The maximum fetch is approximately 12 km to the west-north-west, but the maximum wave size at McLeod Bay is also limited by water depth and duration because of tidal fluctuations.

Figure 43.2: Site photos highlighting natural coastal features

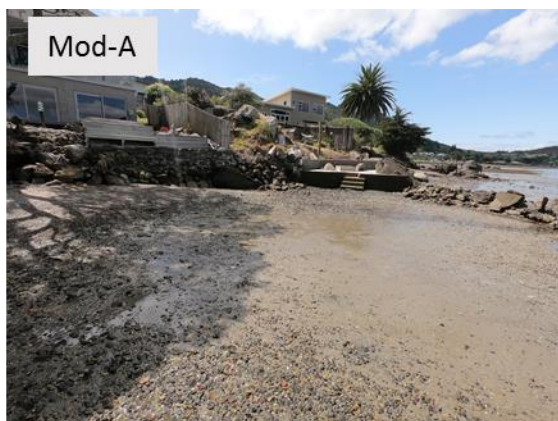
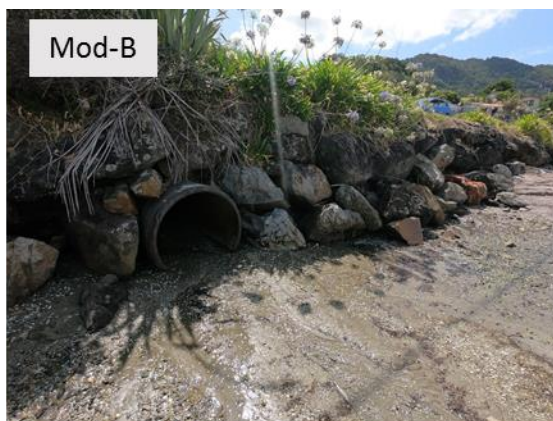
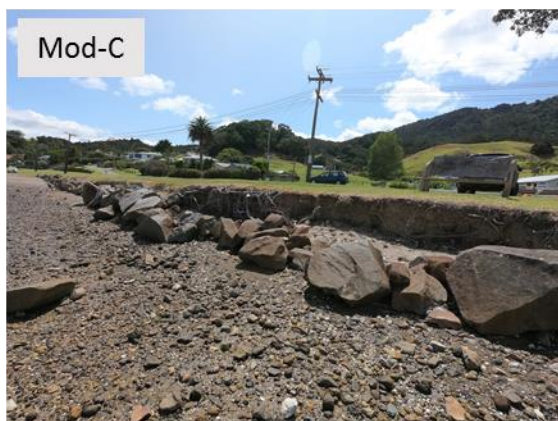
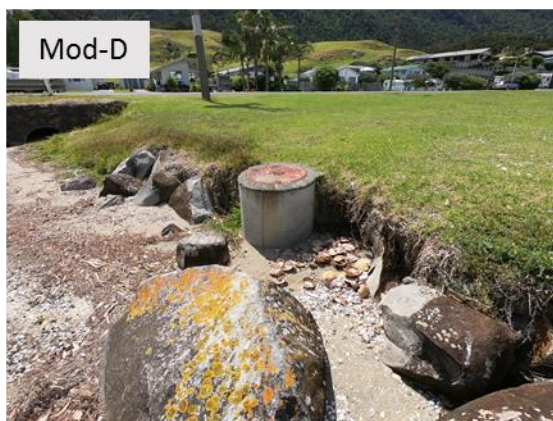
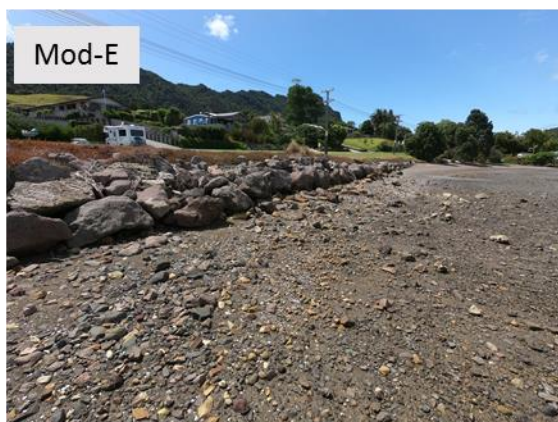
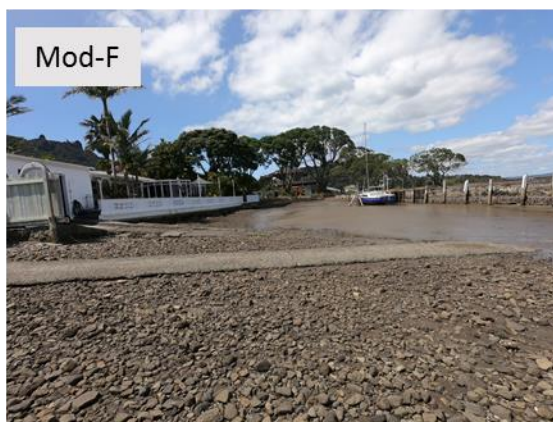
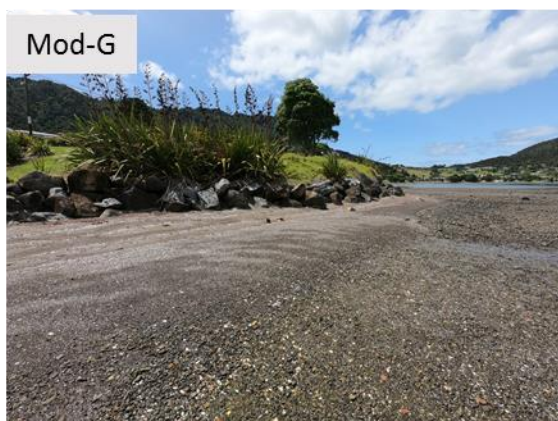
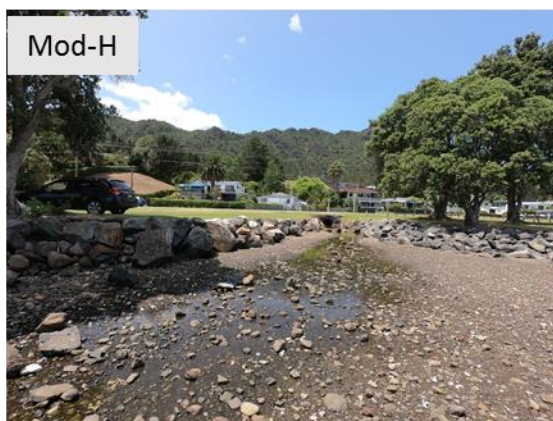
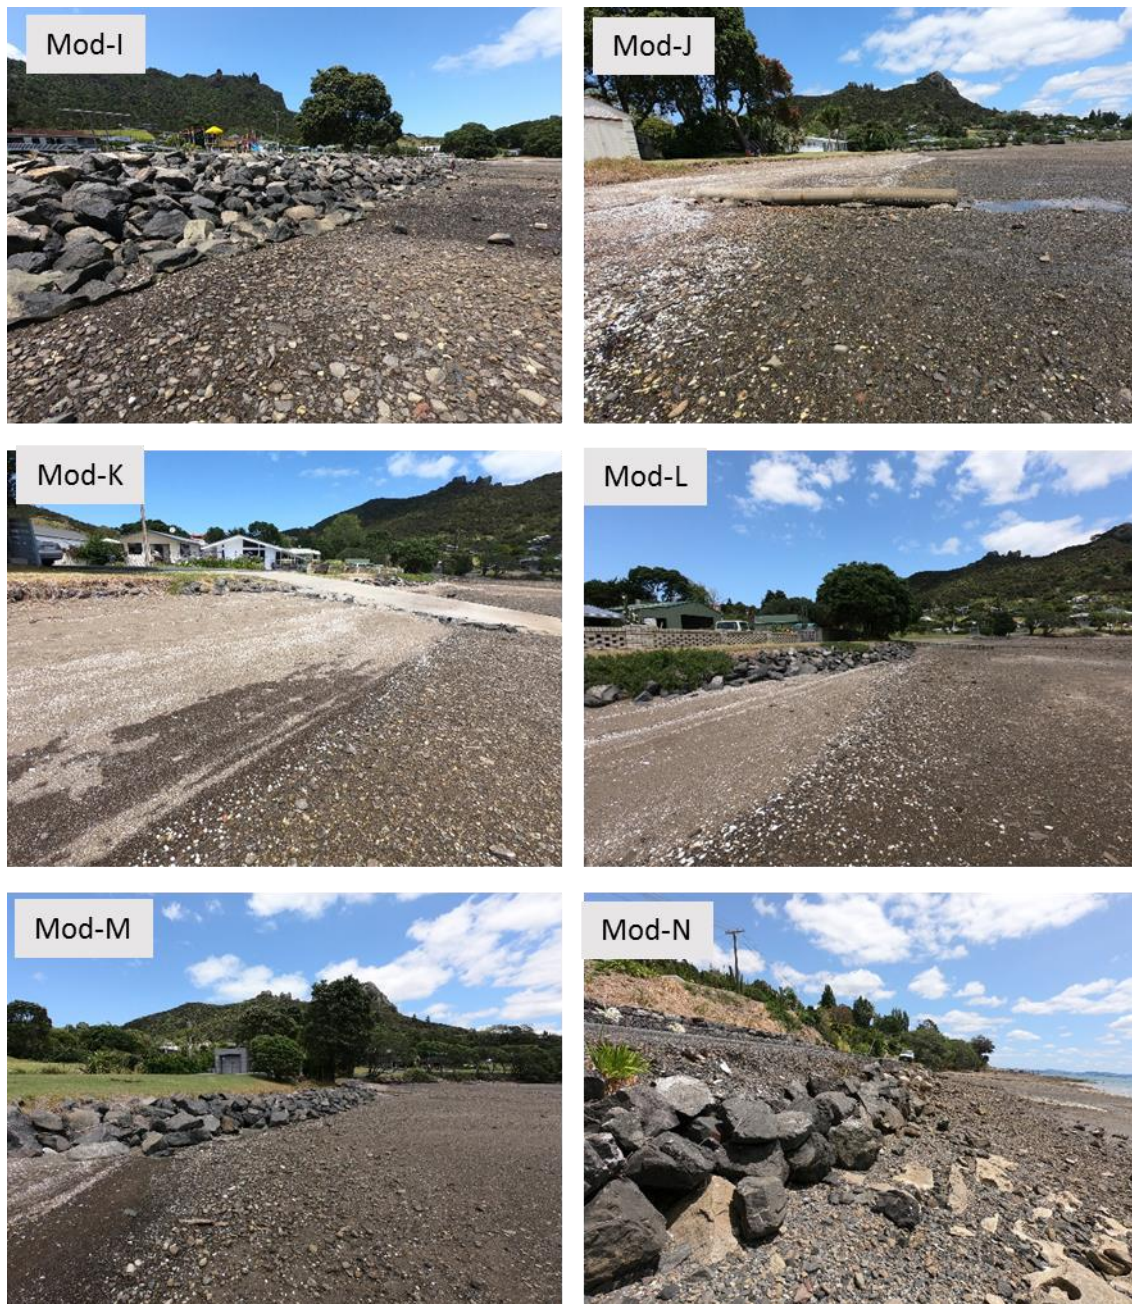
A number of coastal protection works are located along the site. Examples of coastal protection structures at McLeod Bay are presented in Figure 43.3. These include rock armour at the terrace toe, channel stabilisation and various rock revetments. Other forms of coastal modification include property boundary seawalls and boat ramps, culverts and storm water outflow pipes.

At the northern beach location, rock armour is located 1-2 m seaward of the terrace toe (Mod-C). This likely indicates a period of erosion since placement of the toe armour. At this location, erosion has completely exposed a manhole (Mod-D). To the south, rock revetments have been built to protect a playground (Mod-I) and a pump station (Mod-M). Some shoreline armour has been placed to protect the road and reserve from erosion (e.g. Mod-E), but this is discontinuous and irregular alongshore, with some sections remaining natural (e.g. Figure 43.2D).

Figure 43.3: Examples of coastal protection structures and coastal modification along McLeod Bay

No coastal erosion hazard assessment was undertaken at McLeod Bay. The proximity of Whangarei Heads Road to the coast, and various existing coastal protection structures of different condition require more localised management. It is recommended that a protection history and condition assessment is undertaken at this site, so that Council can comfortably rely on the performance of the structures or upgrade the structures if required, which would justify the decision not assessing coastal erosion hazards for this site.
