## Poutō Peninsula

Parawanui (Poutō), NRC Lake No. 297.

Summary	Parawanui
<b>Surveyed:</b>	2001, 2016 and 2018.
<b>Overall ranking:</b>	<b>Moderate:</b> A degraded lake, with poor water quality, but fencing has prevented grazing from most of the lake margins permitting the re-establishment of an emergent vegetation band around the lake. Submerged vegetation appears to be well established around the margins despite the presence of pest fish.
<b>Threats:</b>	Pest fish (rudd, koi carp, orfe) have been introduced into this lake. Nutrient enrichment and algal blooms continuing despite fencing. The lake is fished for eels providing an introduction pathway for additional pest fish and pest plants.
<b>Management recommendations:</b>	Advocate the establishment of wetlands to mitigate impacts of the nutrients transported to the lake from the inlet. Advocate the closing of this lake to eel fishing. Five yearly surveillance for pest plants and lake native biodiversity value monitoring.

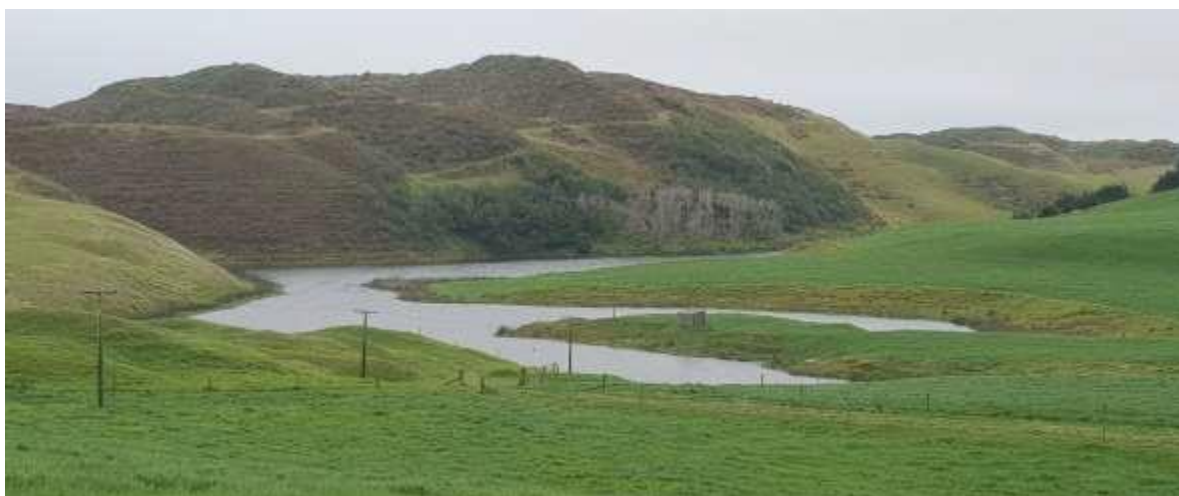
**Parawanui.** Photo from Southern end of lake showing the fenced pasture margins and re- establishing marginal vegetation. (Photo: Tracey Burton 18 September 2018).

Poor water quality remains a concern and continuation of restoration initiatives are advocated, especially the interception of nutrients from inflows, possibly by planting wetlands. The risk of new pests through contaminated fyke nets used for eel fishing is high and the recommendation to close this lake to eel fishing should be advocated to the landowner. Five-yearly monitoring is recommended.

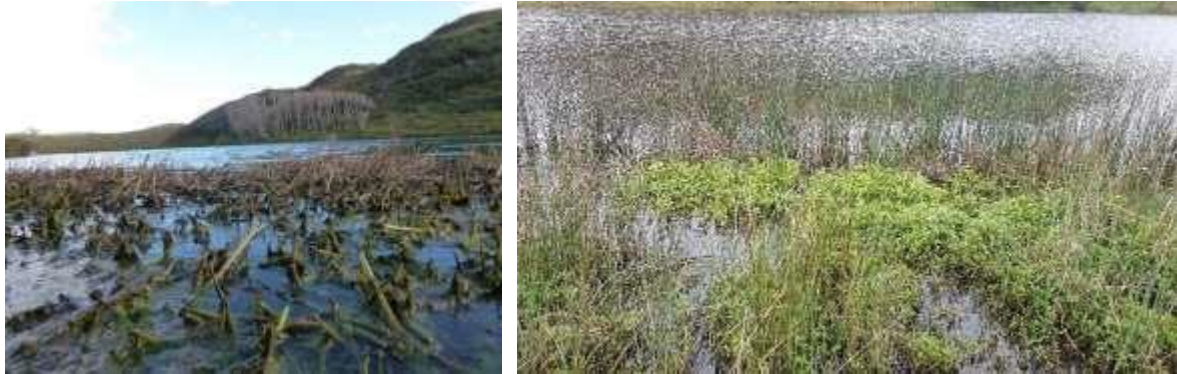
species. Since that time fencing has allowed the development of an almost entire dense margin of emergent species including *S. tabernaemontani*, *Apodasmia similis*, *Eleocharis sphacelata*, *Machaerina juncea* and *Juncus pallidus*. Floating rafts of alligator weed (*Alternanthera philoxeroides*) were noted spreading out from the lake edge in 2018. This showed the heavy browsing by the biocontrol agent *Agascicles hygrophila* seen in 2016 only provided temporary control. The turf community lining the southern margin of the lake, previously reported as containing the locally rare *Fimbristylis velata*, was submerged during the 2018 survey and this plant was not recorded.

**Alligator weed on the margin of Parawanui.** Photo on left shows Alligator weed in autumn 2016 (defoliated by alligator weed flea beetle) and on right, in spring 2018 (healthy). (Photos: Paul Champion March 2016 and September 2018).

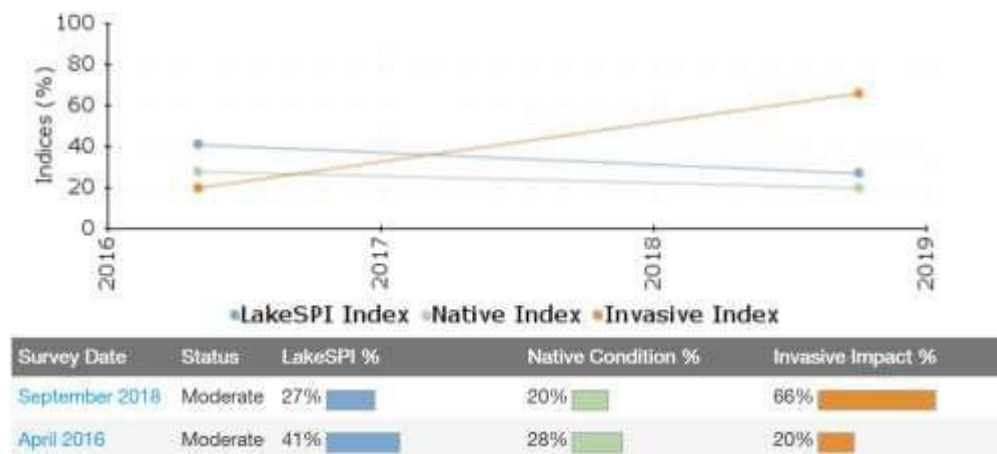
Lake Parawanui Submerged Plant Indicators

**LakeSPI results for Lake Parawanui.** LakeSPI Indices expressed as a percentage of lake maximum potential.

Lake Parawanui is categorised as being in moderate ecological condition with a LakeSPI Index of 27%.

In 2016, several of the profiles had dense plant growths to 3.5 m. Parawanui was categorised as being in moderate condition with a LakeSPI Index of 41%. The decline from 41% in 2016 to 27% in 2018 is likely to be a consequence of greater abundance of the invasive *Potamogeton crispus*, predominantly with maximum biomass produced in winter and spring, before declining during summer. However, continued input of nutrient rich inflows and possible extinction of freshwater mussels may also be related to this decline.
