## 27 Taipa Beach

### Coastal Erosion Hazard Assessment

**NORTHLAND REGIONAL COUNCIL**  
 Coastal Erosion Hazard Assessment  
 Taipa Beach  
 Site: 27

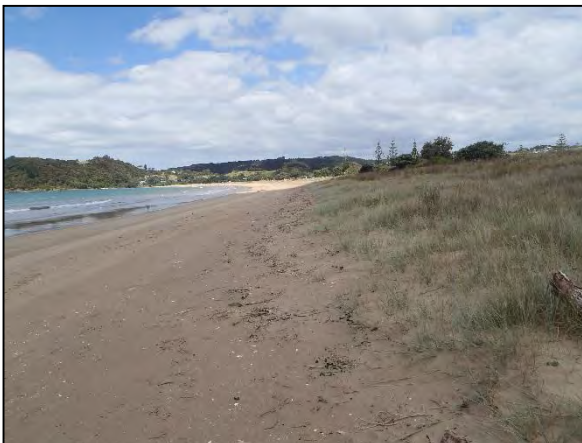
*Site Photograph A (west)*

The site has a sandy beach comprising fine to medium sand. The beach has a berm width less than 5 m above the high tide line. A small stream enters the site at the west end of the site, which does not appear to have any effect on the shoreline at this position.

The dune is well vegetated with spinifex and a foredune is developing along the open coast shoreline. The dune heights range from approximately RL 2 to 5 m along the site. The backshore is developed with the most seaward dwelling located 100 m from the dune toe.

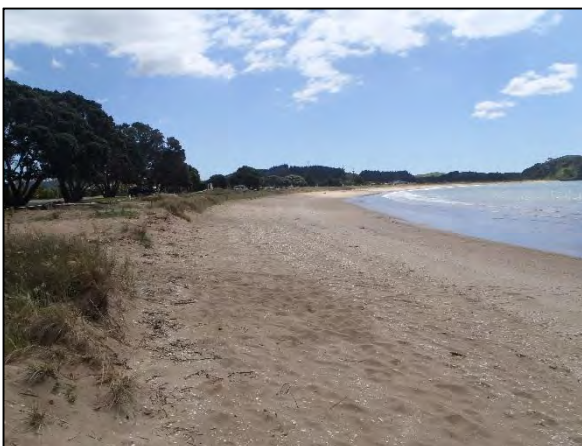
*Site Photograph B (east)*

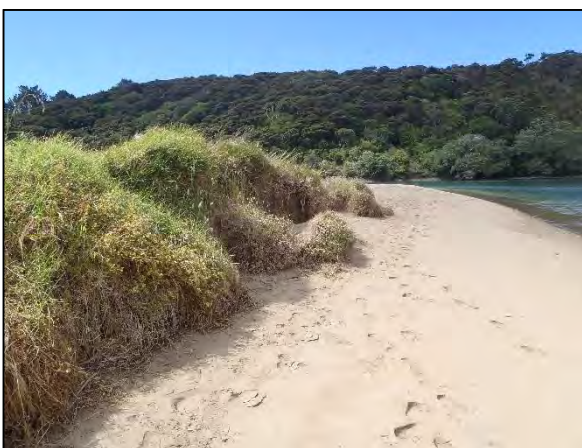
*Site Photograph C (estuary)*

The Taipa River mouth is located at the eastern end of the site. Some erosion is evident on the inside of the spit shoreline.

There are no erosion protection structures along the open coast shoreline. A timber seawall exists along the estuary shoreline.

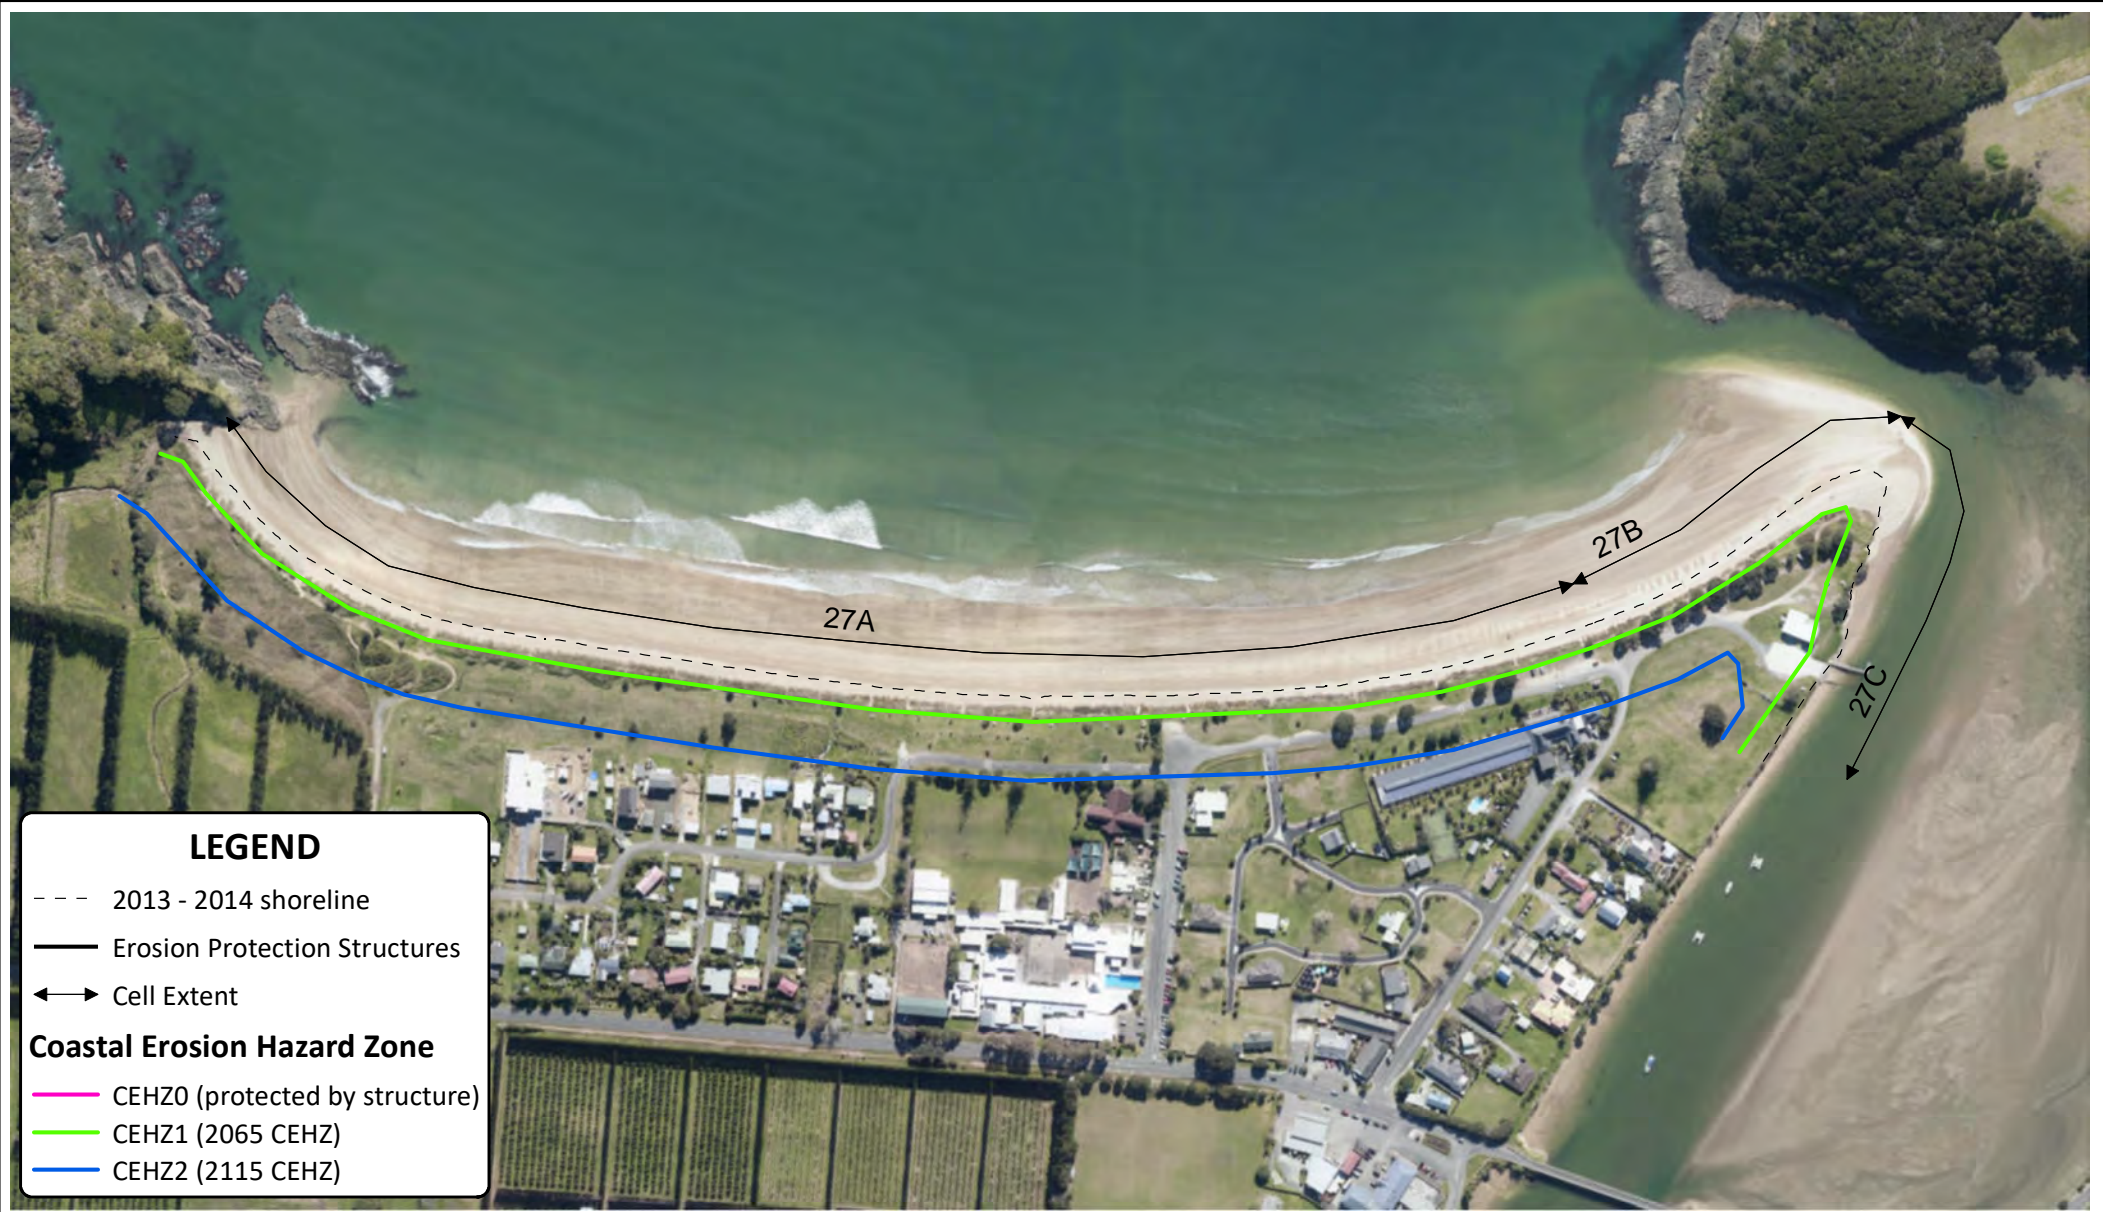
FIGURE No. Figure 27-4

Coastal Erosion Hazard Zone widths are presented within Table 27-2 and Figure 27-4. CEHZ1 values range from 15 to 17 m and CEHZ2 values from 55 to 65 m. CEHZ's have been

mapped in agreement with the calculated values. Note that cell 27A has experienced accretion since about 1961 along its entire length, with CEHZs offset from the accreted most recent shoreline.

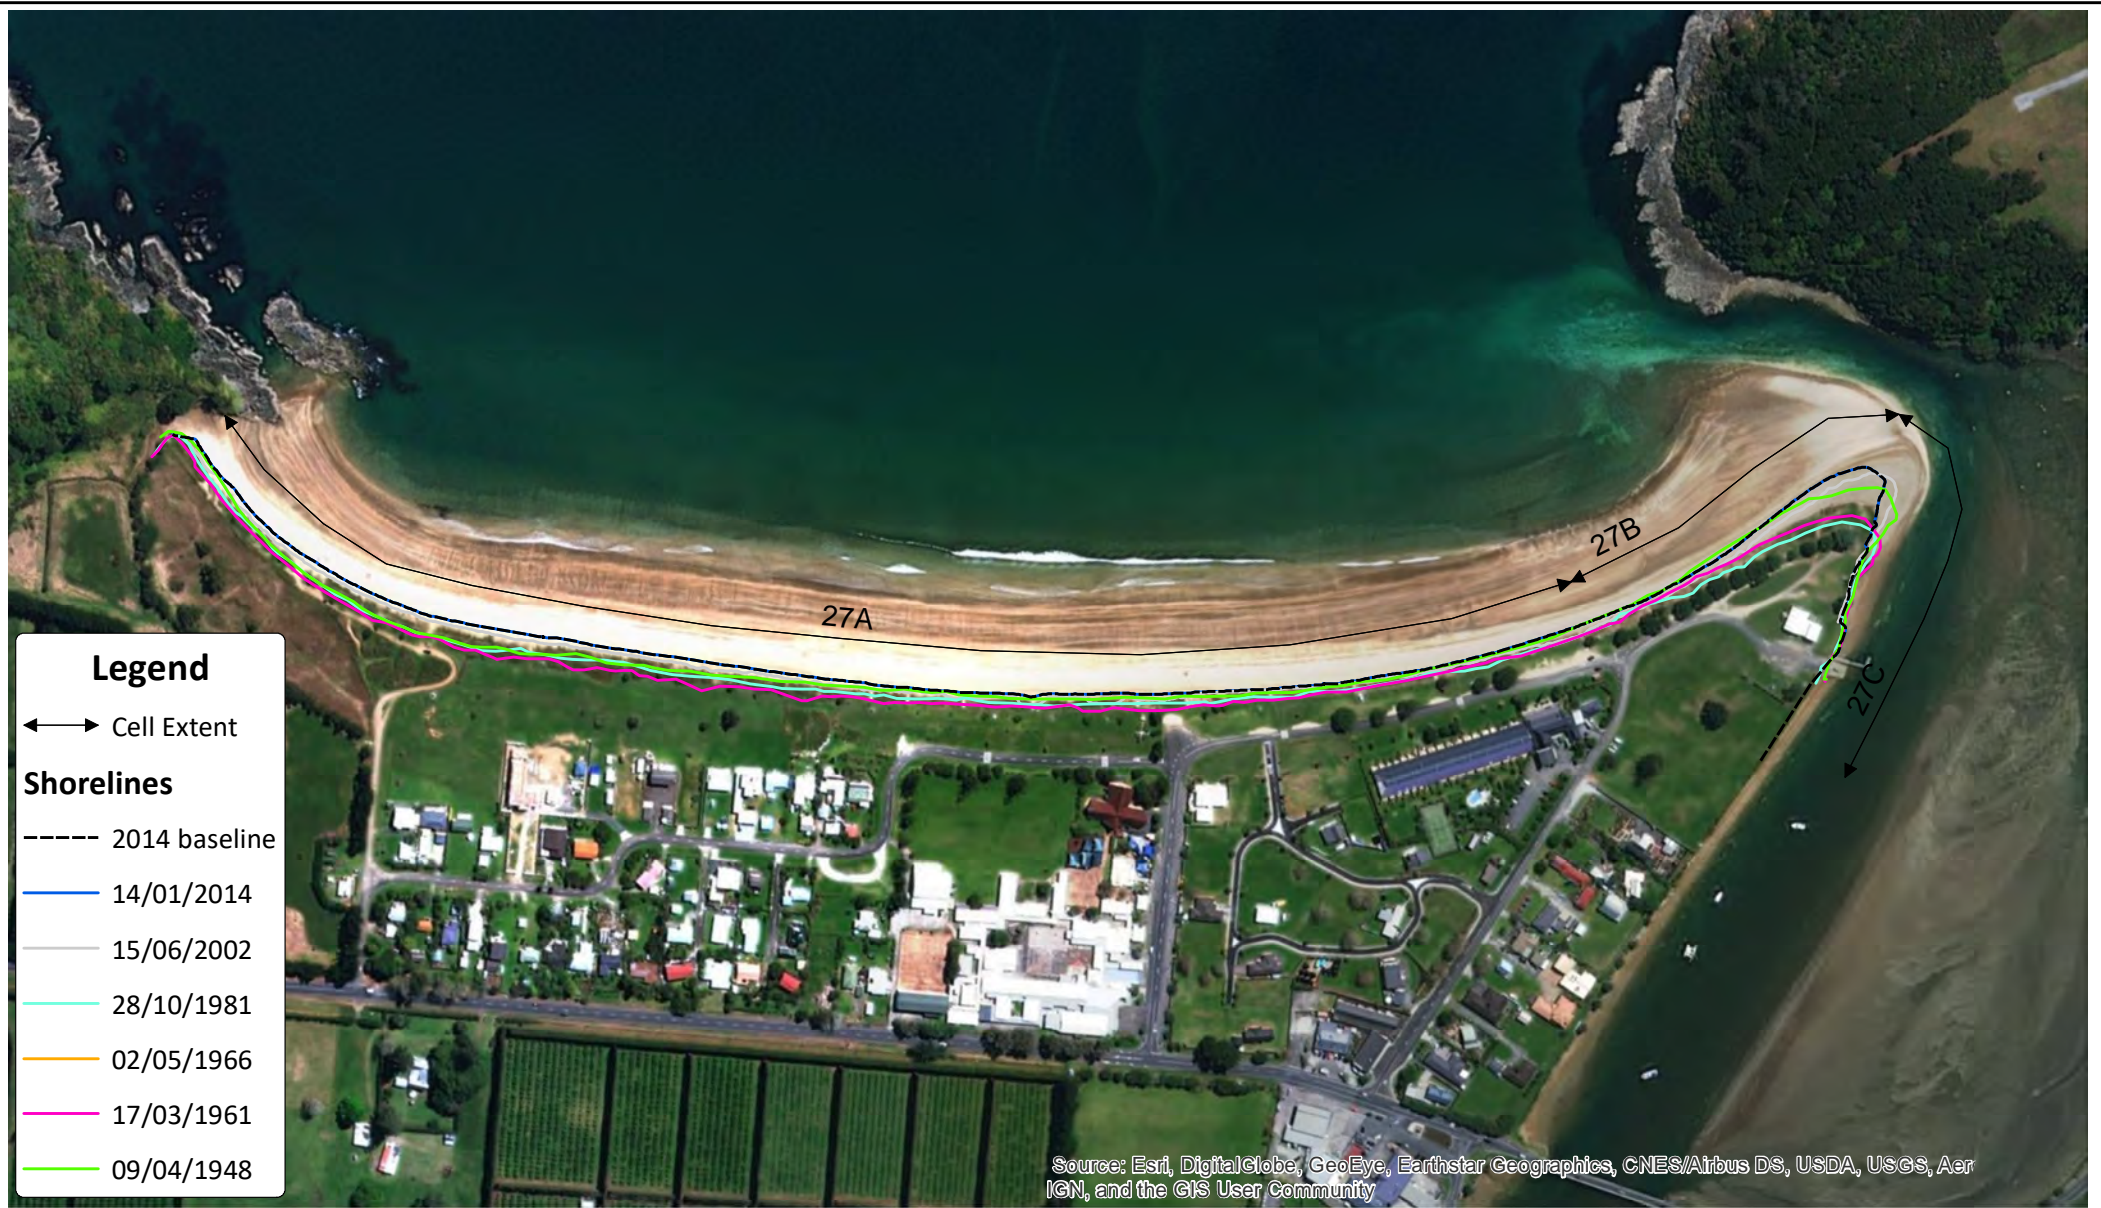
FIGURE No. Figure 27-5

Figure 27-5 shows the available historic shorelines for Taipa Beach.

**NORTHLAND REGIONAL COUNCIL**  
Historic shorelines  
Taipa Beach  
Site: 27
