10 Matapouri

Coastal Erosion Hazard Assessment

NORTHLAND REGIONAL COUNCIL
 Coastal Erosion Hazard Assessment
 Matapouri
 Site: 10

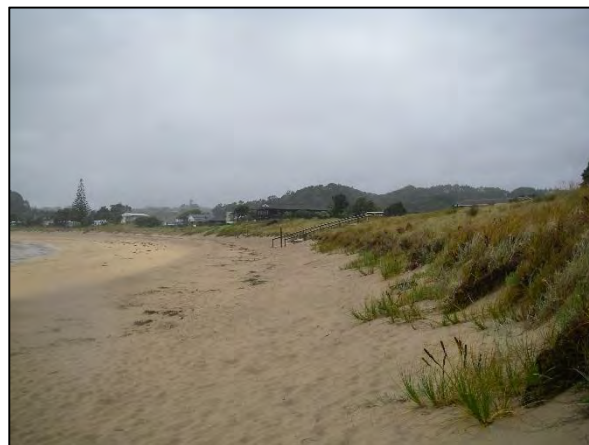
Site Photograph A (northern end)

The site has as a healthy dune system at the northern end of the site which is well vegetated with spinifex. The dune elevation ranges from RL 4 to 7 m. A recent erosion scarp is evident near the centre of the bay where the dune face is over steep.

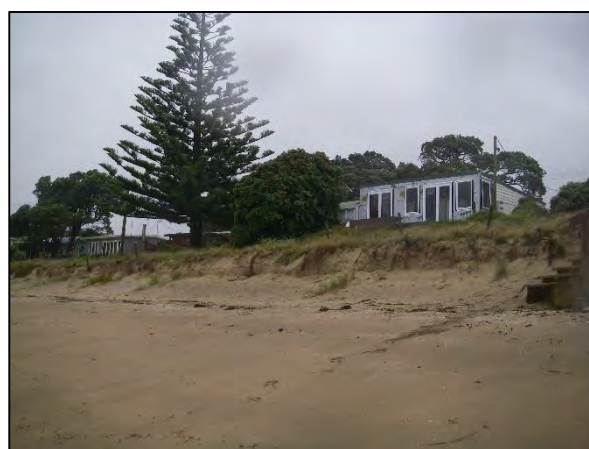
Site Photograph B (centre)

Dune nourishment has been undertaken at the site primarily focussed on placing sand sourced from the estuary along the centre of the site.

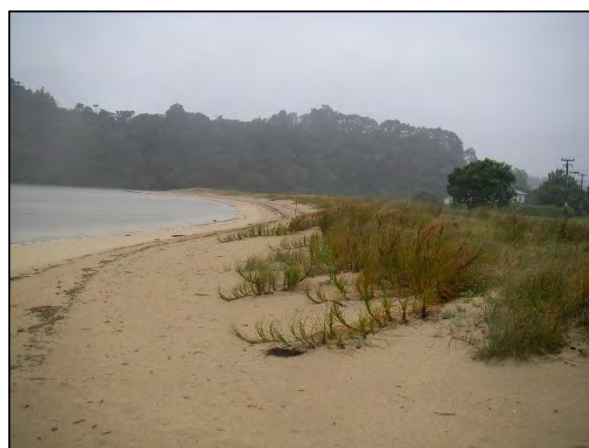
Site Photograph C (estuary – north facing shoreline)

The north facing estuary shoreline located on the opposite side of the channel appears to be building out significantly.

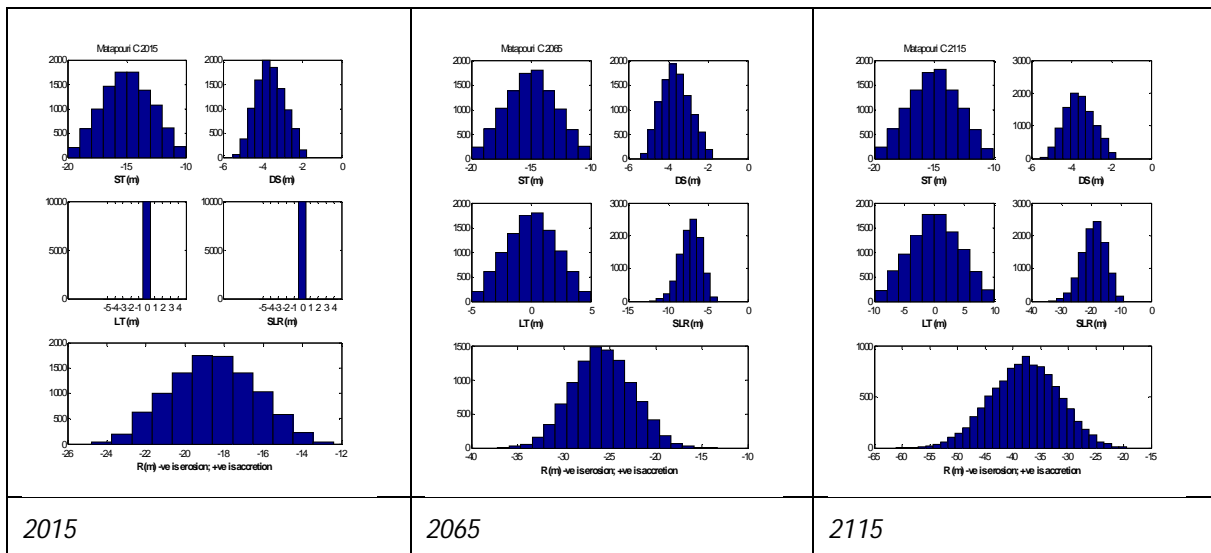
Figure 10-3 Histograms of parameter samples and the resultant shoreline distances for 2015, 2065 and 2115 timeframes for cell 10C

Histograms of individual components and resultant CEHZ distances using a Monte Carlo technique are shown in Figure 10-1 to Figure 10-7.

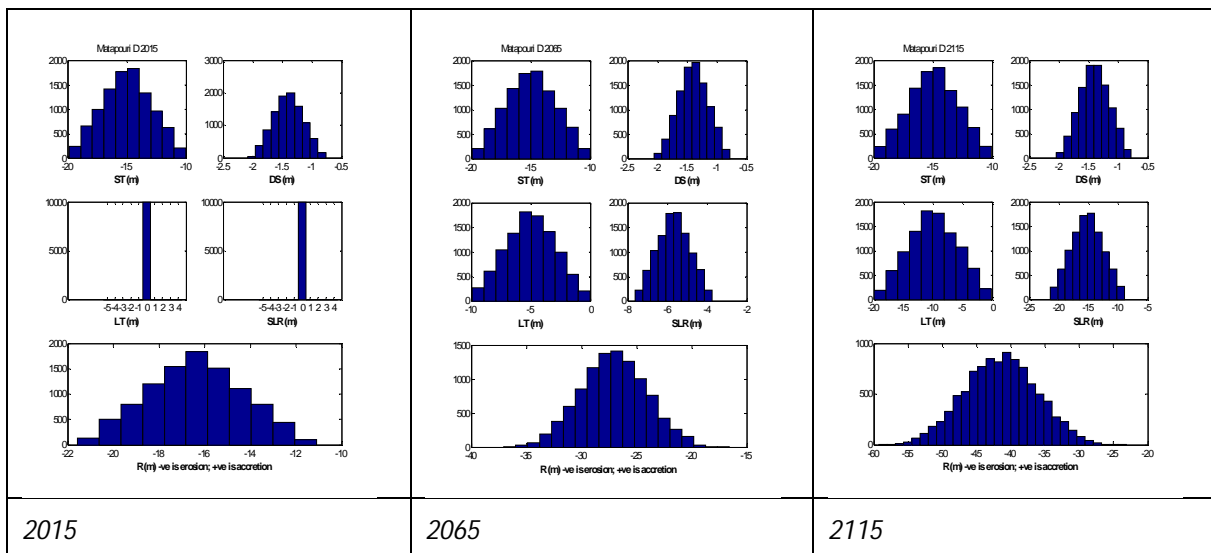
Figure 10-4 Histograms of parameter samples and the resultant shoreline distances for 2015, 2065 and 2115 timeframes for cell 10D

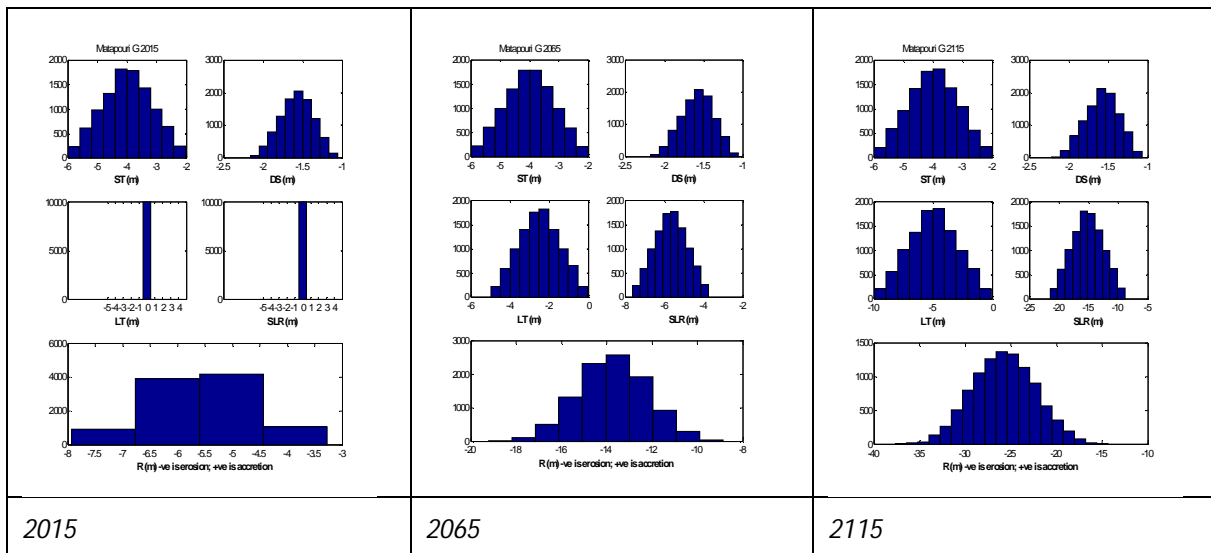
Figure 10-7 Histograms of parameter samples and the resultant shoreline distances for 2015, 2065 and 2115 timeframes for cell 10G

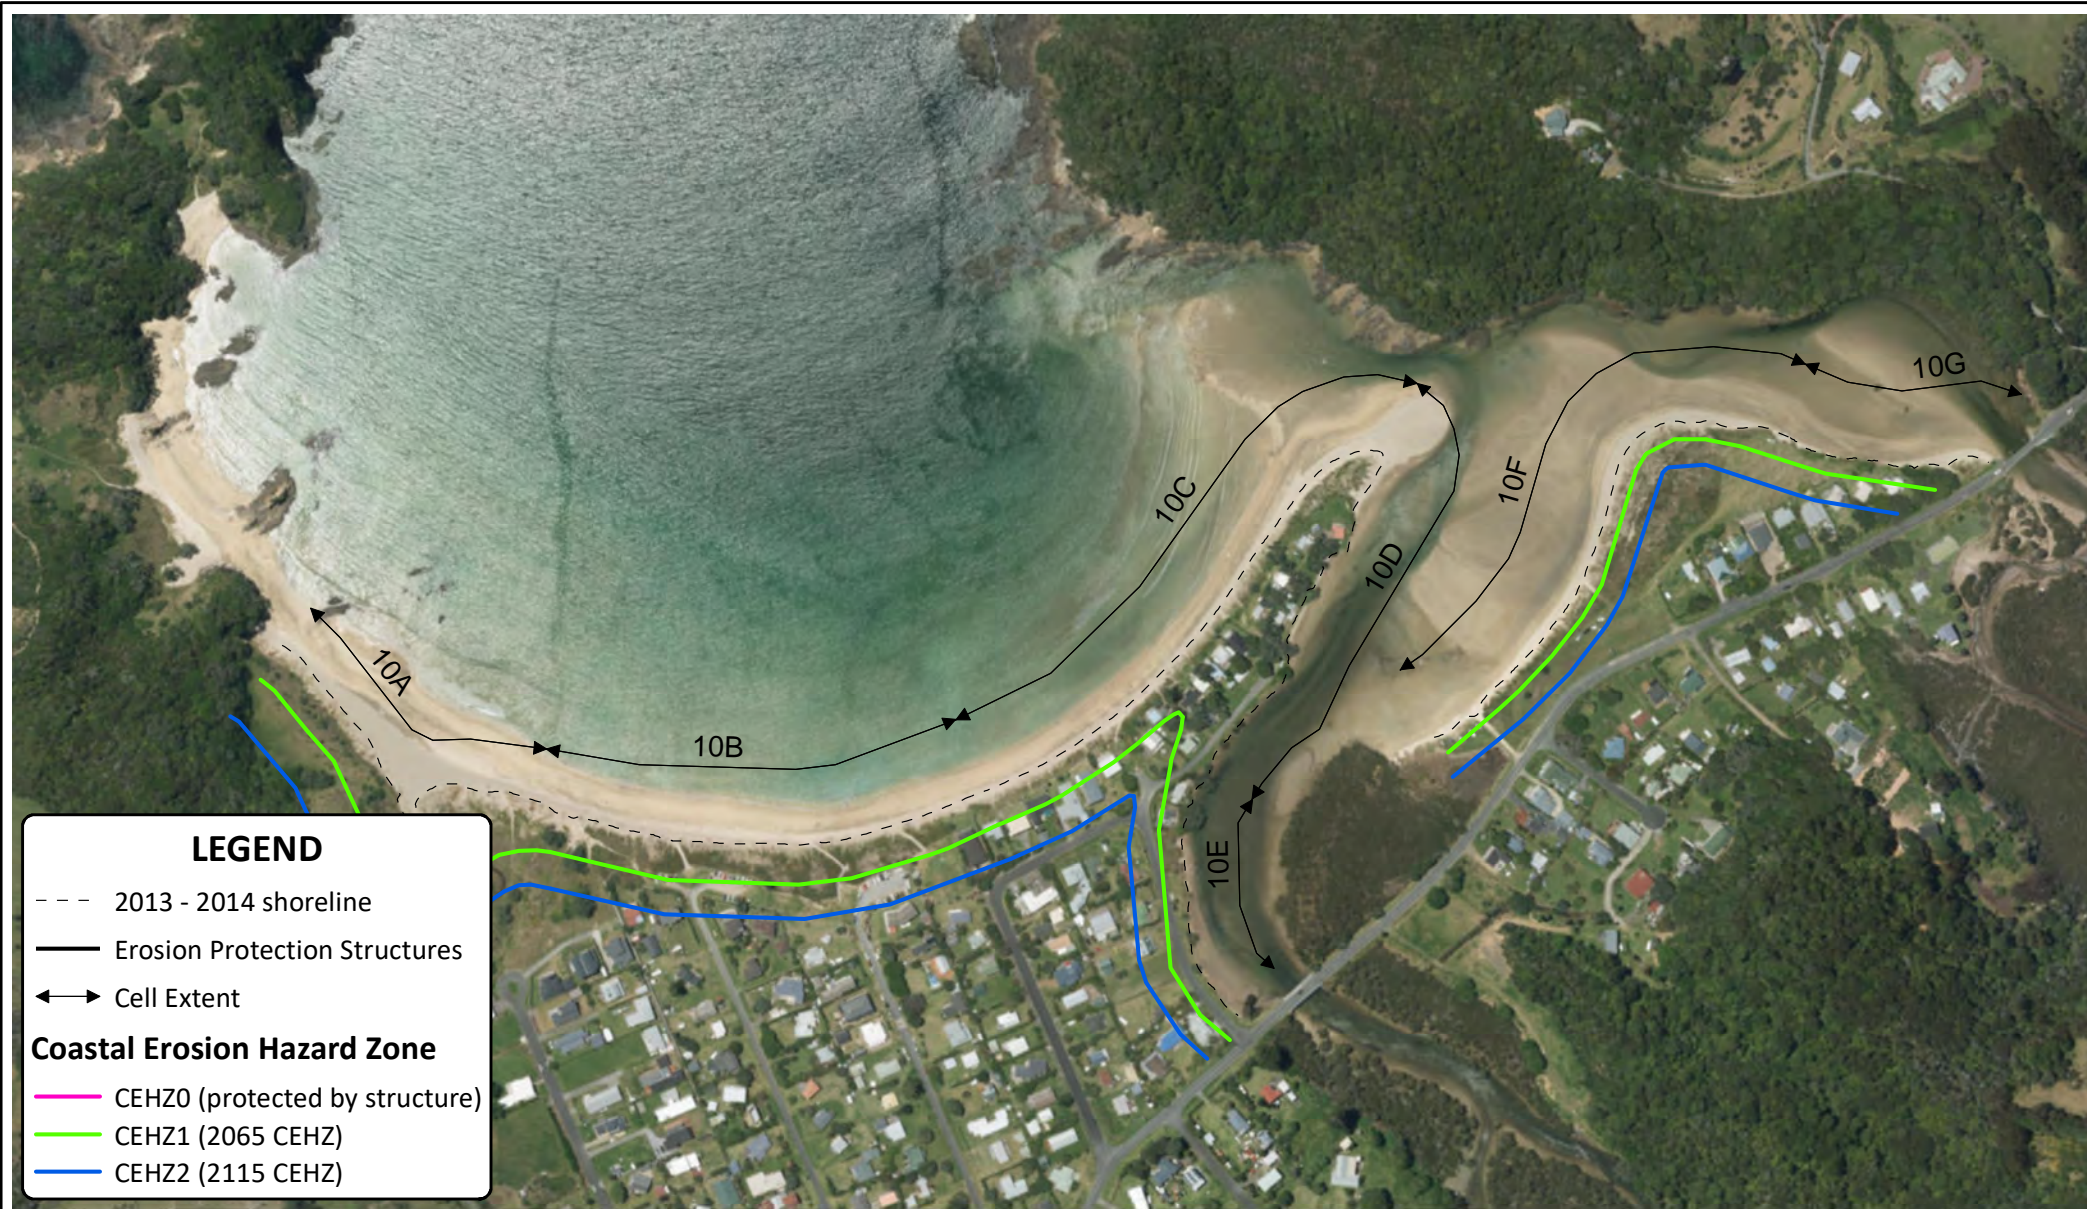
FIGURE No. **Figure 10-8**

Notes: Dashed CEHZ indicates greater uncertainty around stream mouths and backshore topography. Northland 0.1m Rural Aerial Photos (2014-2015).

Coastal Erosion Hazard Zone widths are presented within Table 10-2 and Figure 10-8. CEHZ's have been mapped in agreement with the calculated values, although where CEHZs from the sea and estuary intersect at the distal tip of the sand spit, the hazard zone has been truncated. Note that cell 10F has accreted since about 1942, with CEHZs offset from the accreted most recent shoreline.

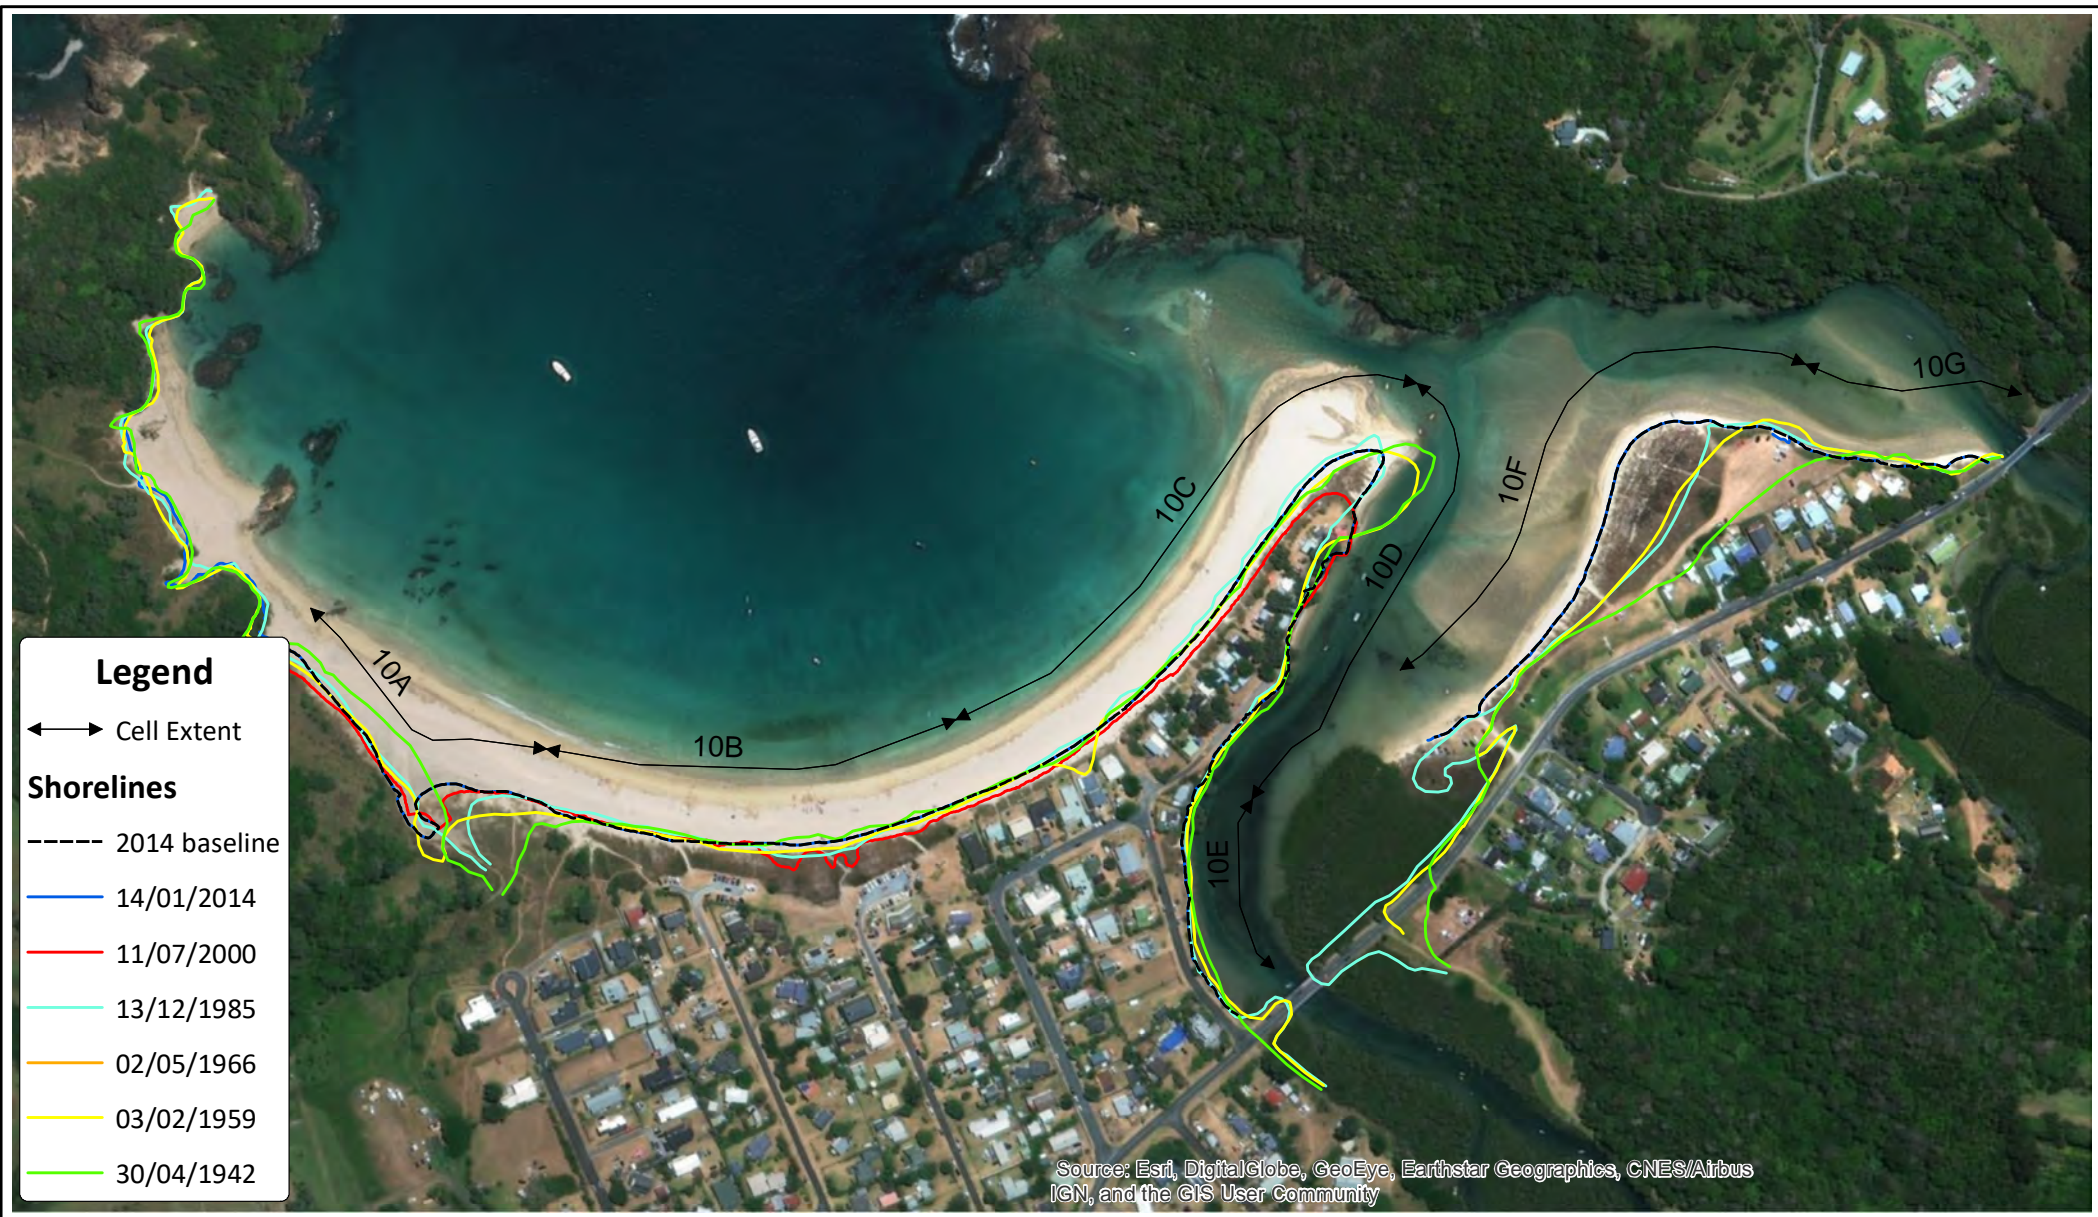
FIGURE No. Figure 10-9

Historic shorelines
Matapouri
Site: 10

Figure 10-9 shows the available historic shorelines for Matapouri.
