# 3. Inventory of Lakes in Northland

# **Aupouri Lakes**

# 3.1 Lake Austria (Aupouri), NRC Lake No. 22; surveyed in 2005.

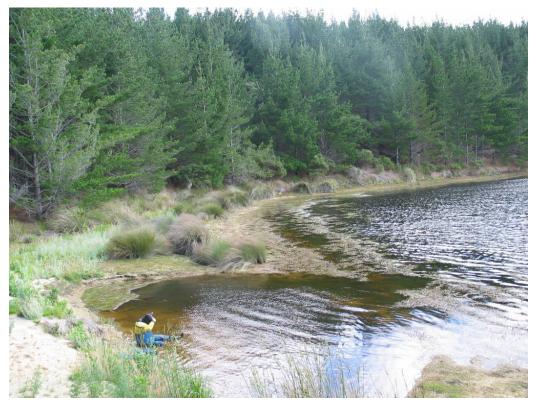
Plate:

Lake Austria margin showing exposed turf communities and *Apodasmia similis* tussocks. Note humic stained water and floating mats of *Utricularia gibba* (centre right).

There is apparently some livestock access (cattle, horses?) based on pugged lake margins and absence of emergent vegetation in shallow water areas (see plate).

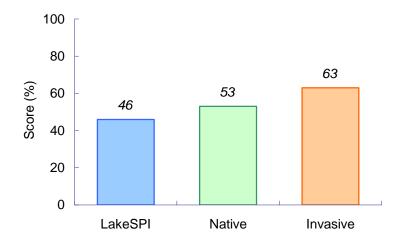
**Figure:** LakeSPI Index as % of potential score, Native Condition Index, and Invasive Impact Index (from left to right).

The low LakeSPI score of 46% reflects the smothering impact of the invasive *U. gibba* on the submerged vegetation. Profiles were limited so this LakeSPI assessment should be considered provisional.

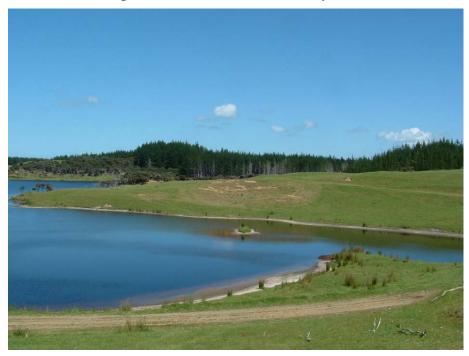
**Plate:** Lake Bulrush showing the lack of emergent vegetation and unfenced shoreline.

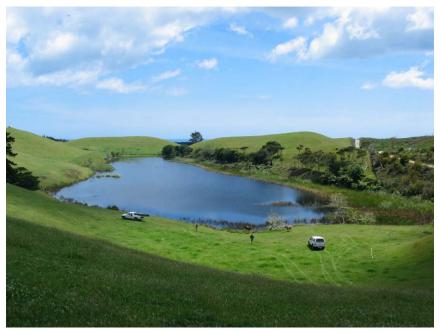
**Plate:** Carrot Lake showing areas of unfenced pastoral catchment and cattle access to the waters edge around the eastern margin of the lake.

The predominantly pastoral catchment is a likely source of nutrients, with areas of the lake remaining unfenced and the infringing emergent plants susceptible to cattle grazing and trampling.

Retirement of the lake edges around the eastern sector of the lake will encourage vegetation development and the interception of diffuse nutrient-runoff.

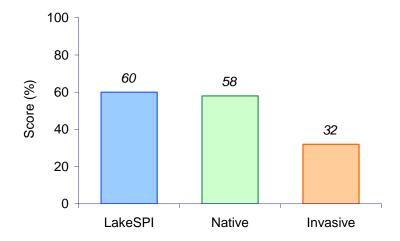
Figure:

LakeSPI Index as % of potential score, Native Condition Index, and Invasive Impact Index (from left to right).

The moderately high LakeSPI score of 60% reflects the extent of development of the charophyte meadows and relatively small impact by the exotic species *Utricularia gibba*.

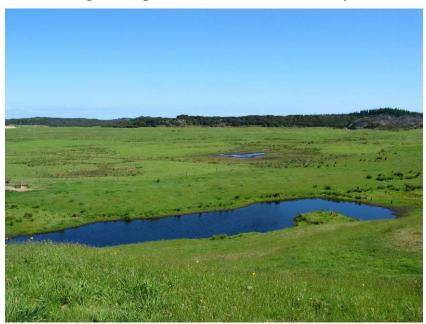
**Plate:** Remnant pools in pasture occupying the area previously containing Half Mile Lagoon.

Half Mile Lagoon is situated 1599378E, 6157875N, and once covered an area 3.6 ha. The plate shows the largest of the remaining pools (approximately  $100 \text{ m}^2$ ).

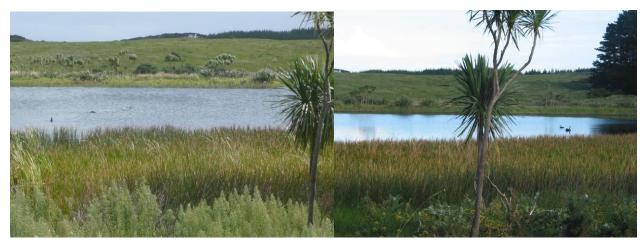
Plate: Lake Heather set in a pasture catchment fenced off with a wetland margin.

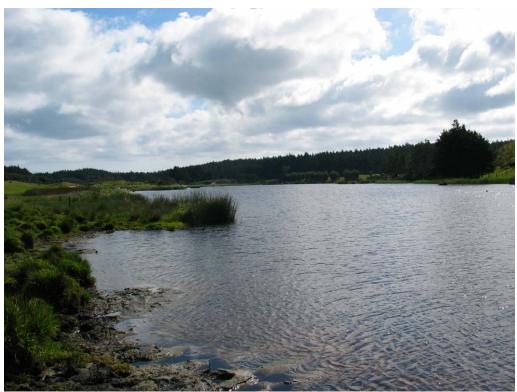
**Plate:** Katavich Lake showing margin of lake impacted by cattle access.

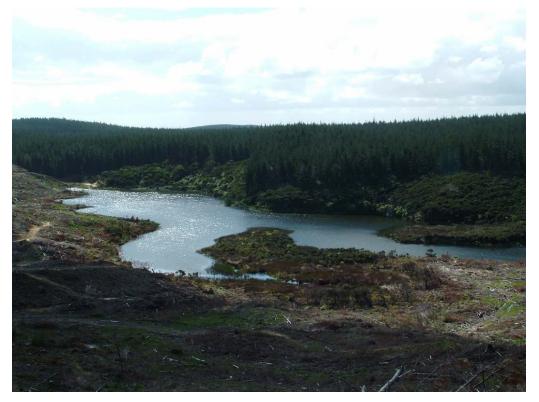
Plate:

Lake Kihona set in a forestry catchment, note the recent harvesting and limited development of emergent vegetation.

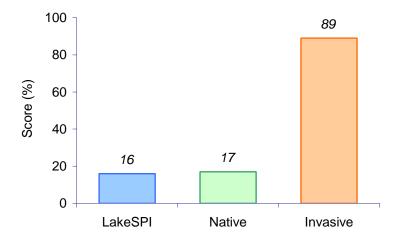
**Figure:** LakeSPI Index as % of potential score, Native Condition Index, and Invasive Impact Index (from left to right).

The LakeSPI score of 16% is low as the lake is dominated by the invasive weed hornwort (*Ceratophyllum demersum*), with little native vegetation present.
