Te Hiku

Lake Ngakapua, NRC Lake No. 115 (South Basin) and 117 (North Basin)

Summary	Lake Ngakapua
Surveyed:	2005, 2010, 2014, 2015, 2016, 2017, 2018, 2020 and 2025.
Overall ranking:	High: Predominantly native vegetation (including regionally rare and At-Risk species) with decreasing impact by <i>Utricularia gibba</i> over time. Fencing has reduced livestock impacts and increased marginal emergent vegetation.
Threats:	A decline in submerged vegetation and loss of charophyte meadows indicate decline in water quality and possible evidence of pest fish browsing. Although lagarosiphon has been eradicated, pest plant introduction is still a major threat to Lake Ngakapua.
Management recommendations:	Undertake a fish survey over the next summer to identify the presence of pest fish. Secure fencing excluding cattle access is likely to improve water quality. Lake ecological monitoring should be undertaken every five years, including a survey for torewai and turf species in the northeastern bay in the South Basin.

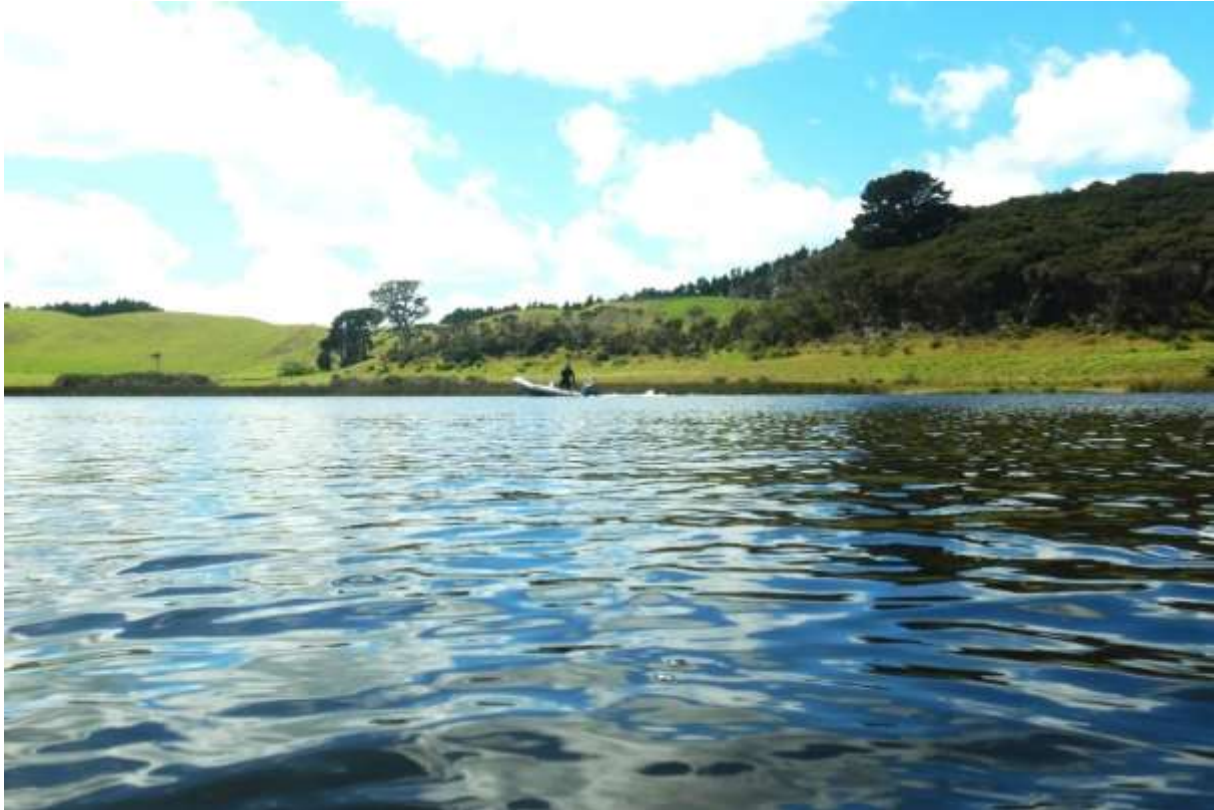
Lake Ngakapua South Basin: looking towards the southern shoreline (Svenja David, 2025).

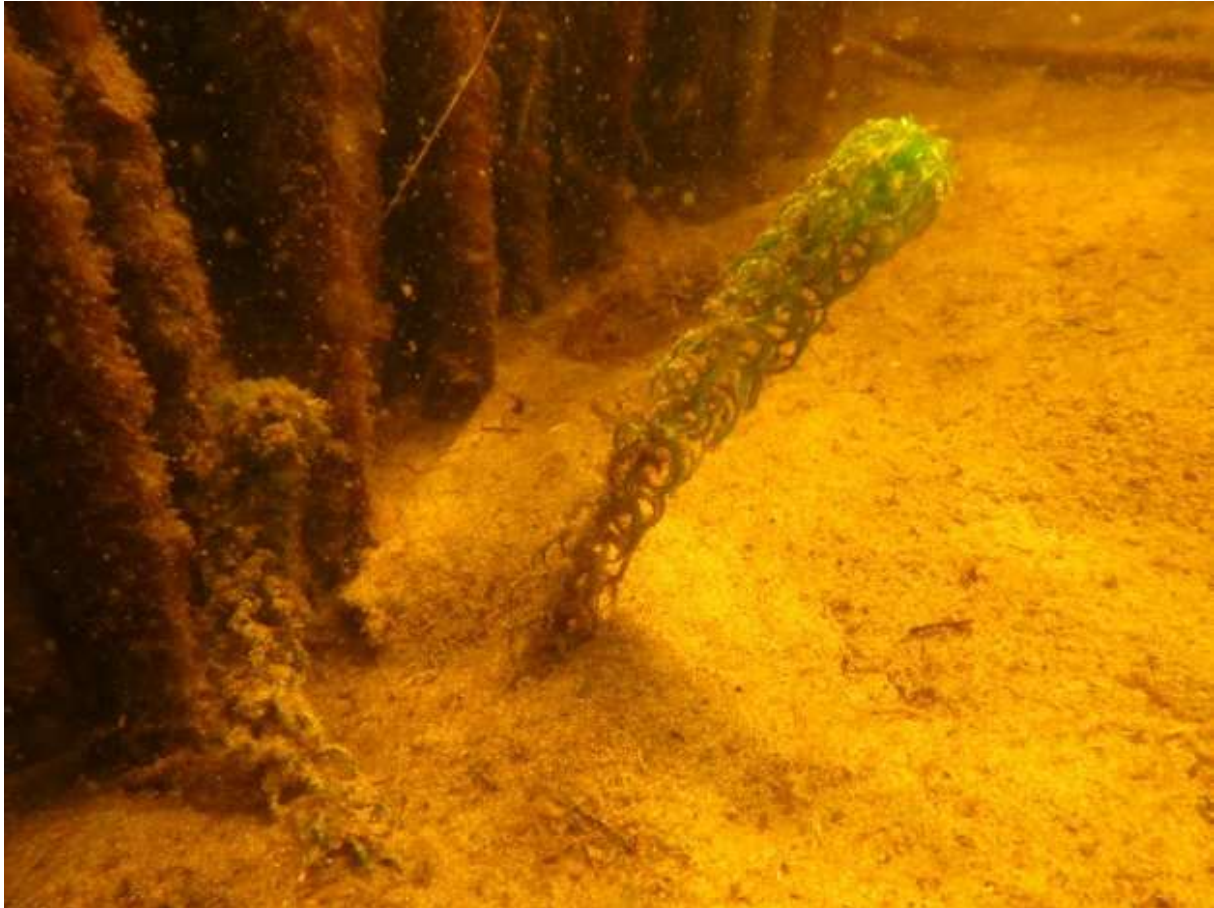
An incursion of the pest plant lagarosiphon (*Lagarosiphon major*) was detected in the South Basin of Ngakapua for the first time in 2014. After delimitation of the incursion, the herbicide endothall dipotassium was applied in 2015, with no further plants found after that. Lagarosiphon is now considered eradicated from Lake Ngakapua. This illustrates the importance of regular dive surveys, allowing for an effective incursion response.

Lake Ngakapua: *Lagarosiphon major* rooted shoot adjacent to emergent kuta (Rohan Wells, 2014).
