Ecological Survey: Doug's Opua Boatyard

For Doug Schmuck

Ecological report

April 2018

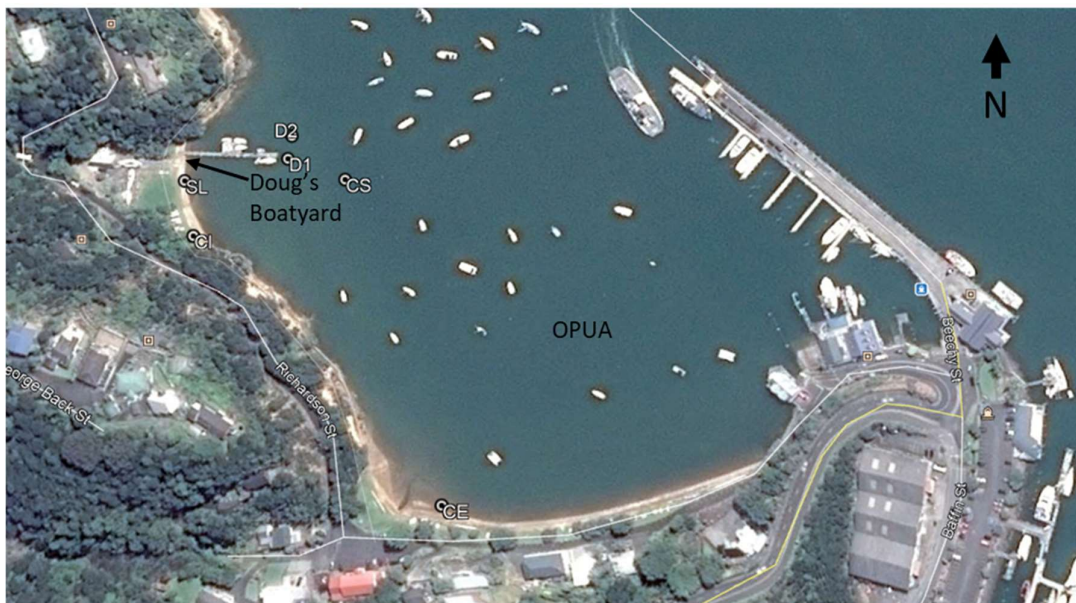
Figure 1: Sediment Sampling Locations

Surficial sediments (to a depth of 3 cm) were collected at 6 sites shown in Figure 1:

- 1) The intertidal zone of the slipway (SL);
- 2) A control or 'background' site (CI) in the intertidal zone on the beach approximately 40 m from the boatyard slipway;
- 3) A control or 'background' site in the intertidal zone at Opuia beach (CE) approximately 230 m from the boatyard;
- 4) A subtidal site in the southern portion of the proposed dredged area (D1);
- 5) A subtidal site in the northern portion of the proposed dredge area (D2); and
- 6) A subtidal control or 'background' site approximately 40 m southwest of the proposed dredged area (CS).

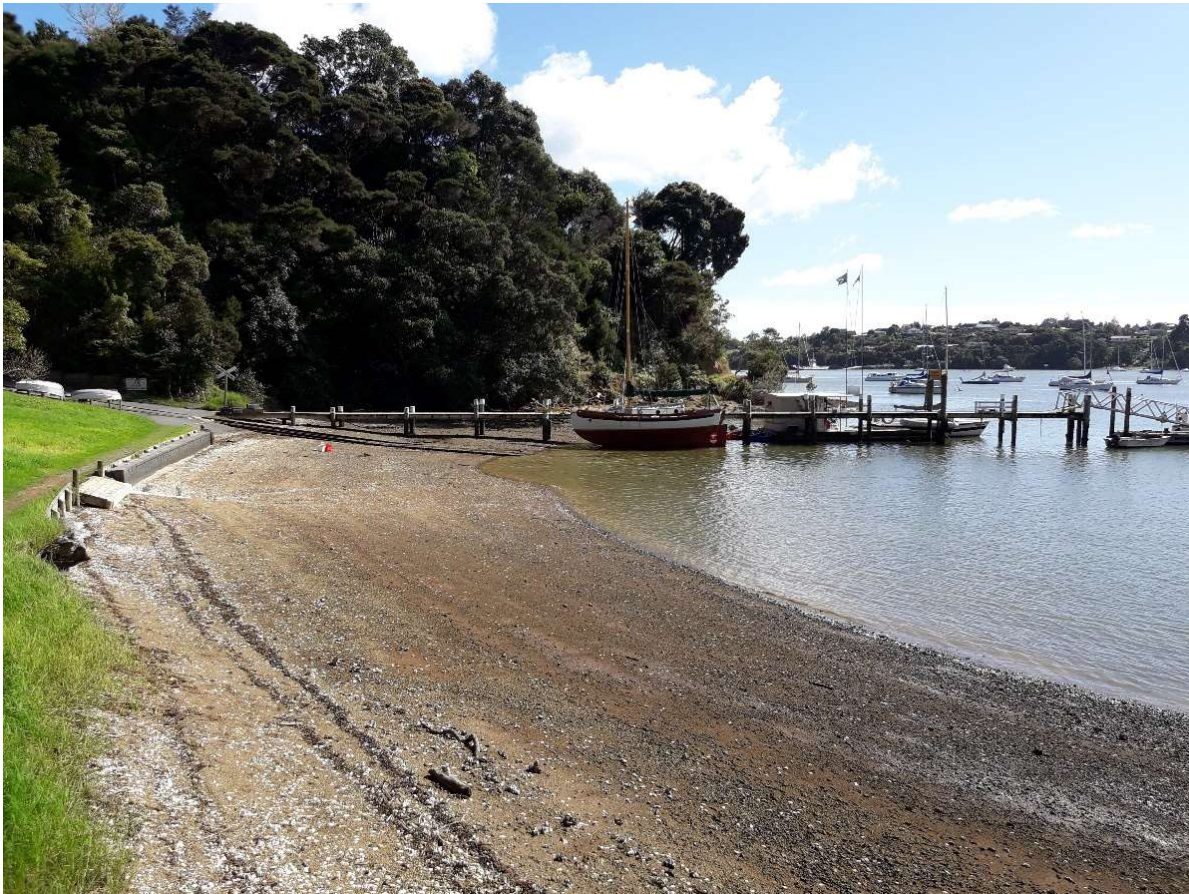
Figure 2: View of Area of Survey Looking from South End of Beach: Beach, Existing Jetty and Slipway.

The slipway and jetty are located at the northern end of the beach adjacent to Richardson St, within the wider embayment at Opuia (Figures 1, 2 and 3). At either end of the beach there is a rocky point extending into the subtidal zone. There is a small retaining wall at the top of the beach, the base of which is approximately at the high tide mark.

The substratum in the upper 1-2 m of shore is comprised mostly of gravel or sand with a high proportion of whole dead shell (mostly *Paphies australis* and also some *Crassostrea gigas* shell). The substratum in the mid intertidal zone comprises sand, gravel and shell gravel. The gravel component of the sediment increases in the mid and lower intertidal and the low intertidal is comprised of coarser gravel and sand overlaying muddy sand.

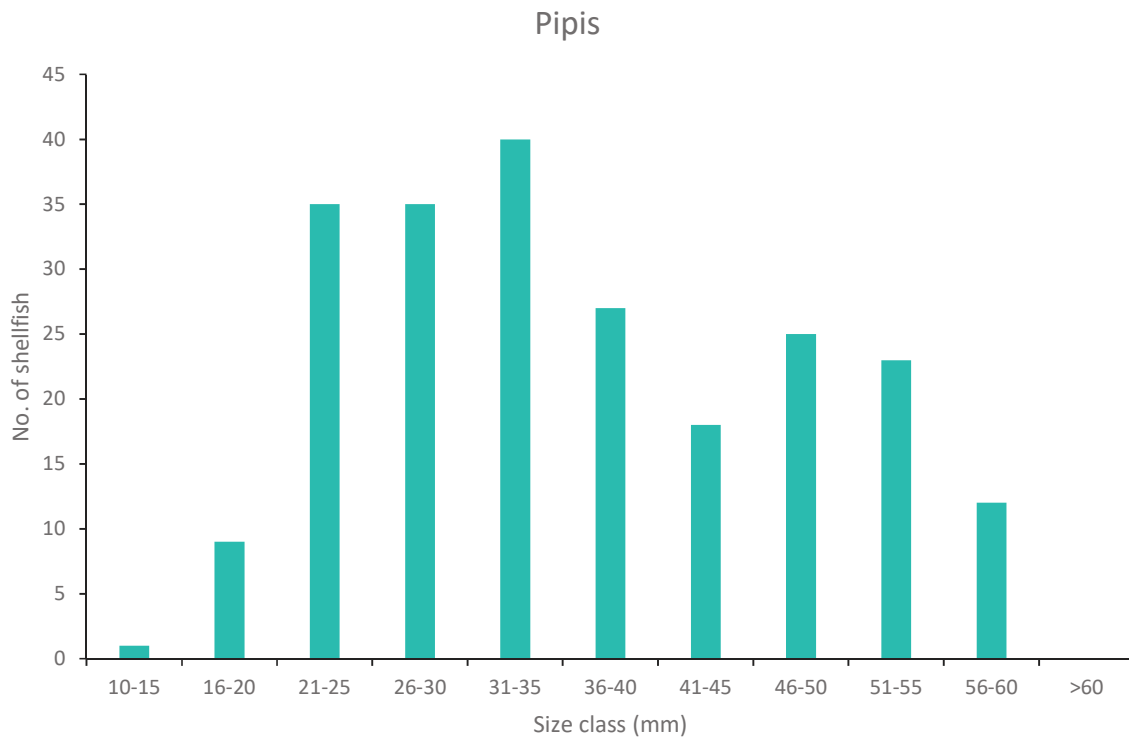
Figure 4: Size Frequency of all Pipis Surveyed

The survey found pipis in all quadrats sampled on the mid and lower intertidal. The mean density of pipis was 288 per m². The population on the beach adjacent to the boatyard is considered to be a 'bed' of pipis according to the accepted definition (where shellfish density is greater than 10 per m² e.g. Pawley and Smith 2014). Length frequency data and summary statistics are shown in Figure 4 and Table 1.

There is no legal minimum size for the harvest of pipis but a generally accepted rule of thumb is that they are considered as harvestable at shell length greater than 50 mm (Pawley and Smith 2014). The mean density of harvestable pipis surveyed at the beach was 51 per m². The Ministry for Primary Industries has historically used a general guideline to define a harvestable shellfish population as 25 per m² for pipis 50 mm and over (Pawley and Smith 2014), so the population surveyed was a harvestable pipi bed, so defined. Assuming a nominal area of 250 m² of suitable beach habitat it can be estimated that the bed holds ~12,750 edible sized pipi. On this basis it is to be regarded as a small bed.

On the day of the survey sampling, a person visited the beach and took shellfish, presumably for consumption. The person is apparently the only one who occasionally takes shellfish from the beach (pers. com. Mr Doug Schmuck). The population structure of the pipi bed on the beach is consistent with relatively light and infrequent harvesting pressure. If the bed was heavily exploited, there would be few larger sized pipis greater than 50 mm length.
