Northland Lakes 2011

Prepared for Northland Regional Council

NIWA Client Report No: HAM2011-073
Report date: May 2011
NIWA Project: NRC11205

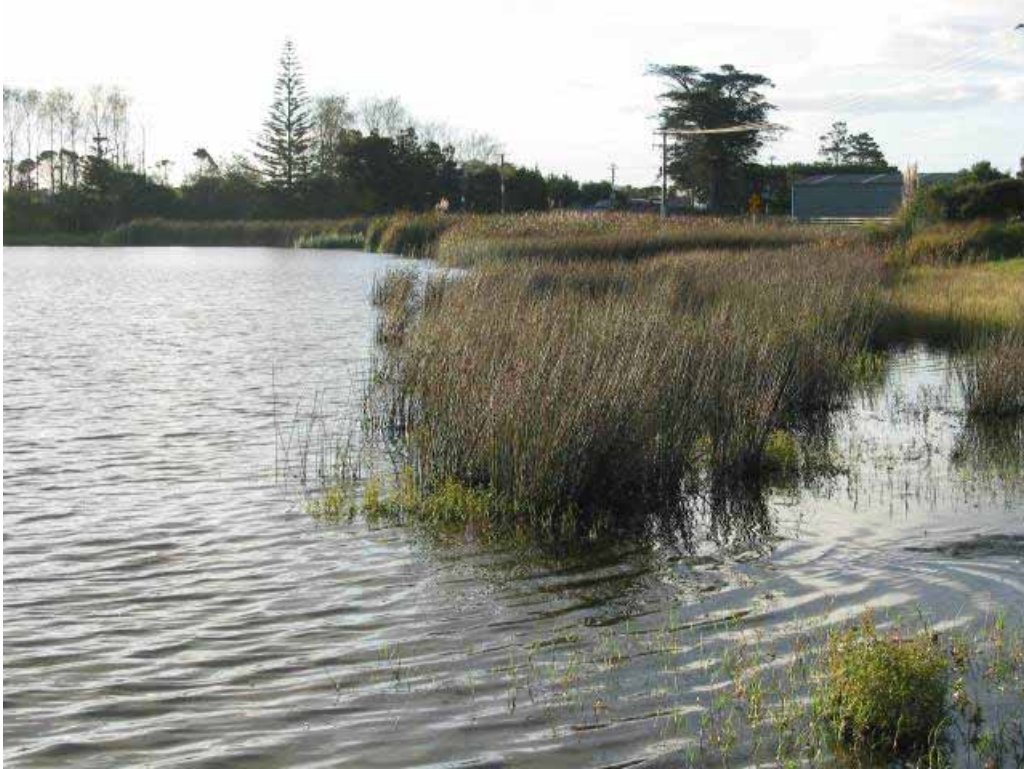
Figure 3-1: Lake Waiporohita showing emergent communities on the east side of the lake accessible from the road.

There were areas of emergent vegetation around the northern end of the lake, mostly up to 20 m across, with bare iron pan in the remaining areas. Dominant species were *Typha orientalis* with an outer fringe of *Eleocharis sphacelata*, with other areas of *Schoenoplectus tabernaemontani*, *E. acuta* and *Apodasmia similis*. The first record of *Gratiola pedunculata*, probably a natural introduction from Australia (de Lange 1997), was made at this lake in 1996 and found again in exposed grass/herb land between tall emergent vegetation. Other species present were *Alternanthera denticulata* (also an Australian vagrant), *Paspalum distichum* and *Centella uniflora*. In 2007 *A. denticulata* had expanded its range over much of the lake margin growing on the lakeward side of some emergent vegetation. The hybrid introduced willow weed *Persicaria lapathifolia* x *P. persicaria*, previously only collected from the Waikato was recorded in 2007. The nationally endangered grass *Amphibromus fluitans* was collected in 1998 but not seen since.

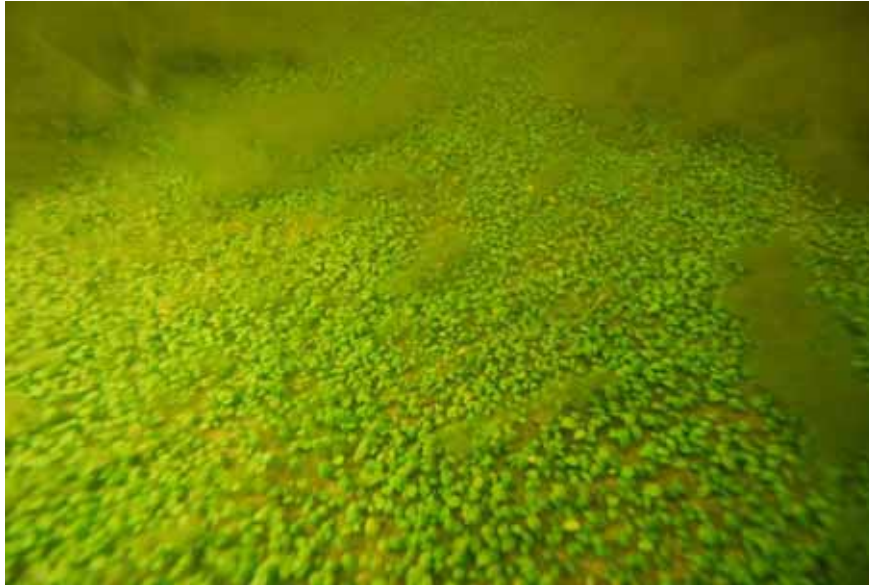
Turf communities were conspicuous in many areas of the lake with *Glossostigma elatinooides*, (Figure 3-2) *Lilaeopsis novae-zelandiae*, *Myriophyllum propinquum*, the exotic *Ludwigia palustris* and at one site *Gratiola pedunculata* extending from the shore to ~ 1 m deep. *Potamogeton ochreatus* and *Nitella* sp. aff. *cristata* or *Chara australis* dominated deep vegetation extending to 2.7 m. Observations of submerged vegetation in 2011 showed only minor change since 2005 such as the establishment of some *Utricularia gibba*.

Figure 3-2: Submerged turfs of *Glossostigma elatinoides* in Lake Waiporohita.

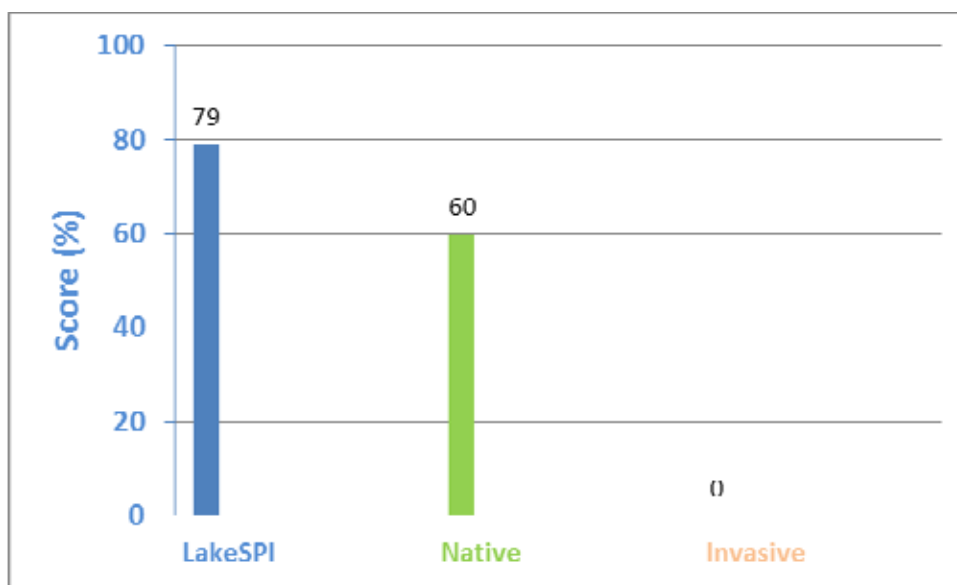
Figure 3-5: LakeSPI Index for Lake Tauanui as % of potential score, Native Condition Index, and Invasive Impact Index (from left to right).

The LakeSPI score was excellent at 95% (Figure 3-5) reflecting an indigenous submerged flora with high covers and diversity. No weed species were present.

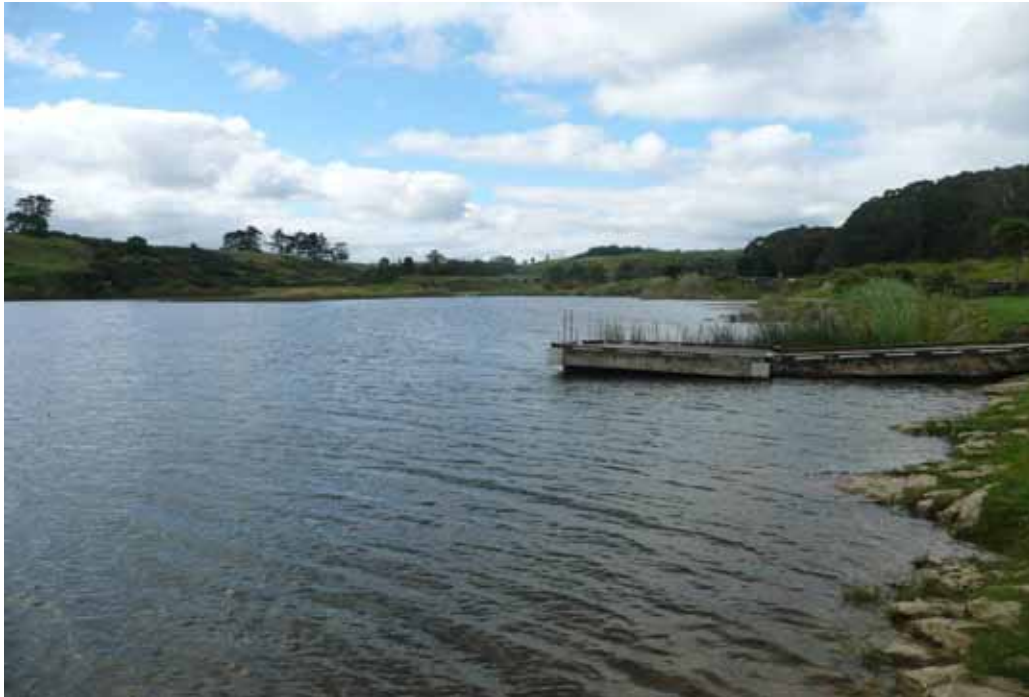
Figure 3-6: Lake Waro is a recreational park and used for contact recreation, particularly swimming. It is not used for boating, but is a prime site for further pest liberations.

The lake water was black and indicative of anoxia below the 5 m thermocline. Dense growths of nuisance weed are likely contributing to the anoxia but the catchment inputs should also be checked for high nutrients sources. Anoxic bottom waters will lead to sediment nutrient release and deteriorating water quality, threatening the safety of human contact during recreational activities.

Monitor and interpret water quality data. Aim to determine the cause and prevent anoxia in the bottom waters of the lake.

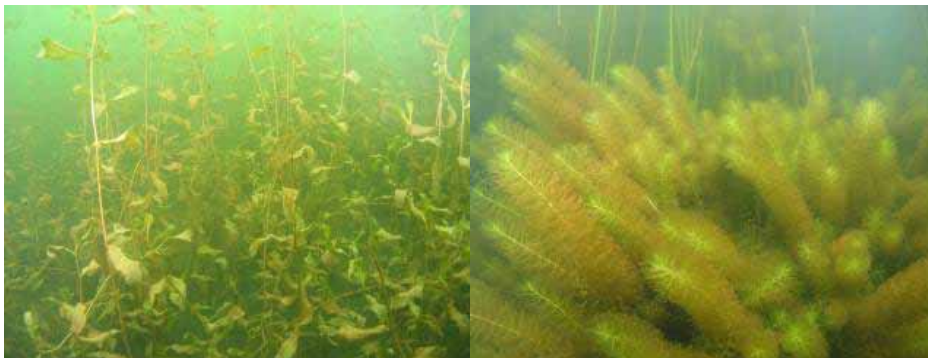
The plants were large-leaved and quite robust, probably reflecting the higher calcium content of water in this limestone quarry.

Figure 3-7: The plants were large-leaved and quite robust looking; *Potamogeton cheesemanii* left and *Myriophyllum propinquum* on the right photographed in 2006 when the water was much clearer.

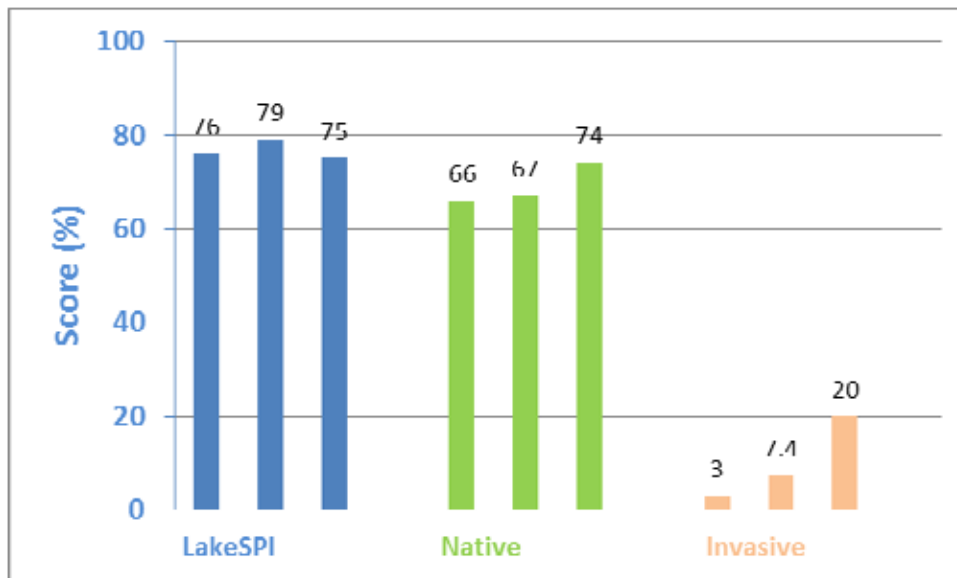
Figure 3-14: LakeSPI Index for Lake Waikere 2011 as % of potential score, Native Condition Index, and Invasive Impact Index (from left to right) with 2005, 2007 and 2011 values shown respectively.

An excellent LakeSPI score of 75% (Figure 3-14) was driven by the large extent of native vegetation, and presence of charophyte meadows with little impact from invasive exotic plants. Deep-growing *U. gibba* is a new observation for New Zealand and has increased the Invasive Index of this lake from 3% to 20%.

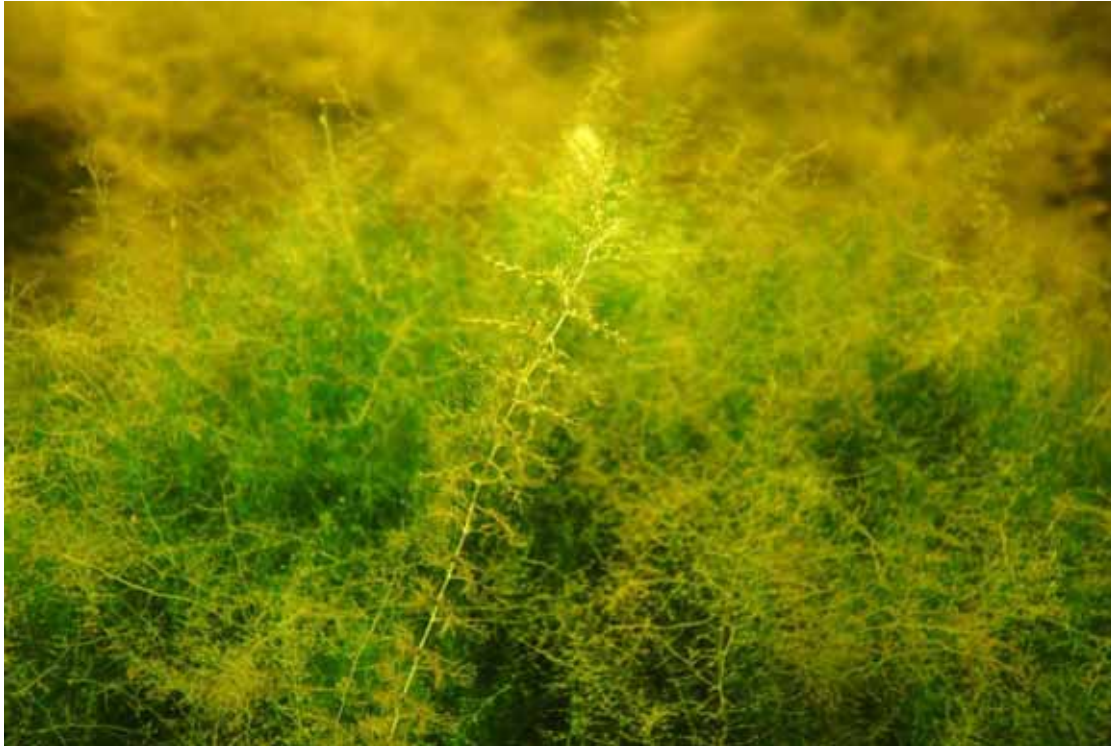
Figure 3-16: The nationally endangered *Utricularia australis* co-existing with dense mats of the exotic *U. gibba* in Te Riu Lagoon.

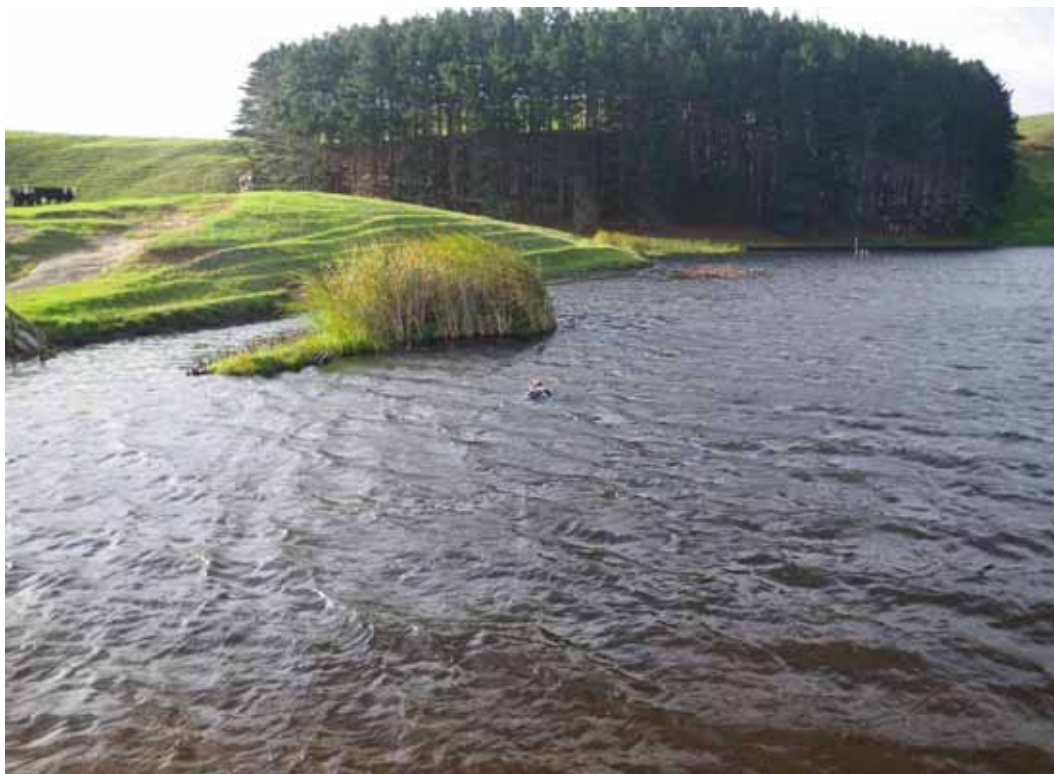
Figure 3-18: Midgley's Lake 2011 showing the pasture and pockets of plantation pine catchment with remnant emergent vegetation remaining after grass carp introduction in 2007.

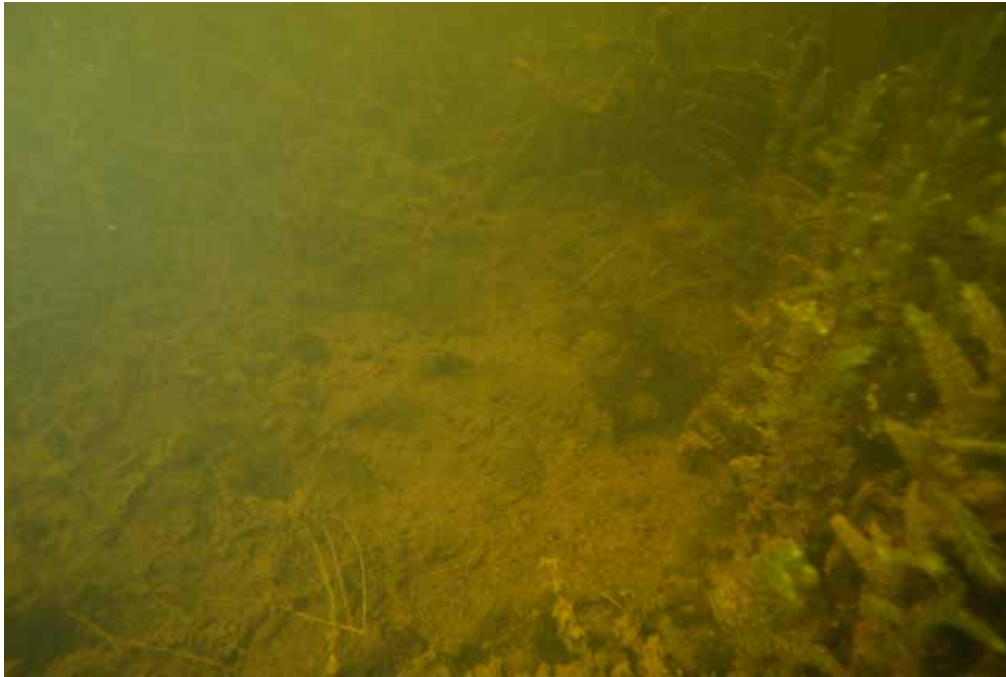
In April 2010 virtually all the *E. densa* had gone and about half the *C. demersum* had been removed (Figure 5-2). At a few locations with sandy margins, a wide range of turf species were present with *Glossostigma elatinoides* the dominant species. Also charophytes persisted at one small site in water to 1.8 m deep on the eastern shore of the main body of the lake.

Figure 5-2: Lake Swan after 11 months of grass carp grazing with a few remnant stalks of *E. densa* (foreground left) and the rest is *C. demersum*.

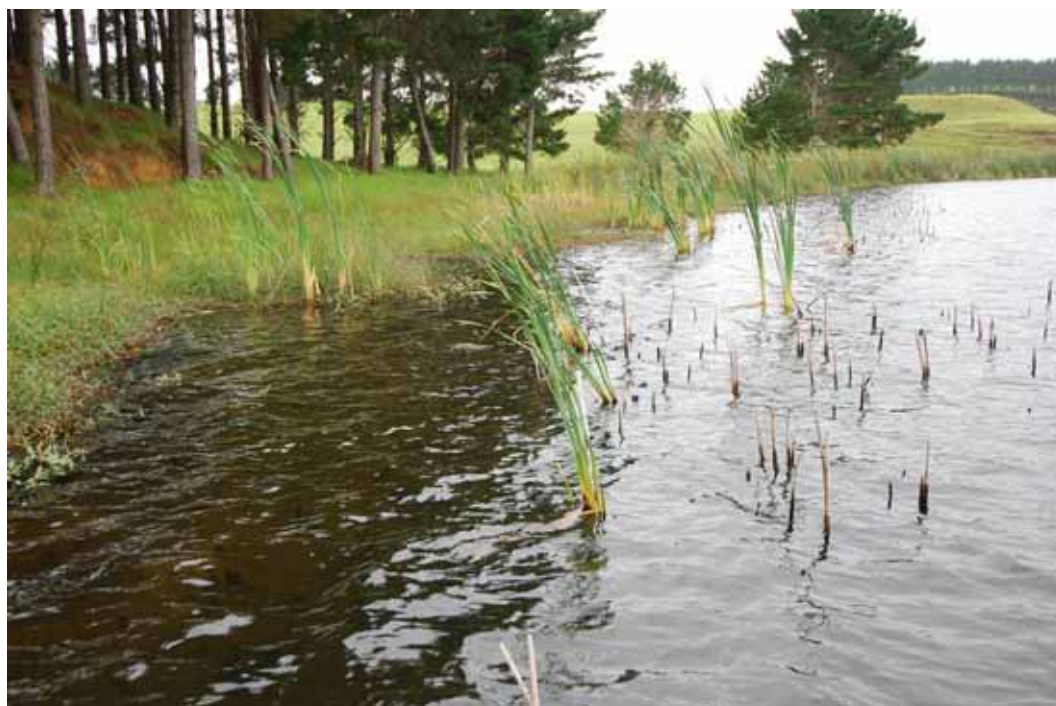
Figure 5-4: Grass carp were introduced in May 2009 to lake Swan and by 2011 had removed much of the *T. orientalis* (raupo) from the margins.

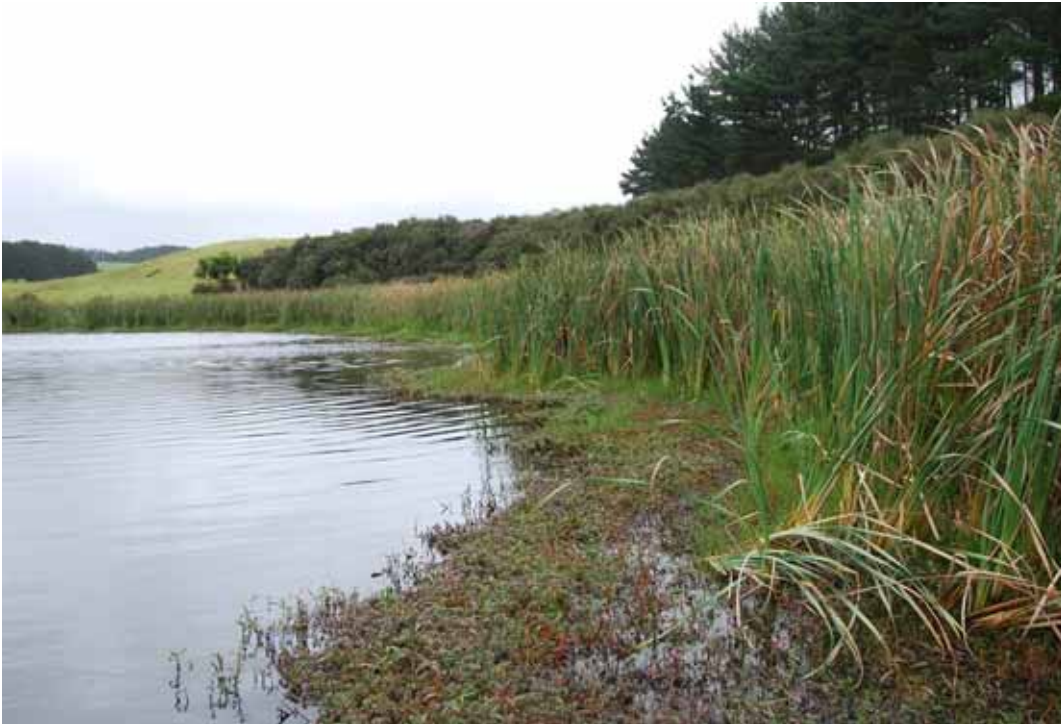
Figure 5-5: The margins were least grazed in the north arm of Lake Swan.

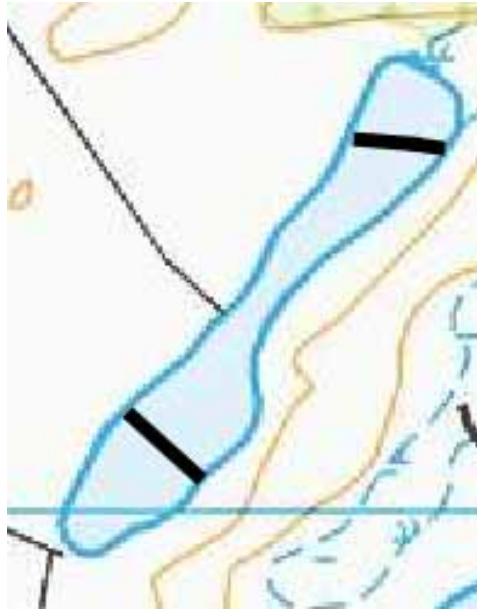
The two baseline profiles recorded prior to grass carp release in 2010 were repeated in 2011 (Fig. 5-6).

Figure 5-6: Lake Heather showing the location of the 2 profiles monitored, with one in each basin.

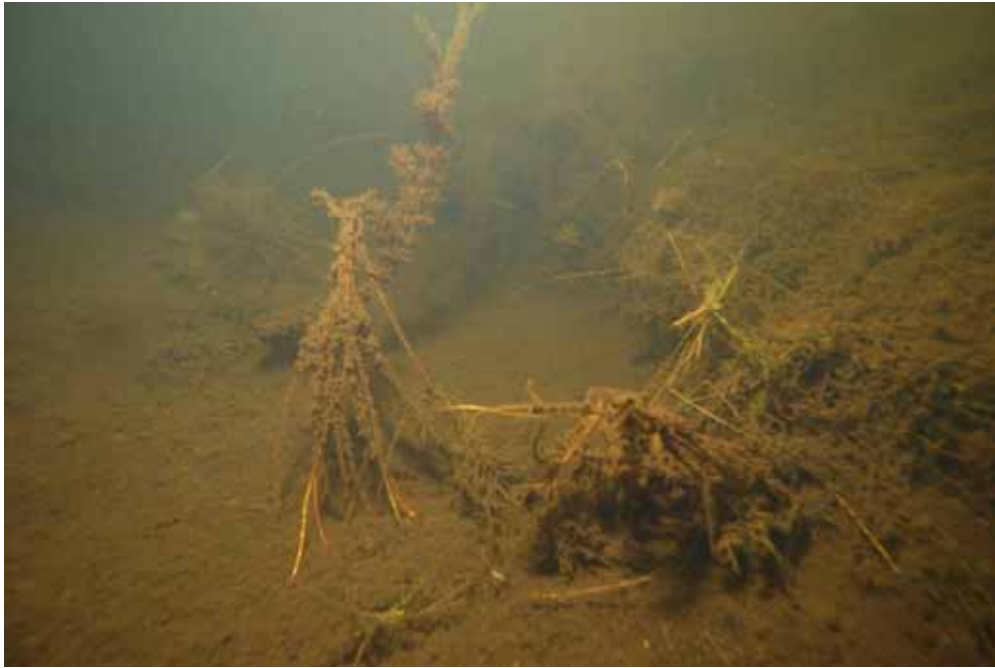
The *E. densa* had been heavily grazed and reduced to basal stalks (Fig. 5-7) but only about 20% of the *C. demersum* has been removed. Most of the *C. demersum* was still recorded up to 3.4 m tall and had also expanded further in the north basin and displaced the *Potamogeton ochreatus* beds. The rate of progress for grass carp in removing the weed beds is similar to that seen in Lake Swan. On that basis we would expect the *C. demersum* to be almost gone by March 2012.

Figure 5-7: Lake Heather in 2011 with *E. densa* remnants (2.6 m deep) heavily grazed by grass carp.
