# COASTAL MONITORING

## Coastal Water Quality

### *Marine Bathing Water Quality*

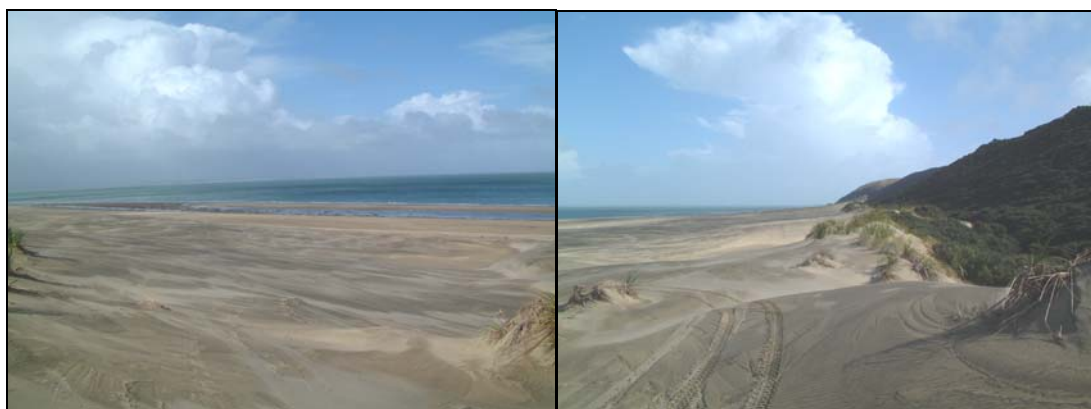
**Figure 6.5:** Left to right; the Pouto shoreline and dune system, which comprise part of the area of the Kaipara Sand Study.

- Historical Sand Movement – Maori and European Knowledge.
- Historical Sand Movement – Geomorphic Evidence.
- Amount of sand in the system.
- Sediment mapping.
- Sand transport processes in subtidal and intertidal areas.
- Sand transport along the shoreline.

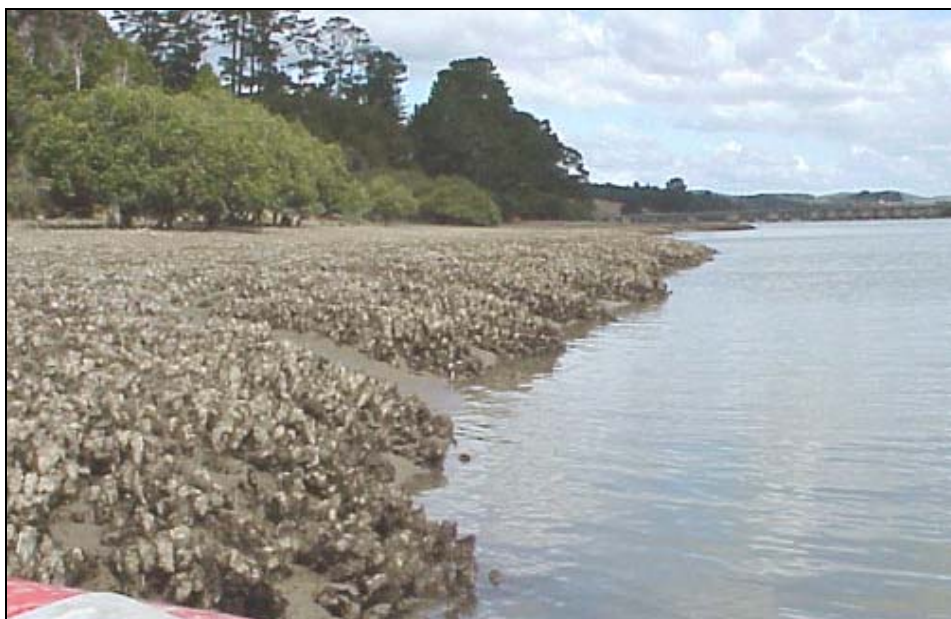
**Mangrove trees, oyster shellfish beds and subtidal water cover of the Otamatea arm of the Kaipara Harbour. These are three examples of the more extensive habitat type defined in the broad scale habitat mapping.**

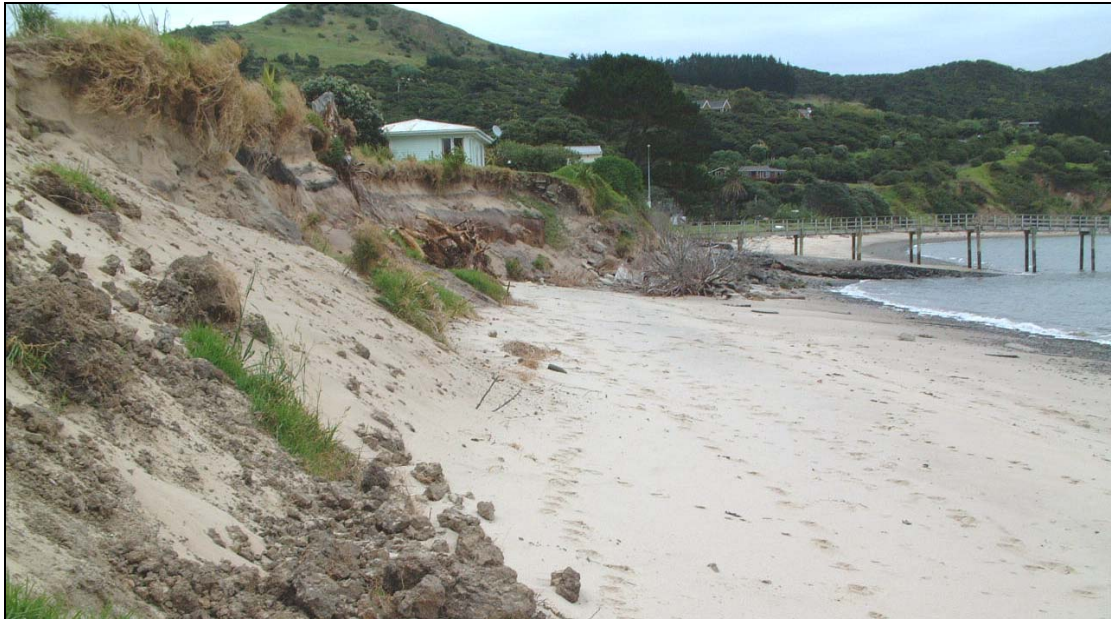
**Erosion of the Omapere foreshore. An example of a coastal hazard. The Coastal Hazard Zone for this area is currently under review.**

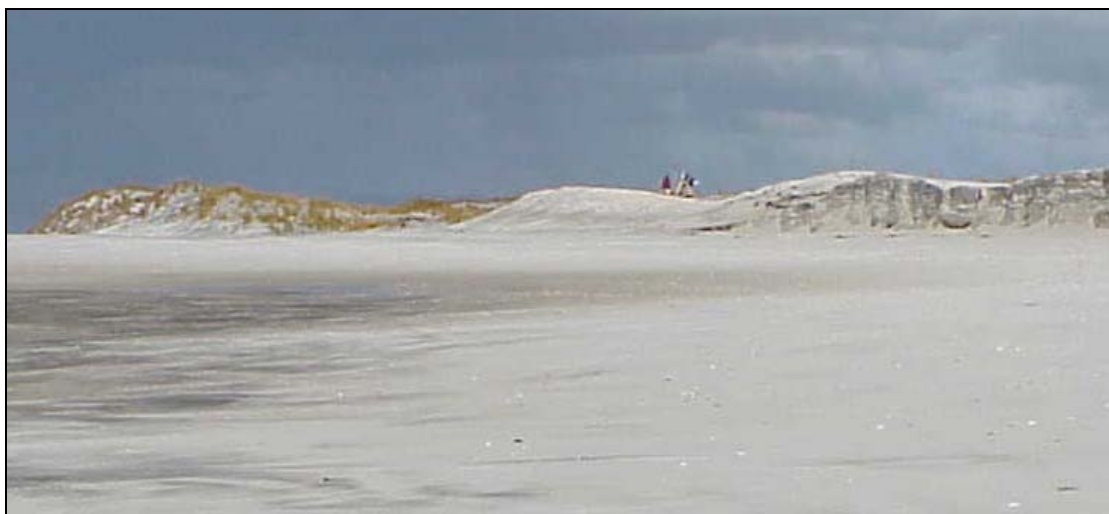
Dunes showing contrasting states of 'health'. On the left a well vegetated foredune and to the right a scarped foredune indicative of recent erosion.
