15 Te Mimiha (Helena)

Coastal Erosion Hazard Assessment

NORTHLAND REGIONAL COUNCIL
 Coastal Erosion Hazard Assessment
 Te Mimiha (Helena Bay)
 Site: 15

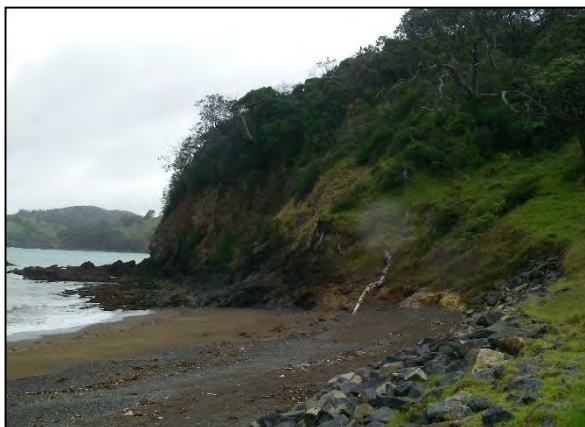
Site Photograph A (southern end)

There is a rock revetment located at the southern end of the site that is approximately 70 m long. The Mimiha stream influences the shoreline position at the spit and there is a greater level of uncertainty in this area because of fluvial processes. The resulting hazard zones are dashed in this area to reflect this uncertainty.

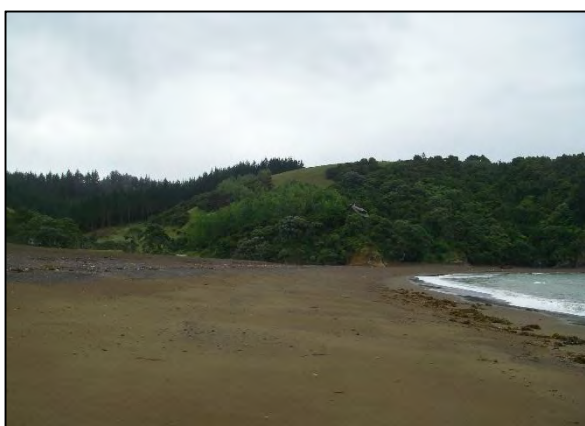
Site Photograph B (beach face)

The site shoreline is approximately 360 m long. The backshore is relatively flat with an elevation of approximately RL 4 to 6 m. The beach comprises medium to coarse sand with a portion of pebbles. The beach has a wide high tide berm and a relatively steep beach slope.

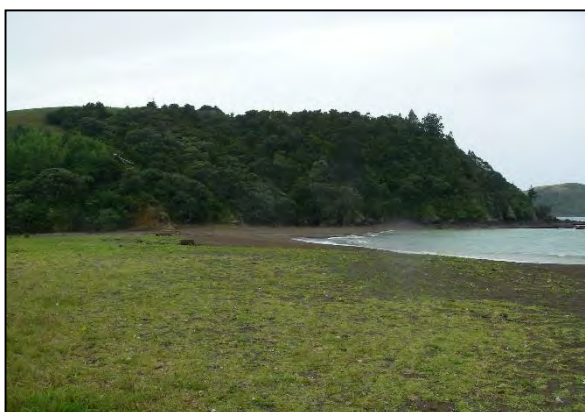
Site Photograph C (spit backshore)

The site comprises a mobile spit feature that is likely to experience significant shoreline fluctuation over time. The spit width is approximately 90 m from the dune toe at the narrowest point and no dune system with vegetation exists.

The Mimiha Stream meanders behind the spit feature and cuts through the shoreline at the northern end of the site. The Mimiha stream is a significant feature at this site that controls the shoreline position over time. Based on visual observations the stream is likely to cause flooding and shoreline movement across most of the site.

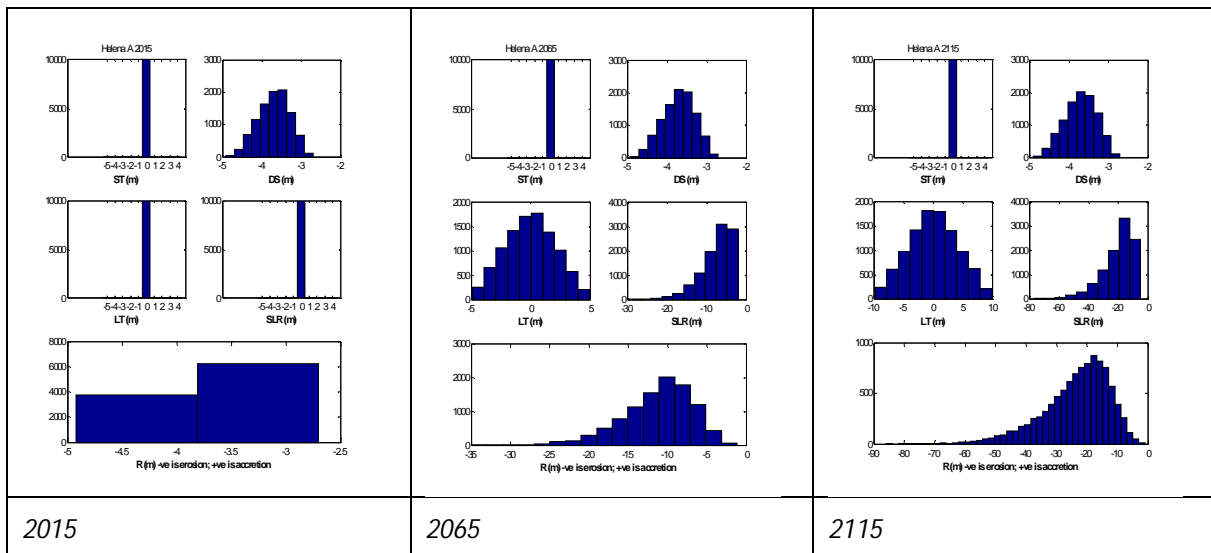
Figure 15-1 Histograms of parameter samples and the resultant shoreline distances for 2015, 2065 and 2115 timeframes for cell 15A

Histograms of individual components and resultant CEHZ distances using a Monte Carlo technique are shown in Figure 15-1 to Figure 15-3. Coastal Erosion Hazard Zone widths are presented within Table 15-2 and Figure 15-4.

The CEHZ1 value for Cell A has been rounded from 9 m to the minimum 10 m width and CEHZ2

has been set at 25 m due to the adopted landward baseline at this end.

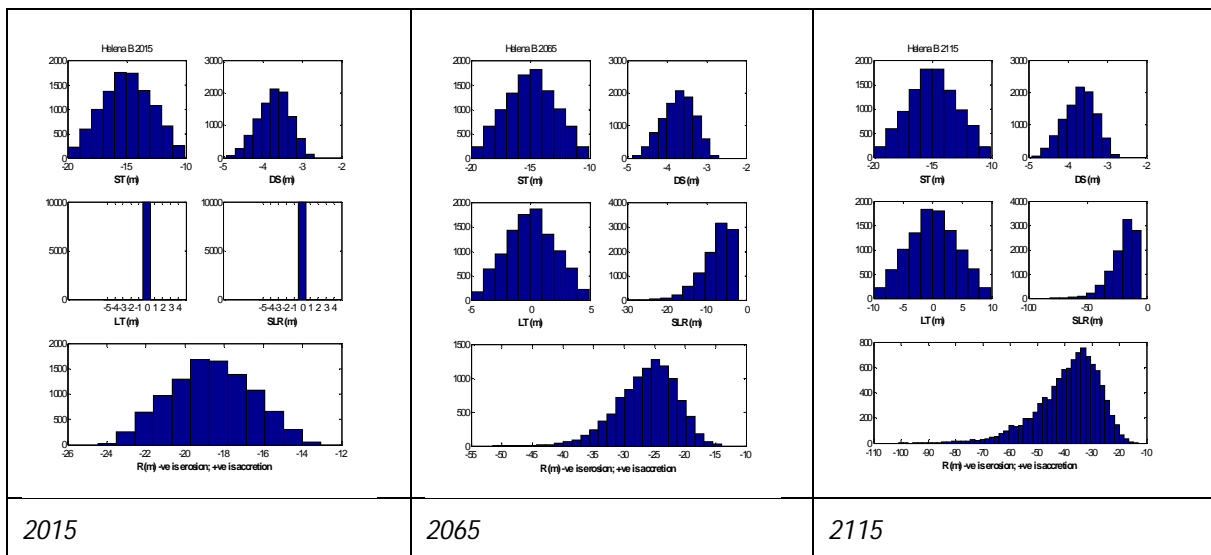
Figure 15-2 Histograms of parameter samples and the resultant shoreline distances for 2015, 2065 and 2115 timeframes for cell 15B

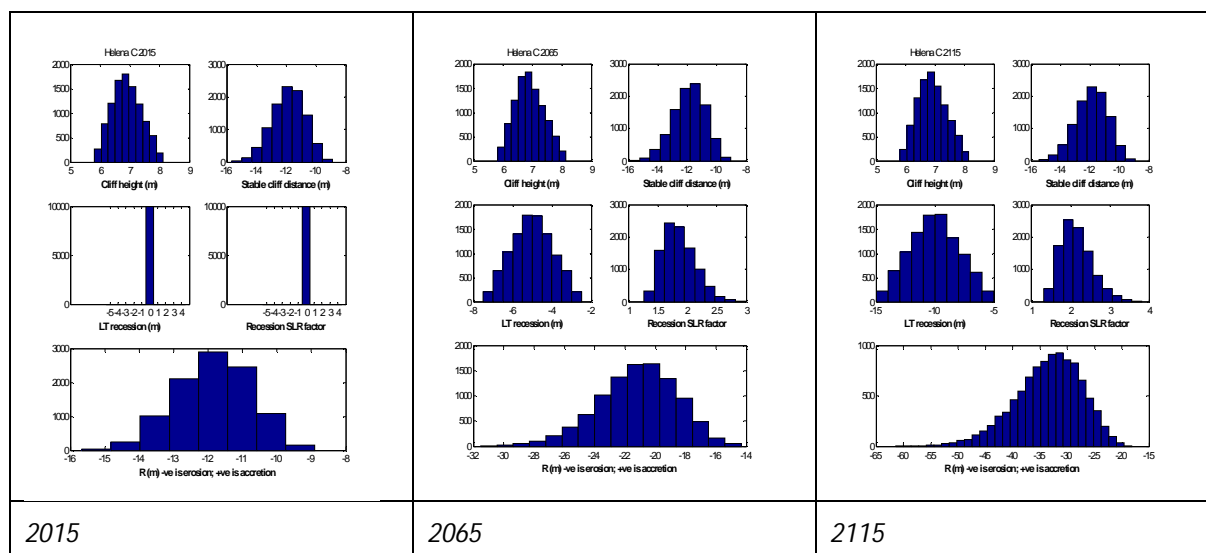
Figure 15-3 Histograms of parameter samples and the resultant shoreline distances for 2015, 2065 and 2115 timeframes for cell 15C

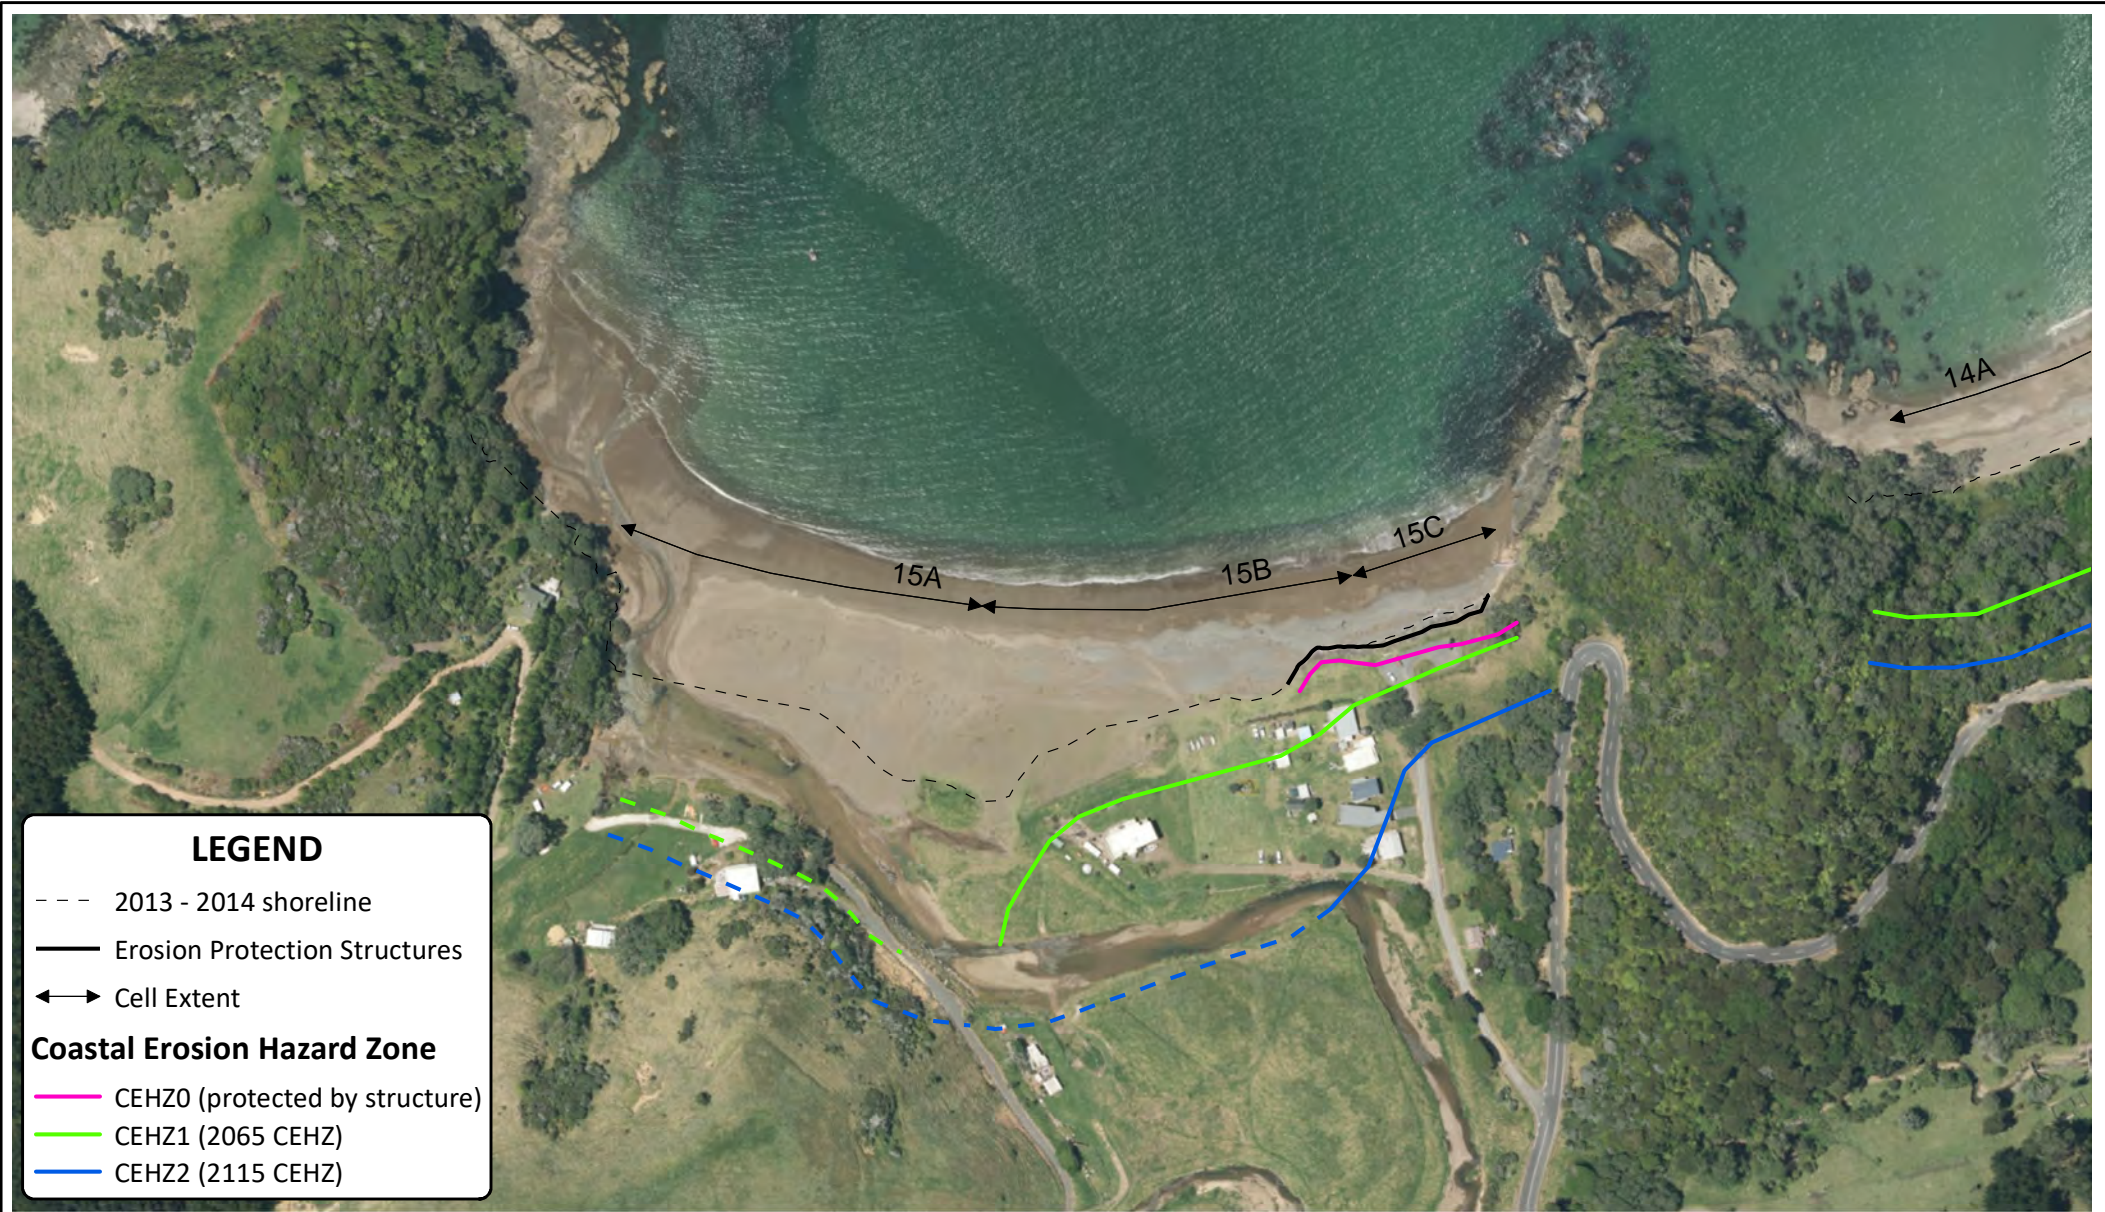
FIGURE No. **Figure 15-4**

Notes: Dashed CEHZ indicates greater uncertainty around stream mouths and backshore topography. Northland 0.1m Rural Aerial Photos (2014-2015).

CEHZ's have been mapped in agreement with the calculated values, although the CEHZ2 value has been located landward of the Te Mimihi Stream rather than on the landward edge of the low vegetated spit and is dashed to reflect the uncertainties to the north. Note that cell 15A has experienced accretion since about 1950 along approximately 150 m, with CEHZs offset from the accreted most recent shoreline.

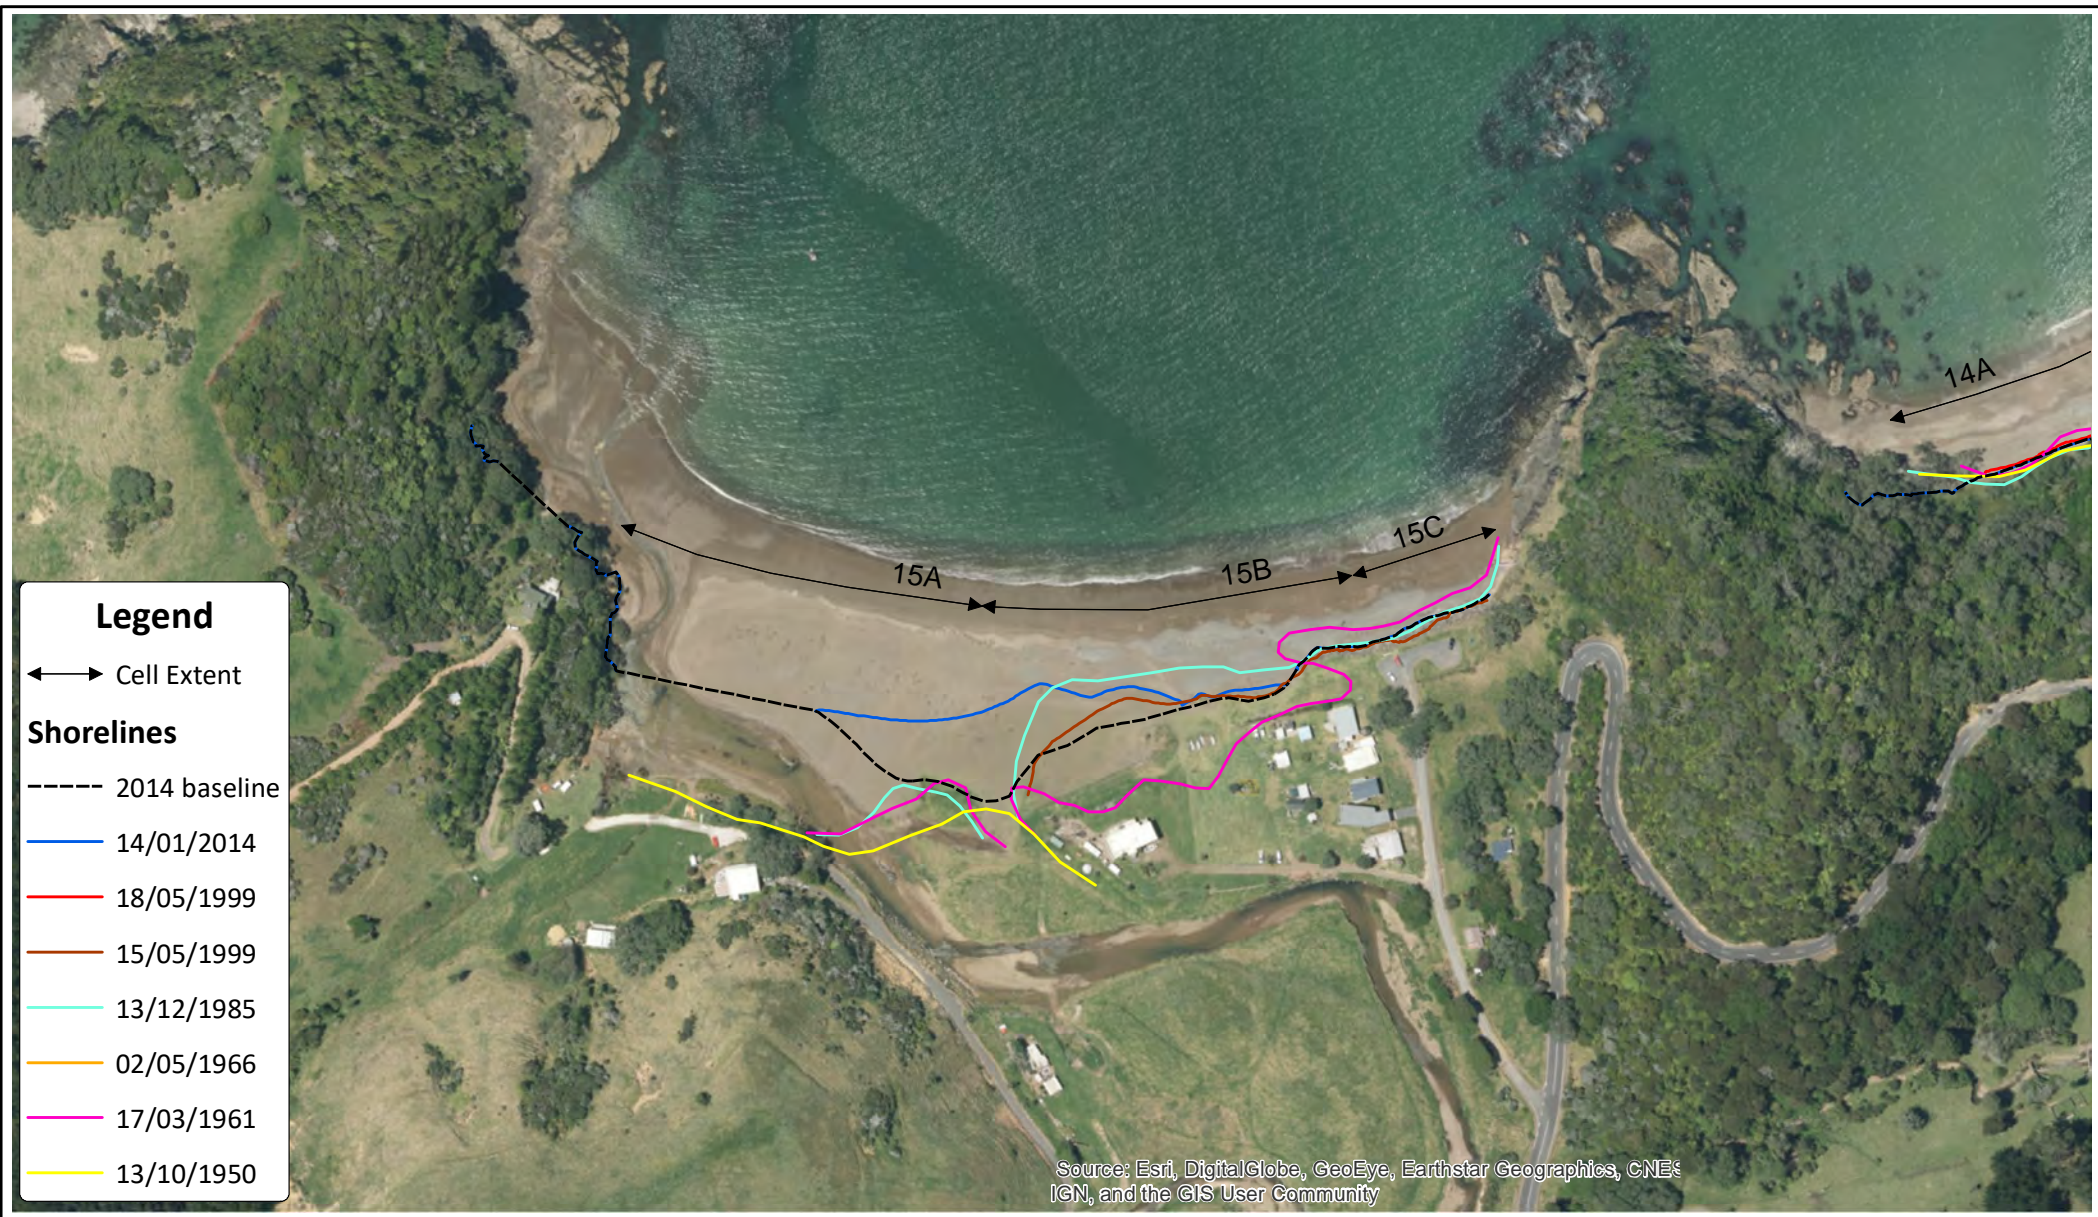
FIGURE No. Figure 15-5

Historic shorelines
Te Mimiha (Helena Bay)
Site: 15

The shoreline north of the stream has also fluctuated over time and we have offset the hazard zones from the most landward shoreline (1951). The backshore area is also hillslope topography north of the stream and the hazard

Figure 15-5 shows the available historic shorelines for Te Mimihi (Helena).
