5 Marsden Cove

Coastal Erosion Hazard Assessment

NORTHLAND REGIONAL COUNCIL
 Coastal Erosion Hazard Assessment
 Marsden Cove
 Site: 5

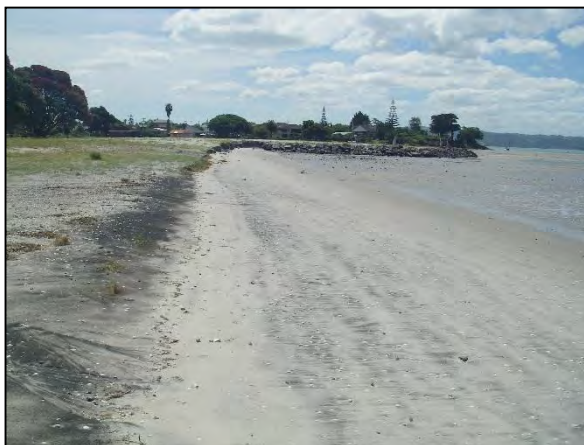
Site Photograph A (west)

Marsden Cove consists of a sandy beach shoreline that is split by a marina channel and associated groynes. The sandy beach is approximately 20 m wide and is fronted by an intertidal flat that extends approximately 500 m out to the main harbour channel. Marsden Cove is relatively sheltered from incident wave energy. The predominant sediment transport direction is toward the east with sand building up at this end of the site. A small erosion scarp is evident along the western half of the shoreline.

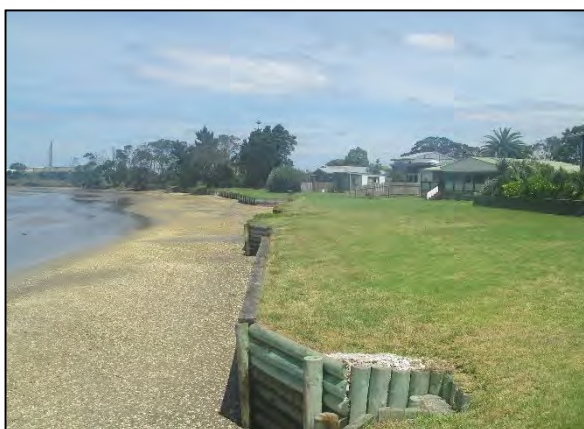
Site Photograph C (Blacksmith Creek)

- NorthPort reclamation at Marsden Point
- training groyne at the entrance to Blacksmith Creek at the eastern end of the site
- creation of a lagoon at the western end of the bay (Marsden Cove) including entrance training groynes
- beach nourishment along the entire Marsden Cove shoreline.

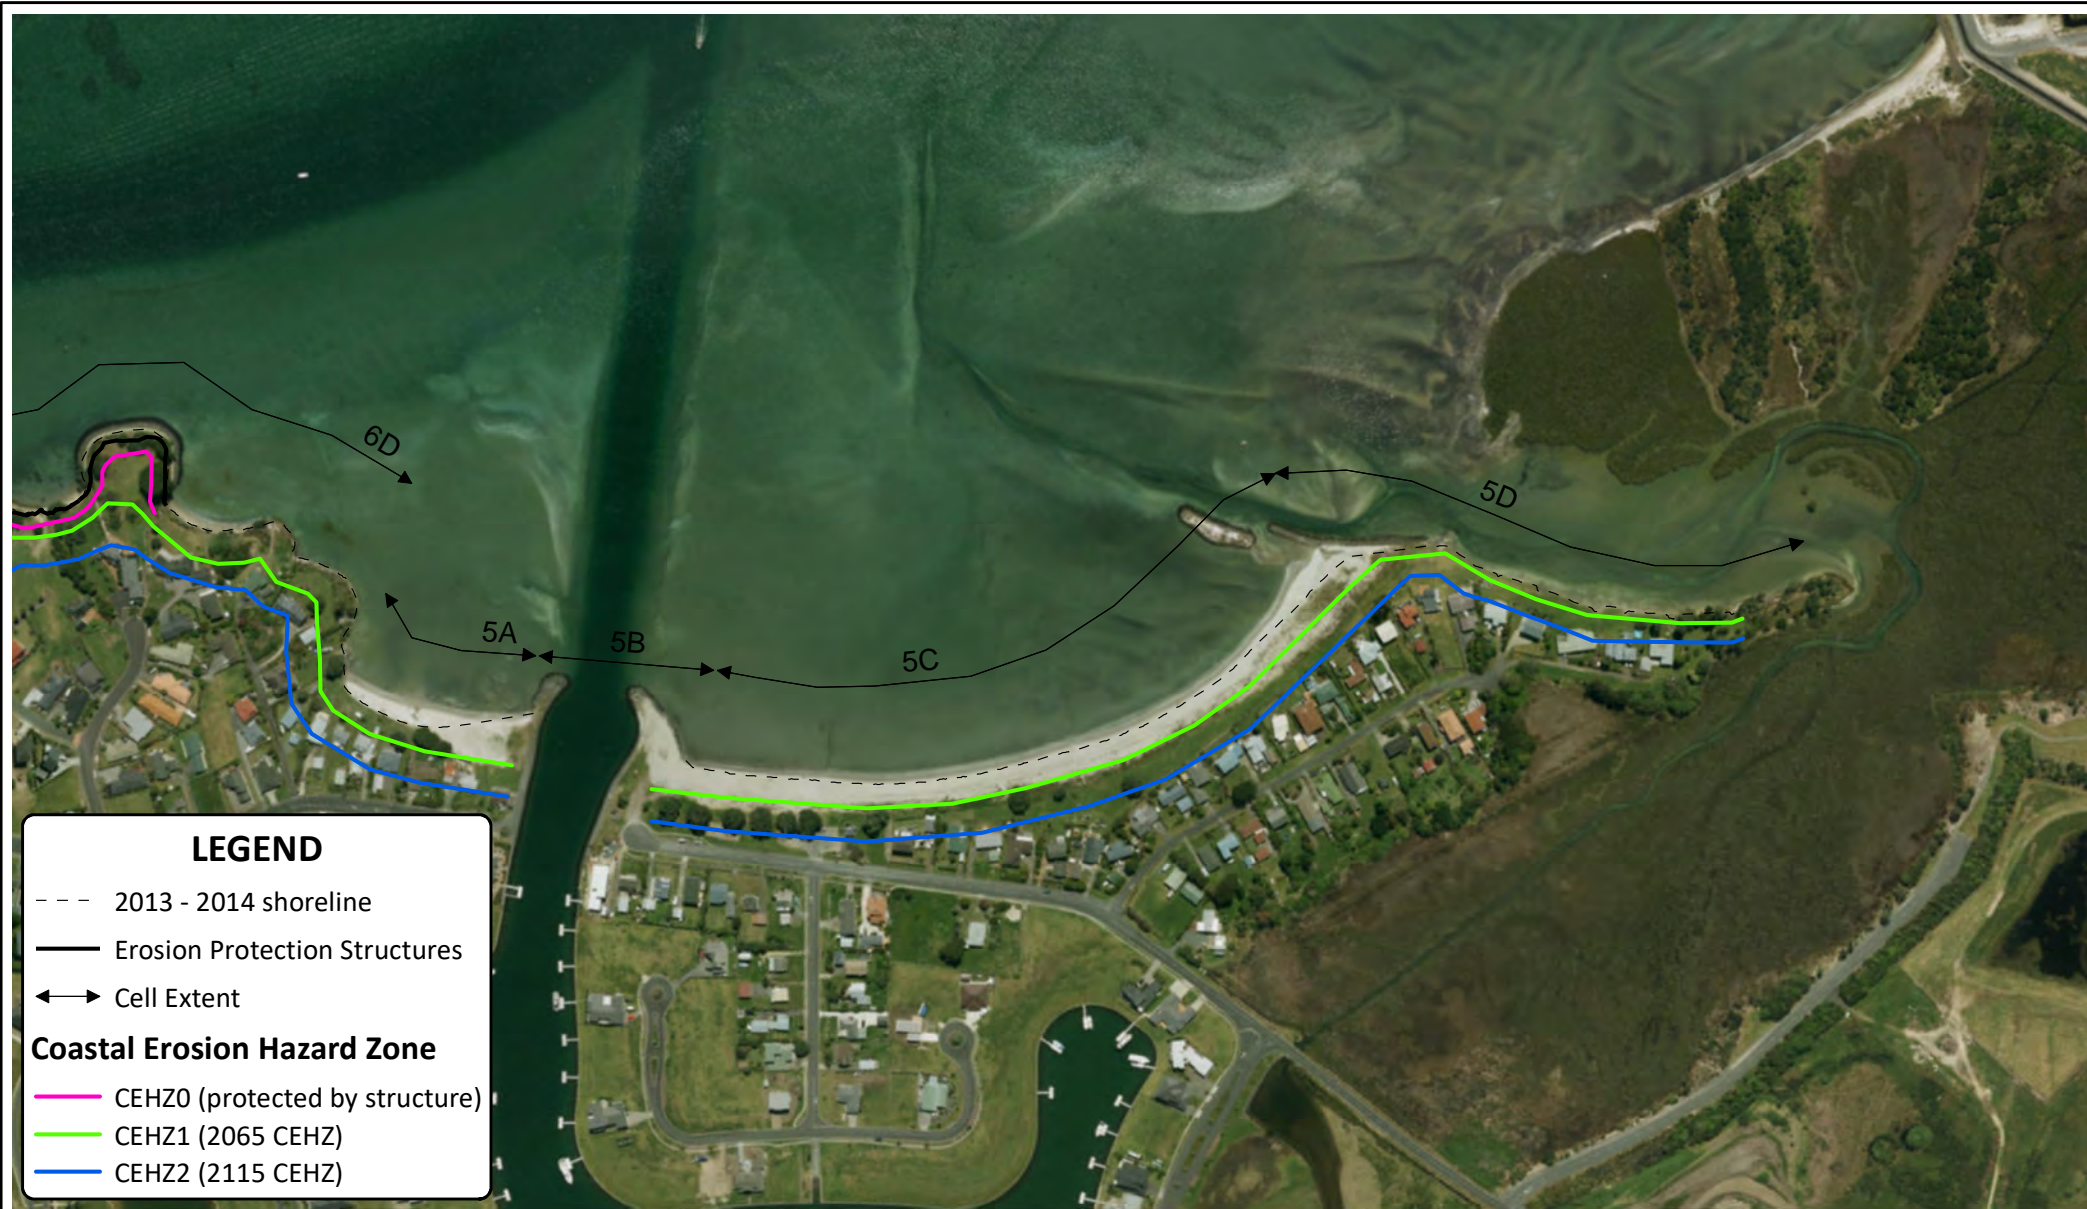
FIGURE No. **Figure 5-5**

- CEHZ0 (protected by structure)
- CEHZ1 (2065 CEHZ)
- CEHZ2 (2115 CEHZ)

Histograms of individual components and resultant CEHZ distances using a Monte Carlo technique are shown in Figure 5-1 to Figure 5-3. Coastal Erosion Hazard Zone widths are presented within Table 5-2 and Figure 5-5.

CEHZ1 values range from 14 to 16 m. CEHZ2 values range from 35 to 38 m. CEHZ's have been mapped in agreement with the calculated values. Note that cell 5C has experienced accretion since about 1985 over approximately 500 m, with CEHZs offset from the accreted most recent shoreline.

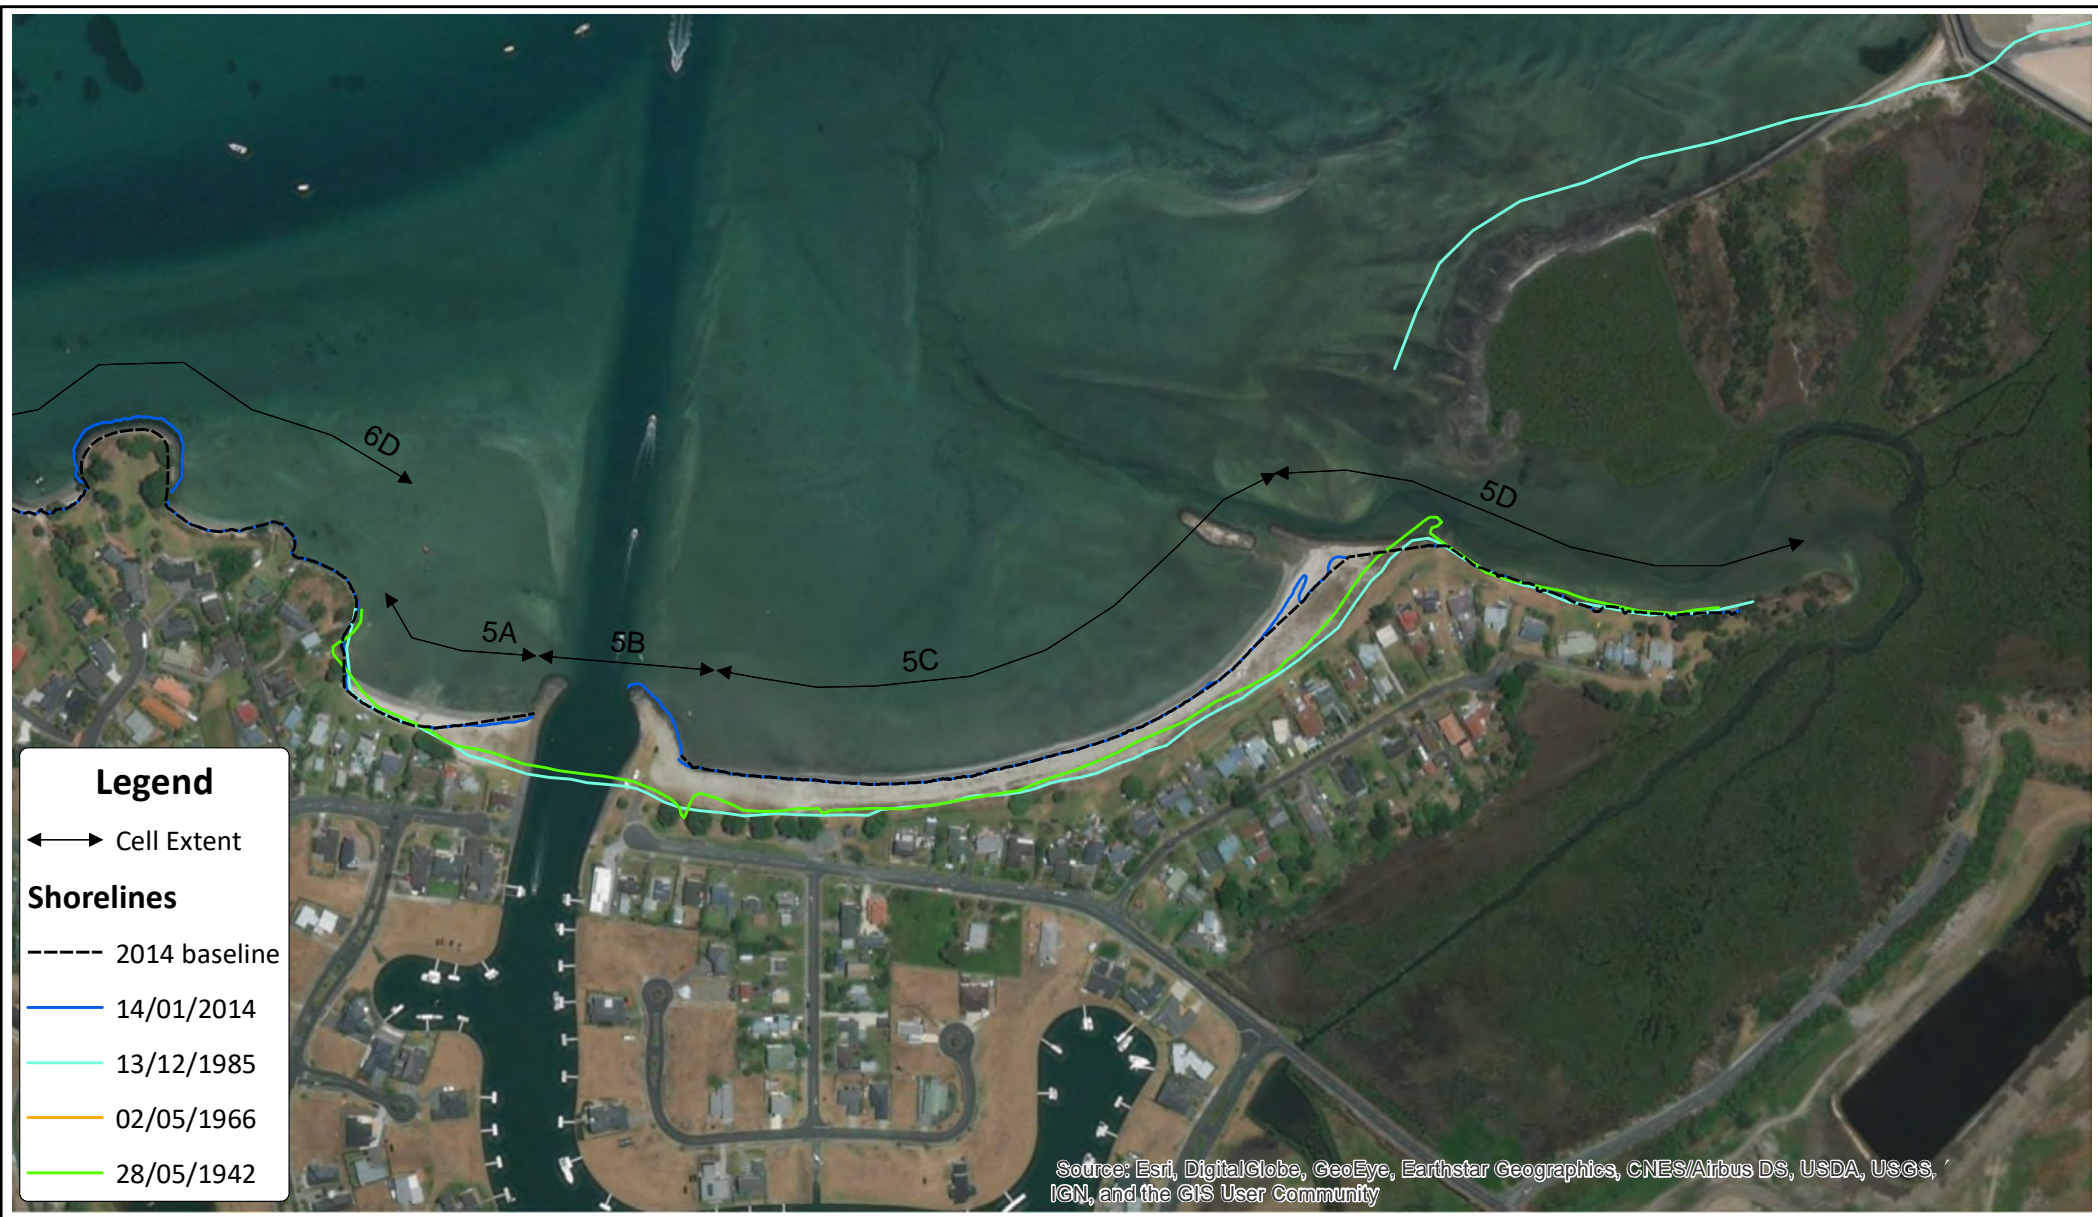
FIGURE No. **Figure 5-6**

- 2014 baseline
- 14/01/2014
- 13/12/1985
- 02/05/1966
- 28/05/1942

Historic shorelines
Marsden Cove
Site: 5

Figure 5-6 shows the available historic shorelines for Marsden Cove.
