19 Te Ti Bay (Waitangi)

NORTHLAND REGIONAL COUNCIL

Coastal Erosion Hazard Assessment

Te Ti Bay (Waitangi)

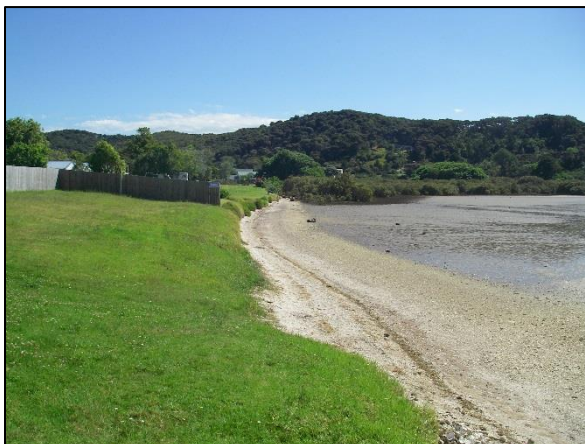
Site Photograph A (estuary shoreline)

The estuary shoreline is approximately 400 m long. There is a relatively narrow fine sand beach that is approximately 5 m wide. The toe of the beach transitions into intertidal mud flats. The backshore elevation is approximately RL 1 to 3 m in this location.

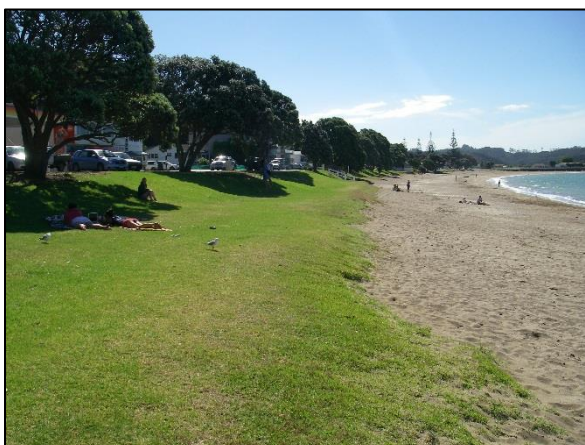
Site Photograph B (Te Ti Bay - centre)

The open coast shoreline (Te Ti Bay) is approximately 1.1 km long and comprises medium to coarse sand with some shell component. The beach face is relatively steep and has a berm width of 5 to 10 m above the high tide line.

The backshore is fully grassed down to the beach face, with no established dune vegetation. The backshore elevation ranges from approximately RL 3 to 6 m.

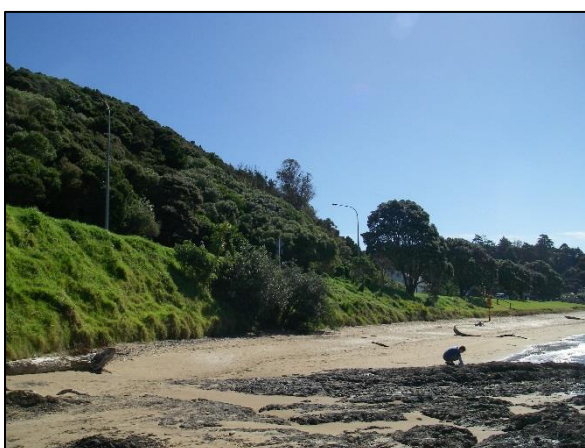
Site Photograph (Te Ti Bay - southern end)

The southern end of the site transitions to a cliff shoreline, which forms a rocky headland at this location. The headland comprises Greywacke material.

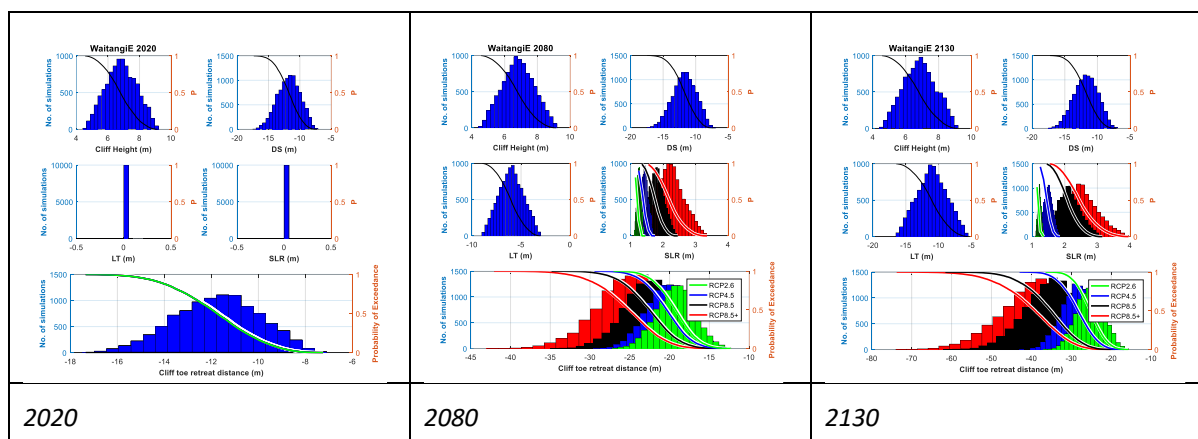
Figure 19-5 Histograms of parameter samples and the resultant shoreline distances for 2020, 2080 and 2130 timeframes for cell 19E

Histograms of individual components and resultant CEHZ distances using a Monte Carlo technique are shown in Figure 19-2 to Figure 19-5.

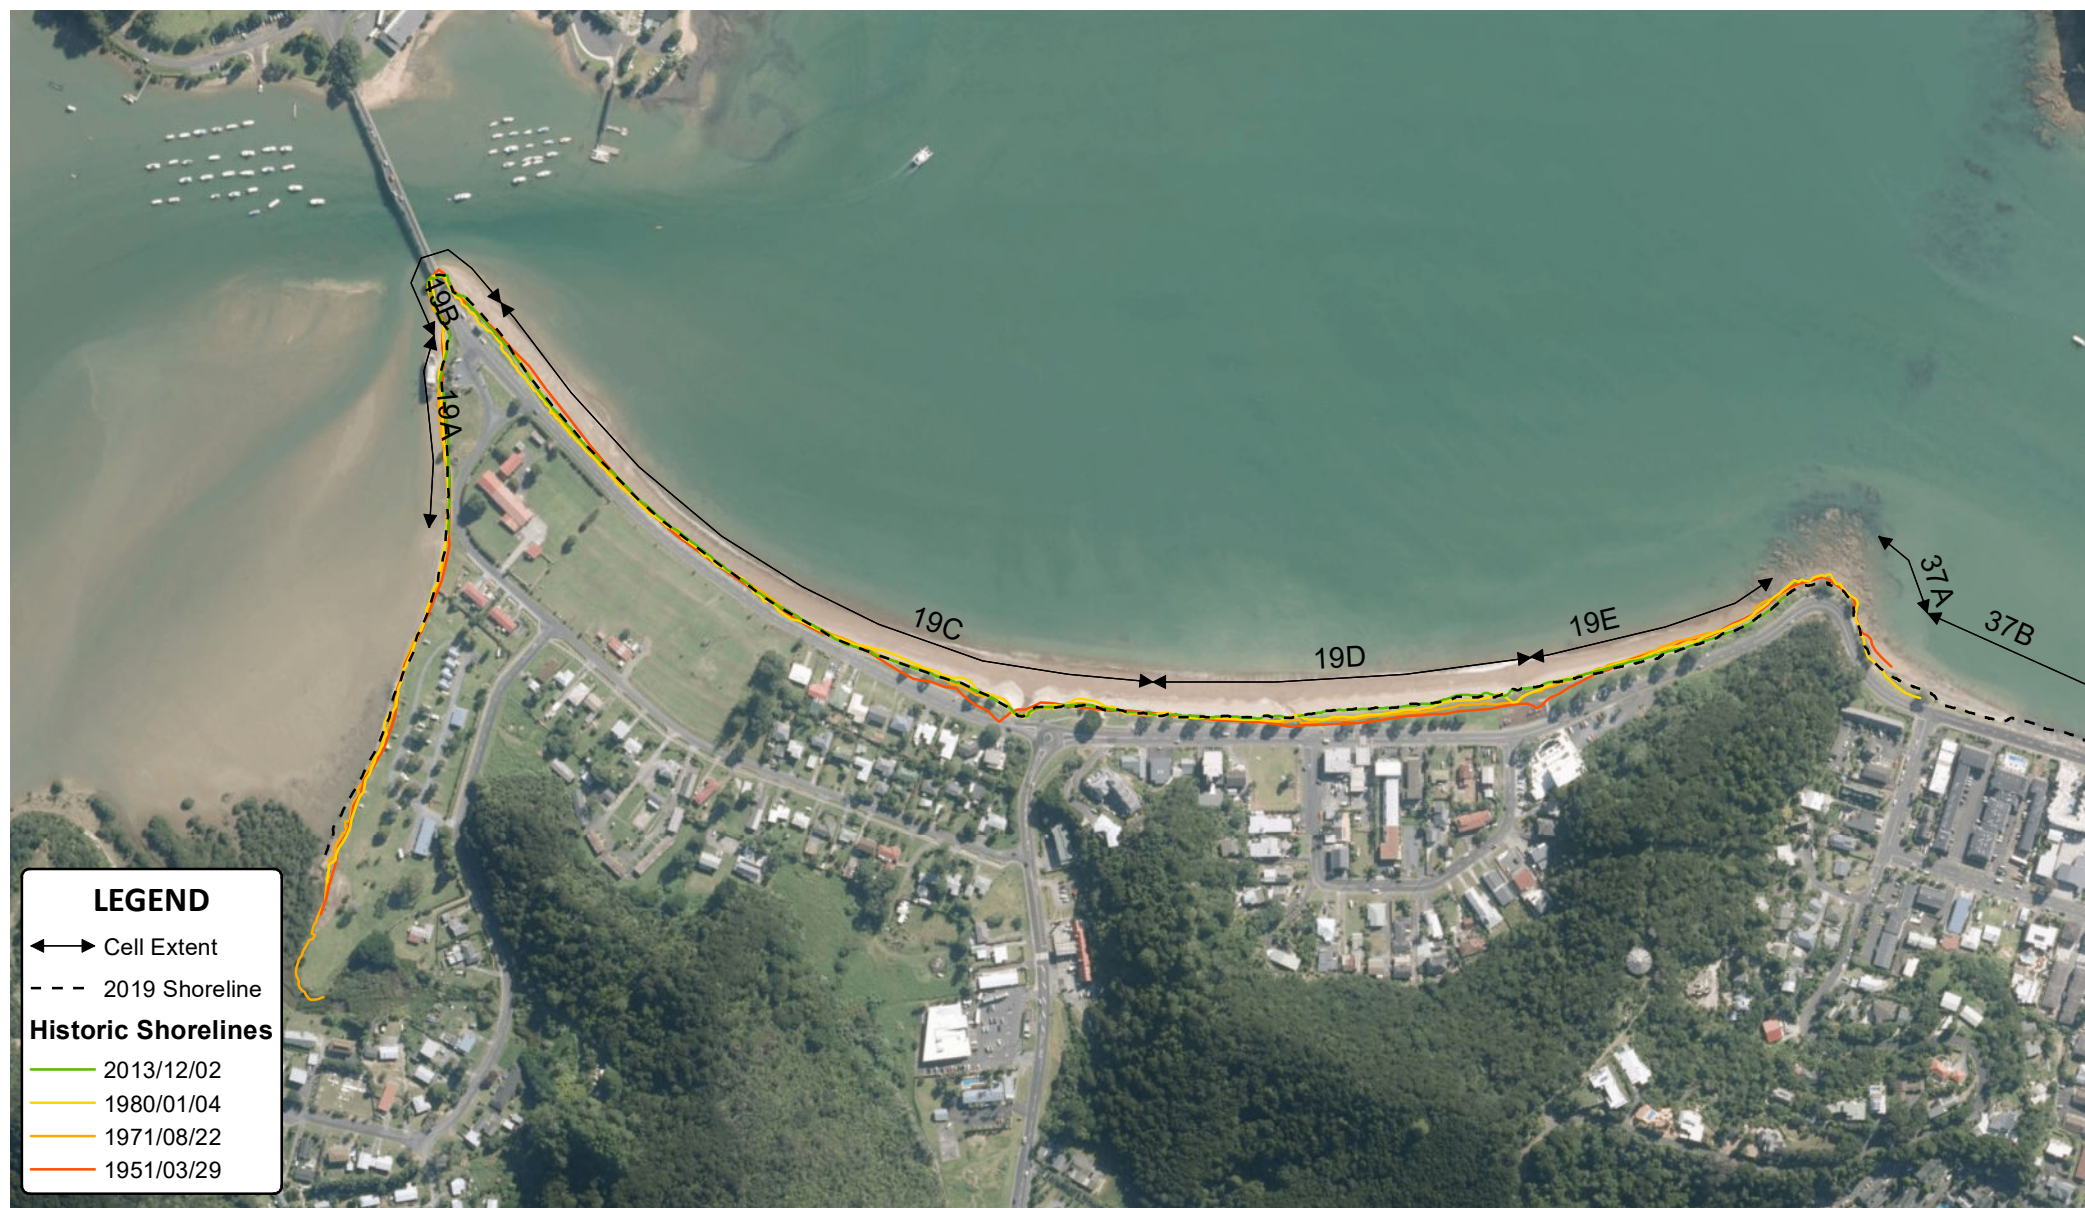
NORTHLAND REGIONAL COUNCIL		
Historic Shorelines		
Te Ti Bay (Waitangi)		
Site: 19		
FIGURE No.	Figure 19-7	Rev.
		1

Figure 19-7 shows the available historic shorelines for Te Ti Bay (Waitangi).
