Poutō Peninsula

Lake Kapoai (Poutō), NRC Lake No. 296

Summary	Lake Kapoai
Surveyed:	2005, 2007 2014, 2018 (all reconnaissance) and 2025
Overall ranking:	Moderate: Submerged vegetation dominated by <i>Potamogeton</i> species is present but the lake has a highly enriched nutrient status and poor marginal and emergent buffering.
Threats:	High nutrient enrichment with frequent algal blooms, likely exacerbated by the pest fish tench and rudd. Access to the lake is difficult and likelihood of submerged pest plant establishment is currently low.
Management recommendations:	Complete fencing the lake and consider planting options around the margins. Continue pest fish removal. Eradicate African feather grass. Lake ecological monitoring every 5 years.

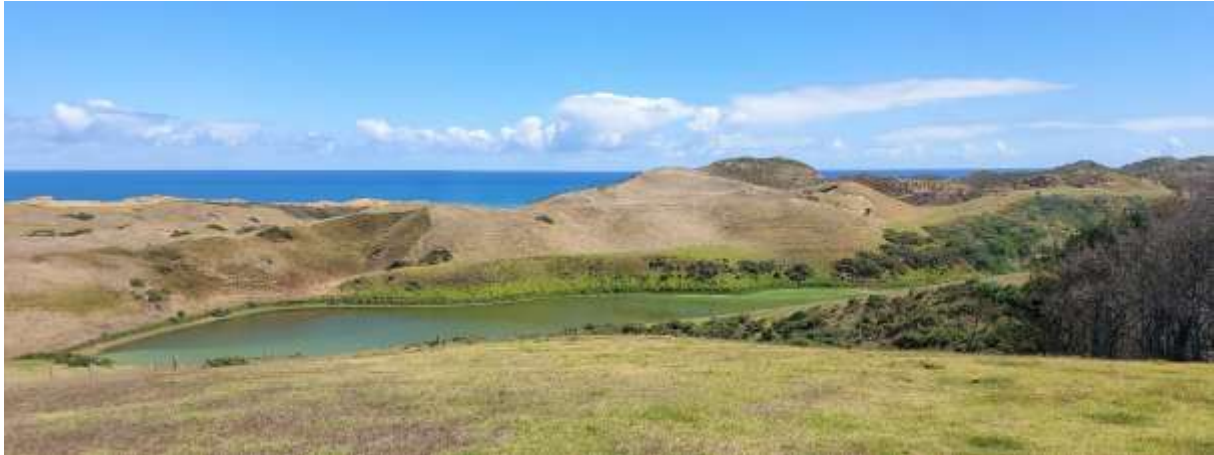
Lake Kapoai: Overview of lake from the eastern side. (Mary de Winton, 2025).

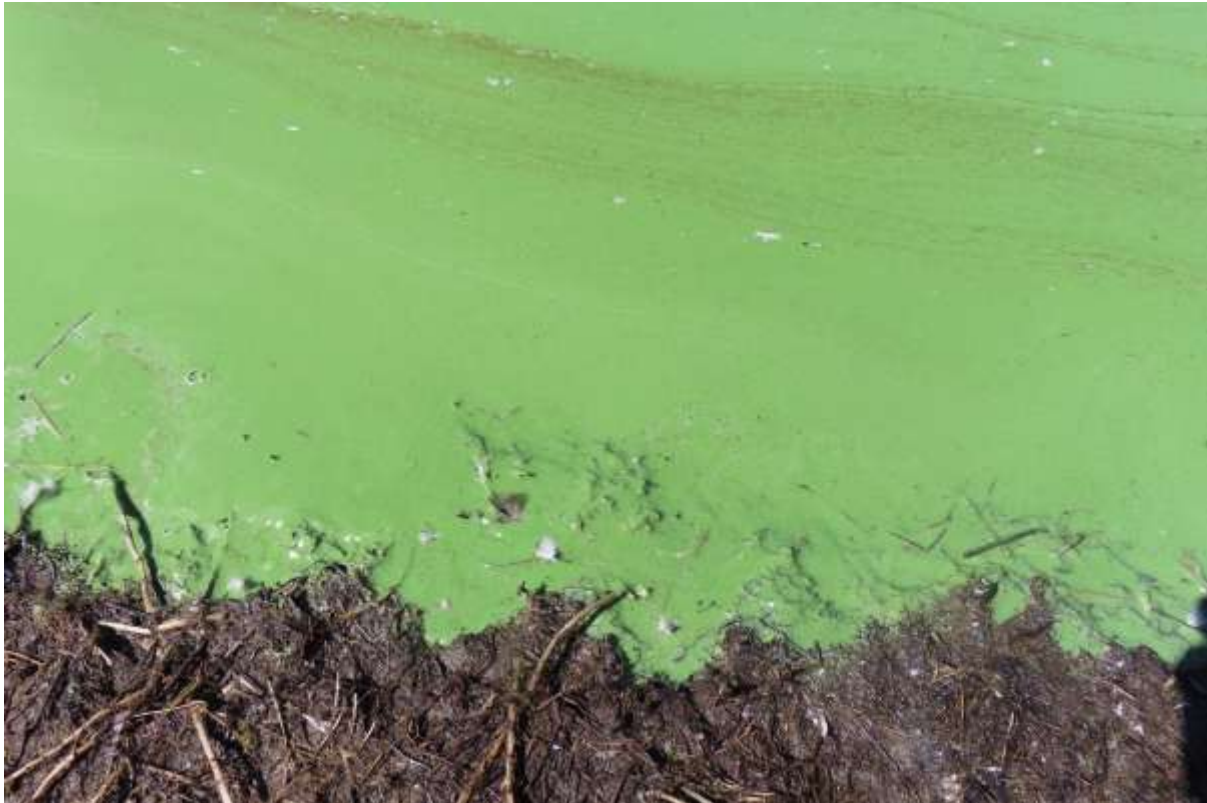
Elevated levels of nutrients and sustained planktonic cyanobacterial blooms remain the highest threat to Lake Kapoai. Poor water quality is likely related to inputs from the pastoral catchment.

Lake Kapoai: Accumulation of cyanobacteria on the shoreline. (Lisa Forester, 2025).

Complete fencing of this lake is recommended to prevent livestock access. Much of the lake margin is vegetated by kikuyu, which is an efficient nutrient remover.
