20 Matauri Bay

Coastal Erosion Hazard Assessment

NORTHLAND REGIONAL COUNCIL
 Coastal Erosion Hazard Assessment
 Matauri Bay
 Site: 20

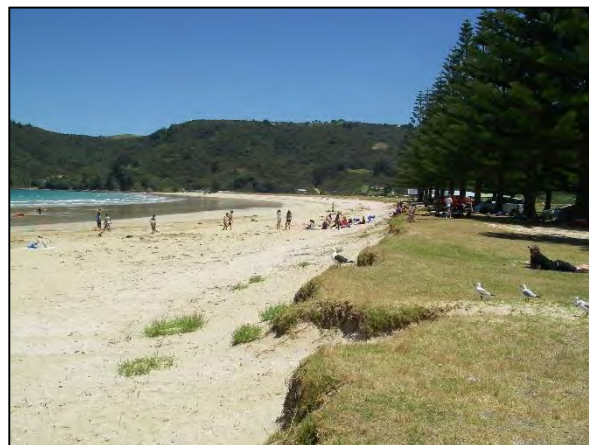
Site Photograph A (Matauri Bay - north)

Matauri Bay is an east facing sandy beach which is approximately 1 km long. The sandy beach comprises fine to medium sand and is a relatively flat dissipative beach. There is a 5 to 10 m berm above the high tide line. There is a high portion of shell material above the high tide line.

The dune system is relatively low lying ranging from RL 3 to 7 m, with no established dune vegetation. There is an erosion scarp along the northern 200 m of the shoreline fronting the campground.

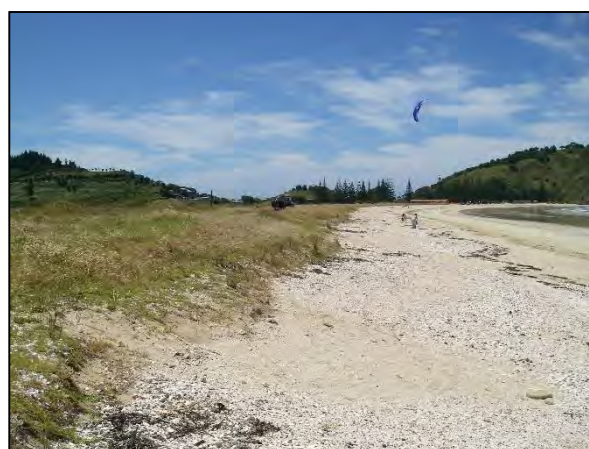
Site Photograph B (Matauri Bay - south)

The Matauri Creek entrance is located at the southern end of the site. The creek meanders across the flats behind the site and the closest position of the creek bank to the dune toe is approximately 80 m. There is a spit feature formed at the southern end of the shoreline, which appears to be building in a southerly direction.

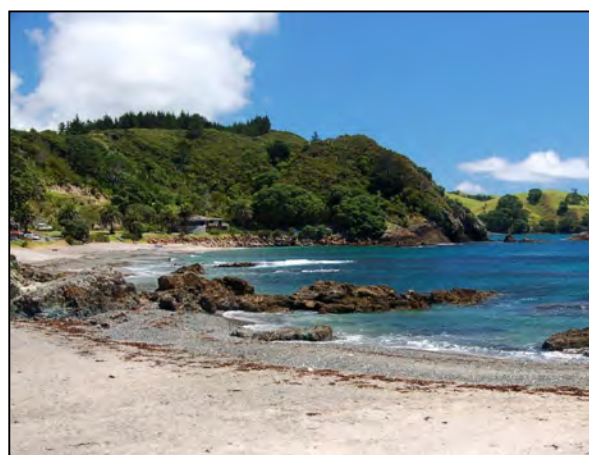
Site Photograph C (Putataua Bay)

Putataua Bay is a north facing sandy beach which is approximately 330 m long situated between two Greywacke rocky headlands. The beach is a mixed sand and pebble beach with the majority of the pebble material located at the eastern end of the bay. There are a number of rock reefs located along the eastern half of the bay. The topography rises up at the western end of the bay towards the Greywacke headland.

There is a rock revetment structure located at the western end of Putataua Bay that is approximately 80 m long.

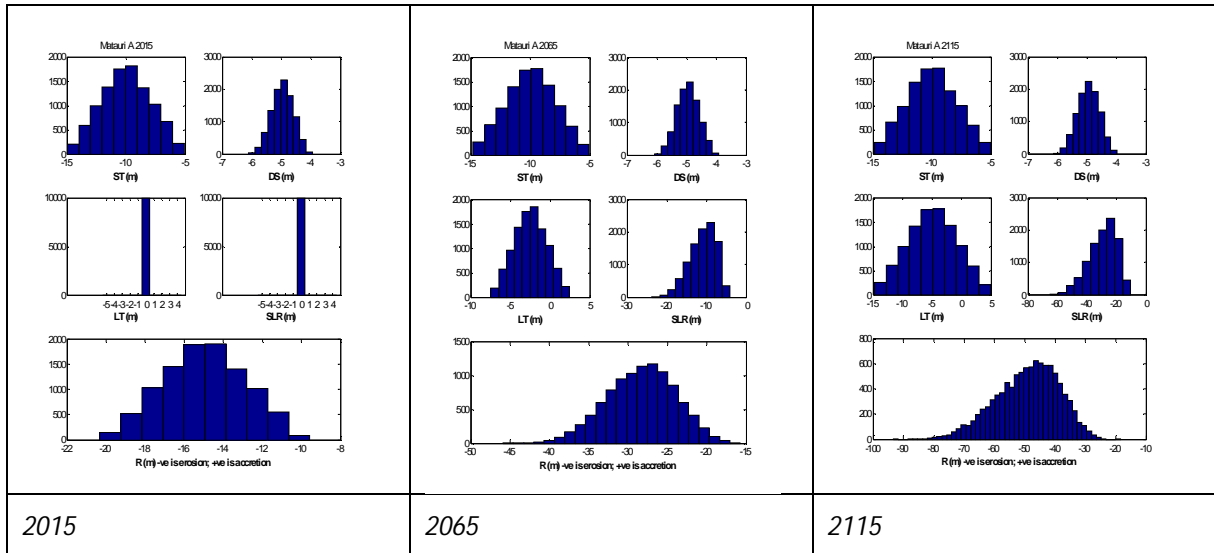
Figure 20-1 Histograms of parameter samples and the resultant shoreline distances for 2015, 2065 and 2115 timeframes for cell 20A

Histograms of individual components and resultant CEHZ distances using a Monte Carlo technique are shown in Figure 20-1 to figure 20-4.

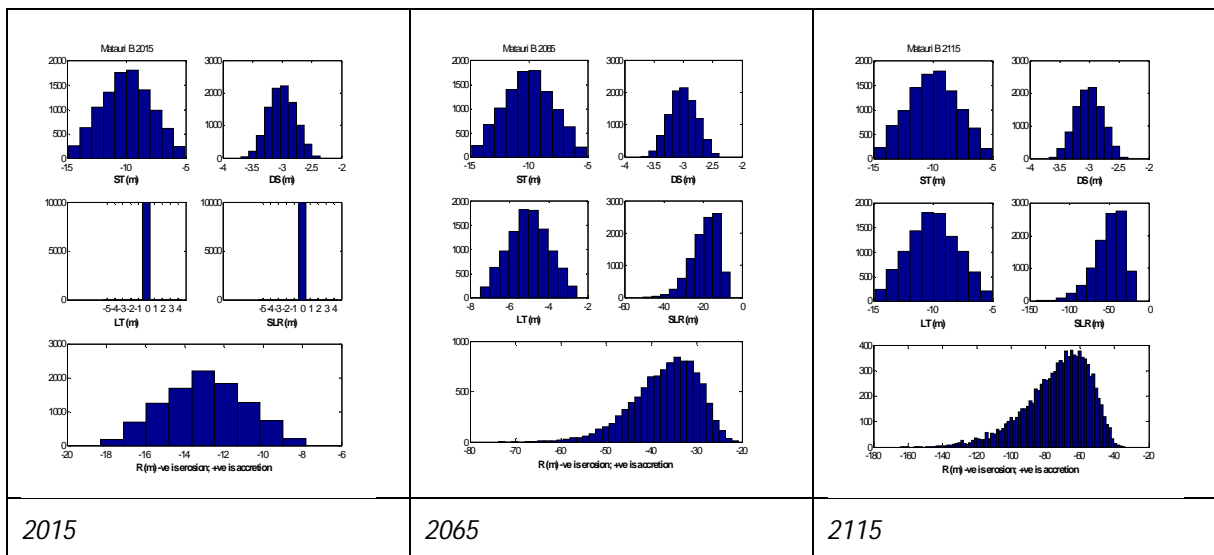
Figure 20-2 Histograms of parameter samples and the resultant shoreline distances for 2015, 2065 and 2115 timeframes for cell 20B

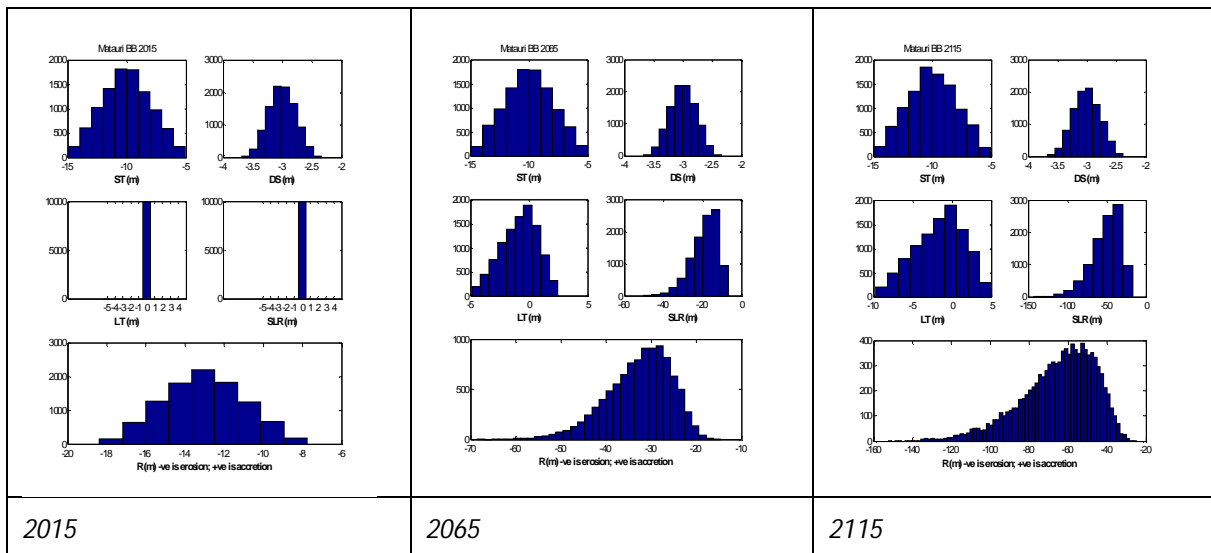
Figure 20-3 Histograms of parameter samples and the resultant shoreline distances for 2015, 2065 and 2115 timeframes for cell 20BB

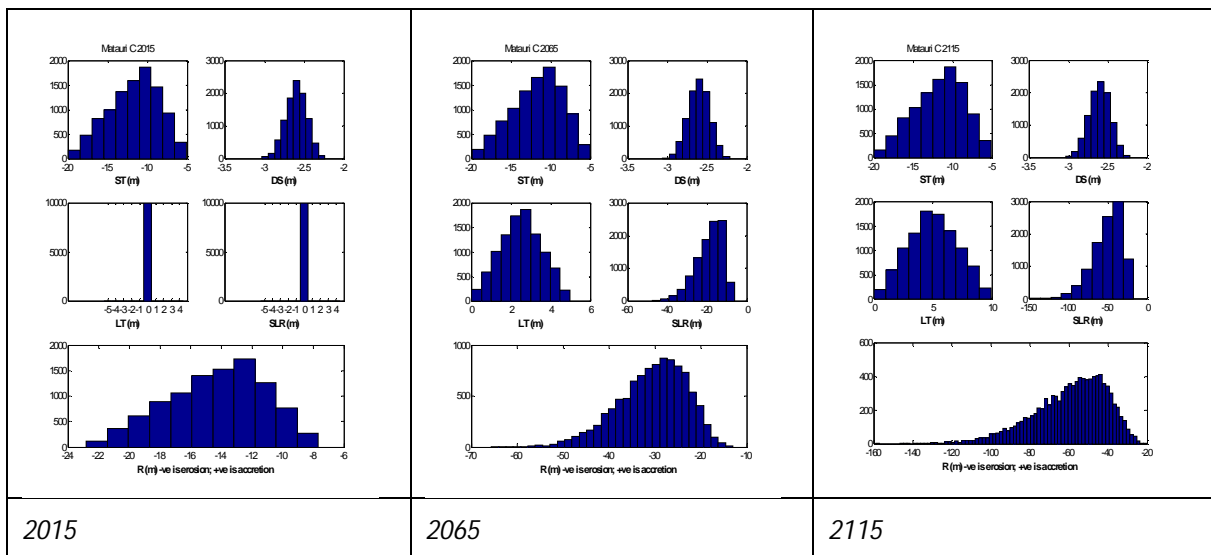
Figure 20-4 Histograms of parameter samples and the resultant shoreline distances for 2015, 2065 and 2115 timeframes for cell 20C

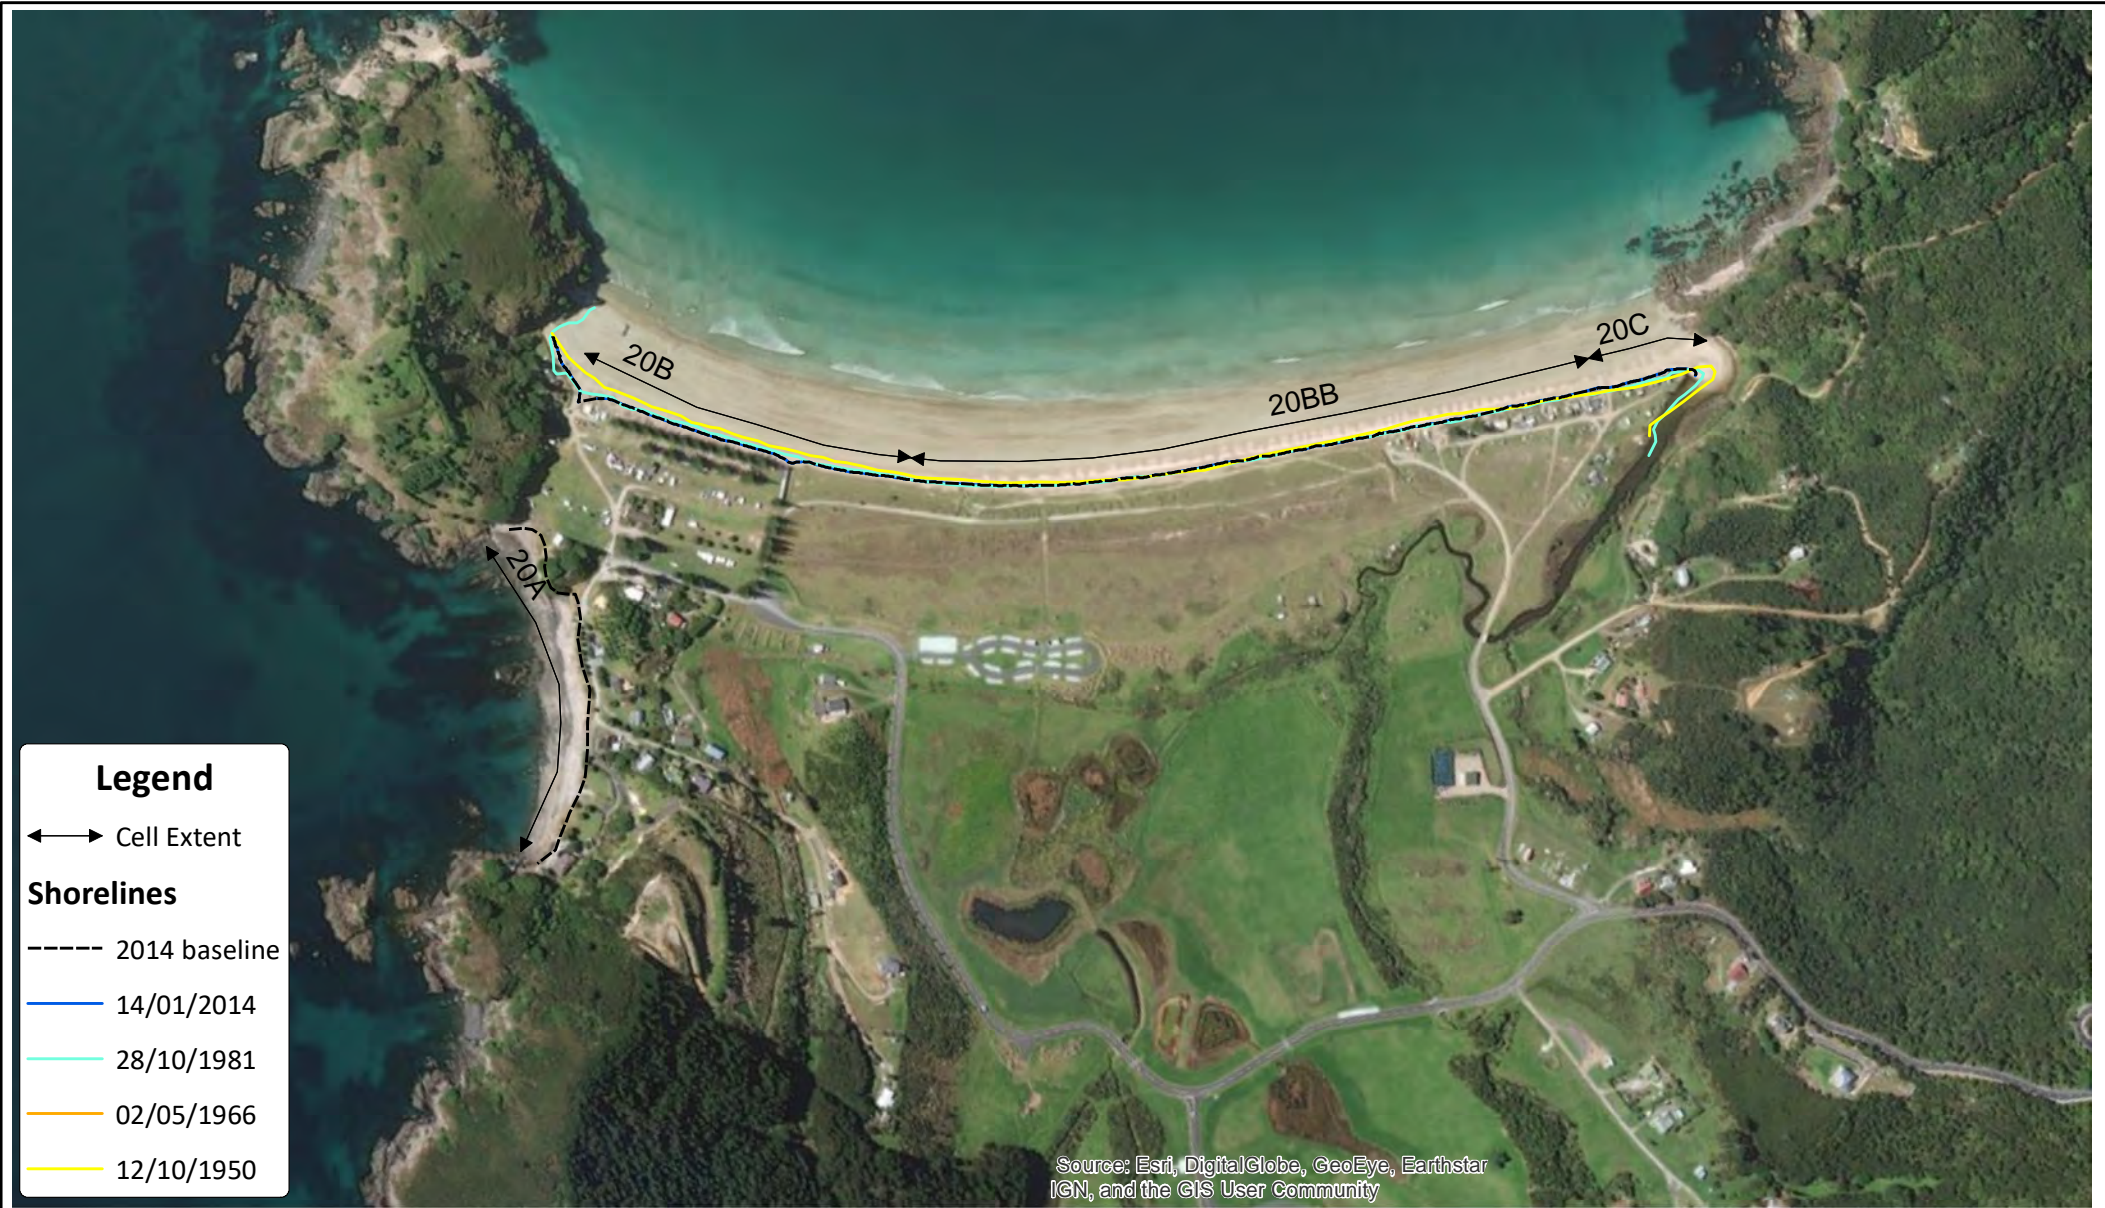
FIGURE No. Figure 20-6

NORTHLAND REGIONAL COUNCIL
Historic shorelines
Matauri Bay
Site: 20

Figure 20-6 shows the available historic shorelines for Matauri Bay.
