Aupouri Peninsula

Lake Morehurehu South 2 (Aupouri), NRC Lake No. 36.

Summary

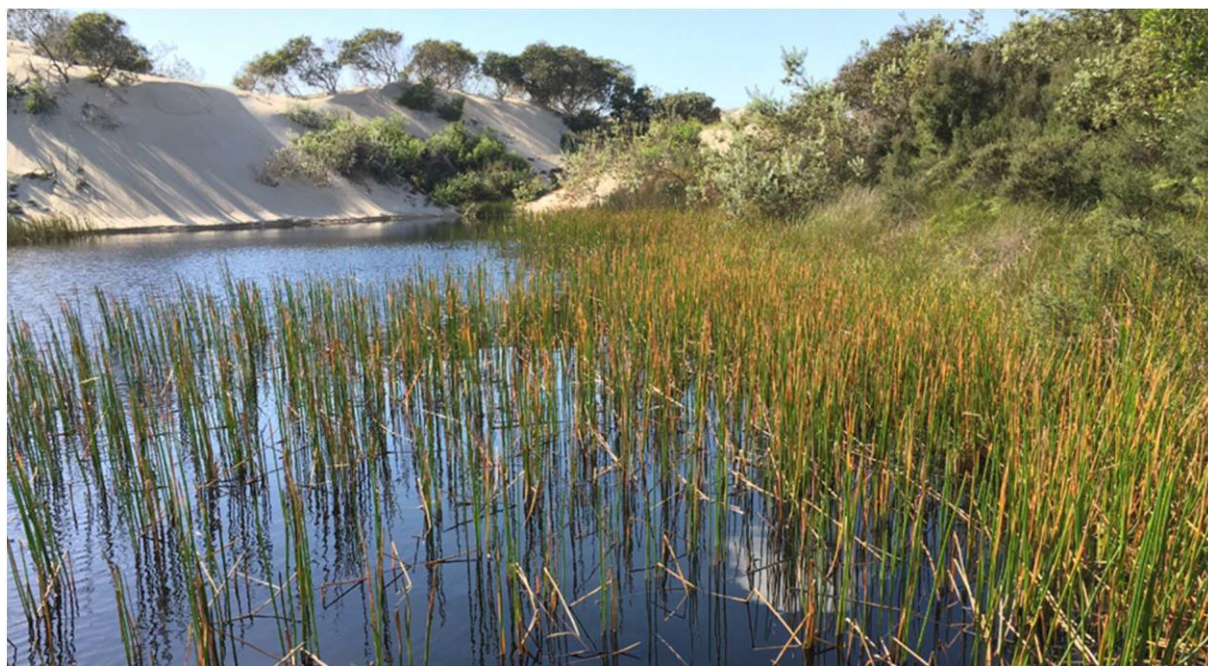
Plate 1: Morehurehu South, a coastal dune lake set in sand dunes, scrub and recently harvested plantation pine forest, 2016

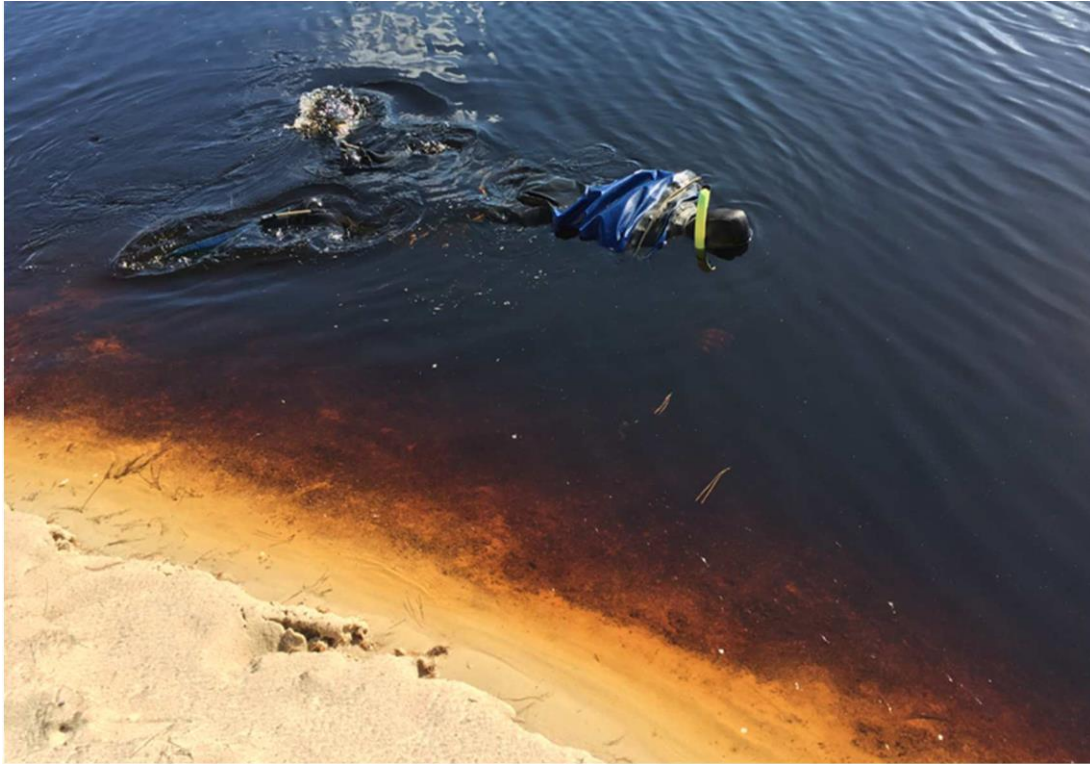
In 2016 water clarity was very low and no submerged species were recorded.

Plate 2: Morehurehu South, showing low clarity due to very dark coloured water, 2016. No submerged plants were recorded.

Based on the 2006 survey a Lake Ecological Value rating of 10 (High) was calculated. A deterioration in the rating of the following parameters: aquatic vegetation diversity and integrity (essentially a loss of submerged vegetation, with a decline of diversity from 1 to 0 and integrity from 3 to 0) and endangered species (loss of *U. australis*) has resulted in a revised score of 6 (Moderate). Water quality was not measured at this lake but water transparency had declined (Plate 2).

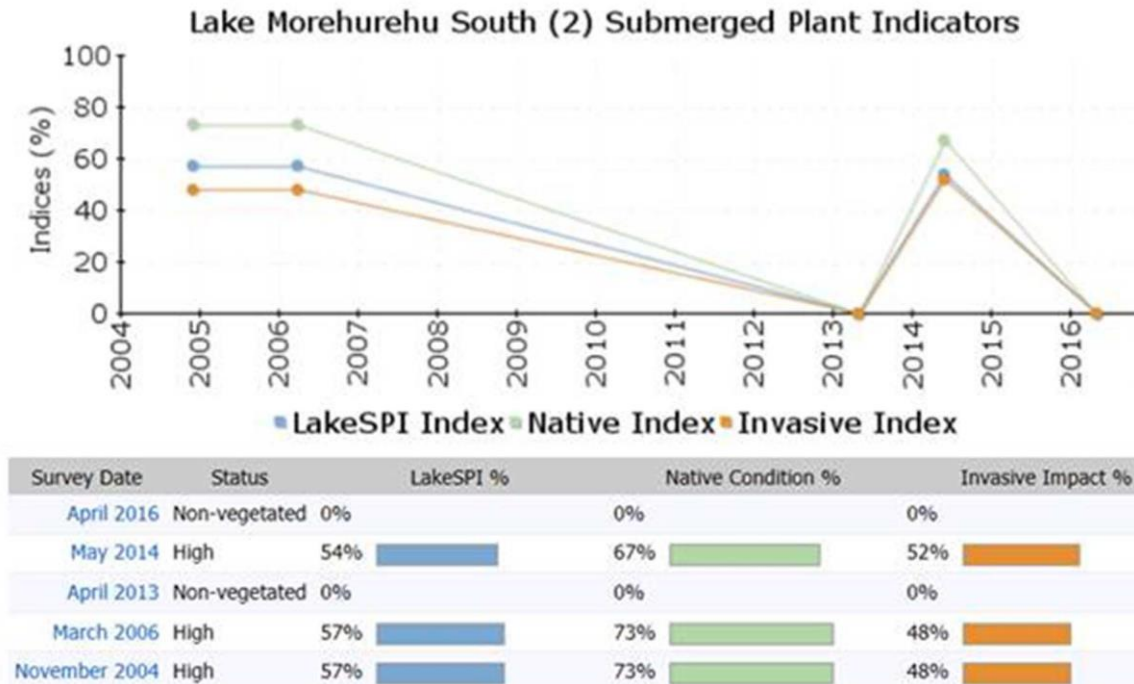
Figure 1: LakeSPI for Lake Morehurehu South 2. Five LakeSPI surveys are recorded. 2013 and 2016 scored 0% due to very low abundance of submerged vegetation.

A decline in water quality occurred around 2013. Since that time, Lake Morehurehu South 2 has fluctuated between a devegetated condition (as was the case in 2016) and re-establishment of submerged vegetation.
