Central and East Northland

Lake Ora (near Whangarei), NRC Lake No. 205

Summary 2006

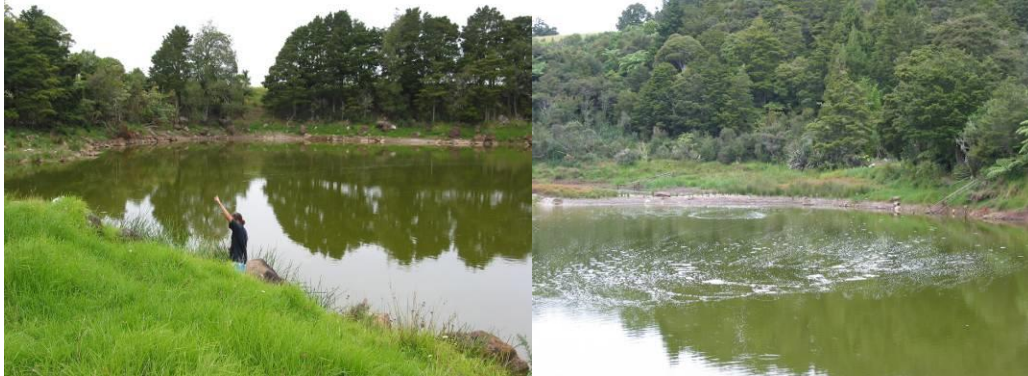
Plate: A lake with few submerged and emergent plants.

Low: Very low water clarity prevents submerged vegetation establishing and there was little marginal vegetation.

There was no submerged vegetation, just the odd amphibious *Myriophyllum propinquum* and *Potamogeton cheesemanii*. The lake was not dived as the water clarity was less than 0.1 m due to a heavy algal bloom.

No monitoring. Consider marginal planting and lake restoration.
