# Recreational Swimming Water Quality in Northland

Summer 2018-19

# 1. Executive Summary

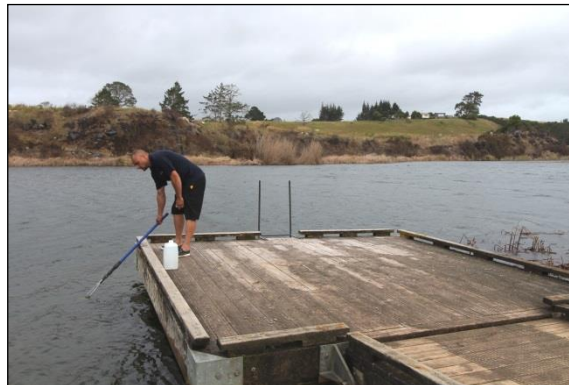
**Photo 4: Council staff taking water sample at Lake Waro, Hikurangi**

Each sample is collected following the methods described in the MfE and MoH (2003) guidelines. Coastal water samples are taken from the shore using a sampling pole at about 0.5 metre depth, from approximately 15 centimetres below the surface. Freshwater samples are taken at approximately 30 centimetres below the surface, at approximately one metre depth. All samples are collected during daylight hours and sites are sampled in the same order each week. This ensures that, where practicable, samples are collected at around the same time each week.

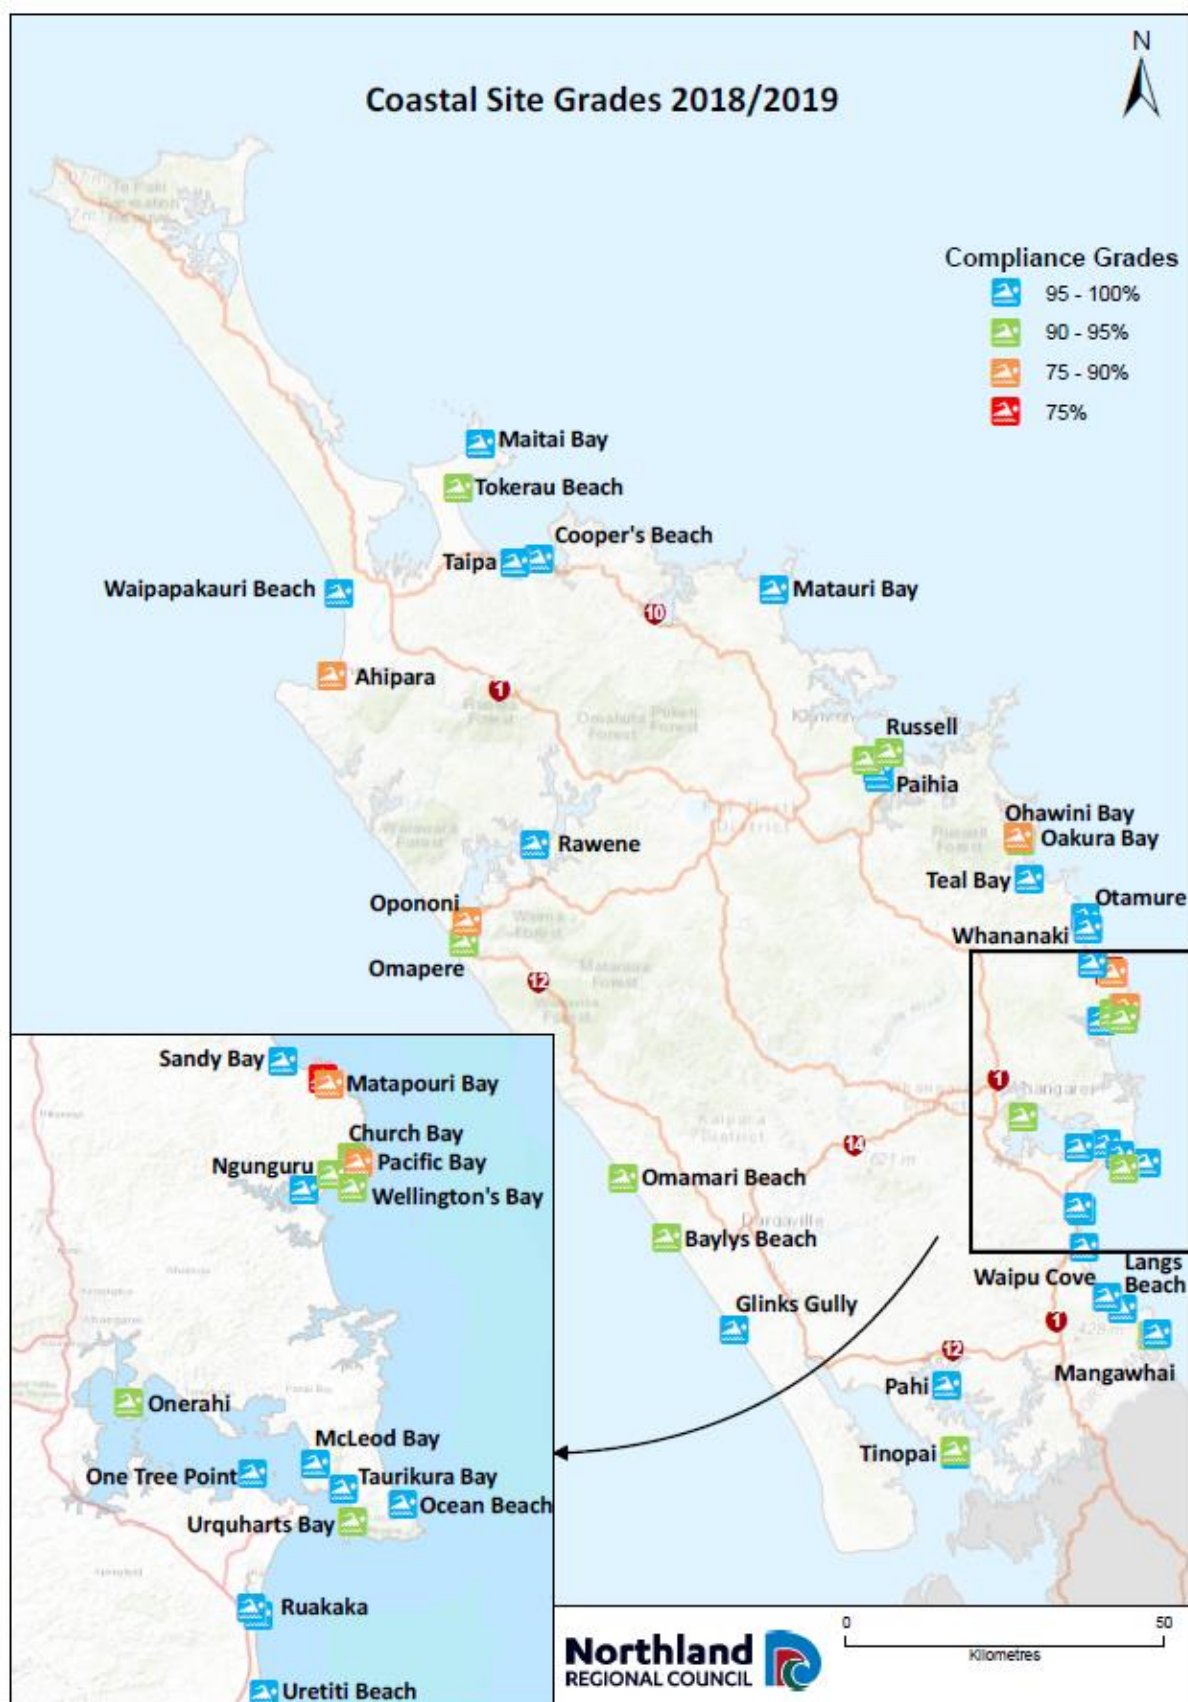
Figure 1: Coastal end of season grading 2018-19

Each 'Action' result has been cross-referenced with accumulated rainfall data collected 72 hours prior to sampling, indicating whether rainfall related runoff from land was contributing to elevated results (refer to tables below). Overall, 14 'Action' level results were recorded for 10 of the 46 coastal sites, of which 64 percent were likely to have been related to rainfall.

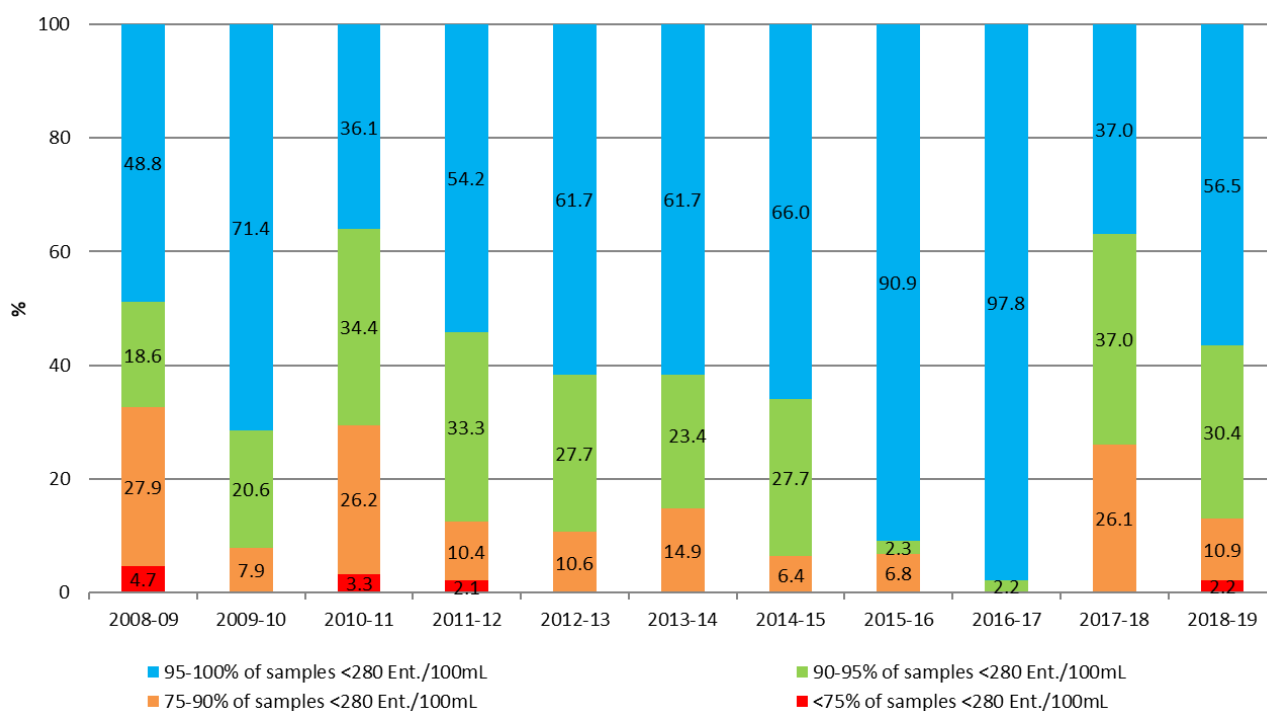
**Figure 2: Yearly overall percentage of coastal sites with corresponding percentage of samples within each category from 2008 to 2019.**

Fifty-seven percent of sites monitored in 2018-19 had more than 95 percent of samples fall within "suitable" level guidelines. Two percent of sites had less than 75 percent compliance with the guidelines. Overall, the results from faecal indicator bacteria testing in 2018-19 were slightly better than 2017-18 which is likely attributed to less rainfall events during the summer.

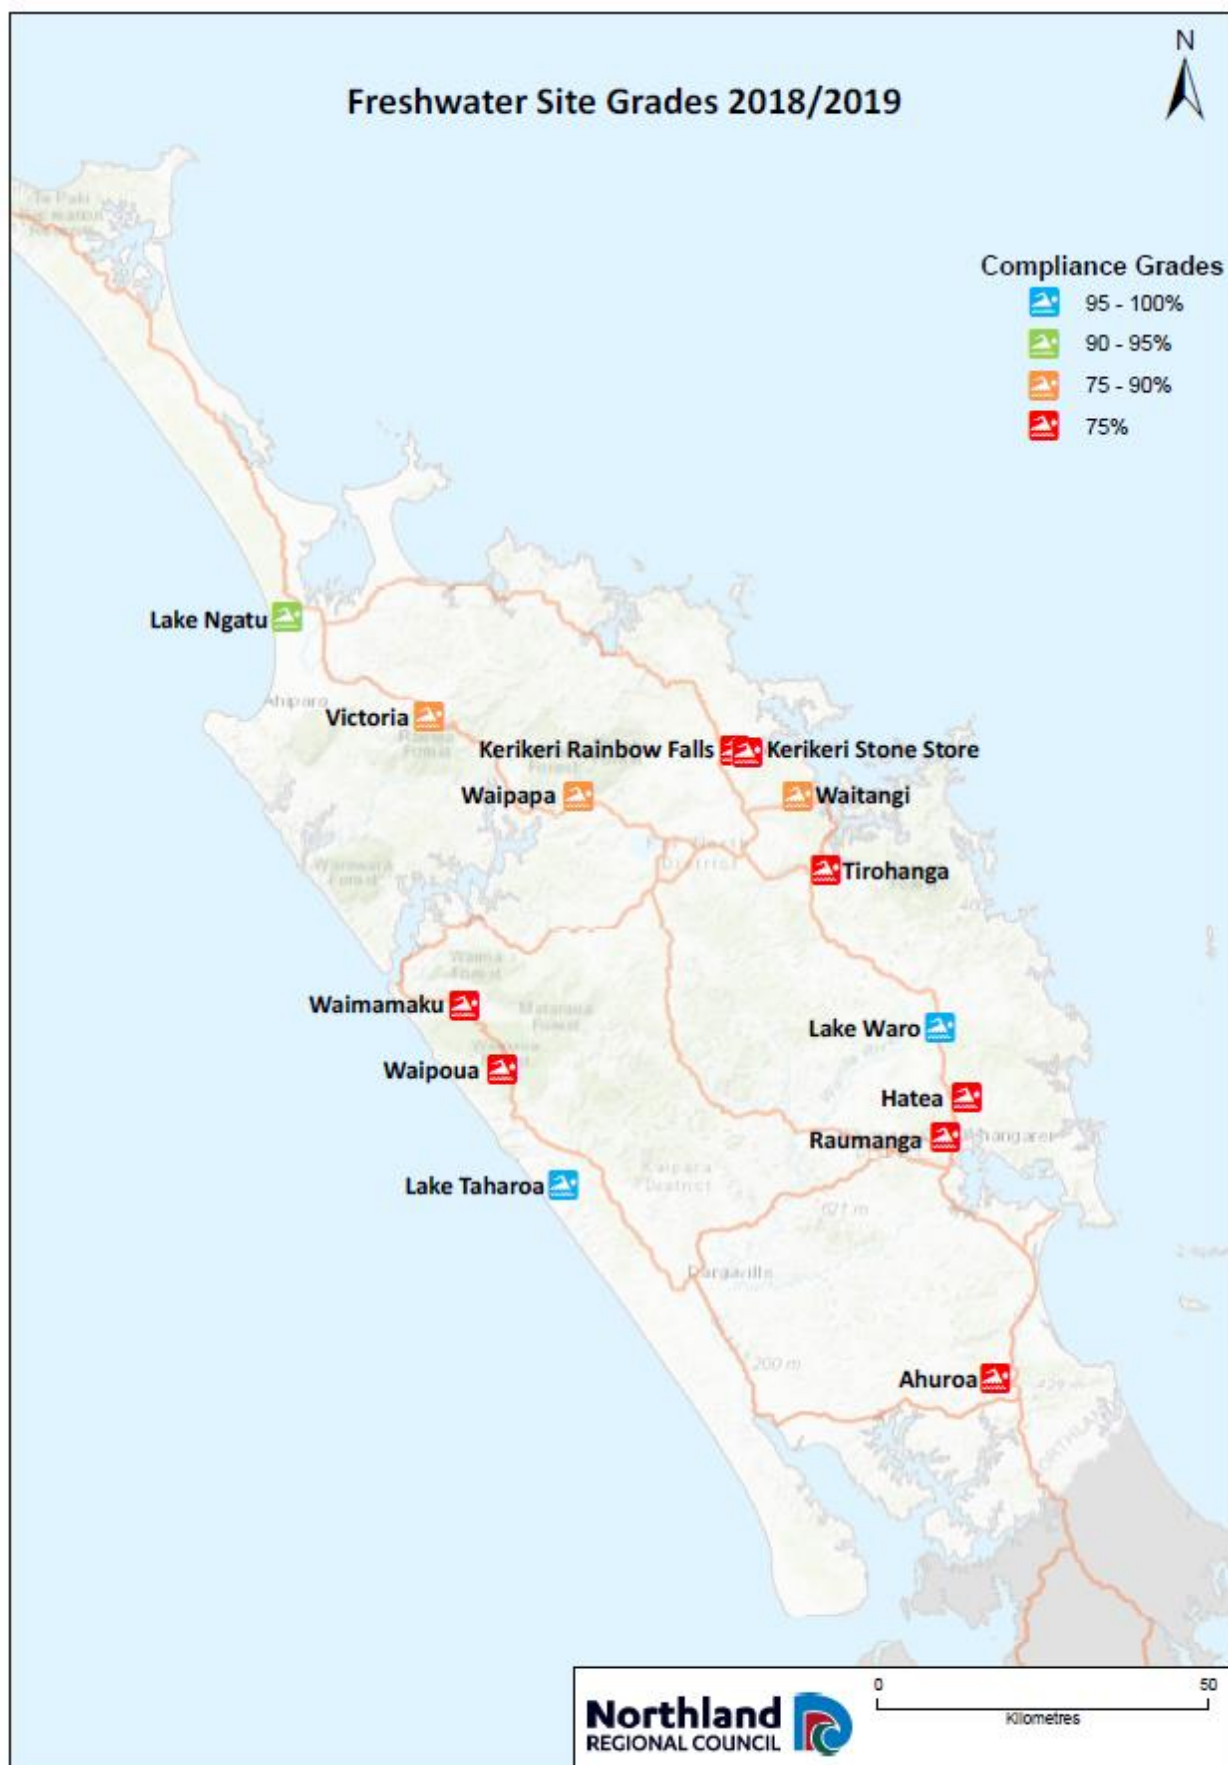
**Figure 3: Freshwater end of season grading 2018-2019**

Figure 3 above displays the end of season grades for samples taken from each of the 14 freshwater sites monitored in Northland during the 2018-19 sampling season (3 December 2018 to 4 March 2019). The grades indicate the percentage of samples which fell within the "suitable" for swimming category at each site over the summer period.

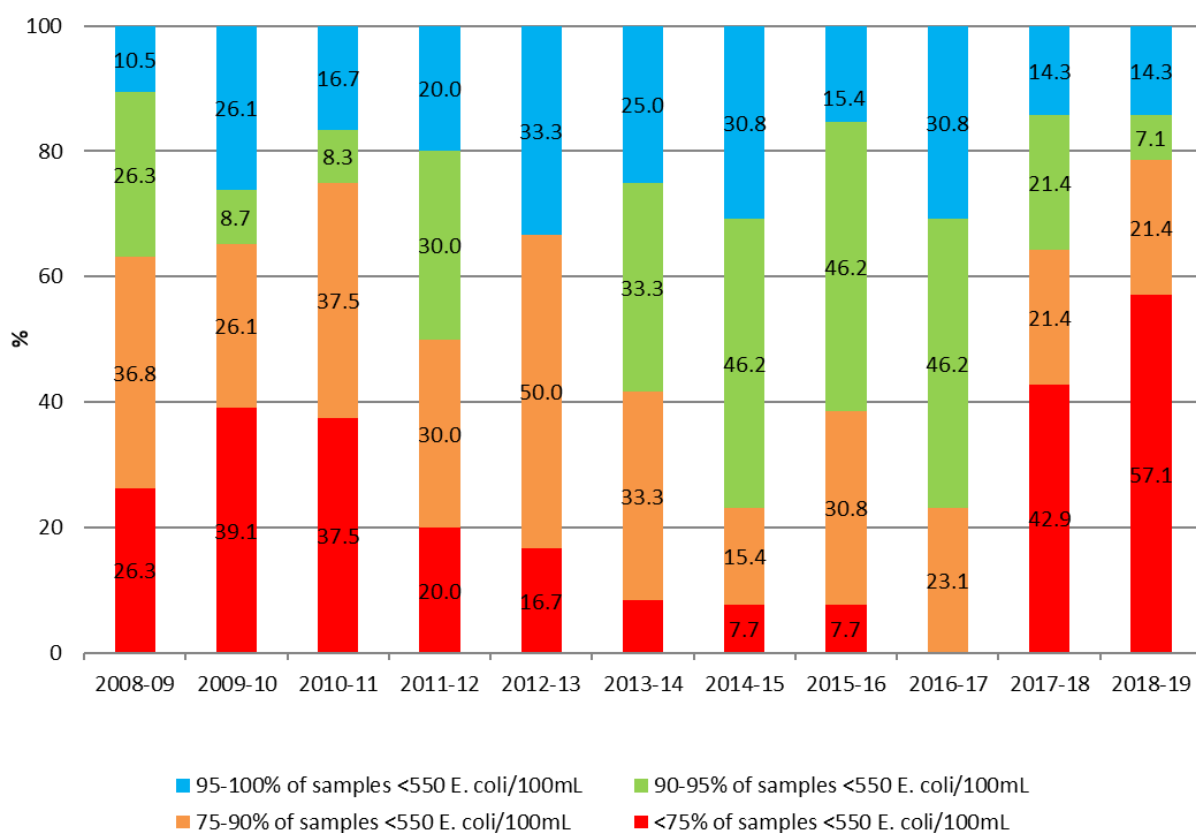
**Figure 4: Yearly overall percentage of freshwater sites with corresponding percentage of samples within each category from 2008 to 2019.**

Over 20 percent of sites in 2018-19 had more than 90 percent of samples fall within the "suitable" faecal indicator bacteria levels. This is lower in comparison to 2017-18 which recorded around 35 percent of sites. Around 57 percent of sites fell in the less than 75 percent compliance category in 2018-19 which is higher than many previous results.
