Contaminated Land Management Detailed Site Investigation Report

17-29 Dunn Street & 28-36 Empire Street, Kaitaia

for Northland Regional Council

4 April 2018

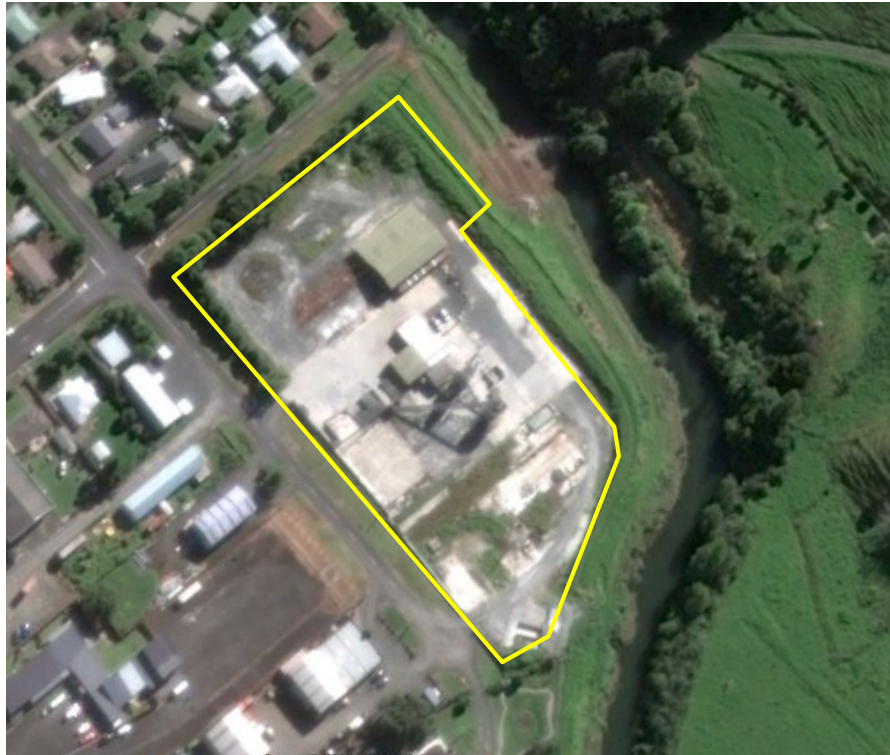
Figure 1. Extent of the subject Piece of Land (yellow)

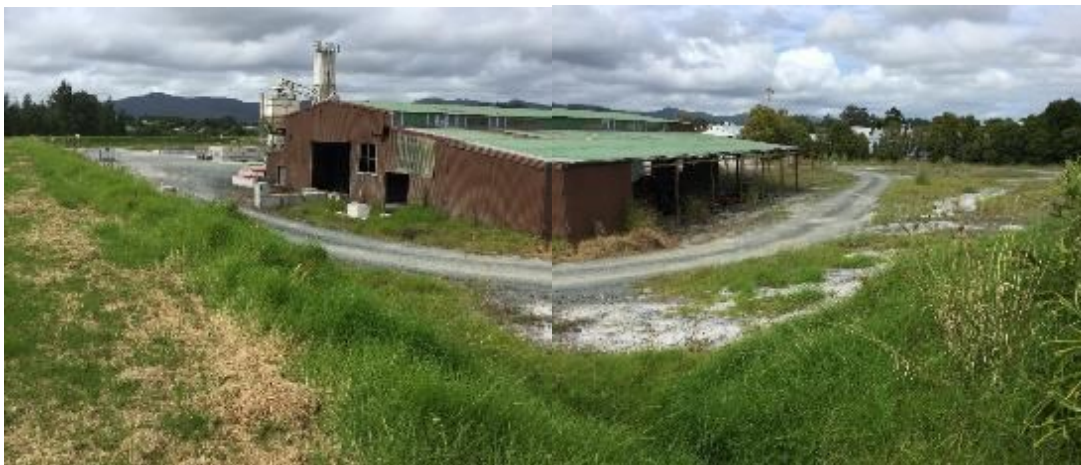
Photograph 1: View of Prestress Shed from top of stopbank on north east boundary with batching plant behind

There are two remaining buildings on the site – the (derelict) Prestress Shed to the north of the site (Photograph 1) and the office/lunchroom/batch/store area in the central portion of the site. Quite a large portion of the site is either concrete pavement, or has had waste concrete placed on it. There were also areas of gravel and bitumen fill (Photographs 2 & 3) and a variety of equipment/plant stored on the site.

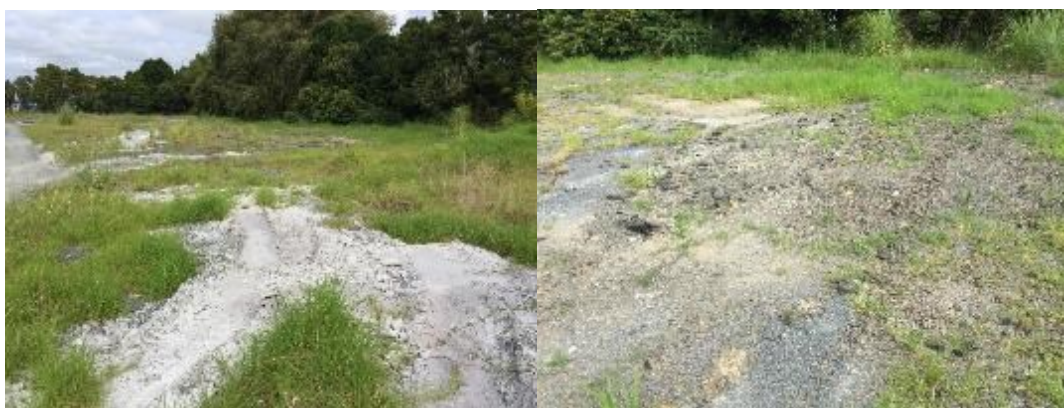
Photographs 2 & 3: Waste concrete and bitumen/gravel fill over the northern portion of the site

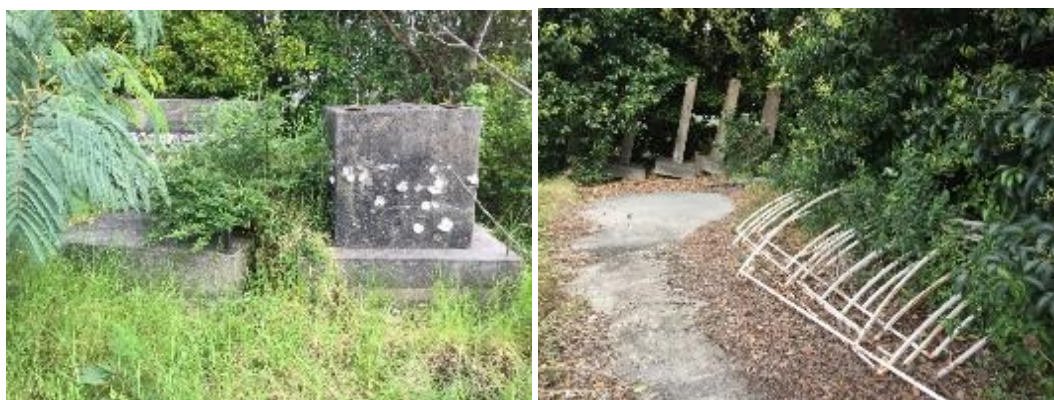
Along the northern boundary of the site (adjacent to Empire Street) was what appeared to be concrete pontoons (Photograph 4), framing and columns (Photograph 5) and an old entrance sign (Photograph 6).

Photographs 4 & 5: Products/equipment along the northern boundary of the site

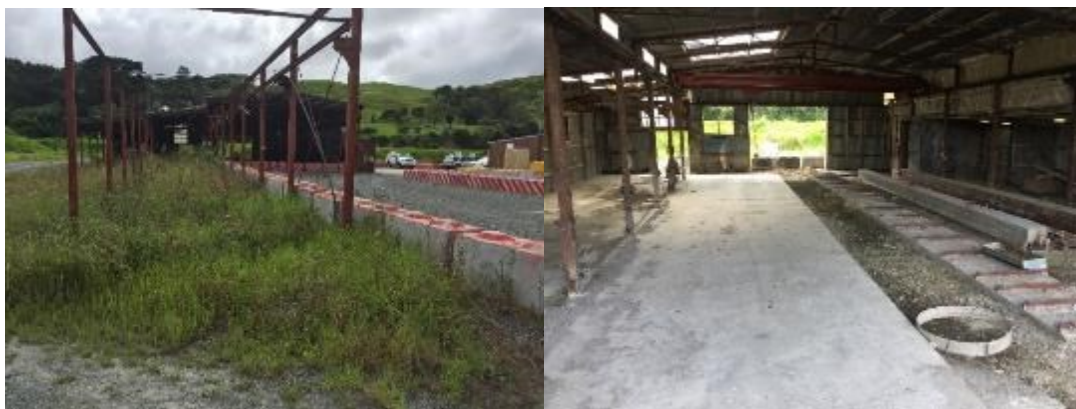
Remnants of the prestress gantry remains (Photograph 7). The now derelict Prestress Shed (Photograph 8) has a concrete floor, corrugated metal roof and walls clad with corrugated metal and presumed asbestos cement material (ACM) (Photographs 9 & 10). The condition of the ACM on part of the southern wall of the Prestress Shed is likely to trigger HAIL as it was in a semi deteriorated state. Approximately one quarter of the northern wall and most of the (internal) southern wall of the Shed was clad with ACM. Above the corrugated ACM on the northern wall, there was also flat presumed ACM in good condition.

Photograph 7 & 8: Prestress gantry and inside of Prestress Shed looking north east

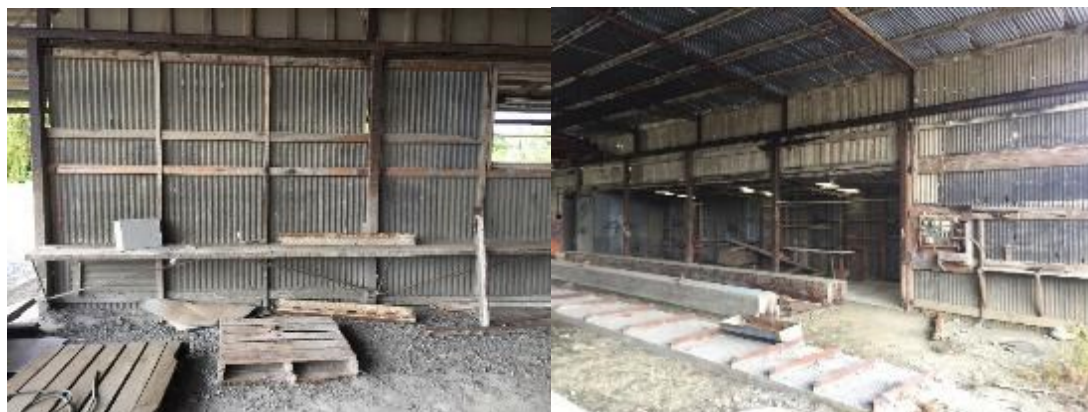
Photograph 9 & 10: Northern and southern (internal wall) of Prestress Shed.

- **HAIL E1:** *Buildings containing asbestos products known to be in a deteriorated condition.* Sections of the Prestress Shed are clad with presumed asbestos cement material in a semi-deteriorated condition.

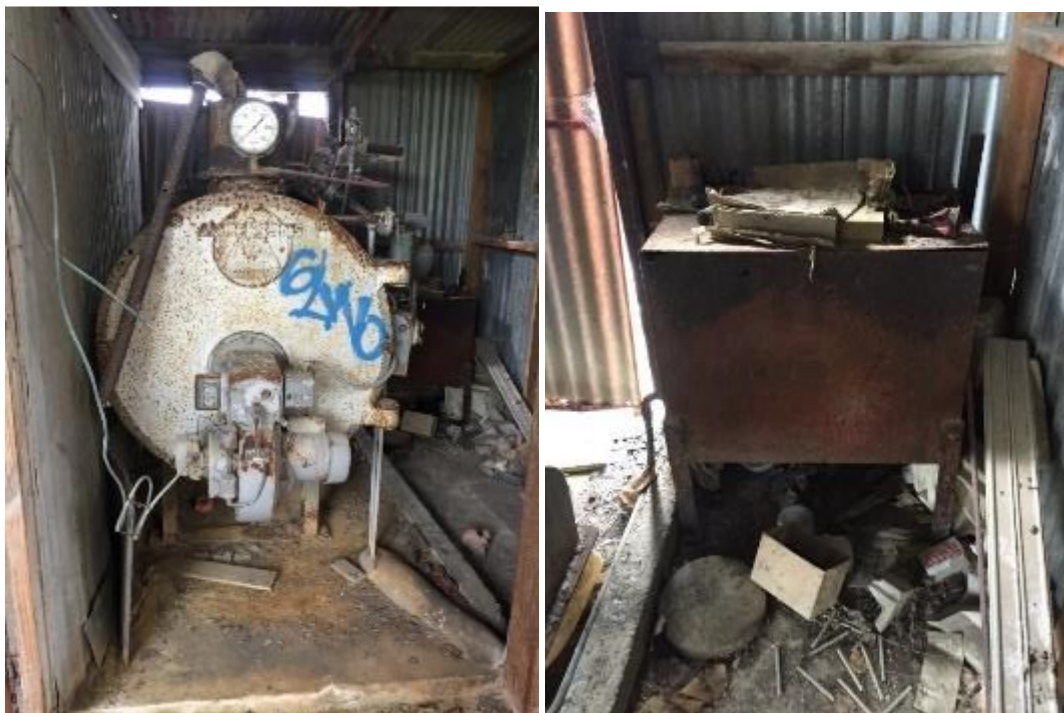
On the eastern corner of the Prestress Shed was an Anderson diesel fuelled boiler and associated day tank (Photographs 11 & 12) sitting on a concrete floor.

Photograph 11 & 12: Anderson Packaged Boiler and Day Tank in the Prestress Shed.

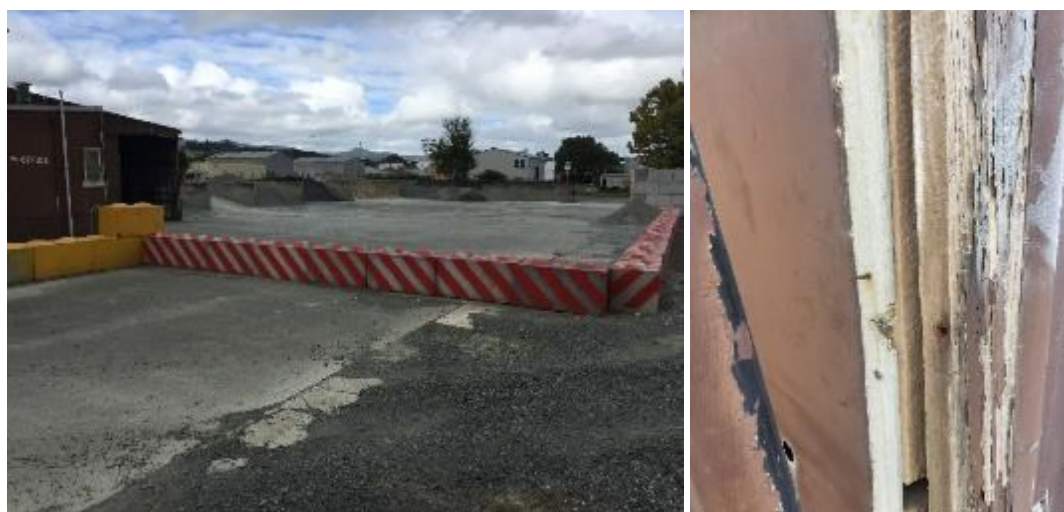
The area around the aggregate stockpiles appeared to be concrete paved (Photograph 13), with the area entering the visitor carpark was mainly gravelled. The area outside the garage/workshop entrance appears to have had concrete pavement installed after that of the aggregate area, possibly indicating the location of historic underground storage tanks removal. The wall cladding on the office/lunchroom (Photograph 14) appeared to be ACM in good condition.

Photograph 13 & 14: Aggregate storage and presumed ACM cladding on office

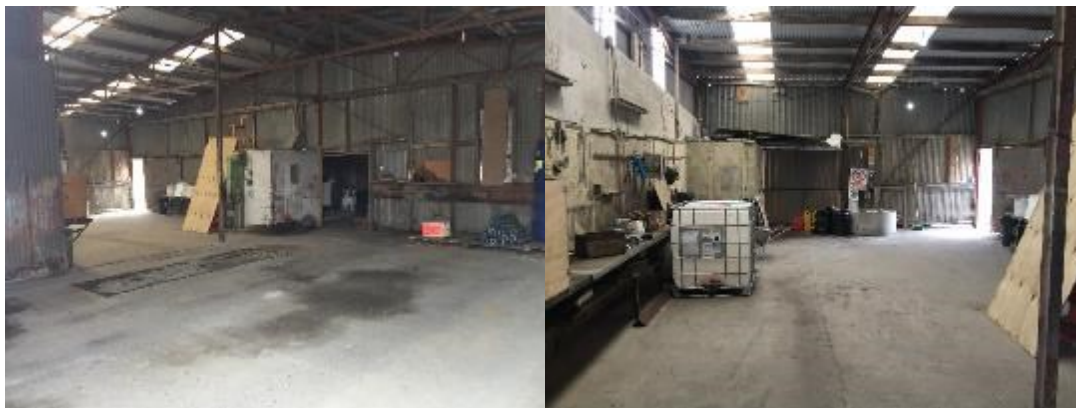
Inside the garage/store area, there was evidence of a maintenance pit (filled in with gravel) (Photograph 15), several empty Intermediate Bulk Containers (IBCs) (Photograph 16), one IBC containing about 80 litres of MasterAir 905, an ultra-stable

air-entraining admixture for use in all types of concrete (a Hazardous Substance Subclass 6.3/6.5 Category B).

Photograph 15 & 16: Garage and storage shed

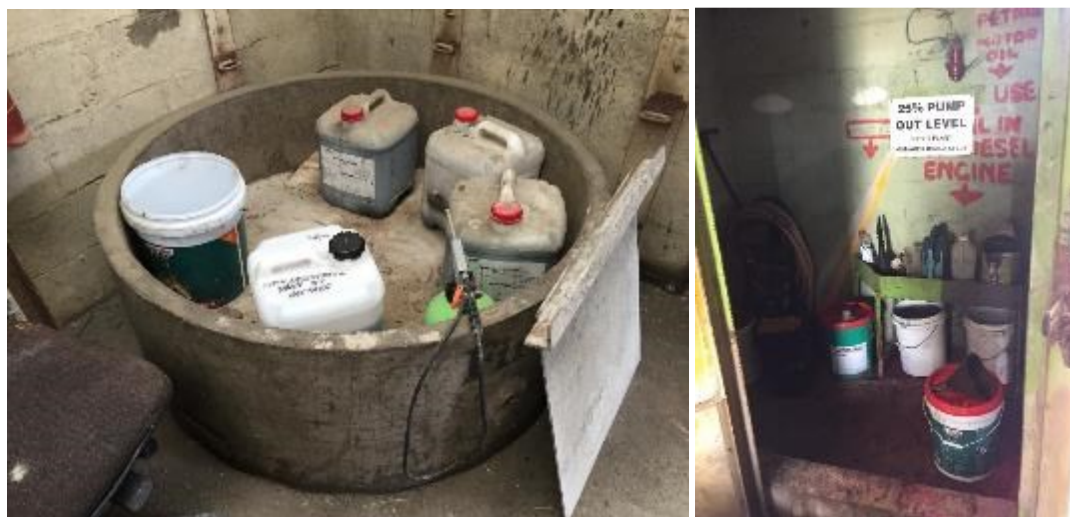
This area contained small quantities of hydrocarbons and other chemicals in a bund made from a concrete tank (Photograph 17) and inside a bunded storage room (Photograph 18).

Photograph 17 & 18: Hydrocarbon/chemical bunding

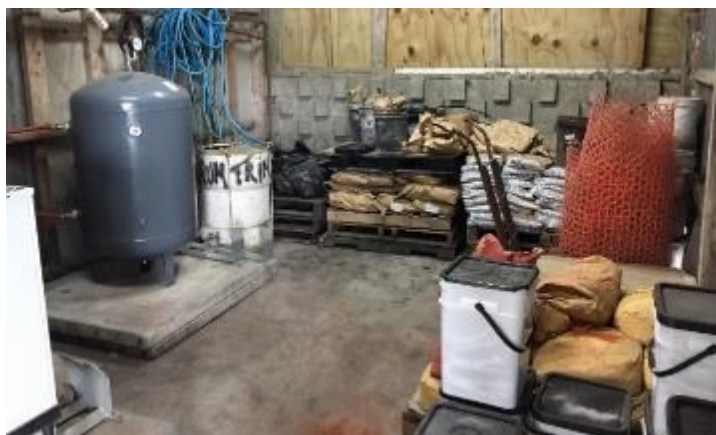
Next to the store area was another storage area which contained oxides, steel fibres in 20-25 kg bags/buckets, as well as an air dryer, air compressor and storage reservoir (Photograph 19). The walls of the garage and store areas appears to be clad with corrugated metal, with a concrete floor.

Photograph 19: Storage of oxides/steel fibres and air compressor/storage reservoir

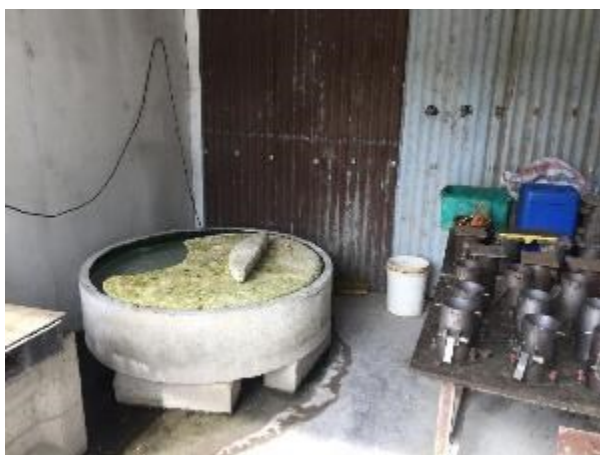
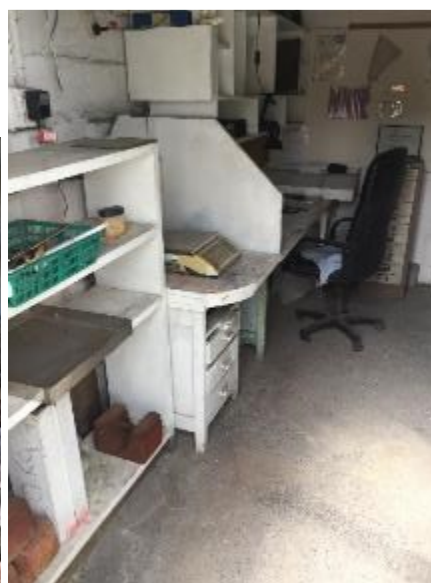
Next to the storage area was a concrete testing facility and an office (Photographs 20 & 21). Three of the internal walls of the office were clad with presumed flat ACM in good condition.

Photographs 20 & 21: Concrete testing area and office

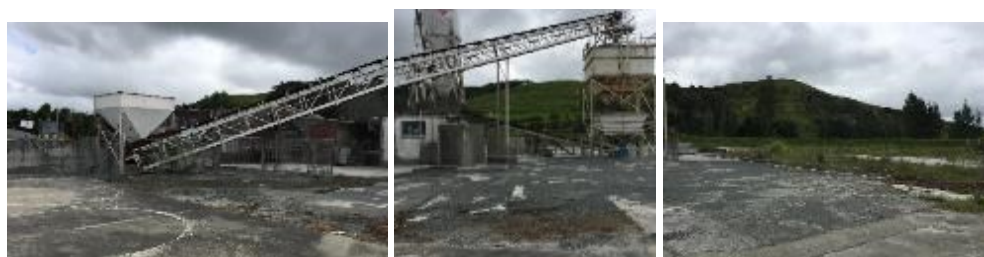
Adjacent to the office was the concrete batching plant (Photographs 22 - 24). Aggregate is loaded into a hopper, which conveys the material up a conveyor into another hopper which feeds it into a lower hopper prior to transfer onto another conveyer and then into the rear of the Transit Mixer. Cement is added directly into the Transit Mixer from a silo located above where the Transit Mixer is loaded. The area around the batch plant is predominantly concrete paved.

Photographs 22-24: Concrete batching plant looking north east

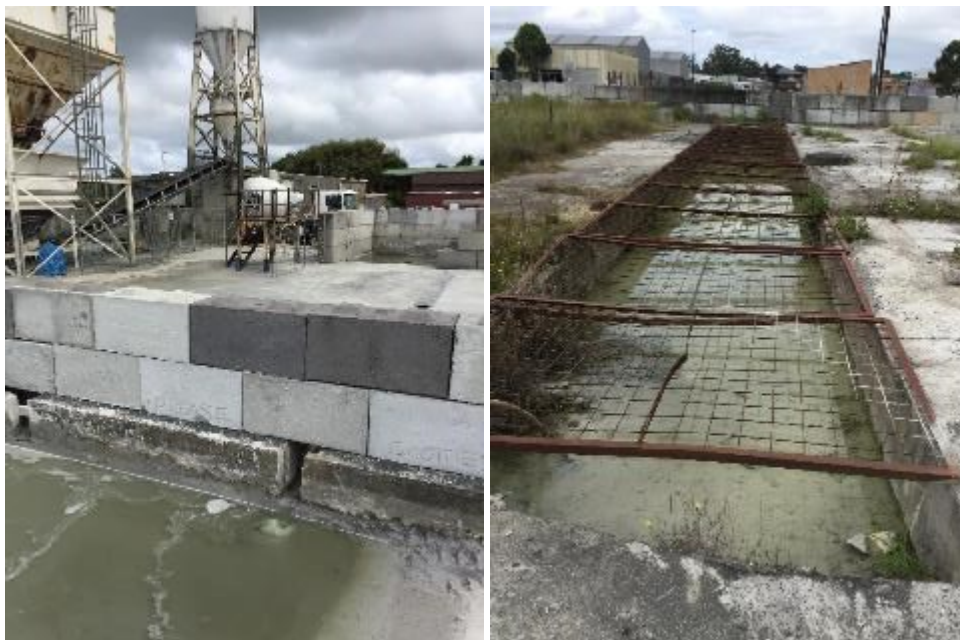
Transit Mixers are washed out into a slurry pit near the batch shed, which overflows into a settlement pond (Photograph 25) and then into a long settlement pond (Photograph 26) which was historically a “sunken road” used to load water tanks etc onto trucks. Water from the final settlement pond is reused to make ready mix. Historically, water from this settlement pond was either reused to wash out Transit Mixers and/or discharged to the stormwater system.

Photographs 25 & 26: Slurry pits/settlement ponds

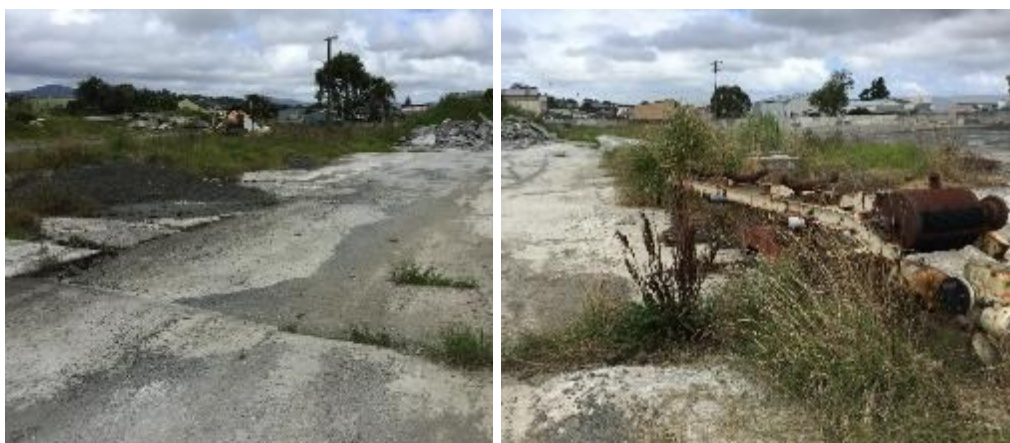
The southern portion of the site contained stockpiles of gravel and waste concrete, and disused plant. All of the buildings had been demolished, with the footprints/foundations still visible. Most of the area was either concrete paved or gravelled.

Photographs 27 & 28: Yard area in southern portion of site looking south west

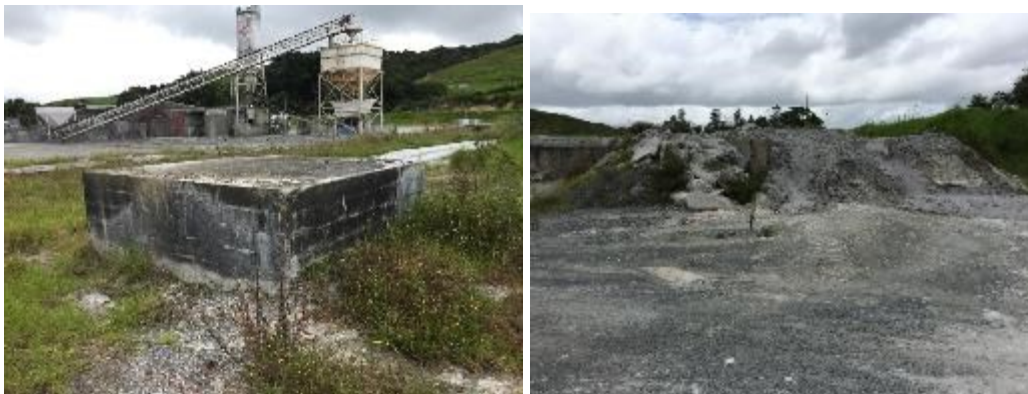
On the southern portion of the site was located a tank stand (Photograph 29) used to hold a tank used to store water for the washing of Transit Mixers. Adjacent to this on the south east boundary was a slurry pit/stockpile (Photograph 30) where Transit Mixers were historically washed out, but is now being used as a waste concrete stockpile area.

Photographs 29 & 30: Tank stand and slurry pit/stockpile

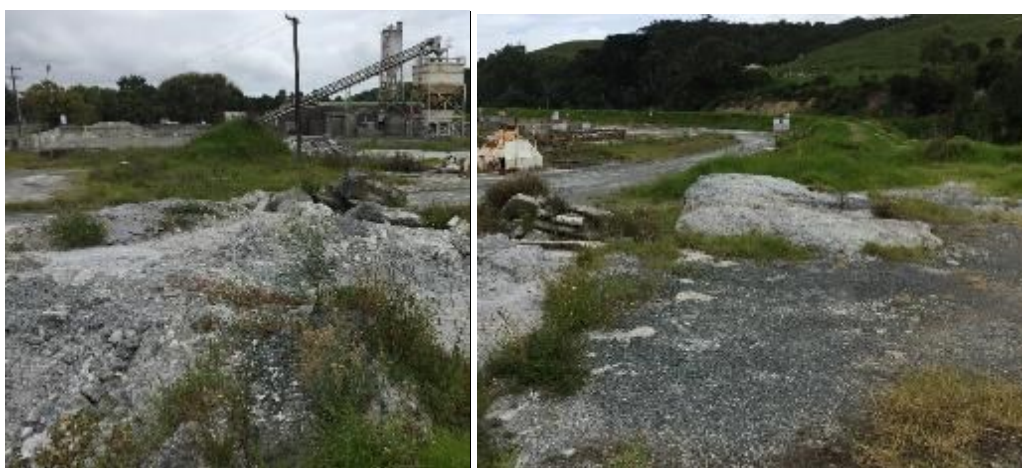
Stockpiles of material and plant can be viewed when standing on the stopbank on the south east corner of the site, looking towards the batch plant (Photographs 31 & 32).

Photographs 31 & 32: View from south east corner of site looking north north west

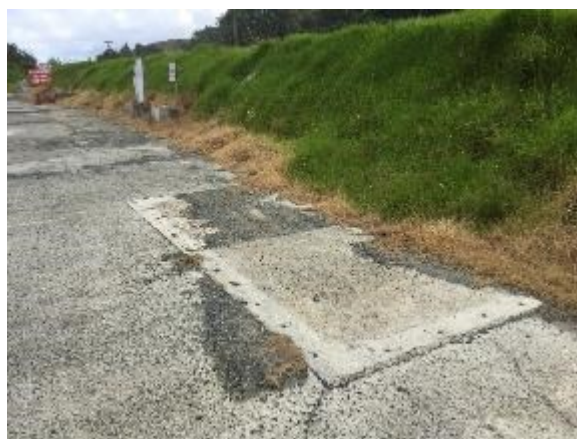
On the walk back to the lunchroom/office, the remnants of an above ground storage tank(s) area was identified (Photograph 33) on the eastern boundary of the site, and of the bowsers and (assumed) tank breather pipes (Photographs 34 - 36) on the north eastern side of the lunchroom.

Photograph 33: Bund footprint of above ground storage tank(s)

The bund location differs from what was observed onsite and information provided by Bob Shaw. It is possible that another above ground tank may have existed onsite, further north along the stopbank.

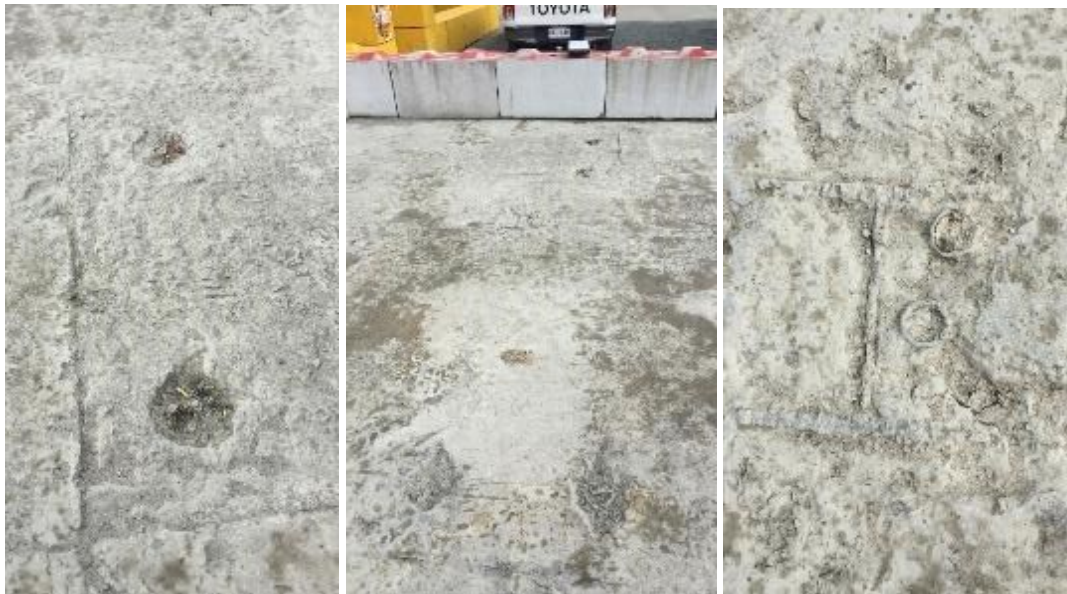
Photographs 34 - 36: Footings of fuel bowser and tank breather pipes

The bowsters and breather pipes are located on the north eastern side of the office/workshop/store. There are differing views on where the underground storage tanks were located. Bob Shaw indicated that the underground storage tanks were located to the south (on the other side) of the office/workshop/store to the bowsters, whilst Henry Tene (Firth Industries) advised that an underground fuel tank was located *in front of the lunchroom*.

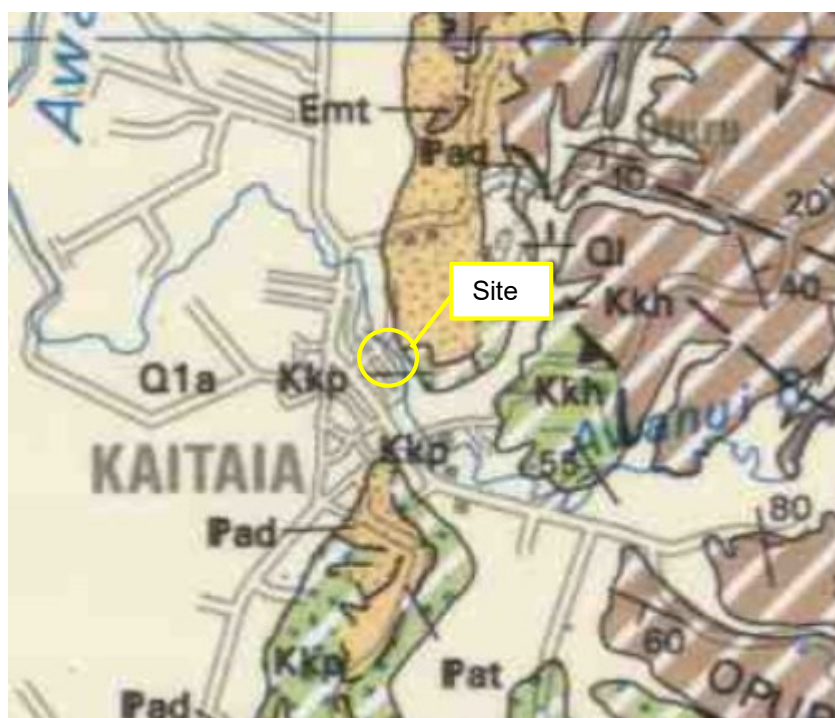
The Institute of Geological and Nuclear Sciences Geology of the Kaitaia Area Geological Map 1 (Figure 6) defines the geology of the site as unconsolidated to poorly consolidated sand, mud, peat and shell deposits of estuarine, lacustrine, swamp, alluvial and colluvial origins (Q1a).

Figure 6. Extract of the Geological Map from The Institute of Geological and Nuclear Sciences Geological Map 1, Geology of the Kaitaia Area, 1:250 000 (1996).

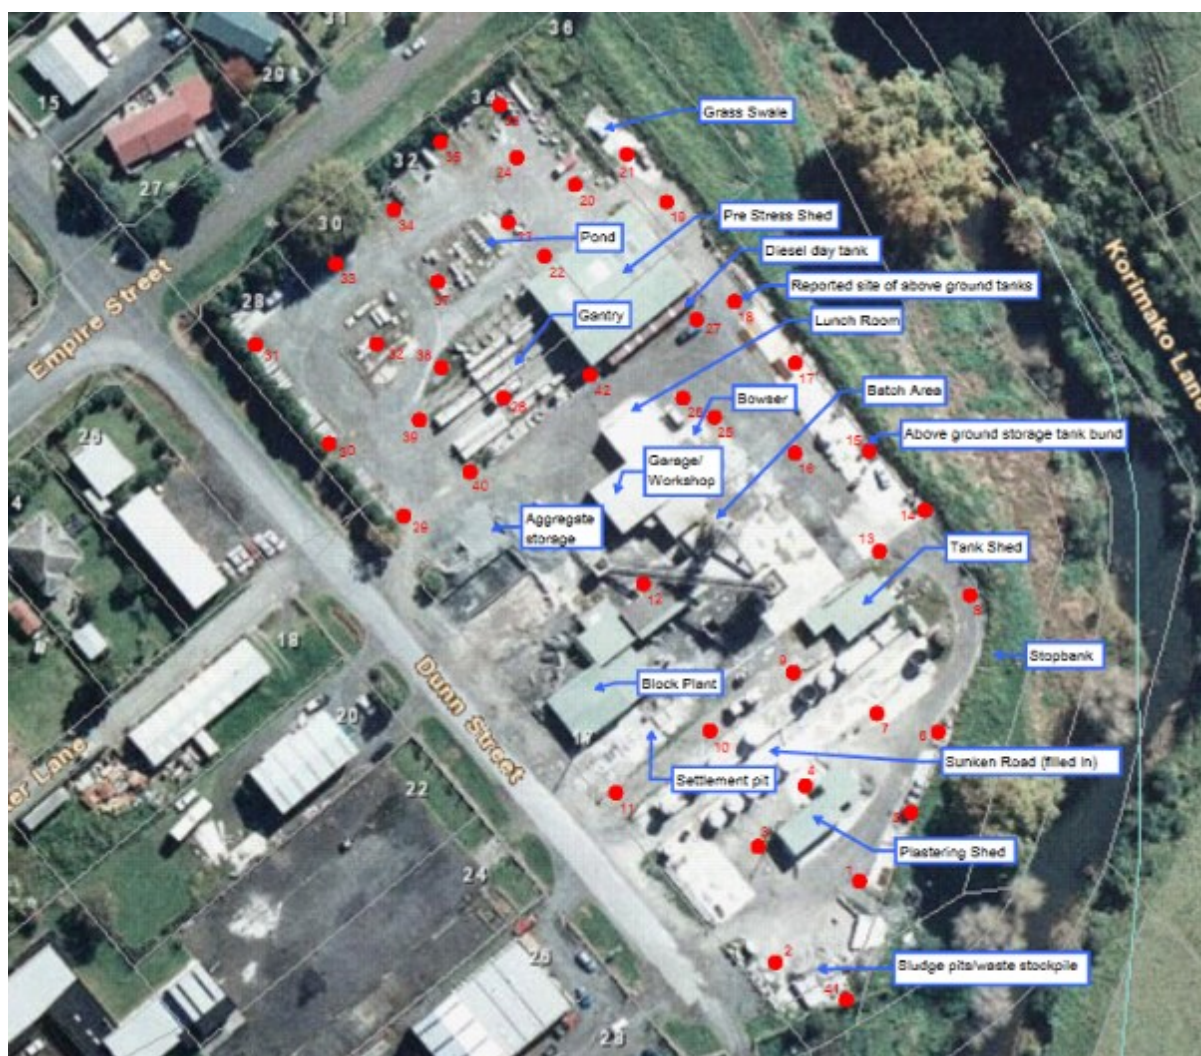
Figure 7. Sample locations and key historic/current site features

The key historic/current site features are also included on Figure 7 to assist in providing context to sample location/results.

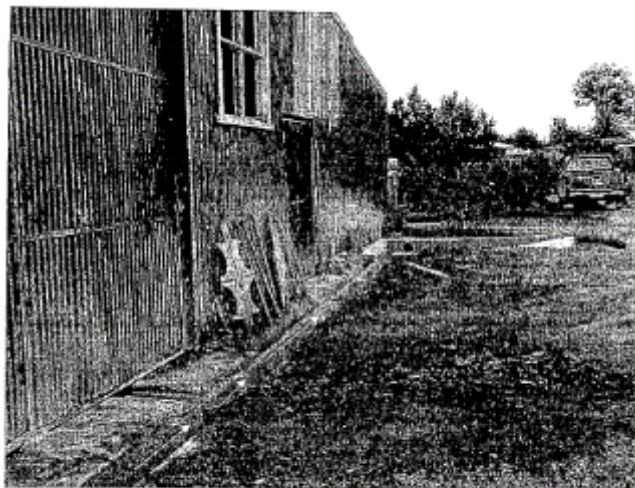
Wastewater from the precast building flows out into a drain and along into a settling pond. Arrows show direction of wastewater flow.

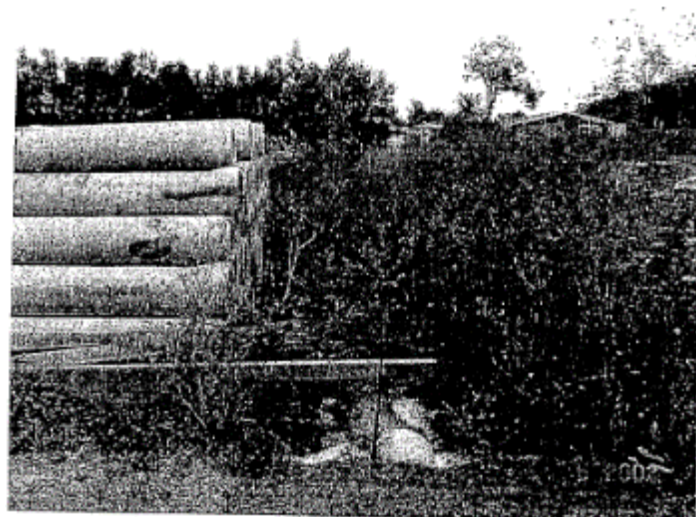
Photo 11

Discharge point from settling pond at rear of precast building into grass swale area.

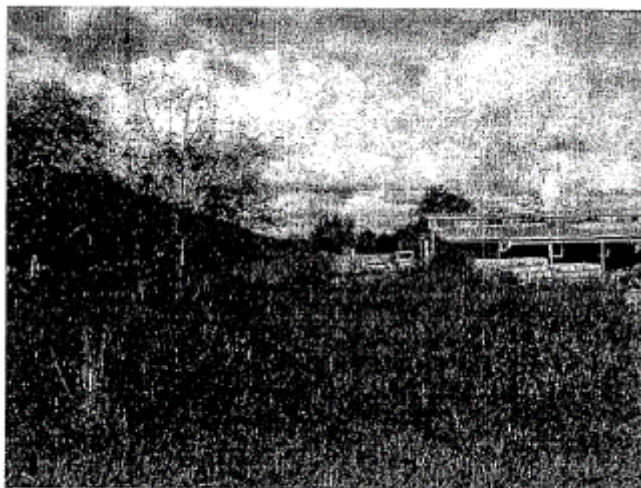
Wastewater from the pond at the rear of the precast area drains away into the ground in this grass swale area near the Empire Street boundary.

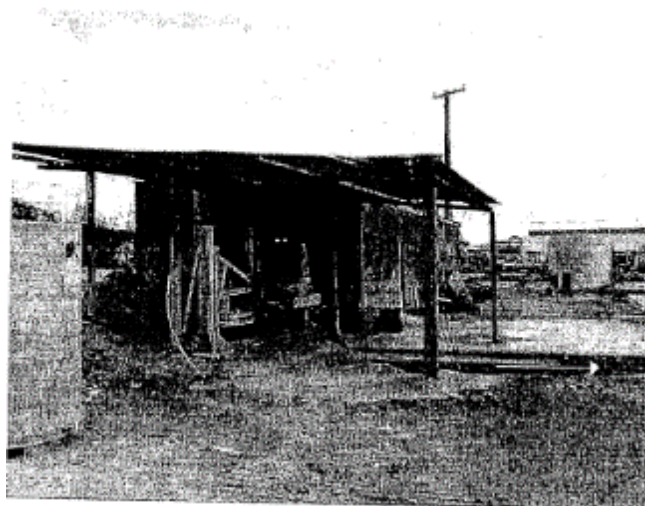
Photo 13

Plastering area. Arrow shows direction of wastewater flow.

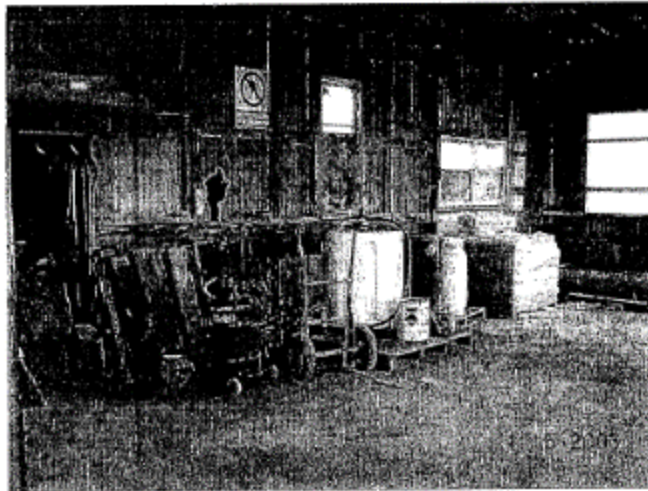
Photo 27

Diesel is in the white tank in centre of photo.

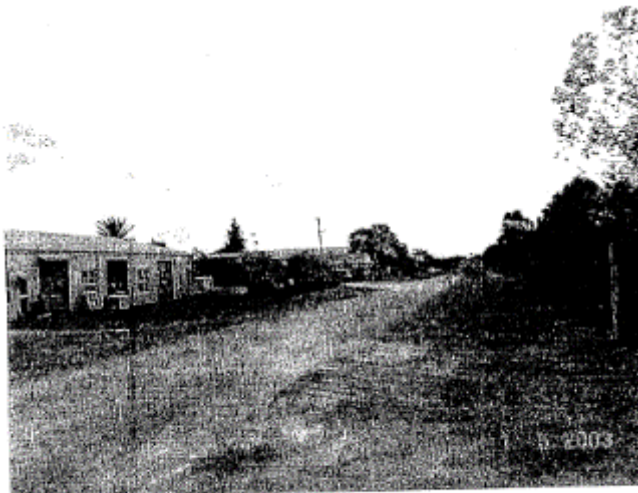
Photo 29

- *Most of the yard is unsealed, resulting in dust from vehicle movements. The vehicle entrance is also unsealed (similar to other properties in the street), resulting in some dust being tracked out onto the road (photograph 29).*
- *The most sensitive nearby properties are the houses north of the site in Empire Street. There is excellent landscaping between the Firth site and the houses, which helps to prevent windblown dust.*
- *There has been one complaint in the past regarding dust.*
- *To a lesser extent there are also dust emissions from activities such as the loading of aggregate and sand into the weigh hopper, unloading of aggregate trucks, cement transfer and the like.*

Vehicle entrance to the site from Dunn St.

- *Some measures in place including a dust sock on the cement silo and spray bars and wind curtains in the batching area (refer photograph 30).*
- *The Firth Environmental Standard requires at least a 12-metre length of driveway inside of access ways to be concreted or paved to minimise dust emissions and to reduce sediment loading of stormwater.*
- *A Dust Management Plan should be developed and implemented as part of an Environmental Management Plan for the site*
- *It is recommended that the following procedures be put in place -*
 - *Dust sock be checked regularly and maintenance recorded in the Site Environmental Diary (EMP, Vol IV)*
 - *Consideration be given to options to reduce dust emissions from the yard and accessways. Use of water sprinklers in high use areas during dry weather is likely to be the most practicable option.*

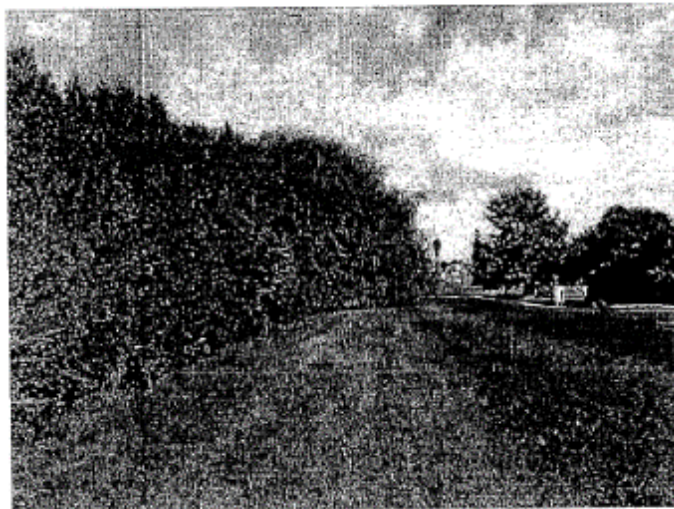
Photo 31

Landscaping along the Empire Street frontage.

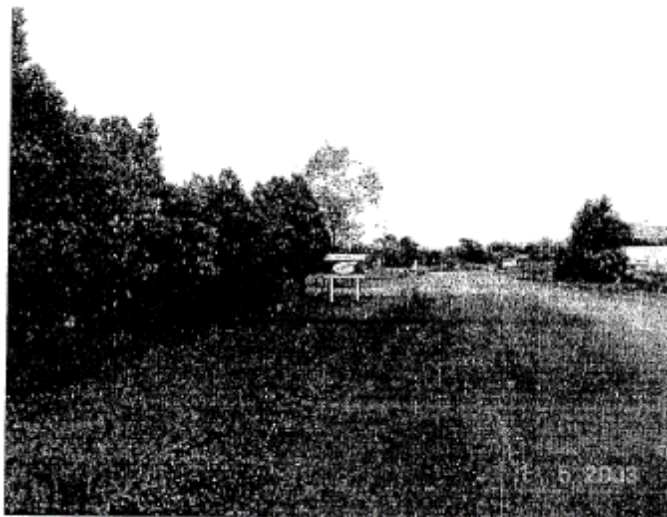
Photo 32

Landscaping along part of the Dunn Street frontage.
