9 Whangaumu Bay

Coastal Erosion Hazard Assessment

NORTHLAND REGIONAL COUNCIL
 Coastal Erosion Hazard Assessment
 Whangaumu Bay
 Site: 9

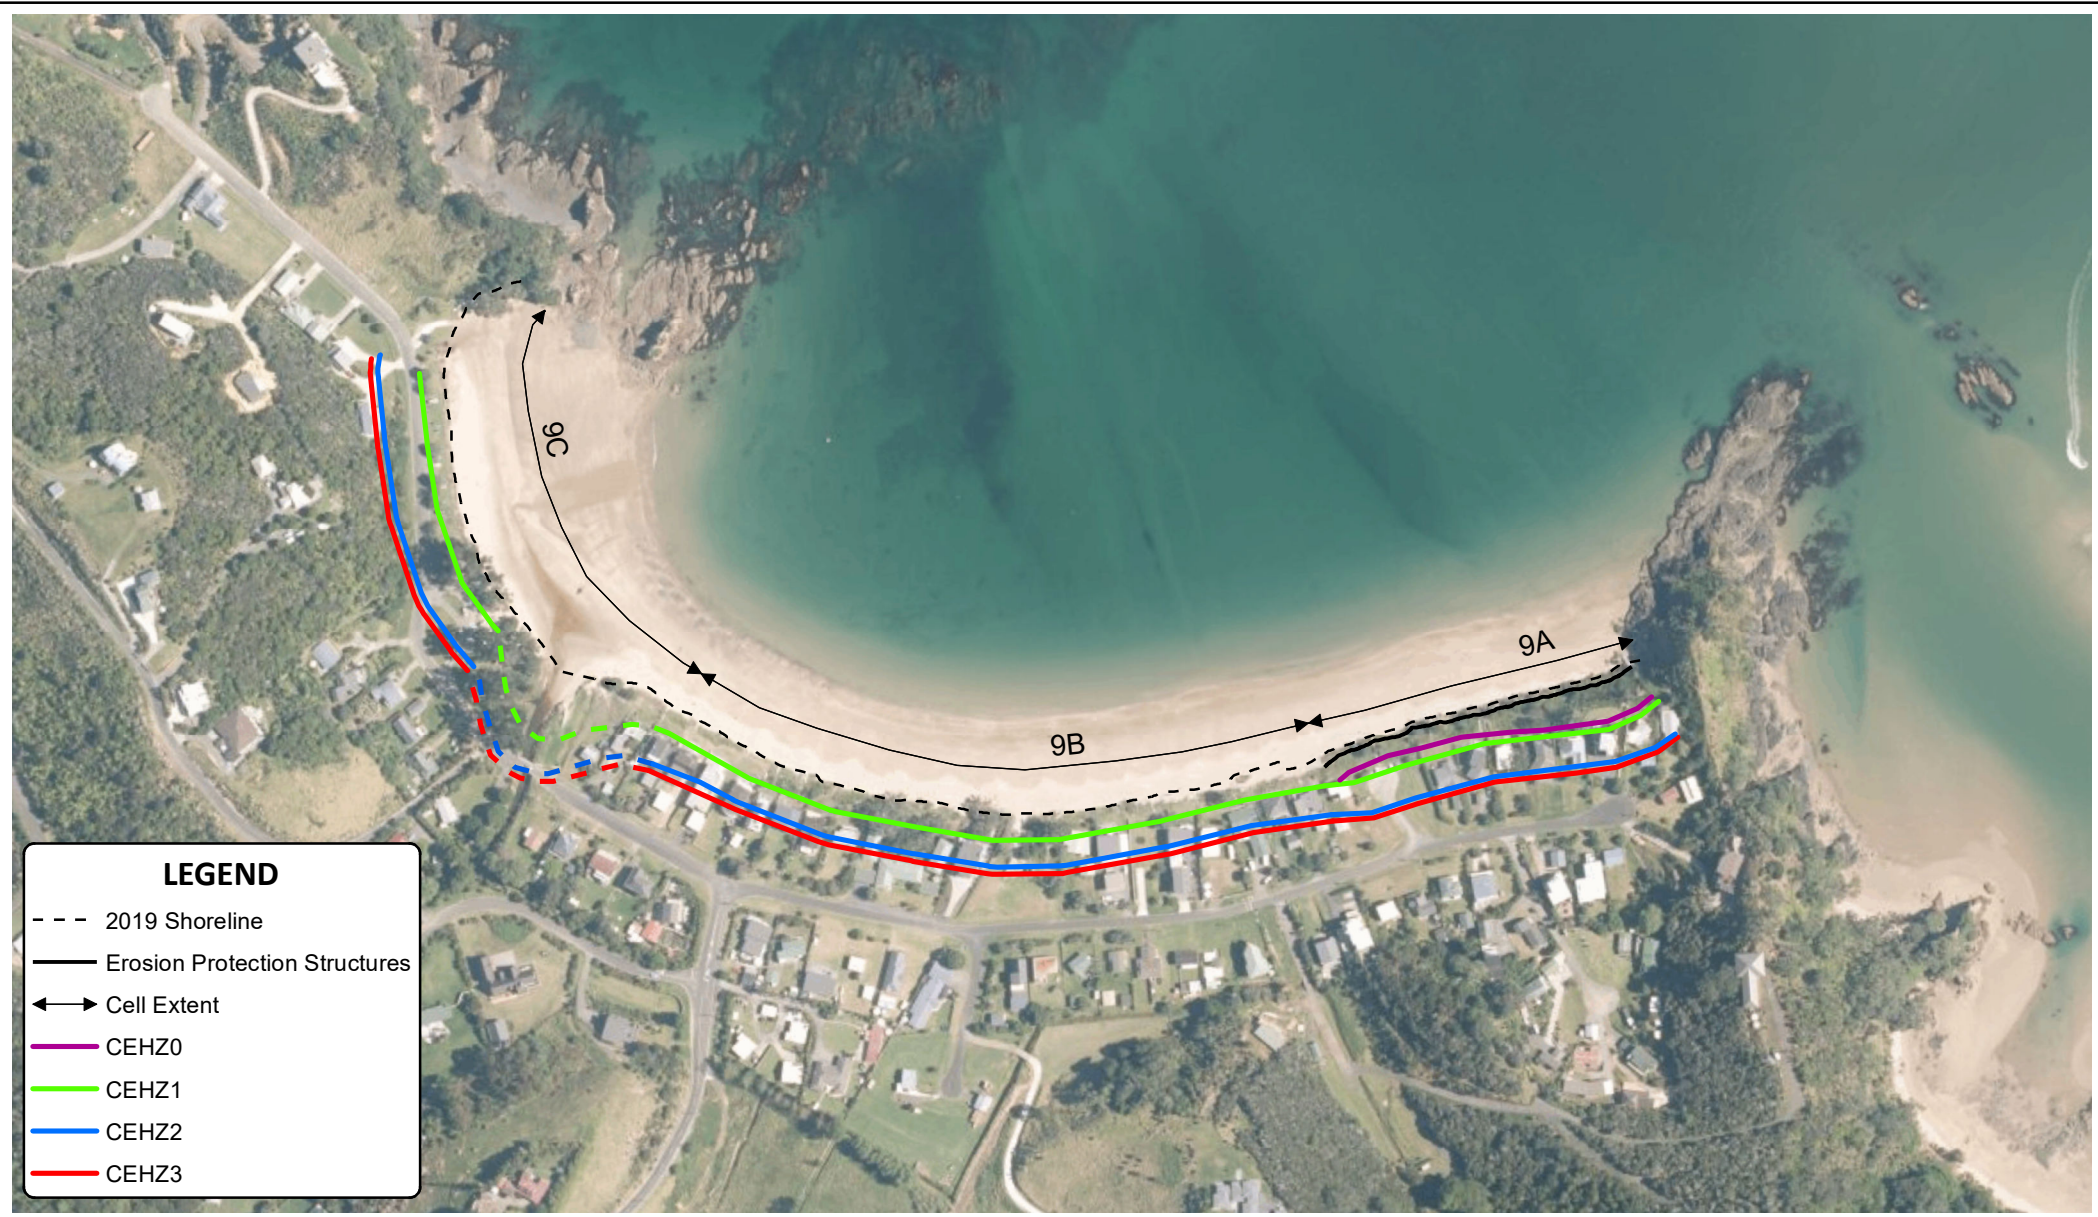
FIGURE No.	Figure 9-4	Rev.	1
------------	------------	------	---

Notes: Dashed CEHZ indicates greater uncertainty around stream mouths and backshore topography. Northland 0.4m Rural Aerial Photos (2014-2016).

The stream located near the eastern end of the site has an influence on the shoreline position. There is a greater level of uncertainty in this area because fluvial processes also effect shoreline movement. The resulting hazard zones are dashed in this area to reflect this uncertainty.

Coastal Erosion Hazard Zone widths are presented within Table 9-2 to 9-4 and Figure 9-4. CEHZ1 values have been rounded to 15 to 20 m, CEHZ2 values are rounded to 35 to 37 m and CEHZ3 values rounded to 35 and 41 m. CEHZ's have been mapped in agreement with the calculated values.

The CEHZ1-CEHZ3 for cell 9A at Whangaumu have been modified to better represent the increase in dune height at the western end of the coastal cell, with a variable dune height adopted for this cell. The dune elevation is approximately 5 m higher at the western end of cell 9A with respect to remaining shoreline of cell 9A. Table 9-2 shows the maximum measured CEHZ width from the coastal edge within cell 9A for CEHZ1-CEHZ3. These maximum values are indicative only and do not supersede the mapped CEHZ1-CEHZ3 lines.

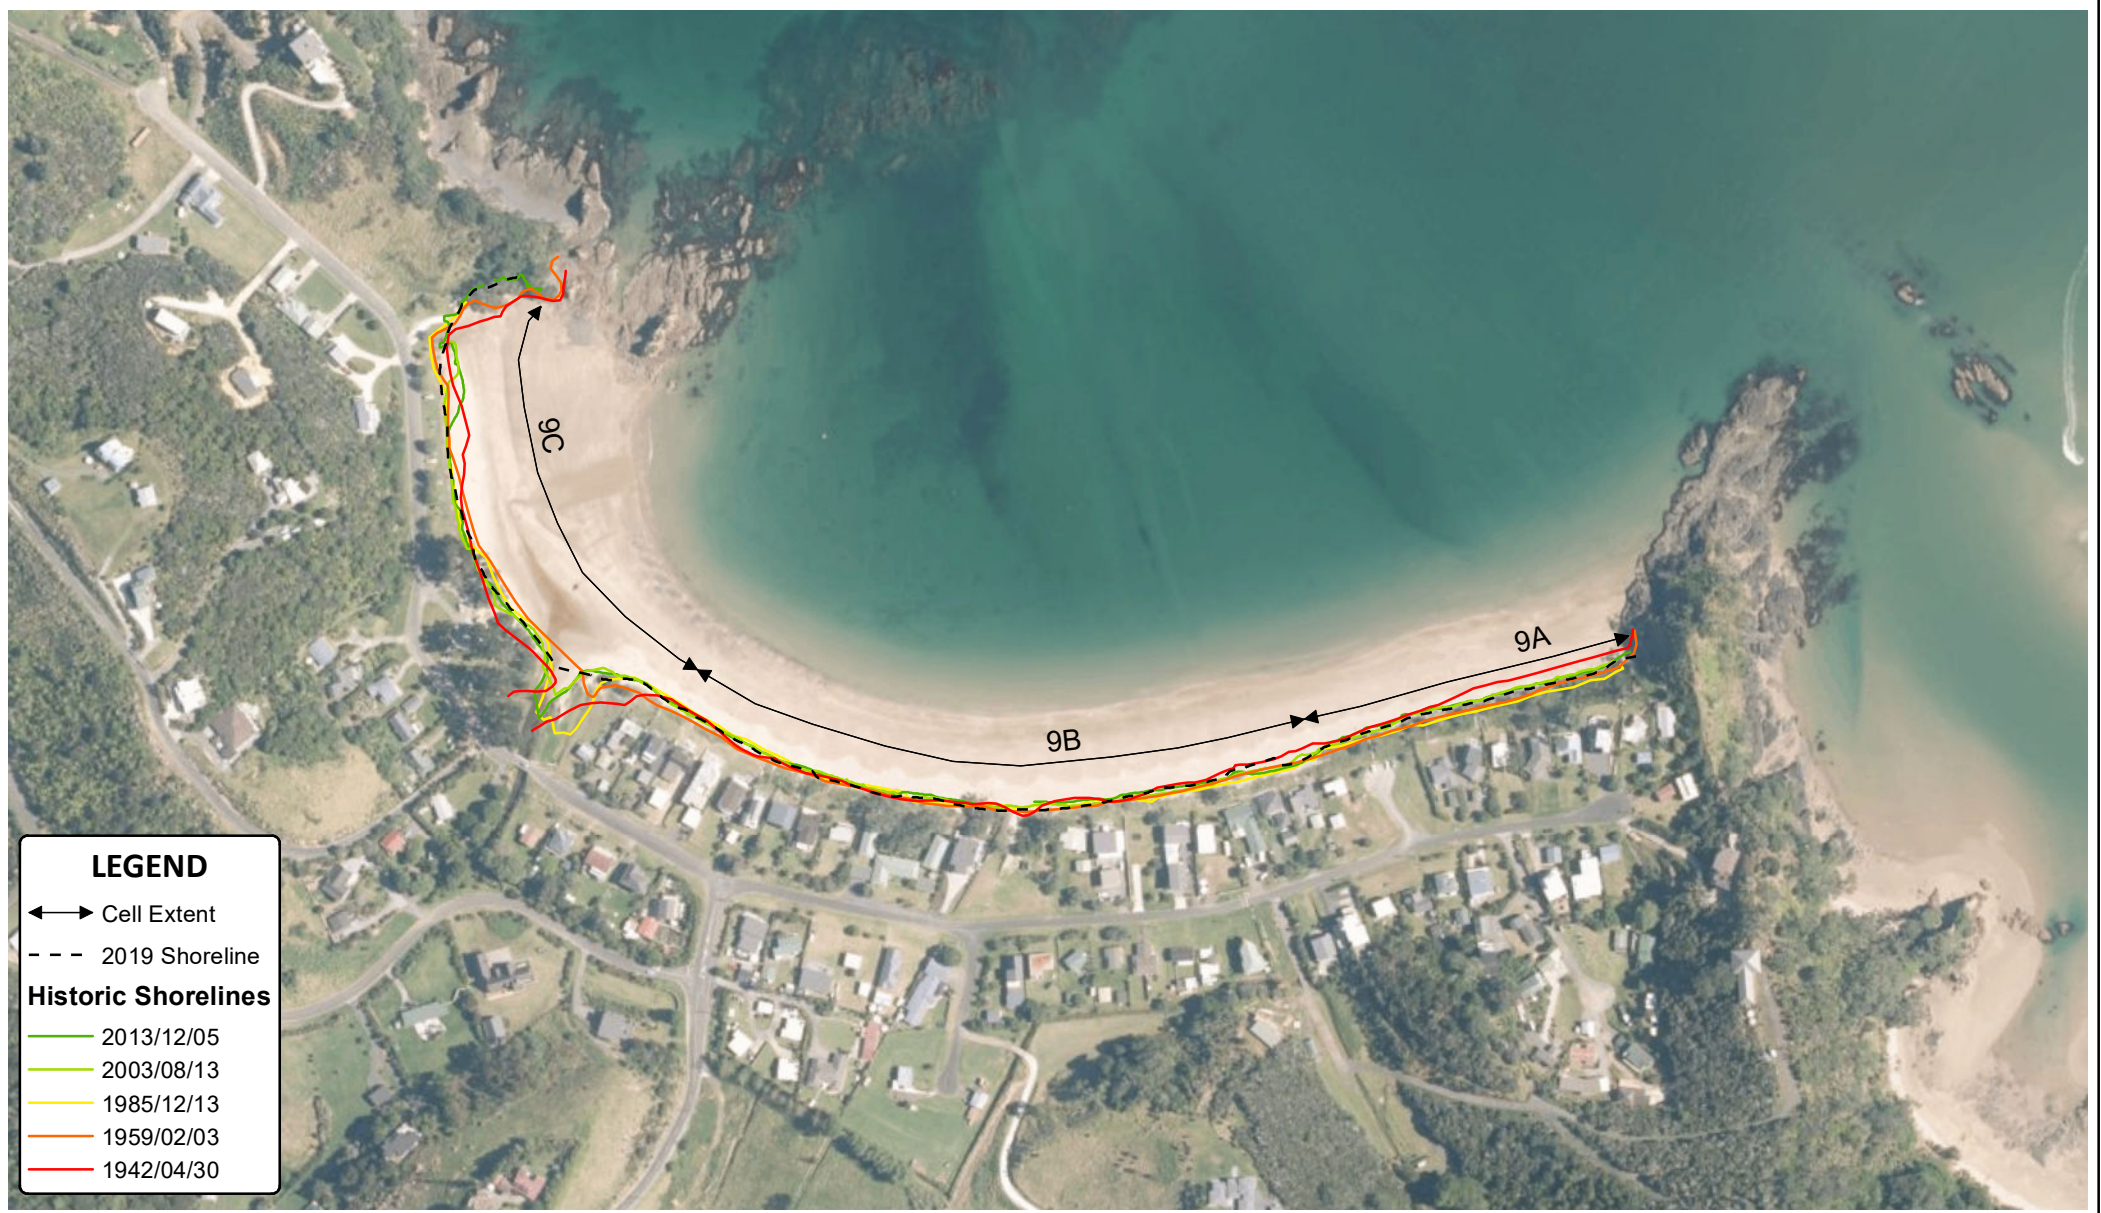
FIGURE No.	Figure 9-5	Rev.	1
------------	------------	------	---

NORTHLAND REGIONAL COUNCIL
Historic Shorelines
Whangau Bay
Site: 9

Figure 9-5 shows the available historic shorelines for Whangaumu Bay.
