## 4 Marsden Point

### Coastal Erosion Hazard Assessment

Coastal Erosion Hazard Assessment

Marsden Point

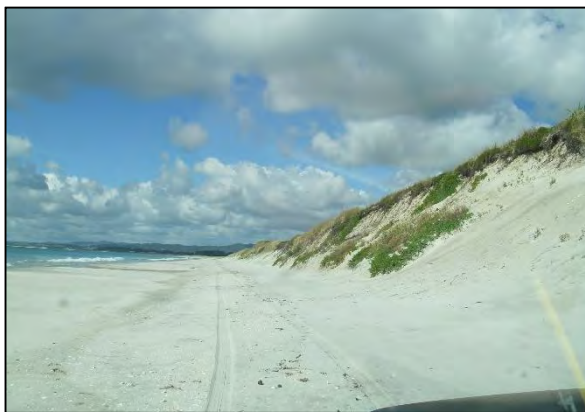
*Site Photograph A (south)*

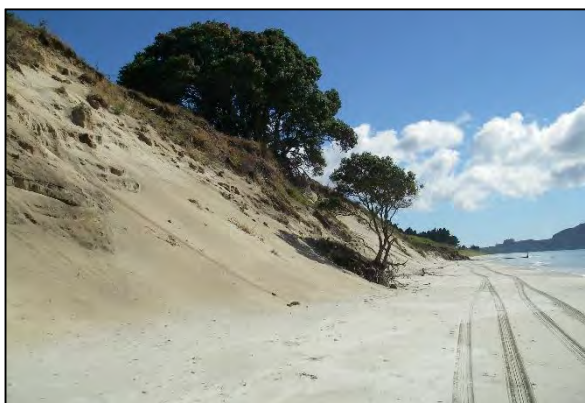
*Site Photograph C (north)*

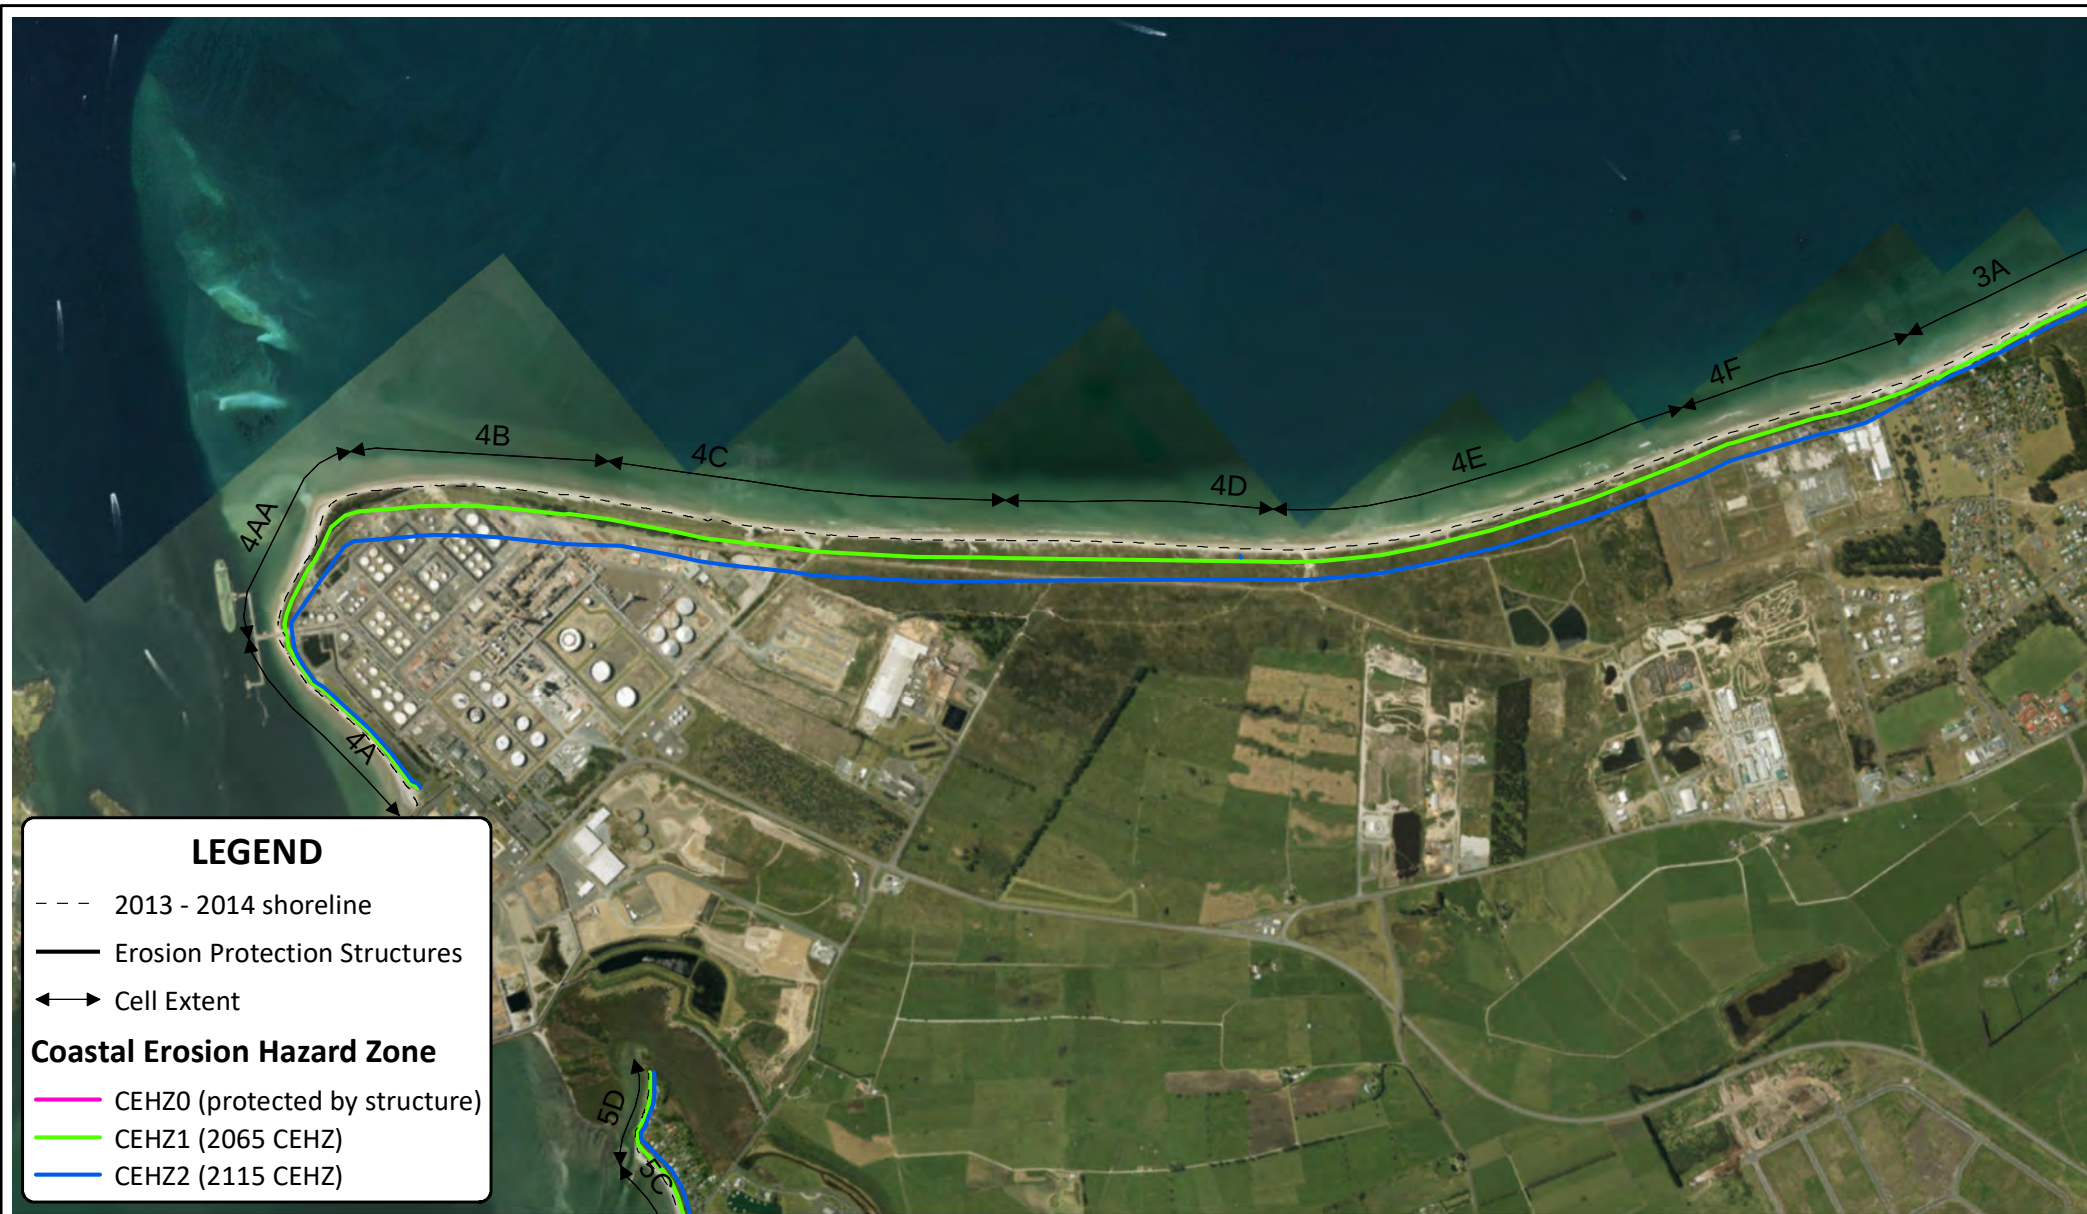
Figure 4-8

Notes: Dashed CEHZ indicates greater uncertainty around stream mouths and backshore topography.  
Northland 0.1m Rural Aerial Photos (2014-2015).

Histograms of individual components and resultant CEHZ distances using a Monte Carlo technique are shown in Figure 4-1 to Figure 4-7. Coastal Erosion Hazard Zone widths are presented within Table 4-2 and Figure 4-8.

CEHZ1 values range from 13 to 65 m with the current  $P_{66\%}$  being adopted for Cell A being larger than the 2065 value. CEHZ2 values range from 25 m within the harbour mouth to 162 m. Large open coast values are due to the long-term erosion trends at Cells B and C and also the very flat offshore profile associated with the ebb tidal delta which results in large recession distances with sea level rise. CEHZ's have been mapped in agreement with the calculated values.

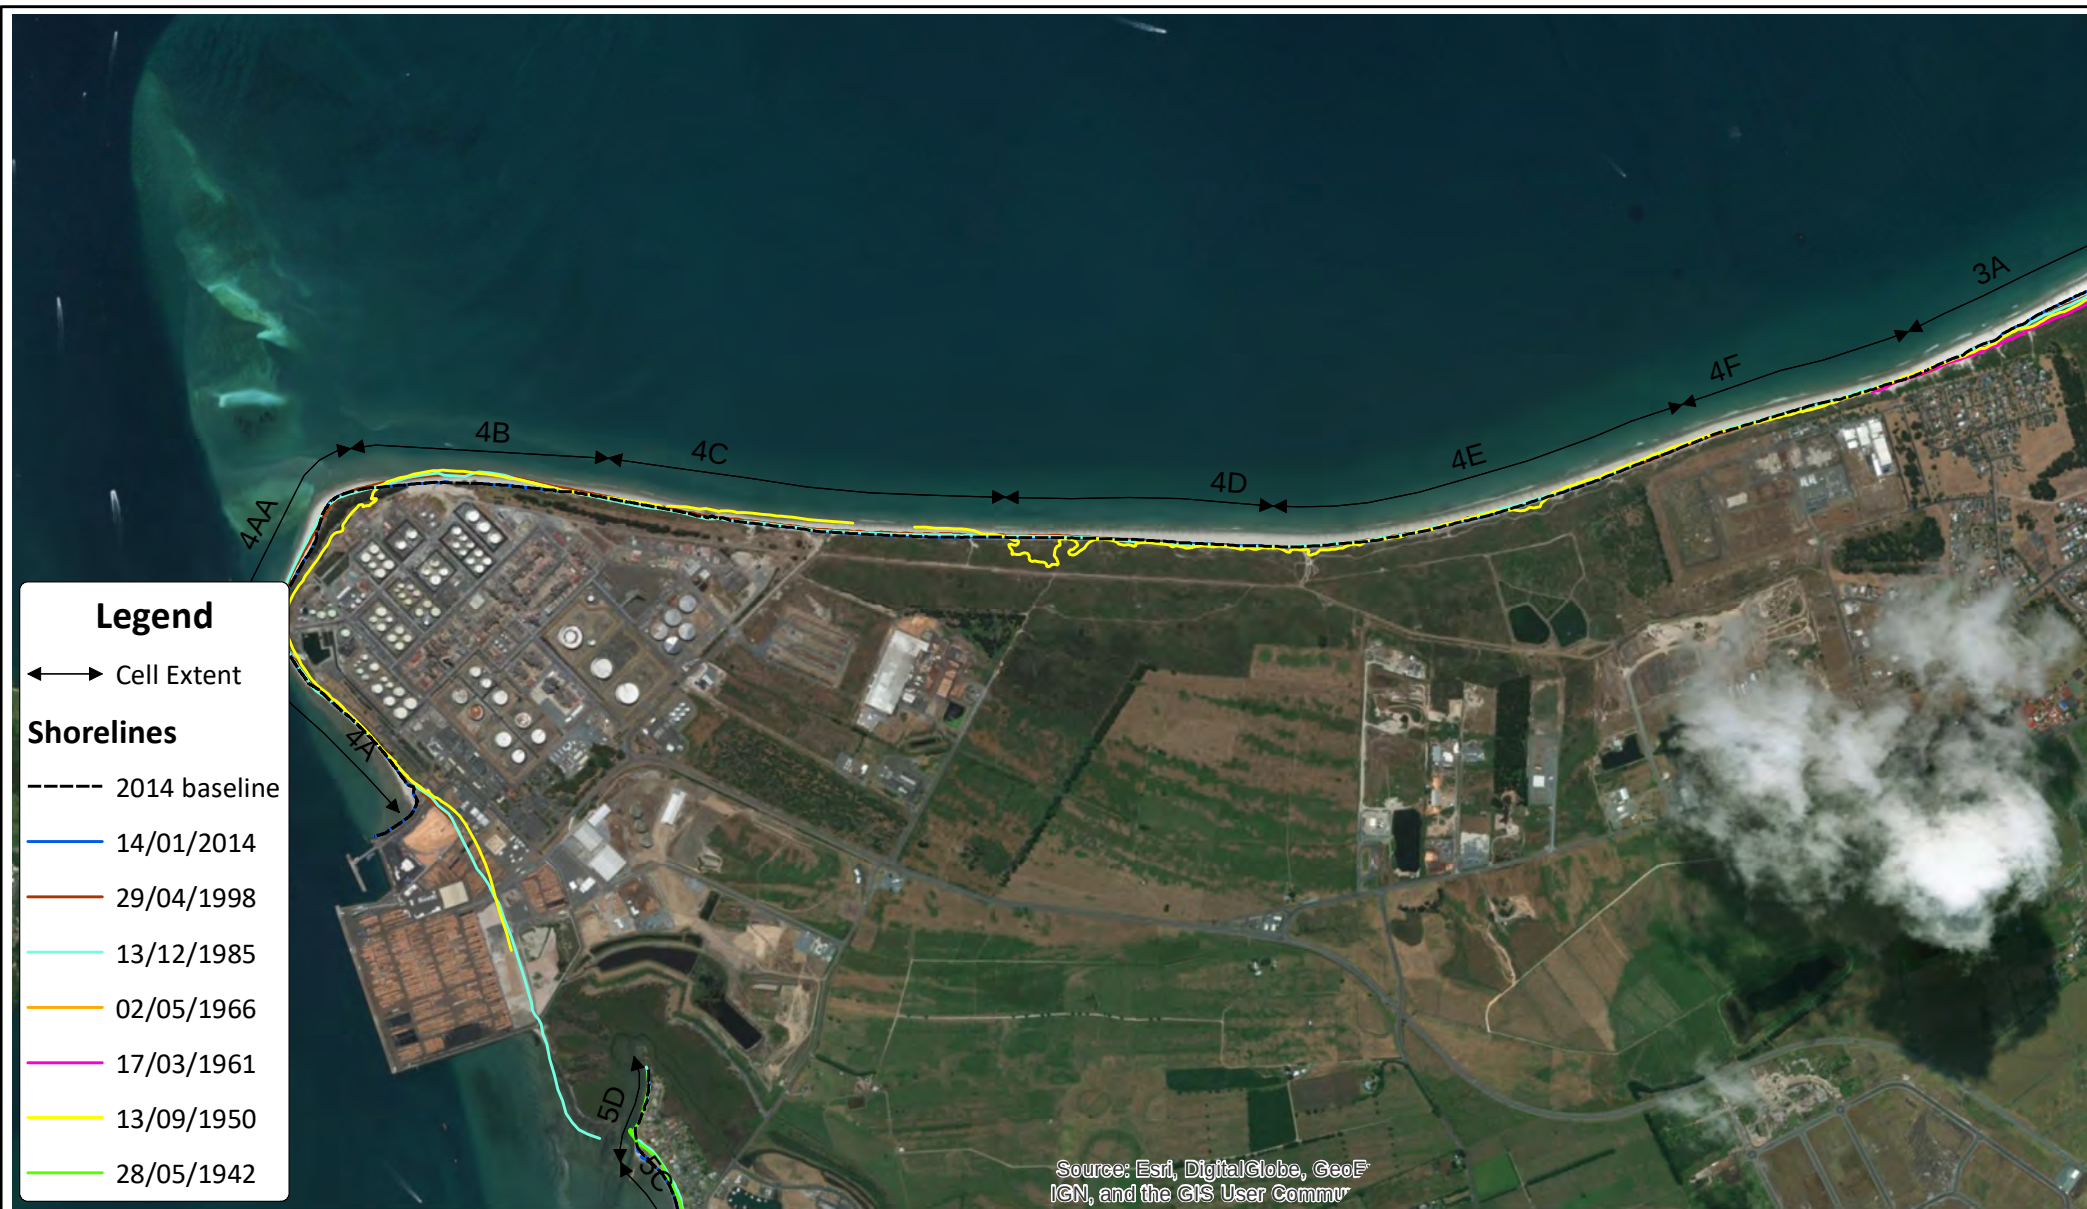
FIGURE No. Figure 4-9

Historic shorelines

Figure 4-9 shows the available historic shorelines for Marsden Point.
