PART ONE: IDENTIFICATION

<b>Place Name:</b>	Former Wharf, Seawall and Road, Stockyard Point, Paihia
<b>Image:</b>

<b>Site Type:</b>	Historic Wharf, Seawall and Road.
<b>Approx. date (or range)</b>	First structure wharf and road construction 1918, Second Structure (wharf section) and seawall 1920.
<b>NZAA Site No:</b>	None
<b>NZ Heritage List:</b>	None
<b>Regional or District Plan Schedule</b>	Regional Coastal Plan Schedule 1 – Existing Structures Permitted 91/PAI-F
<b>Recorded NZTM grid reference:</b>

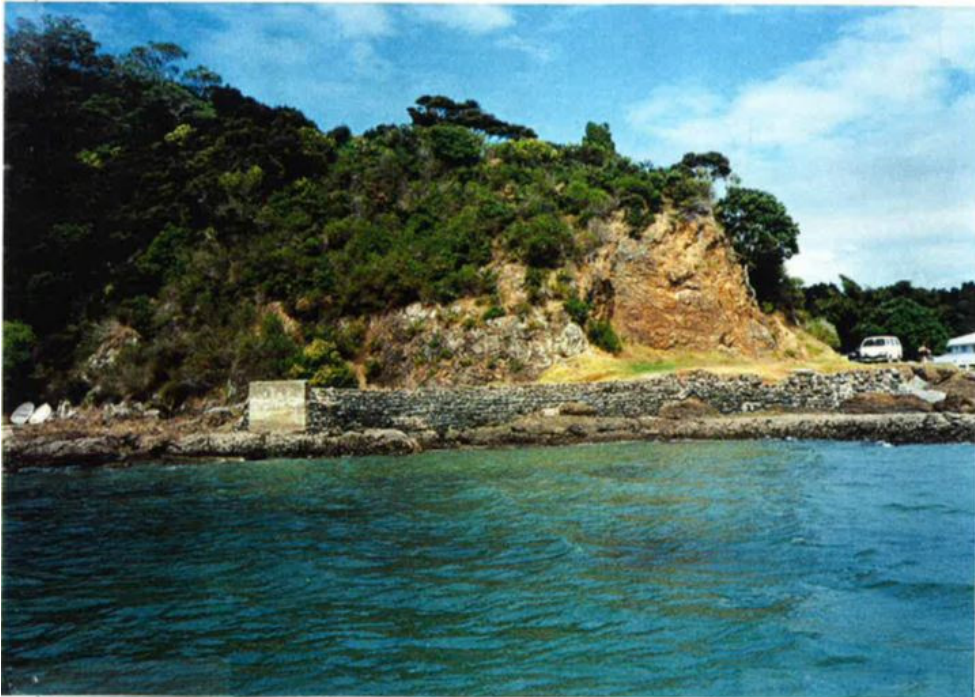
<b>Site Address:</b>	Stockyard Point, Paihia
<b>Legal Description:</b>	TBA
<b>Certificate of Title:</b>	Nil
<b>Physical Description:</b>	First constructed in 1918 possibly with all timber construction. A road formation, across natural rock shelf was also constructed to access the wharf. The first wharf structure was destroyed by a severe storm in March 1918. The wharf was reconstructed in 1920, using concrete piers and wooden pilings with timber railings and boards. The second structure was destroyed in May 1924. The remains of three concrete piers are still visible. Two are within the intertidal zone with only the bases remaining. The third is still intact and borders the former road and seawall structures on foreshore at Stockyard Point, Paihia. After the 1920 wharf had been severely damaged by a storm in 1924, a new location was chosen for a new structure built entirely of timber.

Criterion	Comments	Value*
Occupancy/ Use:	Currently forms the beginning of the Paihia to Opuia Coastal Walkway.	3
Management	Forms part of the Paihia to Opuia Coastal Walkway	3
Condition:	The original wharf structure has since been destroyed/removed however one pier remains intact as an abutment against the seawall/roadway. The seawall and roadway are still intact.	3
Fragility/ Vulnerability	The structure is situated on an exposed site. It is vulnerable to potential erosion caused by tidal action. It is also accessible to the general public and potentially exposed to vandalism	4
Threats	Erosion from tidal action. Potential damage caused by vandalism	3
Overall risk:	High	3
