## Poutō Peninsula

### Lake Tutaki (Poutō), NRC Lake No. 344

Summary	Lake Tutaki
<b>Surveyed:</b>	Recce June 2020
<b>Overall ranking:</b>	<b>Moderate:</b> A small lake highly degraded by a 95% submerged cover of the invasive plant pest hornwort ( <i>Ceratophyllum demersum</i> ) forming surface-reaching beds over an estimated 20% of the lake. A second highly invasive oxygen weed egeria ( <i>Egeria densa</i> ) is present in low amounts. A small pond approximately 80 m to the north is also infested with hornwort.
<b>Threats:</b>	Public access to this lake represents a risk to other lakes in the area through spread of fragments of weed on clothing and gear. This lake is adjacent to a cleared area which is used for camping. There is also a small jetty. Thick covers of hornwort are currently supporting good water clarity. The hornwort is almost growing to the surface and is covering most of the lake floor. A collapse of submerged vegetation and switch to a turbid planktonic algal dominated state is possible.

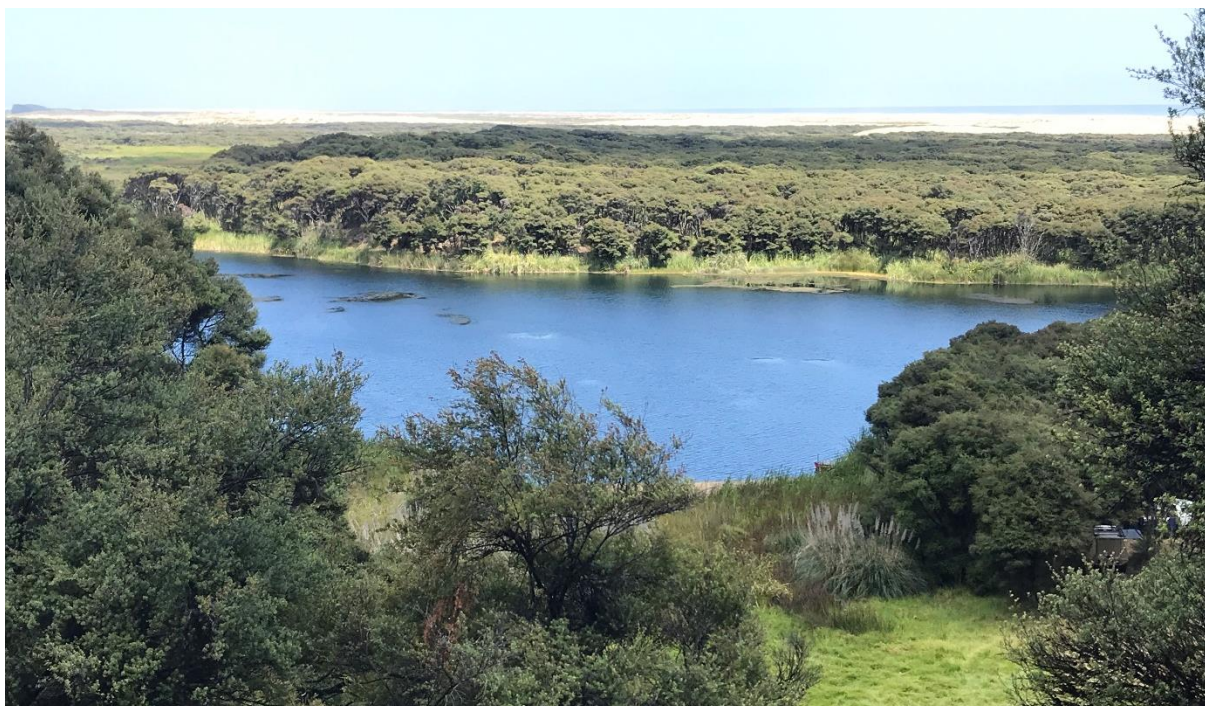
**Figure: Lake Tutaki.** Photo taken from the eastern side of the lake showing surface-reaching hornwort beds. (Photo: Lisa Forester NRC, March 2020).

Submerged vegetation in Lake Tutaki is dominated by an approximately 95% cover of the invasive plant pest *Ceratophyllum demersum* (hornwort) growing to the surface over an estimated 20% of the lake. Very little of the pest oxygen weed egeria was observed from the lake, with several floating fragments near the jetty but less than 10 plants were observed in the lake vegetation. No hornwort or egeria were seen in the inlet stream.

Eradication of hornwort and egeria in this lake is recommended to protect other water bodies from incursion of this species. It is also recommended that lake users are identified and informed of the risks associated with the dispersal of these highly invasive weeds. If possible, the jetty should be removed to discourage lake use. See Elcock et al. (2020) for detail of recommended actions<sup>1</sup>.

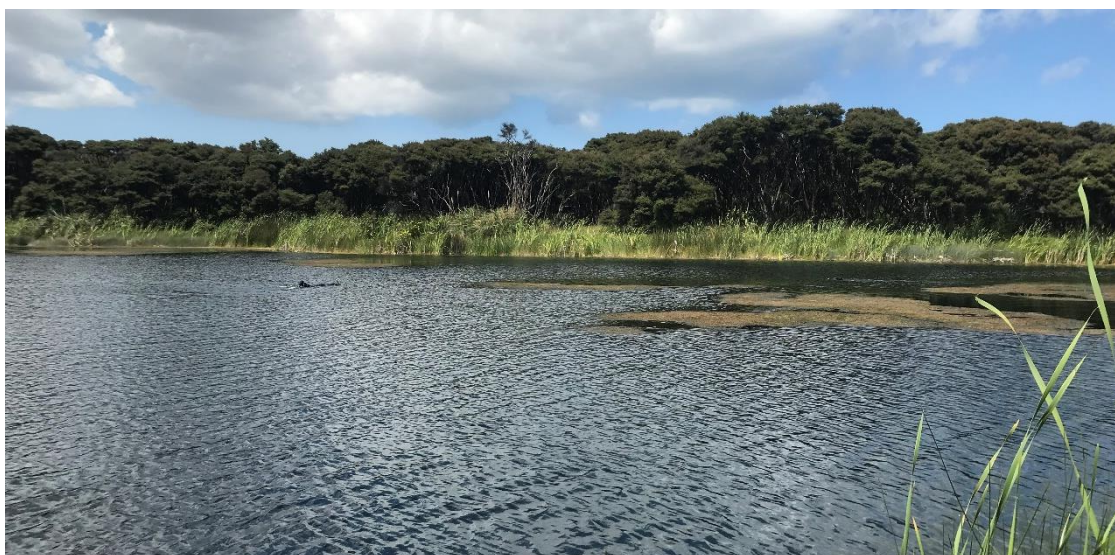
The lake is choked with the serious weed hornwort with minor amounts of the pest oxygen weed, egeria. A collapse of submerged vegetation and switch to a turbid planktonic algal dominated state is possible. Hornwort was also present in a small pond of around 50 m<sup>2</sup> approximately 80 m to the north of the main lake. A low altitude aerial inspection was undertaken in June 2020 with no evidence of hornwort or other weeds being seen in the adjacent wetland pond or other nearby waterbodies, though a small farm lake (Northland Lake#335A) with hornwort was found 11 km to the southeast.

**Dense surface reaching beds of the pest plant, hornwort in Lake Tutaki.** (Photo: NIWA March 2020)
