3.20 Lake Rotokawau (Aupouri), NRC Lake No. 116; surveyed in 2005 and 2009

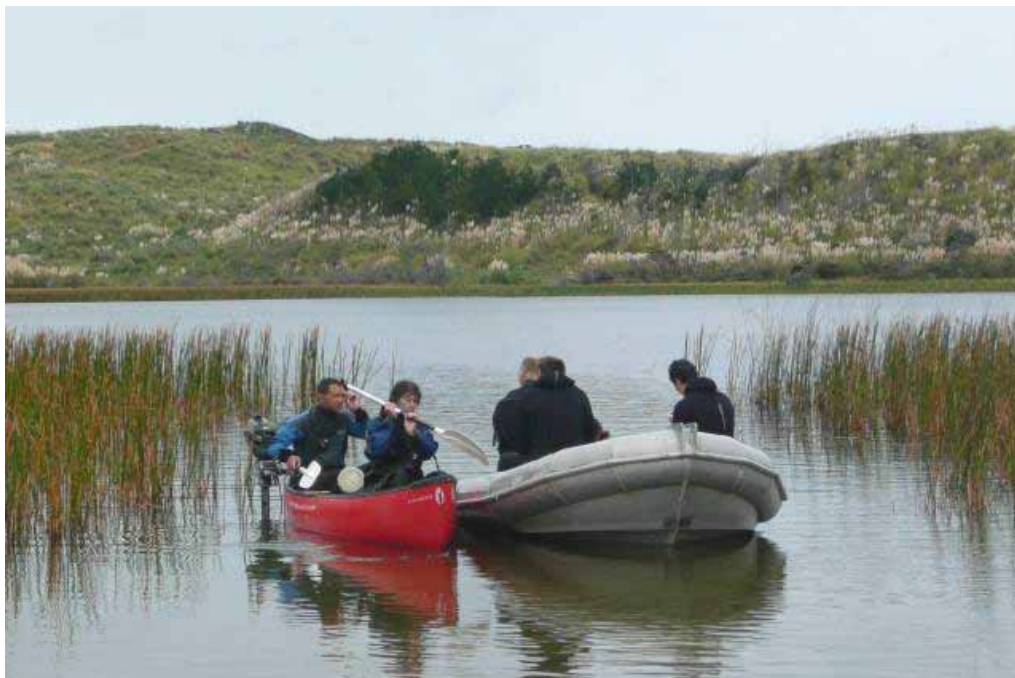
**Plate:** Lake Rotokawau from access point.

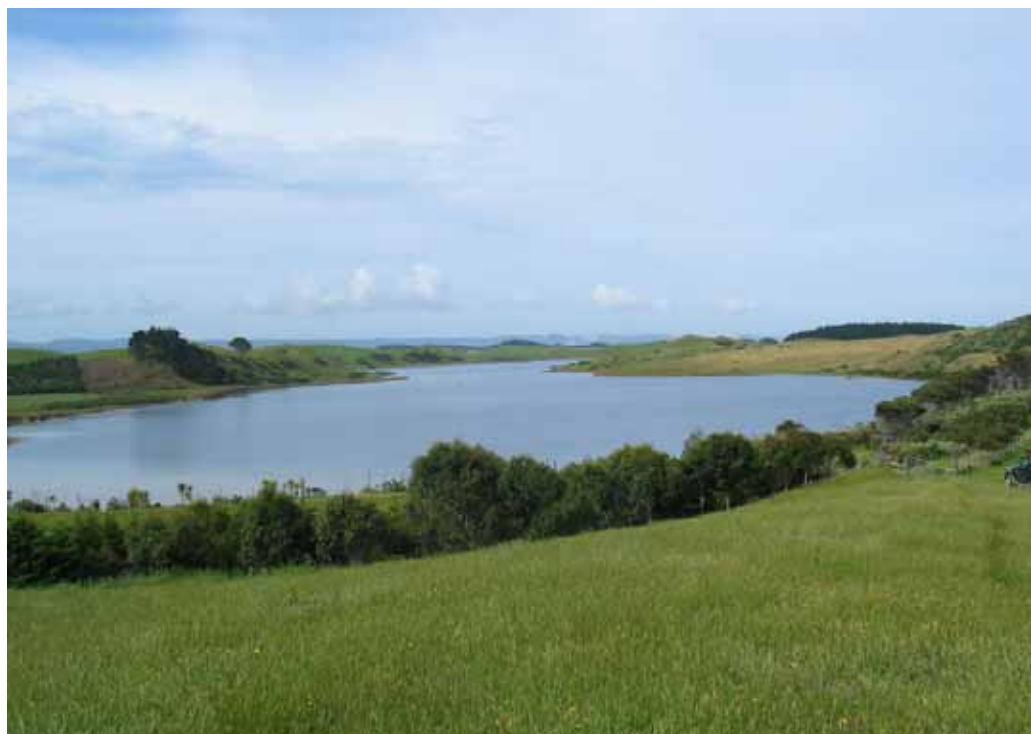
**Plate:** Lake Rotoroa, approaching from the north-east and showing the predominantly pastoral catchment and much of the lake edge fenced with riparian plantings.

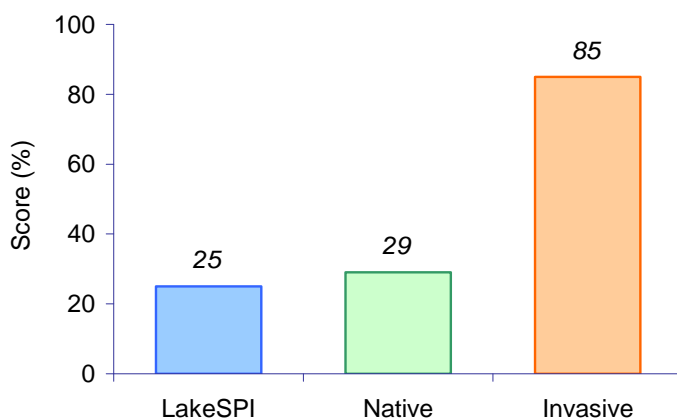
**Figure:** LakeSPI Index as % of potential score, Native Condition Index, and Invasive Impact Index (from left to right).

The low LakeSPI score of 25% reflects the pervasive nature of invasion by *E. densa* and reduced extent of native plant communities.

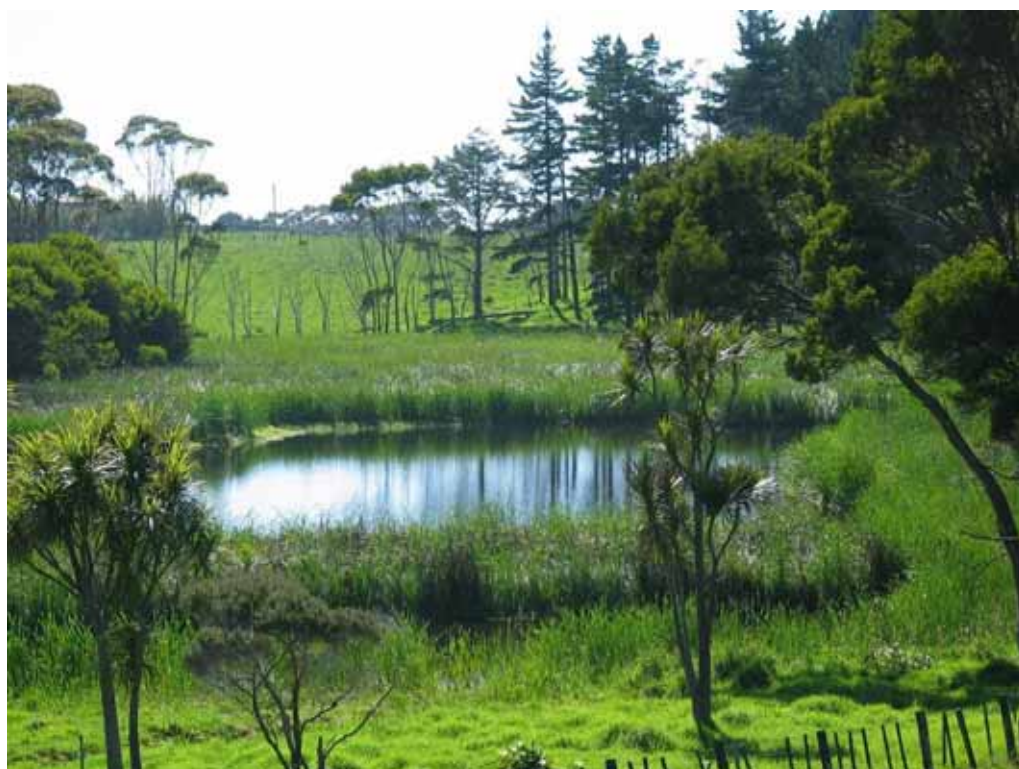
**Plate:** Salt Lake showing the large beds of emergent raupo (*Typha orientalis*) surrounding open water.

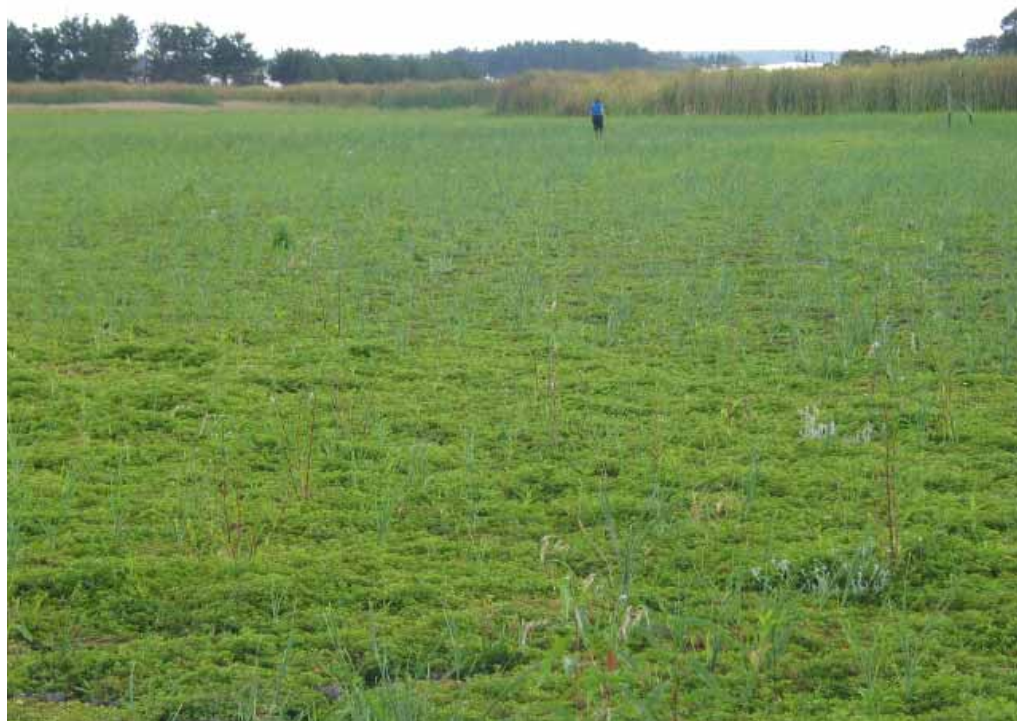
**Plate:** Lake Taeore with no water in April 2010.

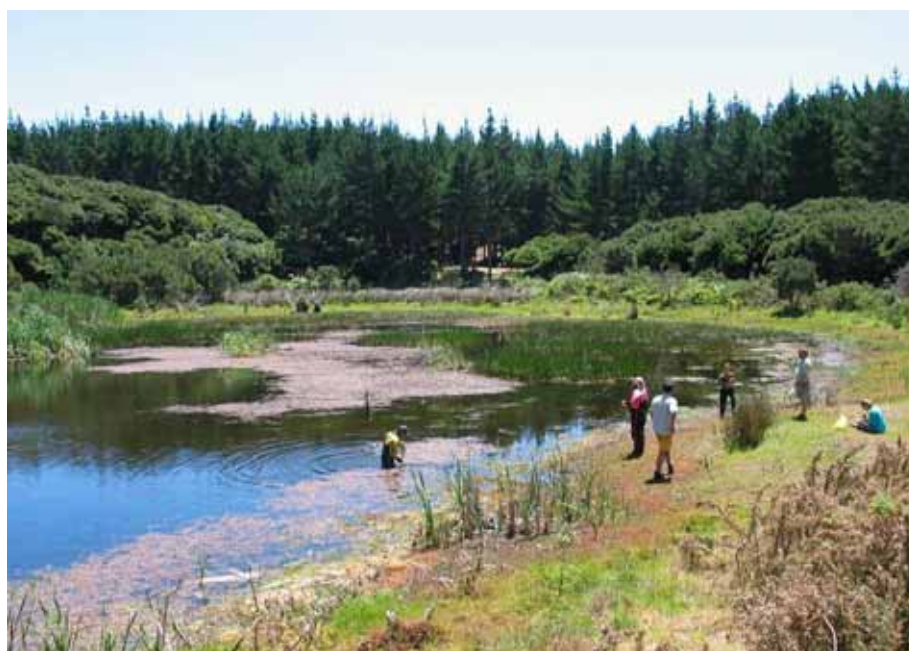
**Plate:** Te Arai Pond with grazed margins and sparse emergent vegetation, note the exotic floating fern (red) *Azolla pinnata*.

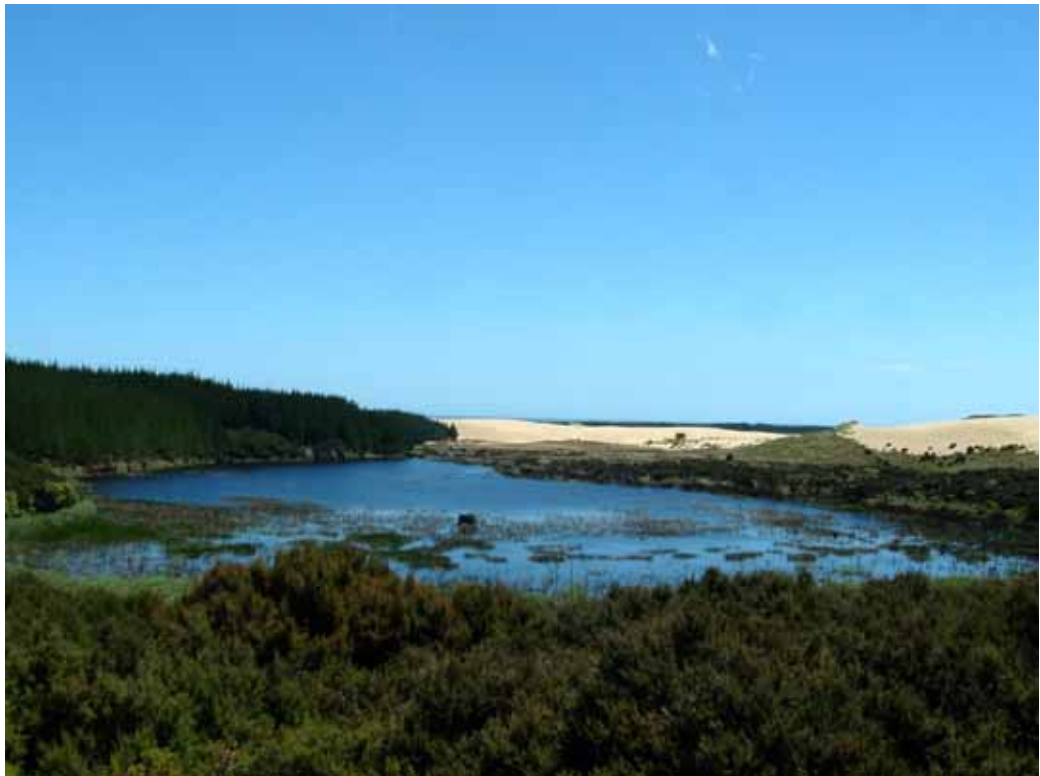
**Plate A:** Te Arai Lake with scrub and forestry margins and mobile sand dunes to the north west.

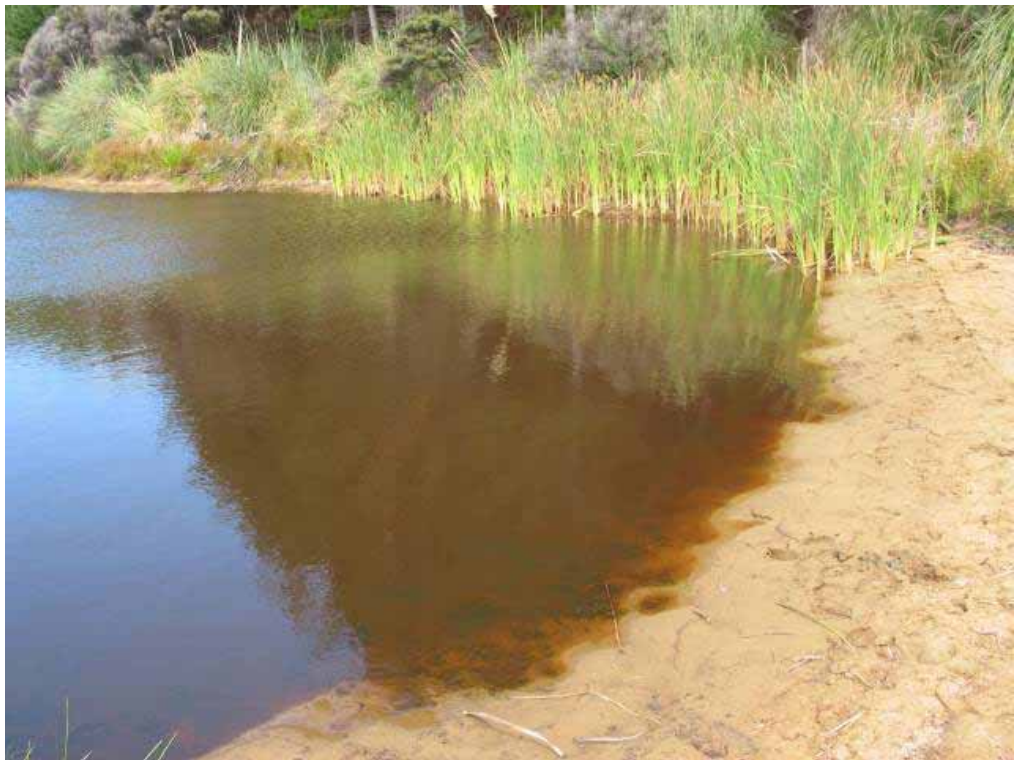
**Plate B:** Lake Te Arai west end 2006, showing highly stained water not suitable for submerged vegetation.

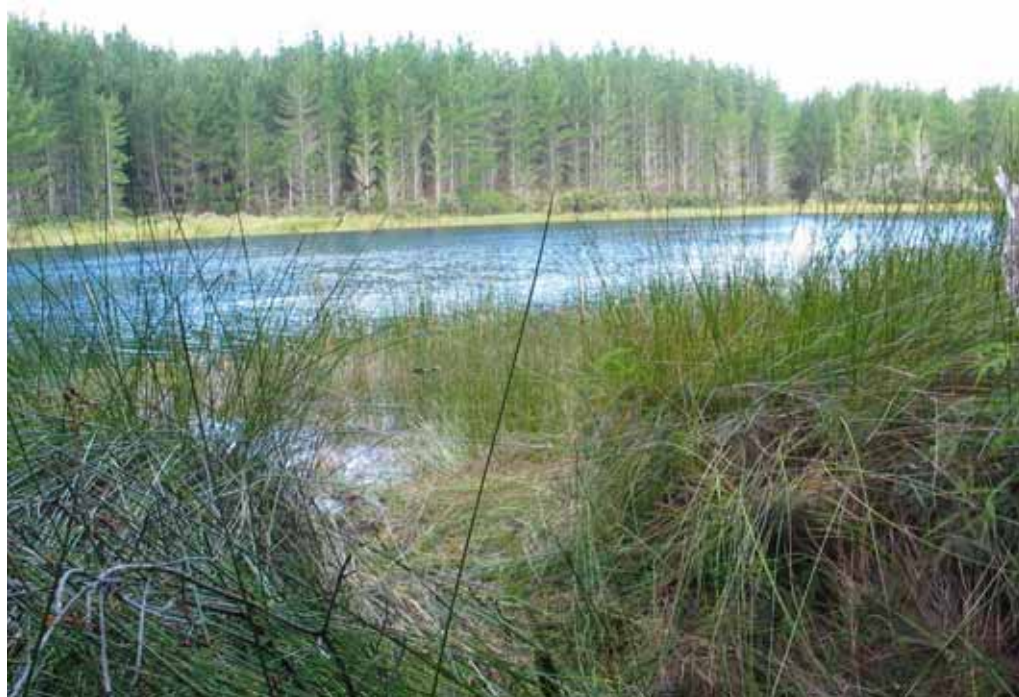
**Plate A:** Lake Te Kahika showing marginal emergent vegetation and scrub/pine catchment.

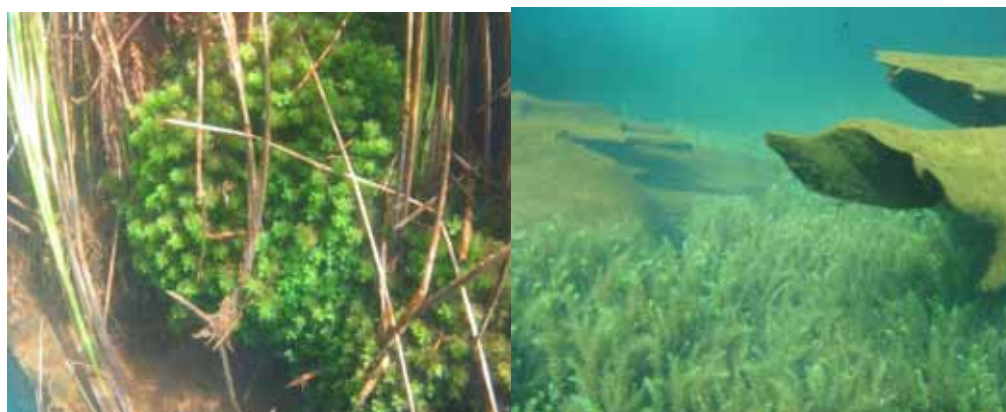
**Plate B:** Lake Te Kahika showing *Sphagnum* (LEFT) at 1.0 m in marginal emergent vegetation and a rare sight, *Utricularia australis* (RIGHT) abundant in an inflow stream, >3 m deep.

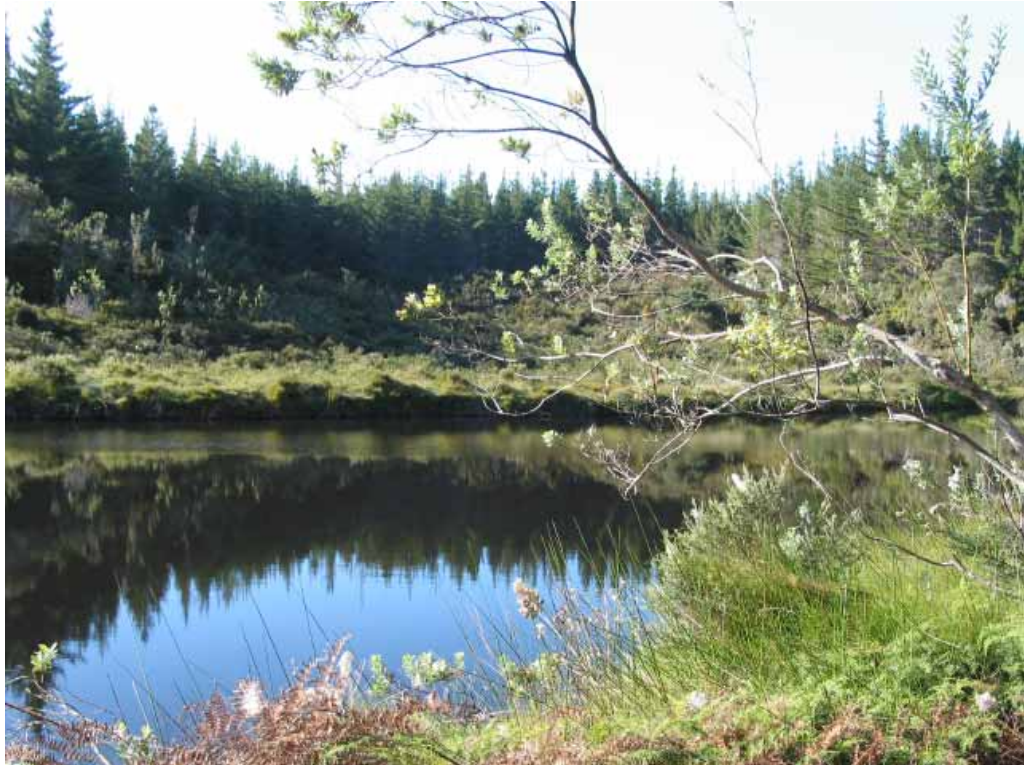
**Plate:** Te Kahika South, a coastal dune lake surrounded by a narrow wetland \ scrub margin within pine plantation forestry.

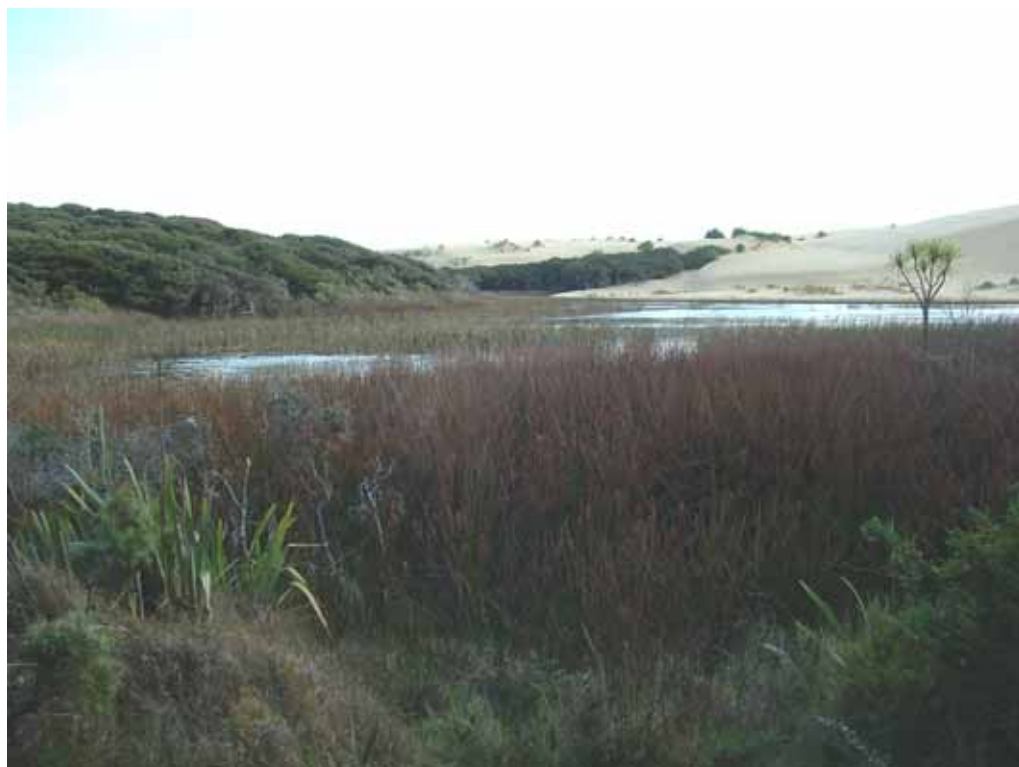
**Plate 1:** Te Paki Dune Lake with emergent *Baumea articulata* (foreground) and *Eleocharis sphacelata* (centre left) and showing the manuka and sand dune catchment.

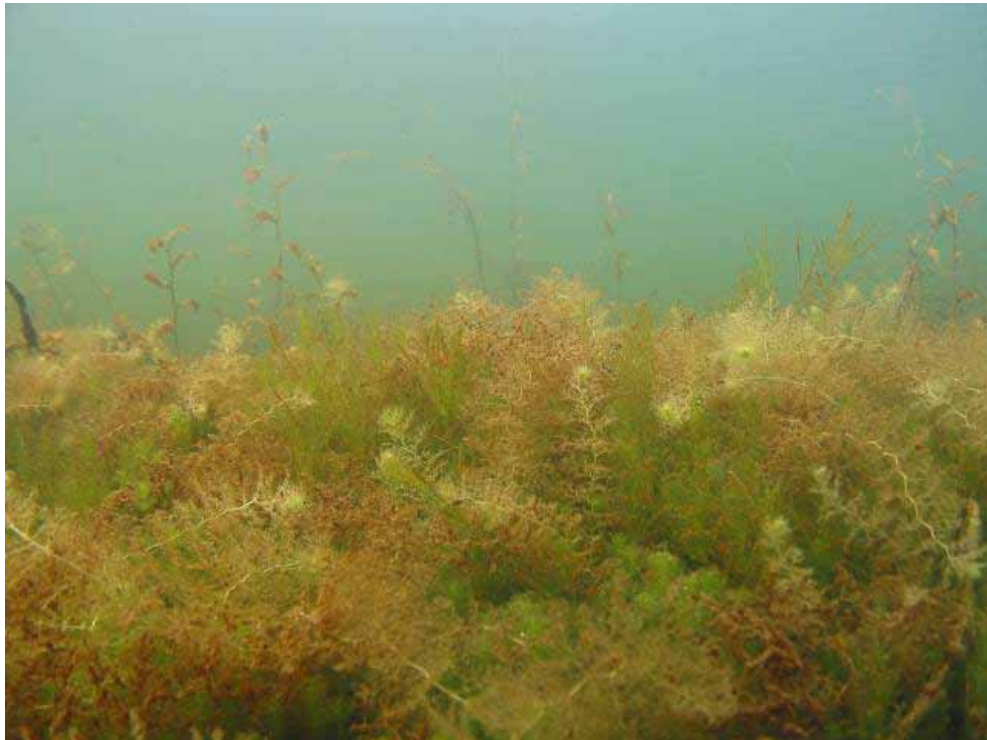
Charophyte meadows of *Chara fibrosa* (Plate 2) or *C. australis* (~ 0.5 m tall) and *Nitella* aff. *cristata* were present in open areas of water and amongst emergents with some areas of tall *Potamogeton cheesemanii* (2.5 m tall) and *Myriophyllum propinquum* (2 m tall), (Plate 3). The nationally endangered *Utricularia australis* was abundant (about 50% cover) throughout the lake (Plate 2). A small infestation of the invasive exotic *Utricularia gibba* was also found. Some turf species *Callitriche petriei*, *Myriophyllum votschii*, *Limosella lineata* and *Lilaeopsis novae-zelandiae* were located on the dune face at the western edge of the lake. *Ottelia ovalifolia* was also found for the first time.

**Plate 2:** Te Pahi Dune Lake with 'nationally endangered' *Utricularia australis* abundant on top of *Chara fibrosa* with tall-growing *Potamogeton cheeseemanii* in the background. This assemblage of native species is very rare.

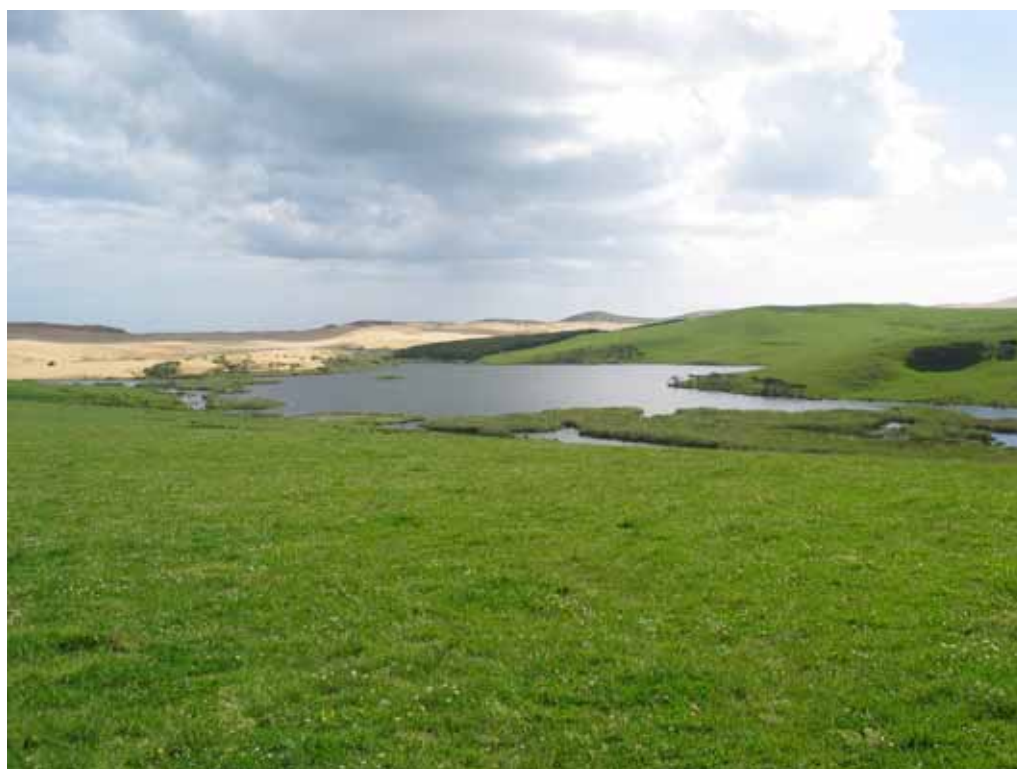
**Plate:** Te Werahi Lagoon showing the pasture and mobile sand dune catchment and low (possibly grazed) beds of raupo (*Typha orientalis*).

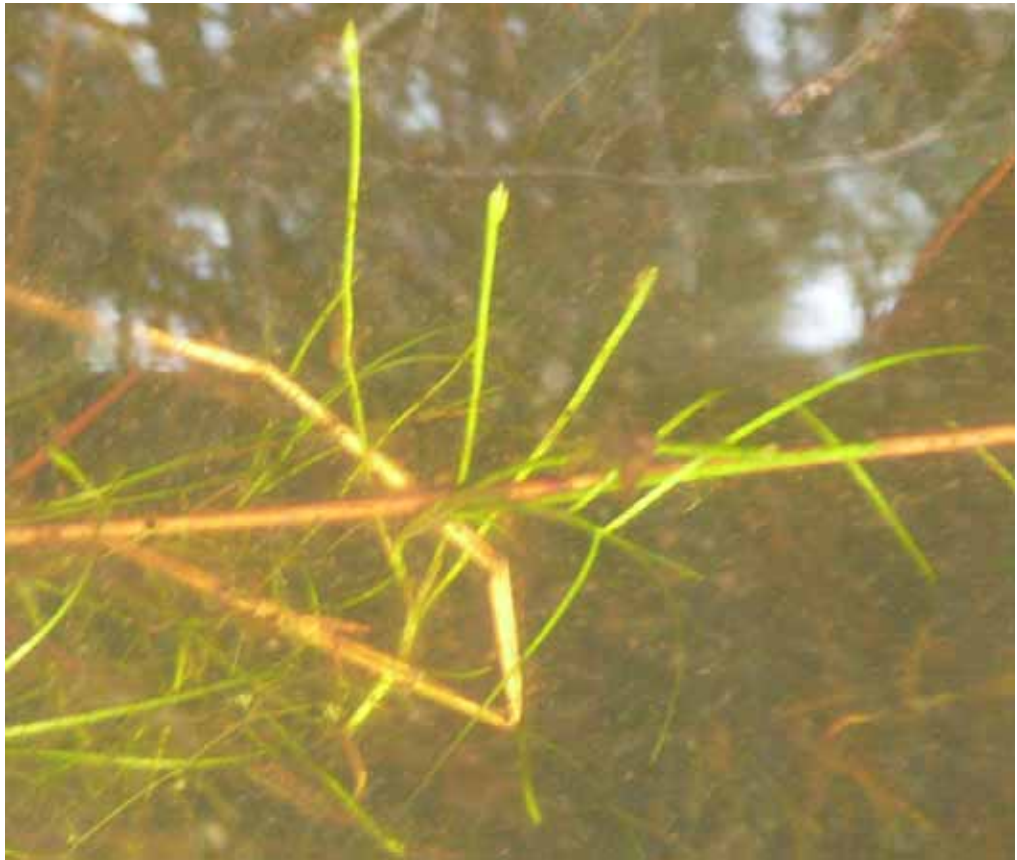
**Plate:** *Isolepis fluitans*

Turf communities were sparse due to extensive and dense emergent beds. The nationally threatened species *Utricularia australis* was relocated at one site and *Isolepis fluitans* (Plate below) was found in three locations. This included two profiles, amongst *E. sphacelata* beds and also amongst *Apodasmia similis* at the south eastern bay. Charophytes (mostly *Chara fibrosa*, *C. australis*, and *Nitella* aff. *crustata*) were found from the edge of emergent communities to a maximum depth of ~3 m in 3 profiles. Below this, the pondweed, *Potamogeton ochreatus* formed scattered low density growths (~ 0.5 m tall) to 5.7 m. *Utricularia gibba* had recently spread to this lake (since 2004). It was restricted to the emergent vegetation zone to a maximum depth of 1.5 m, occasionally with high covers of 50-75%.

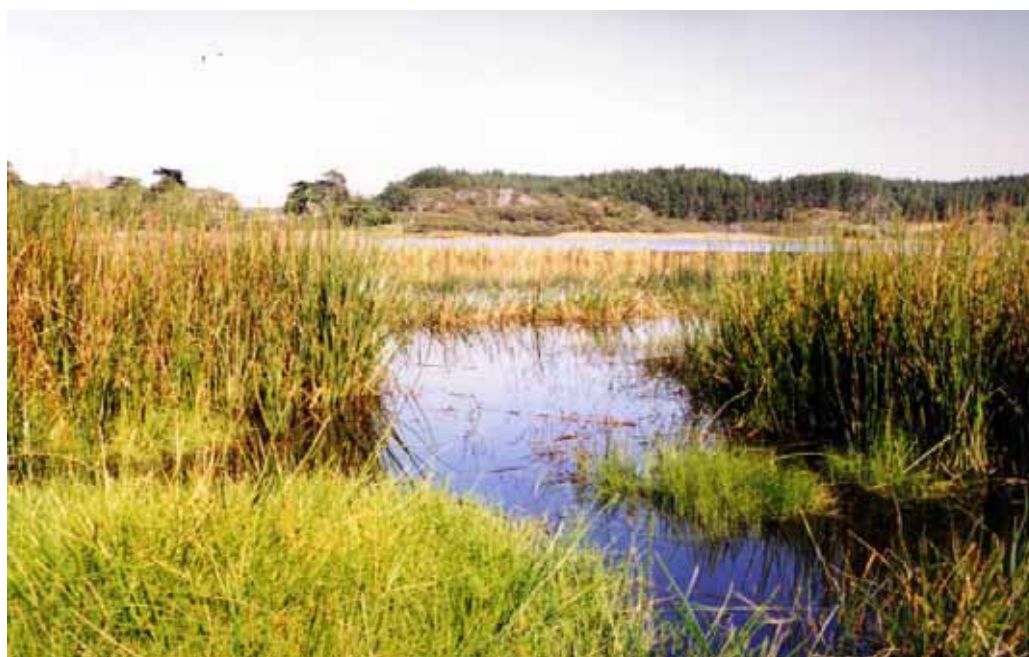
**Plate:** Lake Waihopo from the boat access point, note the extensive emergent vegetation.

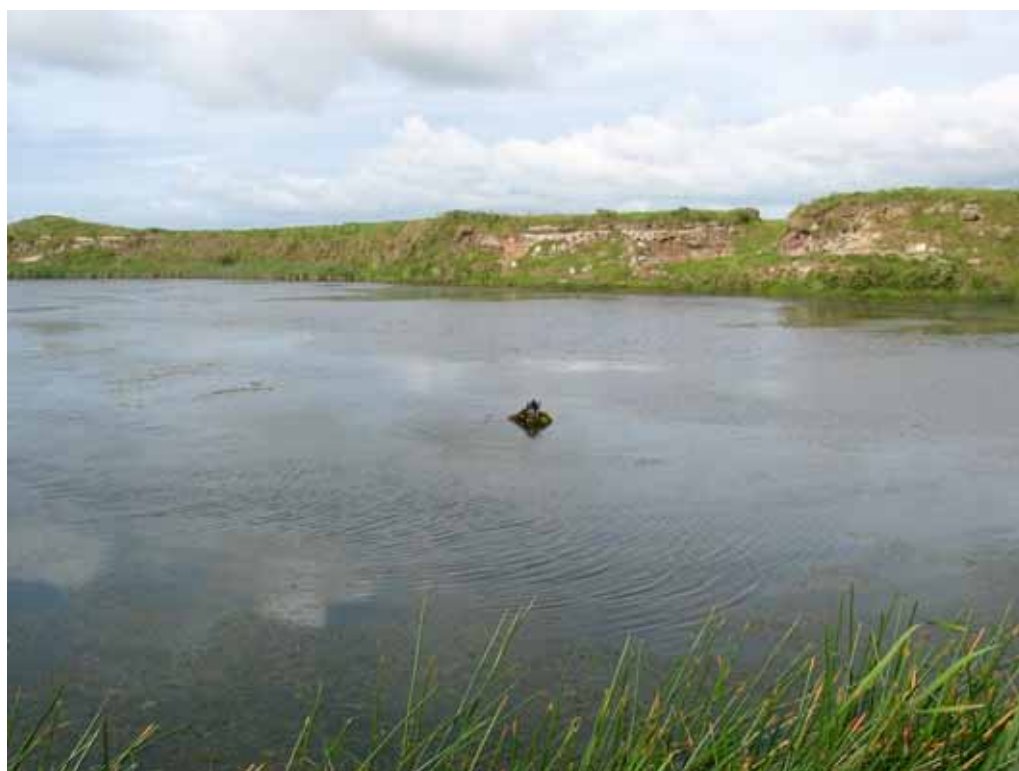
**Plate:** Lake Waimimiha North showing surface-reaching beds of *Ceratophyllum demersum* (bottom left) on the margin of emergent vegetation.

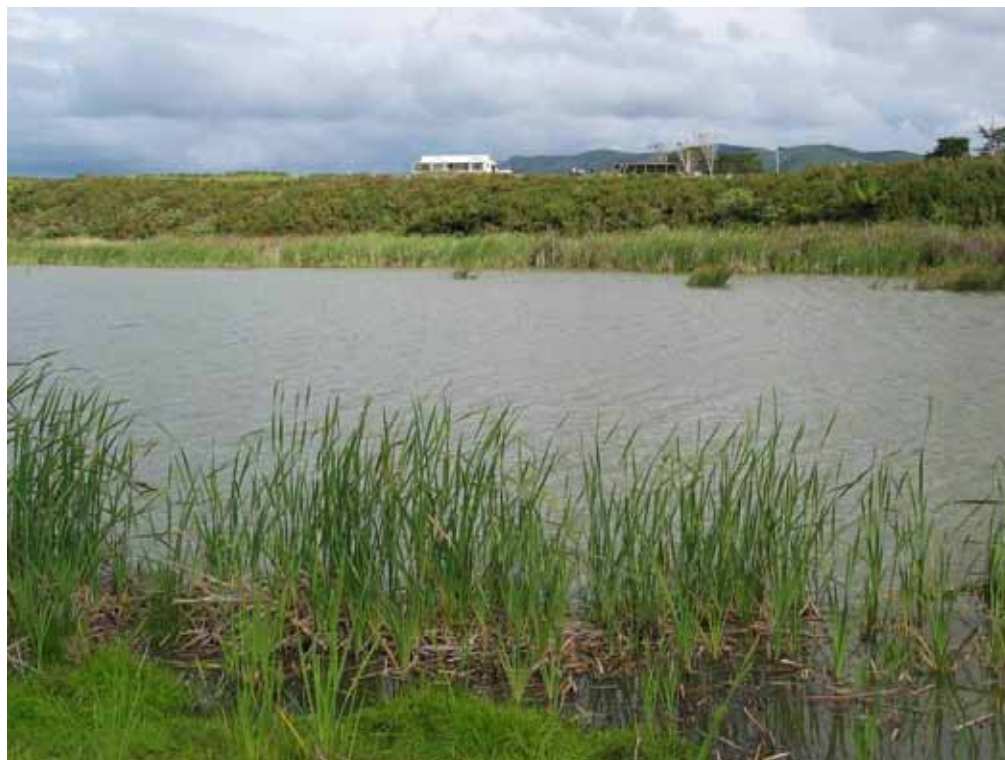
**Plate:** Lake Waimimiha South showing margin of emergent vegetation. Note the green tinge to the water indicating an algal bloom.

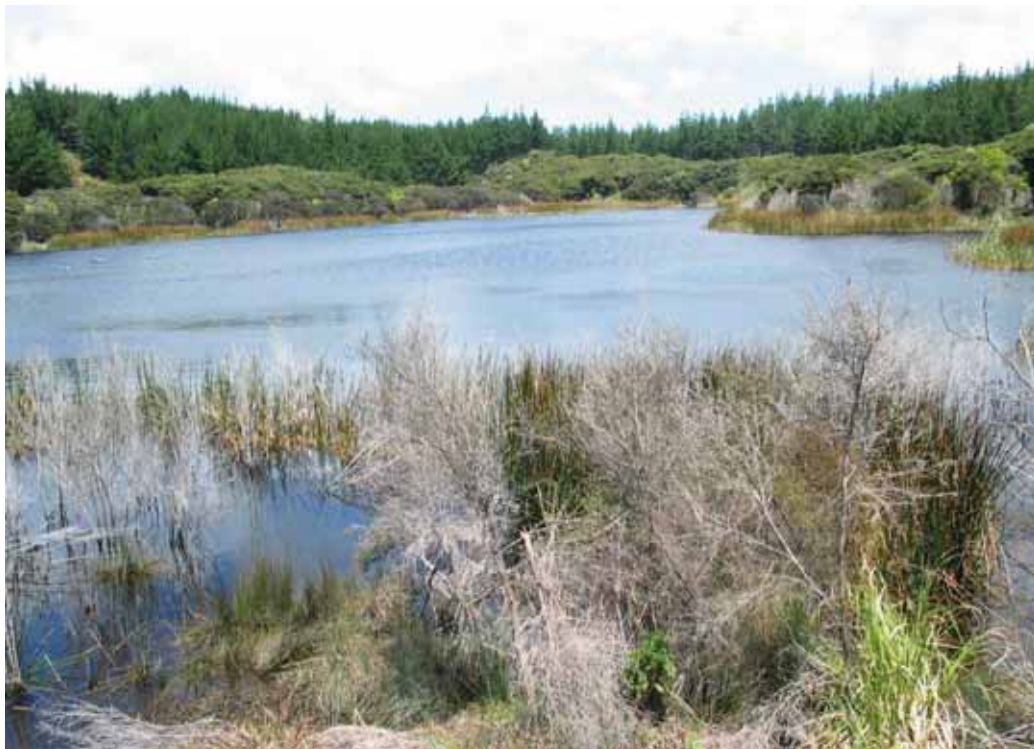
**Plate:** Lake Waipara showing the margin of scrub vegetation with pine forestry behind this. Note the narrow emergent zone.

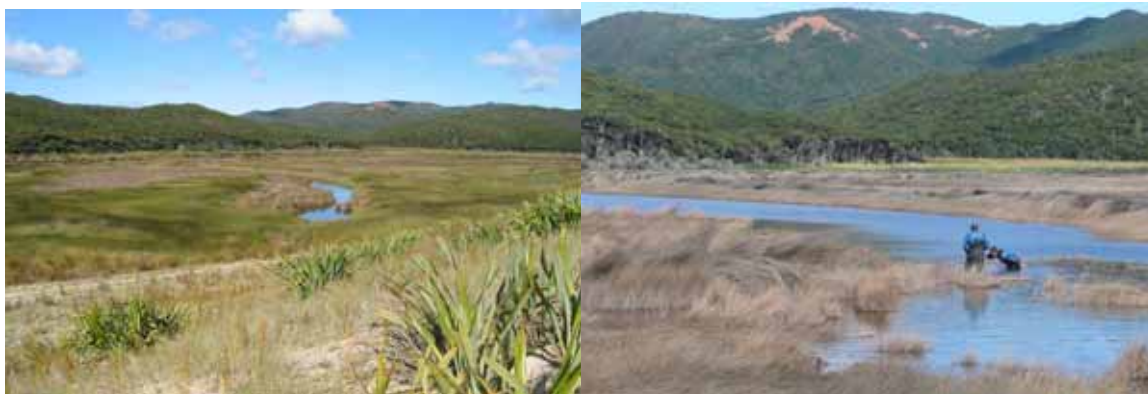
**Plate 1:** LEFT 2007 showing the east end of Waitahora Lagoon, showing a saline influenced wetland dominated by the green oioi (*Apodasmia similis*) and brown sea rush (*Juncus kraussii* var. *australiensis*), RIGHT 2009 showing a closer of the same area but with the oioi impacted by saltwater intrusion.

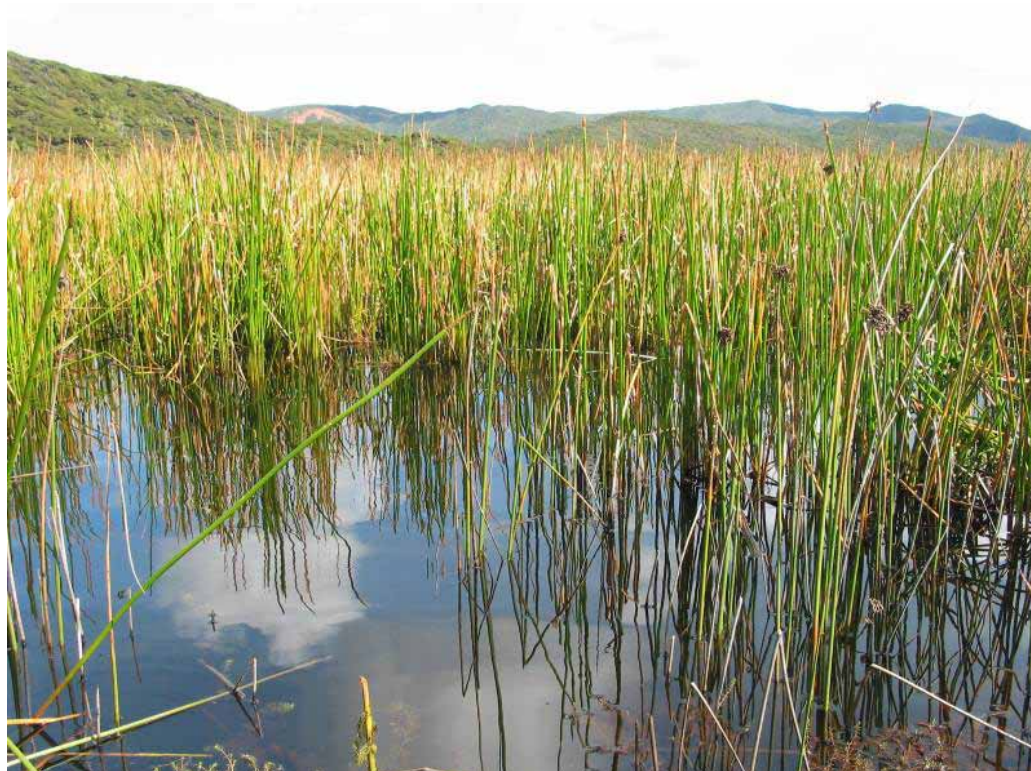
**Plate 2:** Freshwater lake, east of Waitahora Lagoon dominated by *Eleocharis sphacelata*.

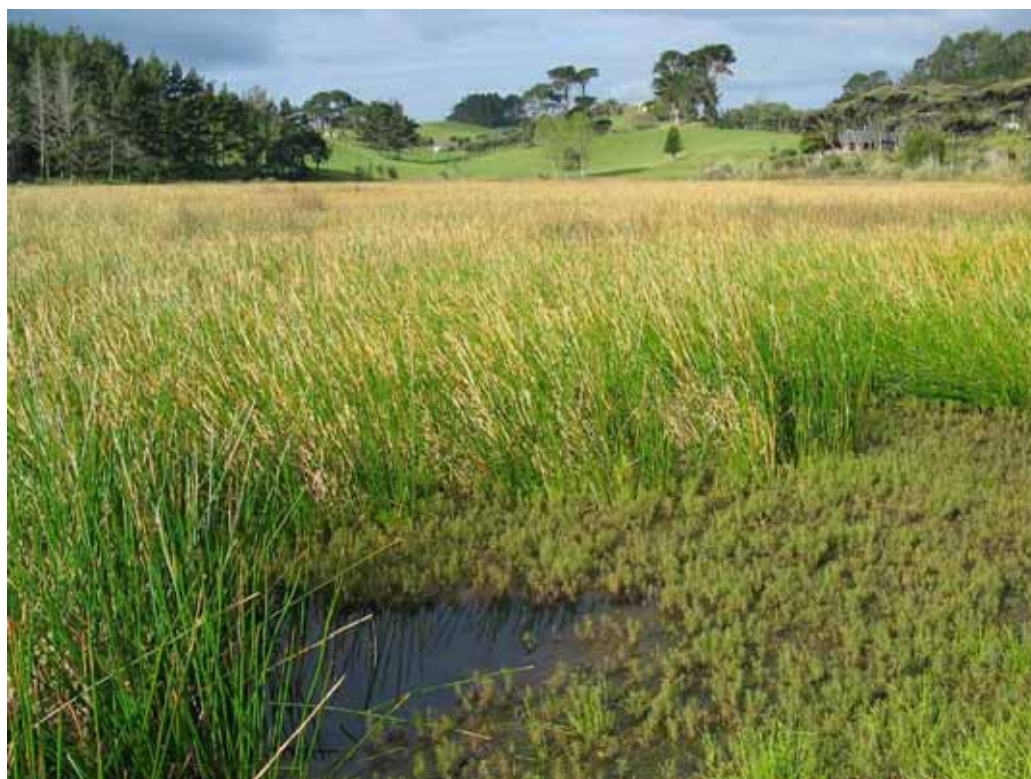
**Plate:** West Coast Road Lake showing emergent dominated water body with the endangered *Myriophyllum robustum* (bottom right) 2005, However (without disturbance spraying) emergents have taken over the whole lake and there is no open water and no *M. robustum* was seen in 2010.

Control some areas of *E. sphacelata* with glyphosate to provide open water habitat for growth of the endangered *M. robustum*.

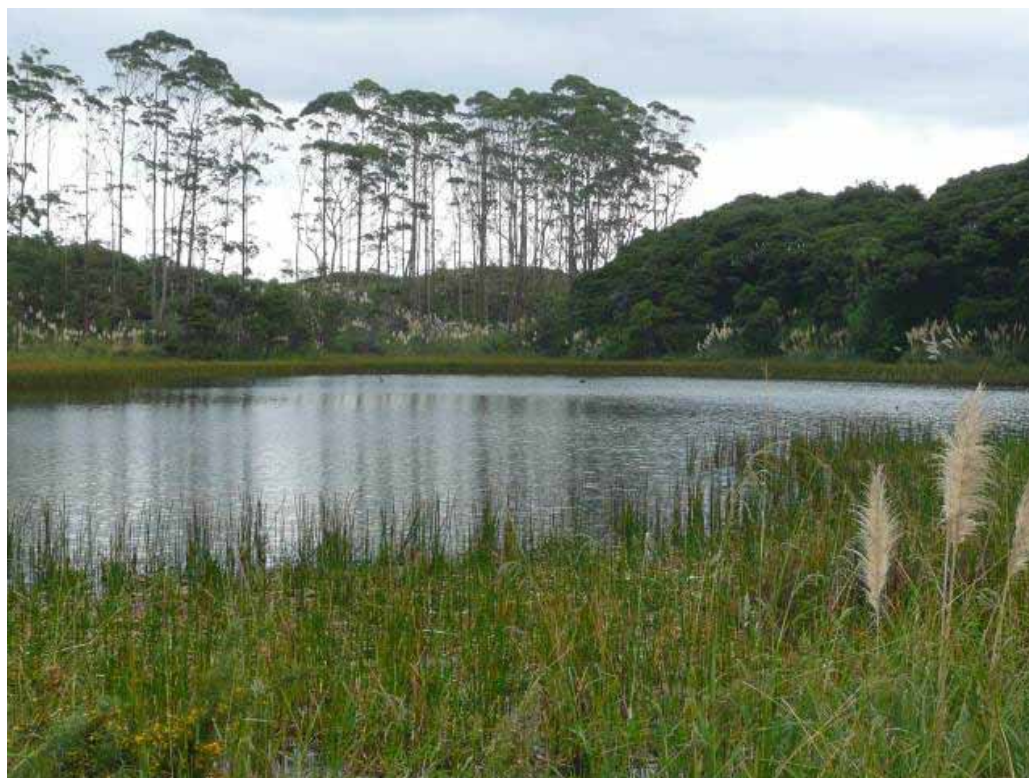
**Plate:** Lake Yelavich, a dune lake within plantation pine forestry
