## 28 Rangiputa

### Coastal Erosion Hazard Assessment

## NORTHLAND REGIONAL COUNCIL

Coastal Erosion Hazard Assessment

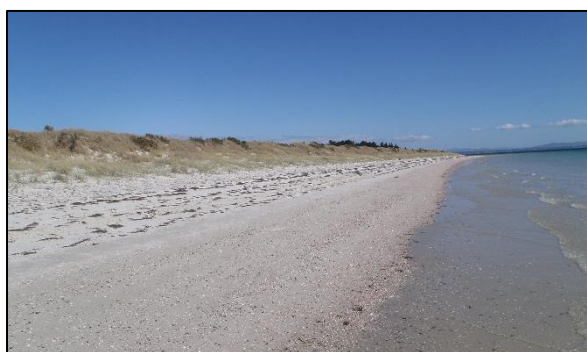
*Site Photograph C (southern end)*

The site has a dune system in areas where no revetment exists, which is well vegetated with spinifex. The dune elevation ranges from RL 2 to 6 m. The southern 750 m of the site has an accreting dune system with a healthy foredune developing (cell 28C).

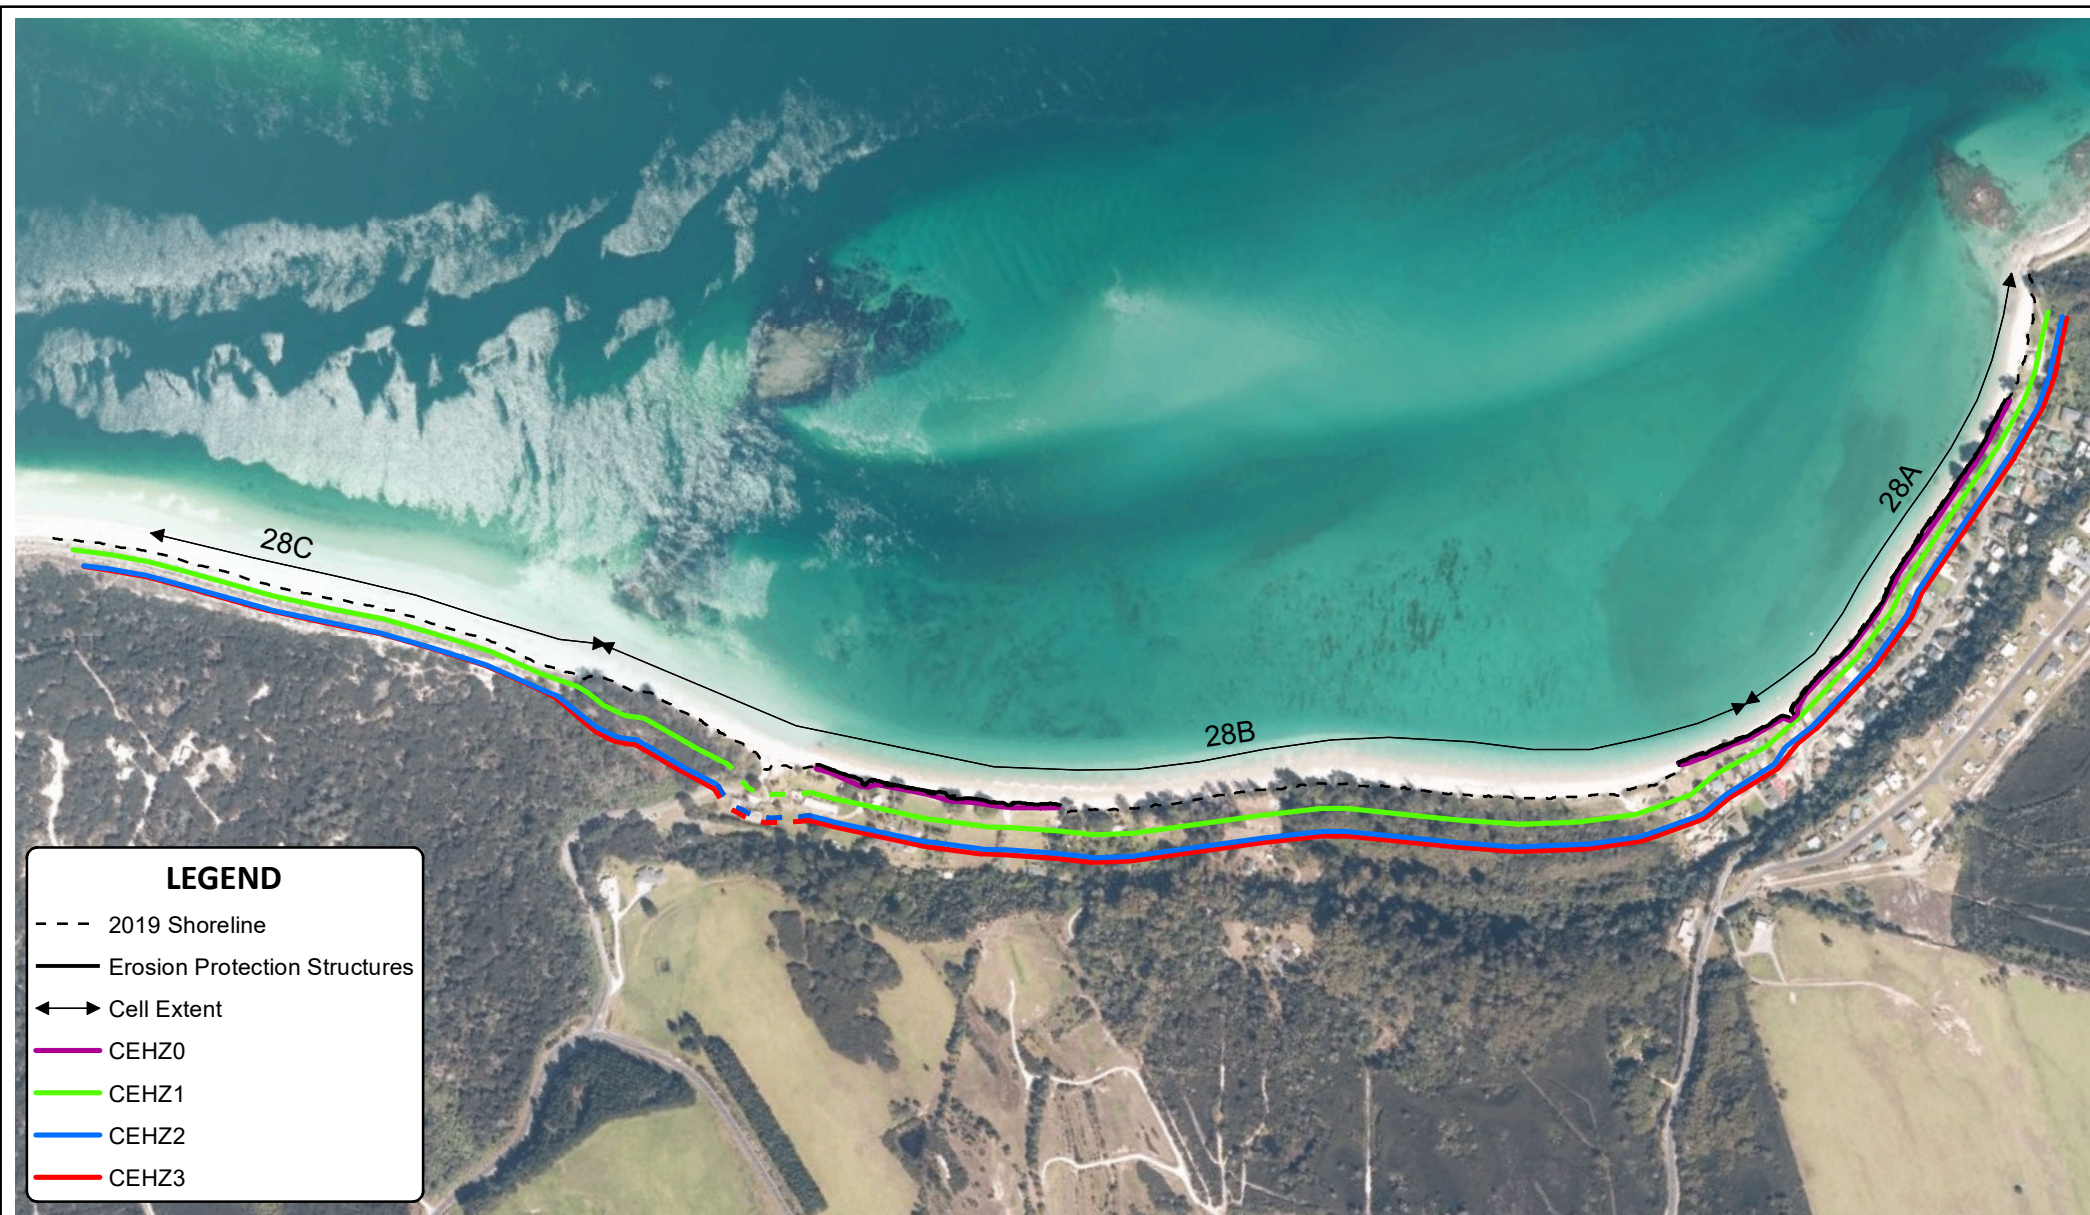
Rangiputa

Coastal Erosion Hazard Zone widths are presented within Table 28-2 to 28-4 and Figure 28-4 and are generally a function of the historic long-term trend. CEHZ1 values are rounded to 10 to 27 m. CEHZ2 values are rounded to 25 to 51 m and CEHZ3 values are rounded to 25 to 56 m.

CEHZ's have been mapped in agreement with the calculated values. Note that cell 28C has

experienced accretion since about 1945 over approximately 600 m, with CEHZs offset from the accreted most recent shoreline.

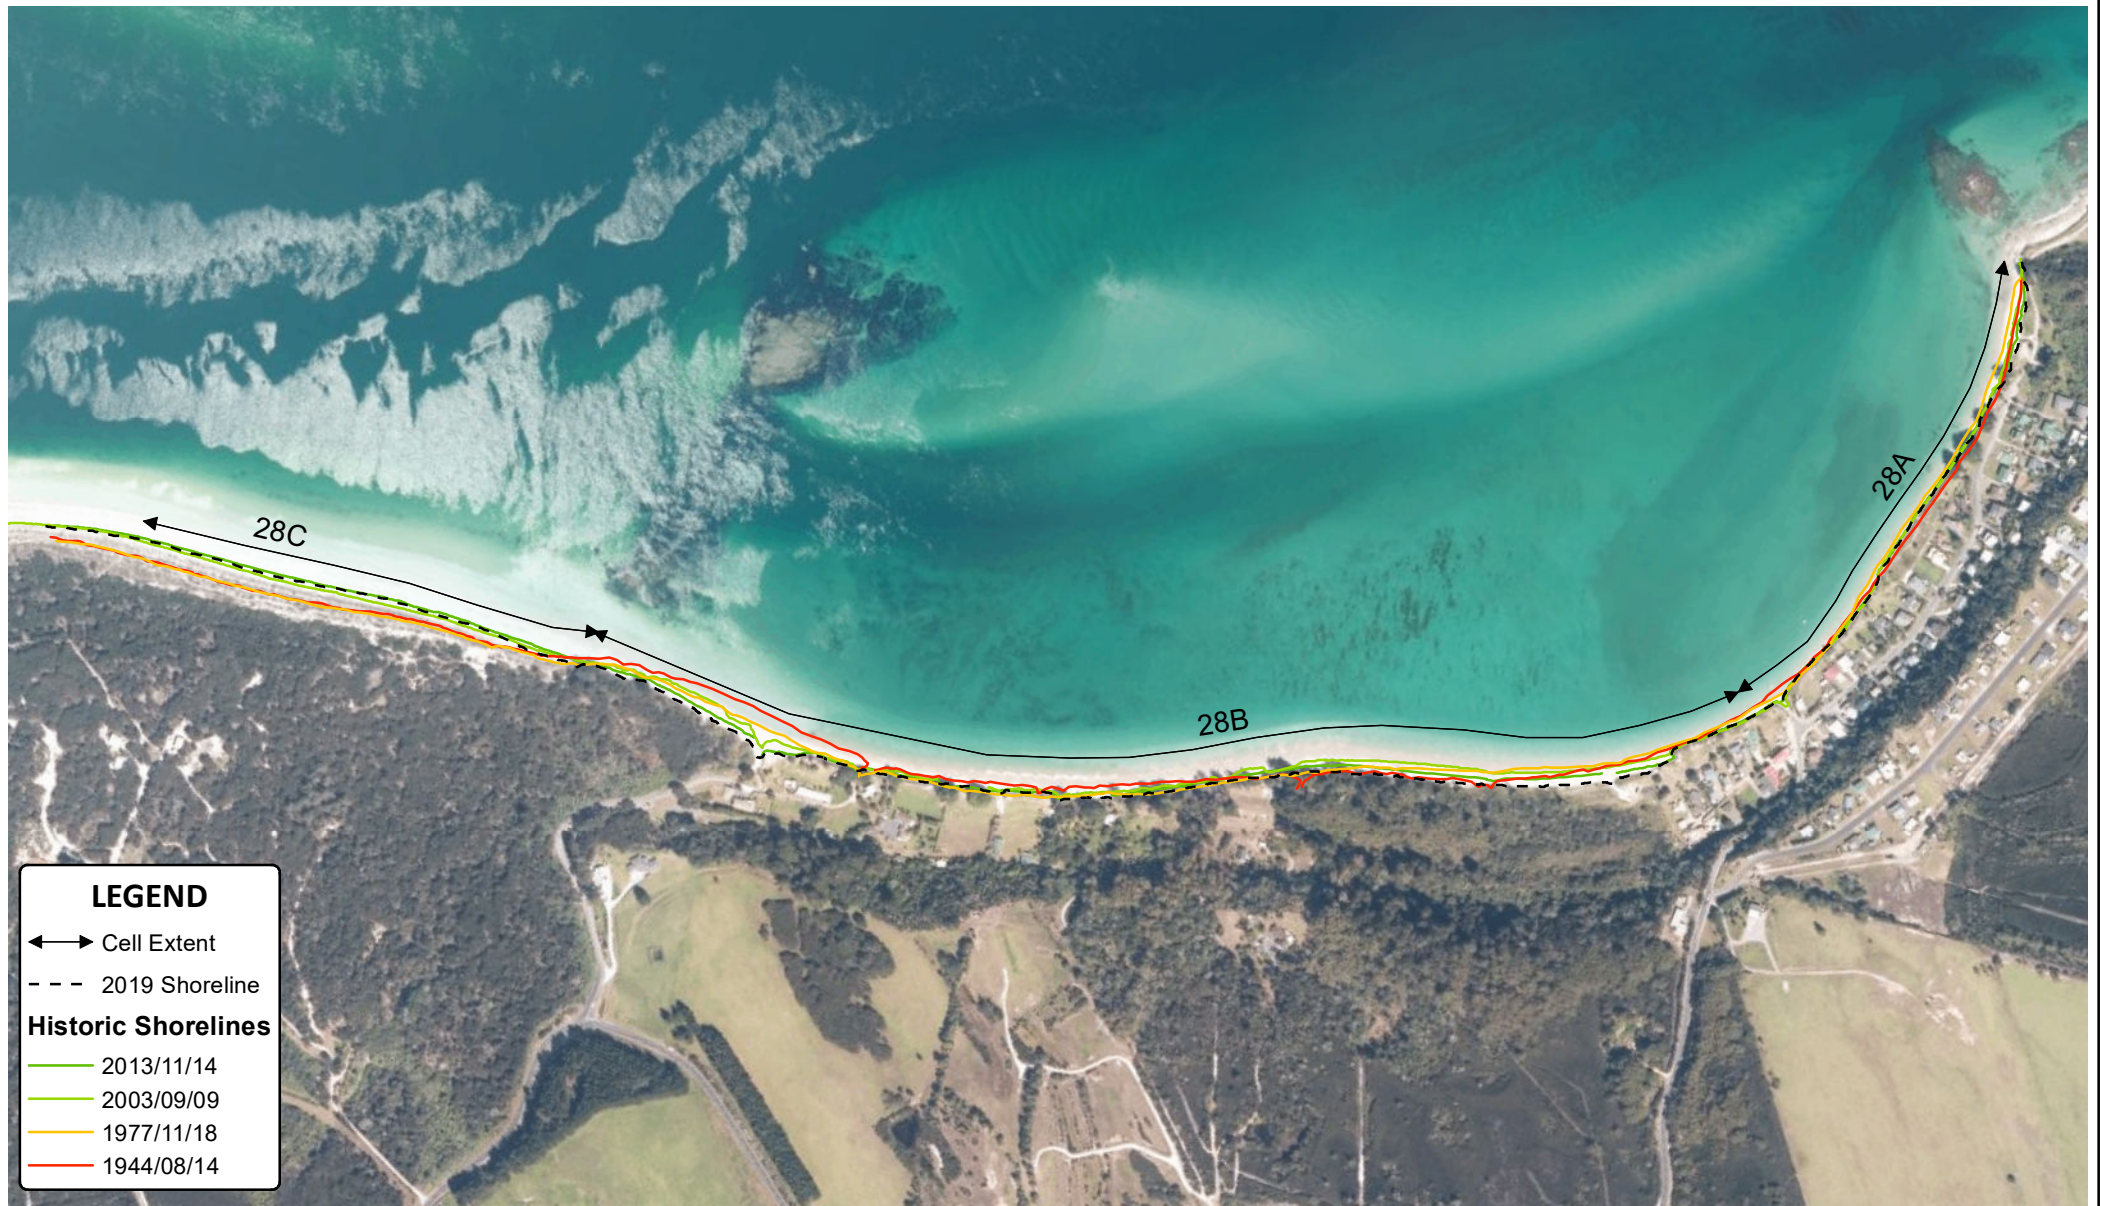
Historic Shorelines

Rangiputa

Figure 28-5 shows the available historic shorelines for Rangiputa.
