Poutō Peninsula

Kapoai (Poutō), NRC Lake No. 296.

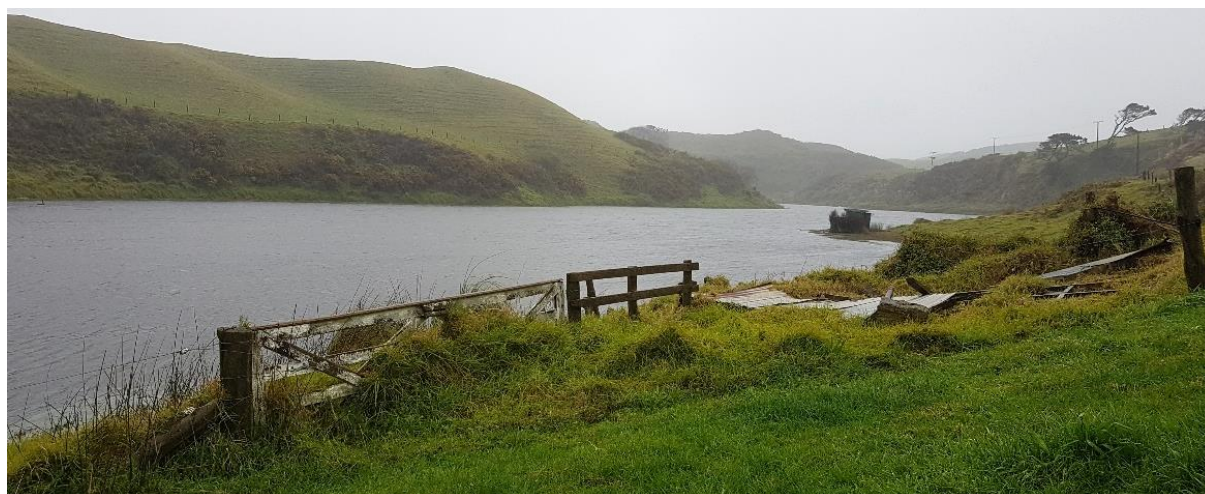
Kapoai. Photo showing the fenced margin with dense kikuyu (*Cenchrus clandestinus*) dominating the retired margin. (Photo: Paul Champion 18 September 2018).

The emergent sedges *Schoenoplectus tabernaemontani* and kuta (*Eleocharis sphacelata*) were re-establishing on the lake margins but much of the lake margin was fringed by kikuyu (*Cenchrus clandestinus*).

Lake native biodiversity value monitoring every 5 years. Complete lake fencing and consider planting options around the margins. Advocate eradication of African feather grass to the landowner before it spreads further.
