5. Kai-Iwi and north Dargaville lakes

5.1 Freidrich's Lake (north Dargaville), NRC Lake No. 282; surveyed in 2005

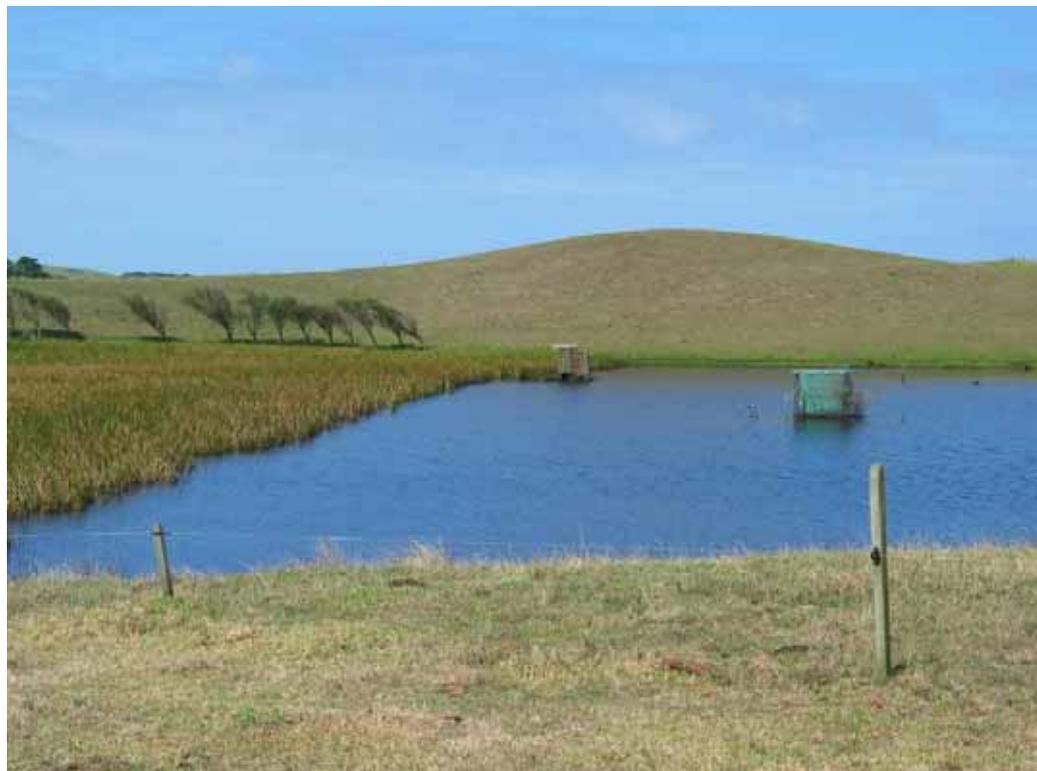
Plate: Freidrich's Lake showing the artificially maintained area of open water evidenced by the straight line of emergent kuta (*Eleocharis sphacelata*).

Eleocharis sphacelata was the dominant emergent vegetation and would fill the lake if the owner had not sprayed it. The straight edge to the *E. sphacelata* beds was taken as evidence of spraying, presumably for duck hunting purposes. Biodiversity has been enhanced by this action as it creates habitat for submerged species. The invasive weed *Alternanthera philoxeroides* was well established amongst marginal kikuyu (*Pennisetum clandestinum*).

No lake native biodiversity value monitoring recommended.

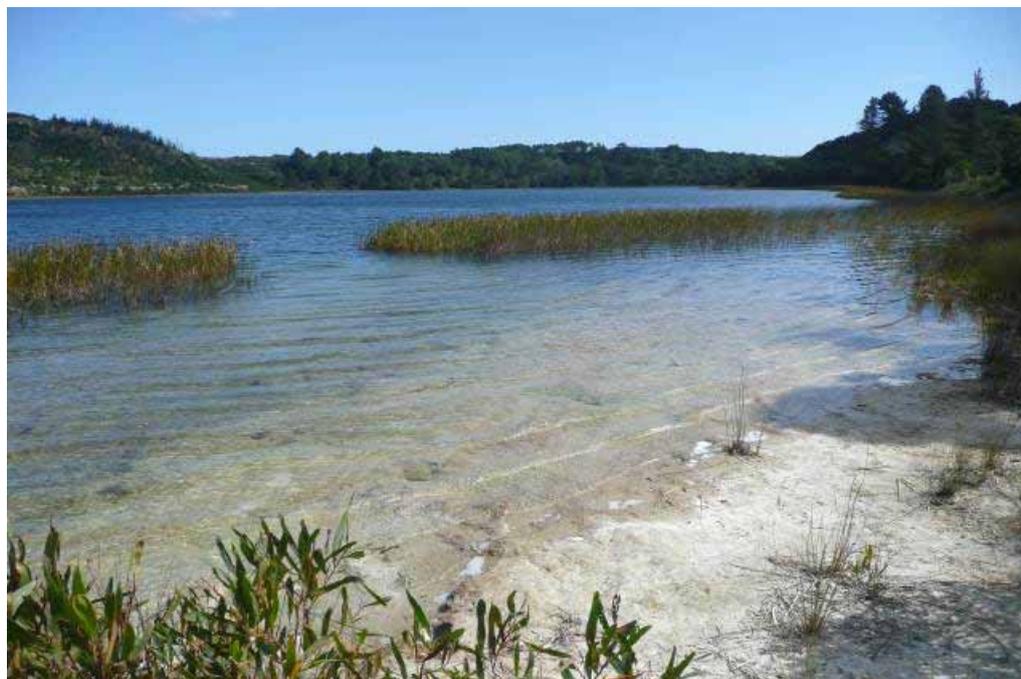
Plate: Lake Kai-iwi from the access point showing an extensive margin of emergent vegetation and the only sandy margin on the lake.

Most of the lake had a wide (3-10 m) band of emergent vegetation, with *Apodasmia similis*, *Baumea arthrophylla* (especially on the exposed eastern shore), *B. articulata* and *B. juncea* were common in shallow water up to 0.7 m deep and an outer zone of *Eleocharis sphacelata* extended to 2.8 m deep in one transect. The invasive *Utricularia gibba* was noted amongst emergent vegetation in 2008 and 2009 surveillance surveys, but not in 2010.

Lake native biodiversity value monitoring every 5 years, pest plant surveillance annually. Prevent uncontrolled access for boats.

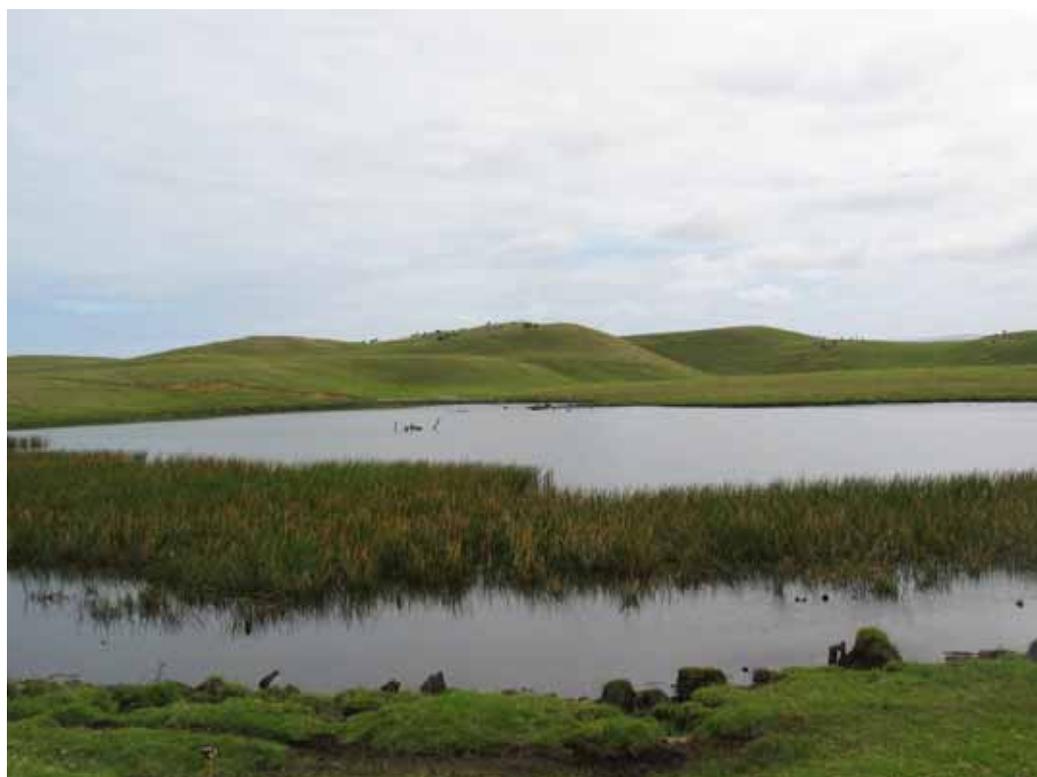
Plate: McEvoy's Lake showing the pasture catchment and impacts of cattle access.

The dominant emergent species was *Eleocharis sphacelata* which formed a 3 to 5 m wide zone, excluded from the lake edge by cattle grazing/trampling. A zone of exposed turf plants was occasionally seen including *Myriophyllum propinquum* and *Potamogeton cheesemani*.

No management recommendations apart from cattle exclusion.

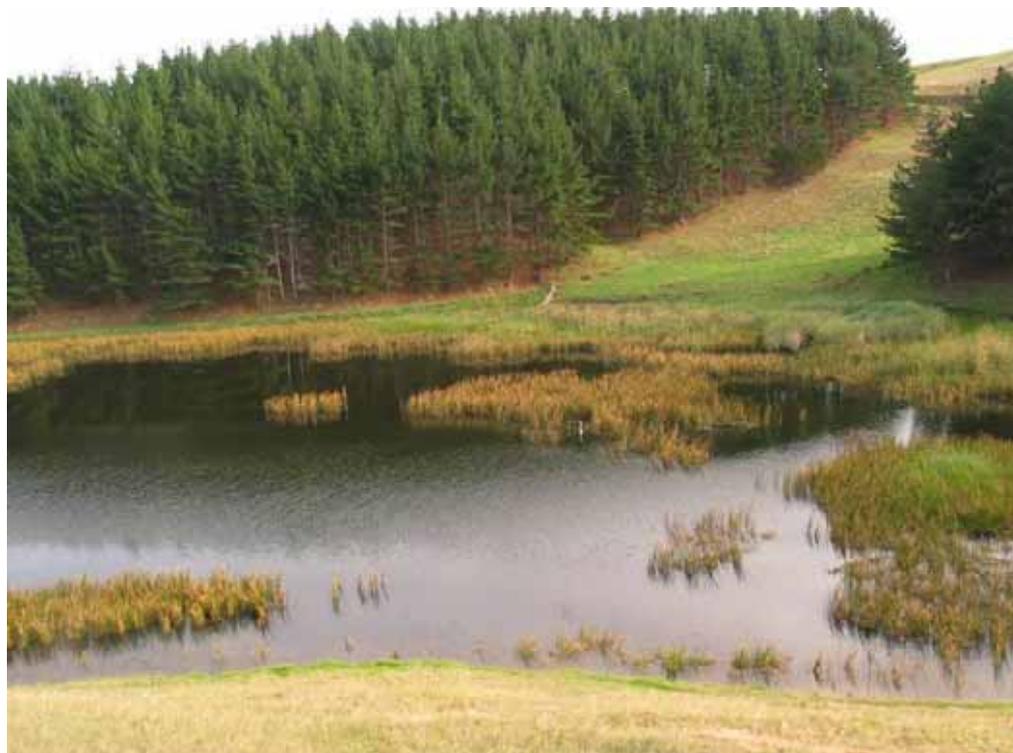
Plate: Midgley's Lake showing the pasture and plantation pine catchment and extensive emergent vegetation.

The dominant emergent species were *Eleocharis sphacelata* and *Typha orientalis* that formed extensive beds over 30% of the lake wide zone. *E. sphacelata* grew to a maximum depth of 2 m. A zone of exposed turf plants was seen bordering the lake including the native *Myriophyllum propinquum* and *Glossostigma elatinoides* and the exotic *Ludwigia palustris* and *Juncus bulbosus*. The invasive weed *Alternanthera philoxeroides* (alligator weed) is present on the property (landowner pers. comm.) so its spread to the lake cannot be discounted.

Recommend fencing lake perimeter.

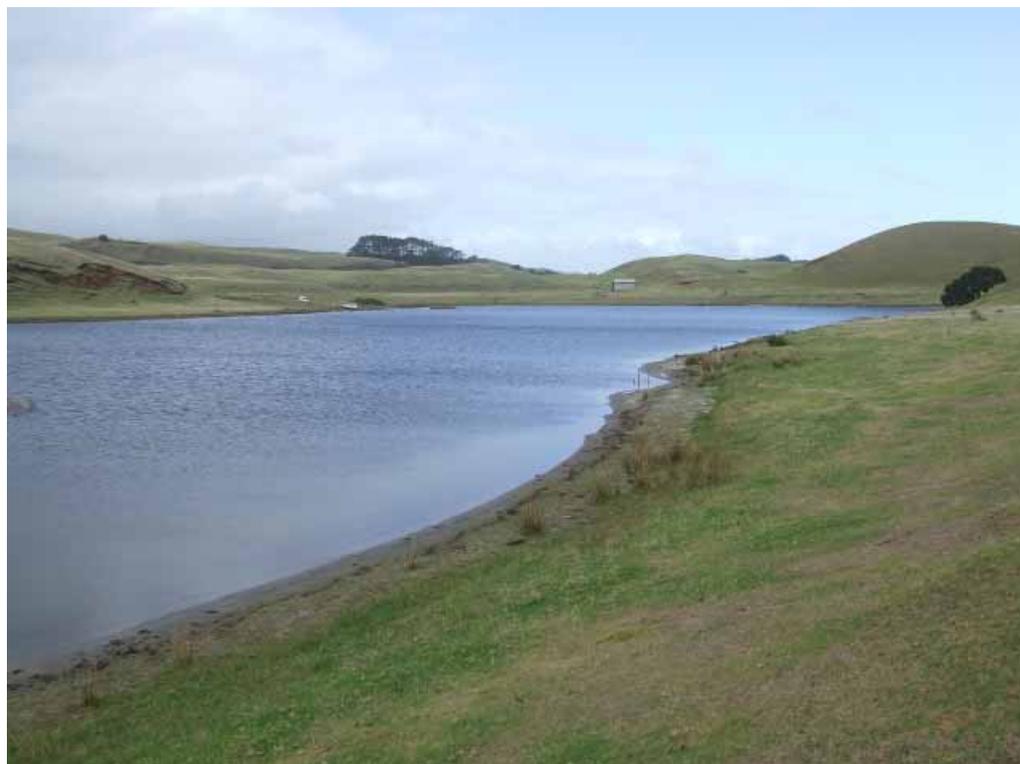
Plate: Shag Lake showing grazing to the lakeshore.

The dominant emergent species occupying <20% of the shoreline was *Eleocharis sphacelata*, which formed a 3 to 15 m wide zone, extending to depths of 2 m but excluded from the lake edge (depths less than 1 m) by cattle grazing/trampling.

This lake would be suitable for enhancement, by retiring and planting the margins and considering ways to reduce pastoral enrichment of water.

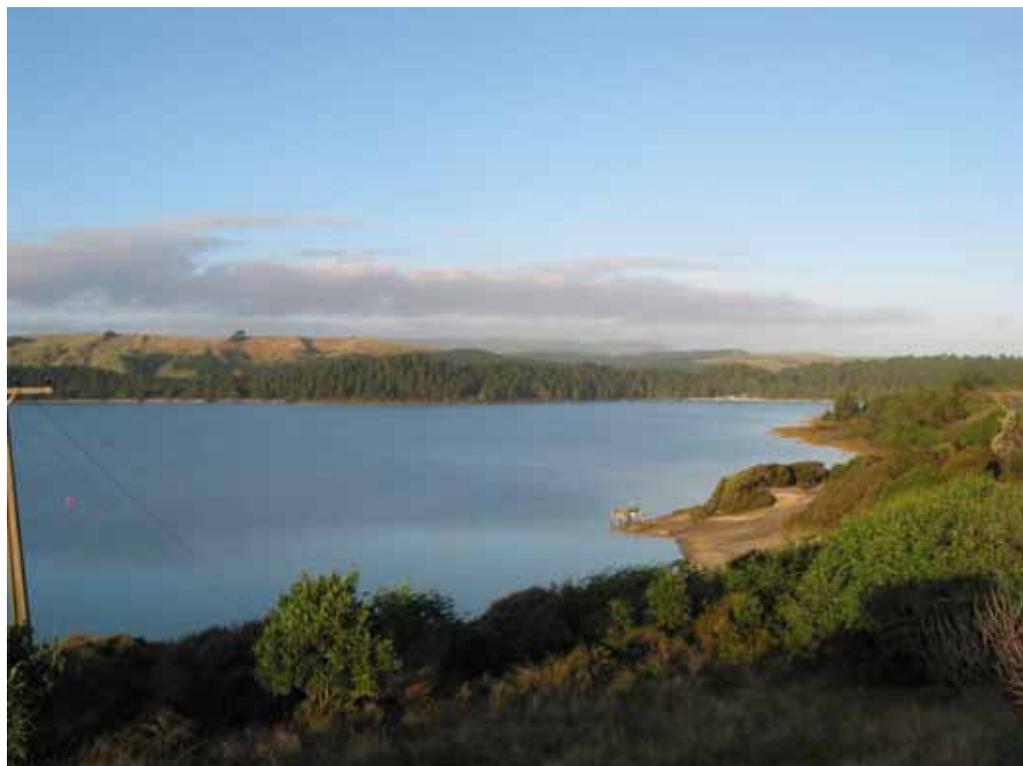
Plate: Lake Taharoa from access road, note the exposed beach and paucity of emergent vegetation.

Much of shore was wave exposed, with hard iron pan or sand, and unsuitable for emergent vegetation development. Low covers (25%) of oioi (*Apodasmia similis*) and *Schoenus brevifolius* were present in places, and seedlings of *Eleocharis sphacelata* were also observed at one site. A survey of marginal zones of Lake Taharoa in 2007 recorded the following additional emergent, or potentially emergent species: *Baumea arthropphylla*, *Baumea articulata*, *Baumea juncea*, *Eleocharis acuta*, *Eleocharis sphacelata*, *Ficinia nodosa*, *Isachne globosa*, *Isolepis prolifer*, *Juncus pallidus* and *Typha orientalis*. The nationally 'at-risk' *Centrolepis strigosa* was found in the marginal turf of this vegetation in 2009 and 2010. This is the first known collection from the Kai-Iwi Lakes since the 1980's.

Pest plant surveillance at access points annually.

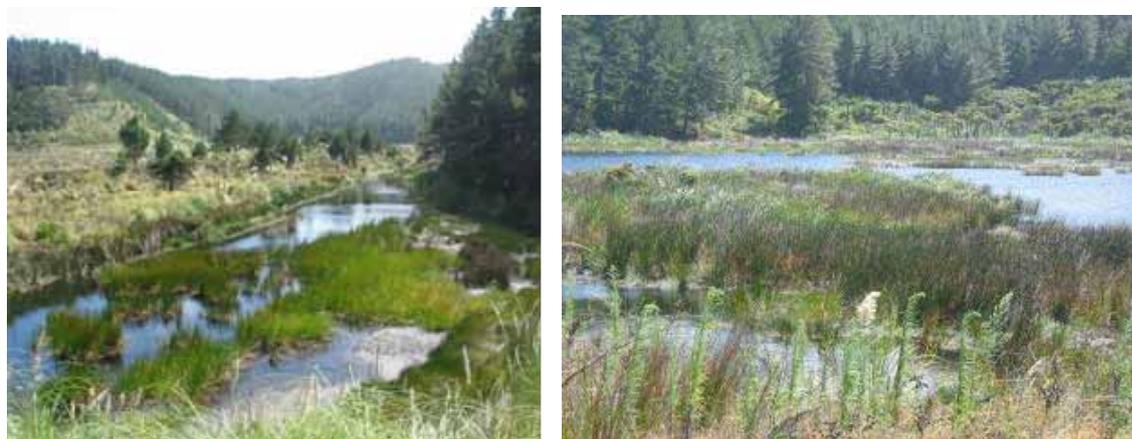
Plate A: Te Riu Lagoon, showing the west half of the lagoon left and eastern on the right.
