25 Coopers Beach

Coastal Erosion Hazard Assessment

NORTHLAND REGIONAL COUNCIL
 Coastal Erosion Hazard Assessment
 Coopers Beach
 Site: 25

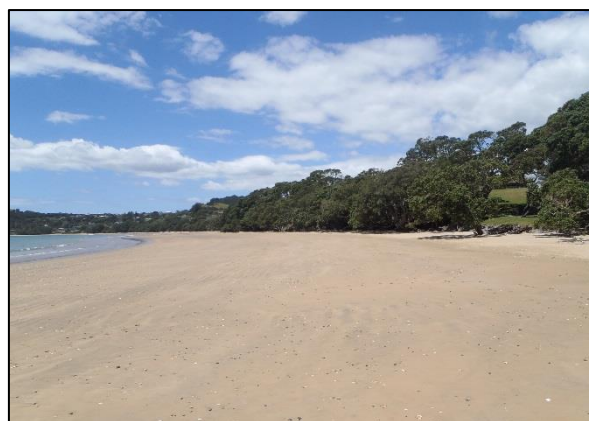
Site Photograph A (looking east)

Erosion protection structures exist along the toe of the cliff east of Kanekane Stream. The structures range from loose rock revetments to timber seawalls. There are also a number of stormwater outlets located at the base on the cliff. These structures can result in lowering the adjacent foreshore level causing more wave induced erosion at the toe of the cliff. A boat ramp is situated at the eastern end of the site.

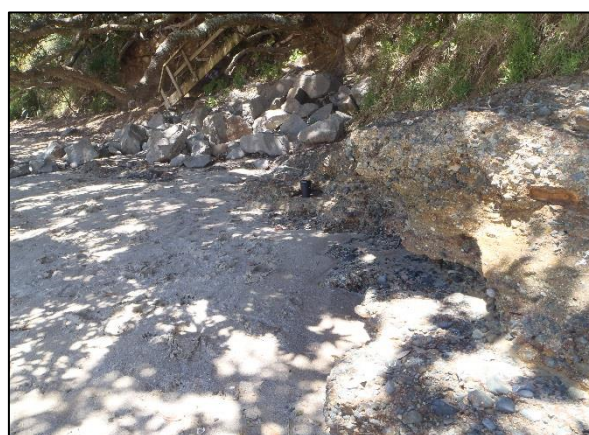
Site Photograph B (conglomerate rock)

The fine sand beach has a relatively flat slope with a wide intertidal area. The beach is backed by cliffs with no foredune system protecting the toe of the cliff. The cliff material is relatively weathered and weak sedimentary rock comprising conglomerates, claystone, siltstone and sandstone (Mangonui Formation). The cliff crest elevation ranges from RL 2.5 to 16 m.

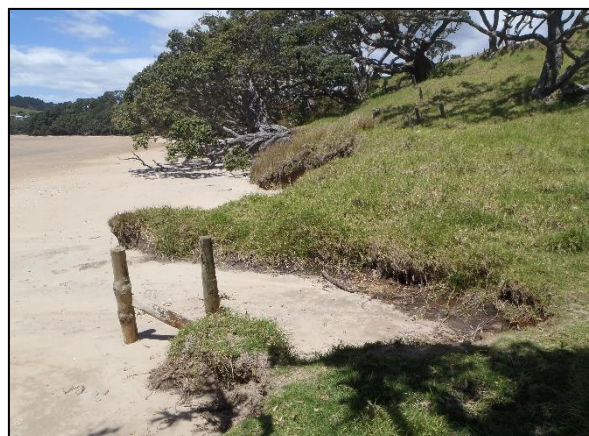
Site Photograph C (western end)

The Kanenane and Otanenui Stream mouths are located approximately 200 m and 600 m from the western end of the site respectively. They have a localised effect on shoreline position in these areas.

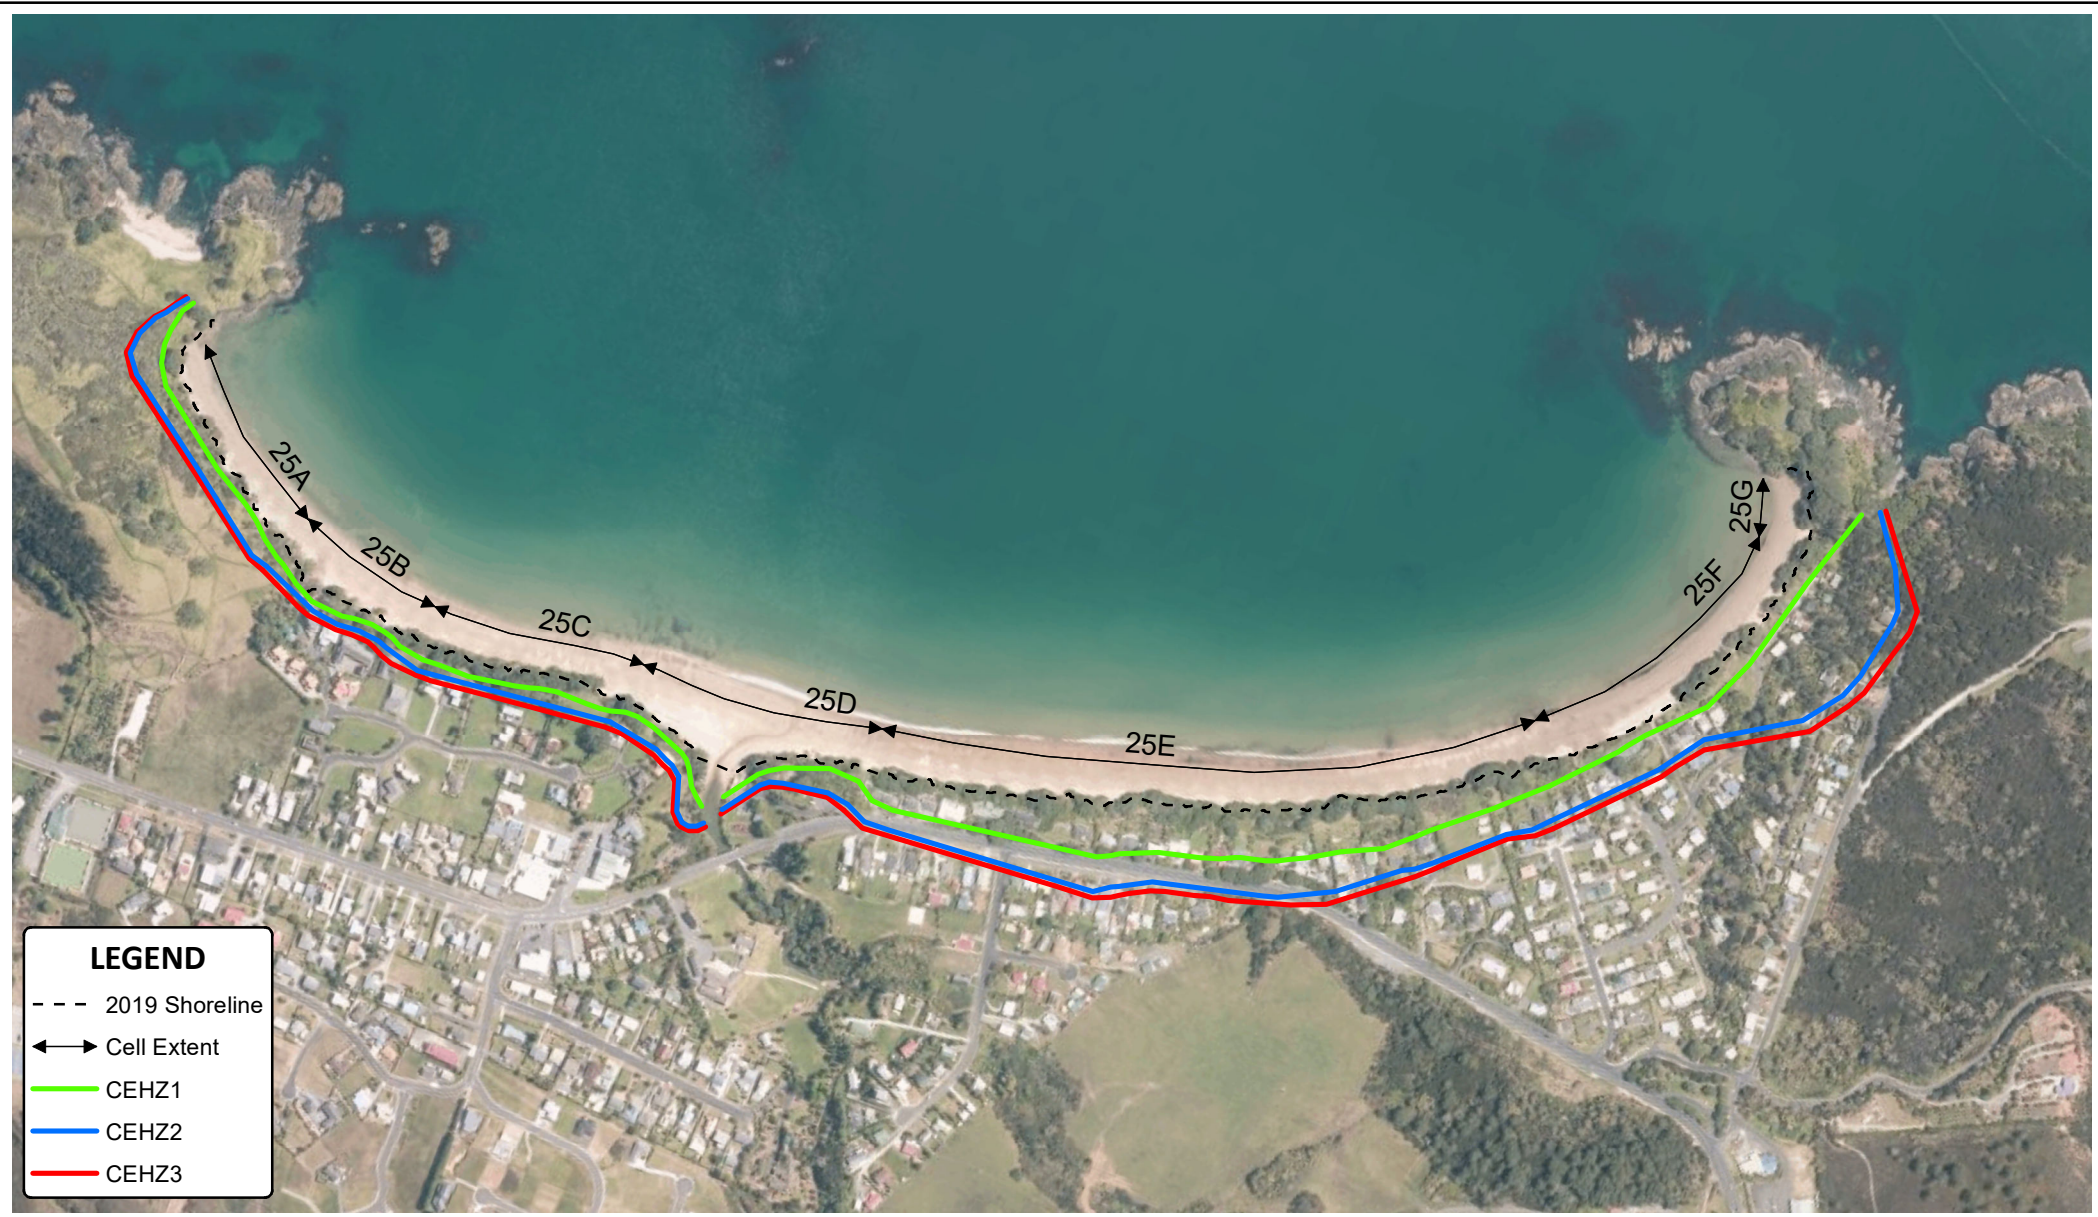
FIGURE No.	Figure 25-8	Rev.	1
------------	-------------	------	---

Notes: Dashed CEHZ indicates greater uncertainty around stream mouths and backshore topography. Northland 0.4m Rural Aerial Photos (2014-2016).

There are two streams that enter the site and influence the shoreline position. There is a greater level of uncertainty in these areas because fluvial processes also effect shoreline movement. The resulting hazard zones are dashed in these areas to reflect this uncertainty.

CEHZ's have been mapped in agreement with the calculated values, although lines have been dashed around stream entrances to reflect the increased uncertainty due to fluvial processes.

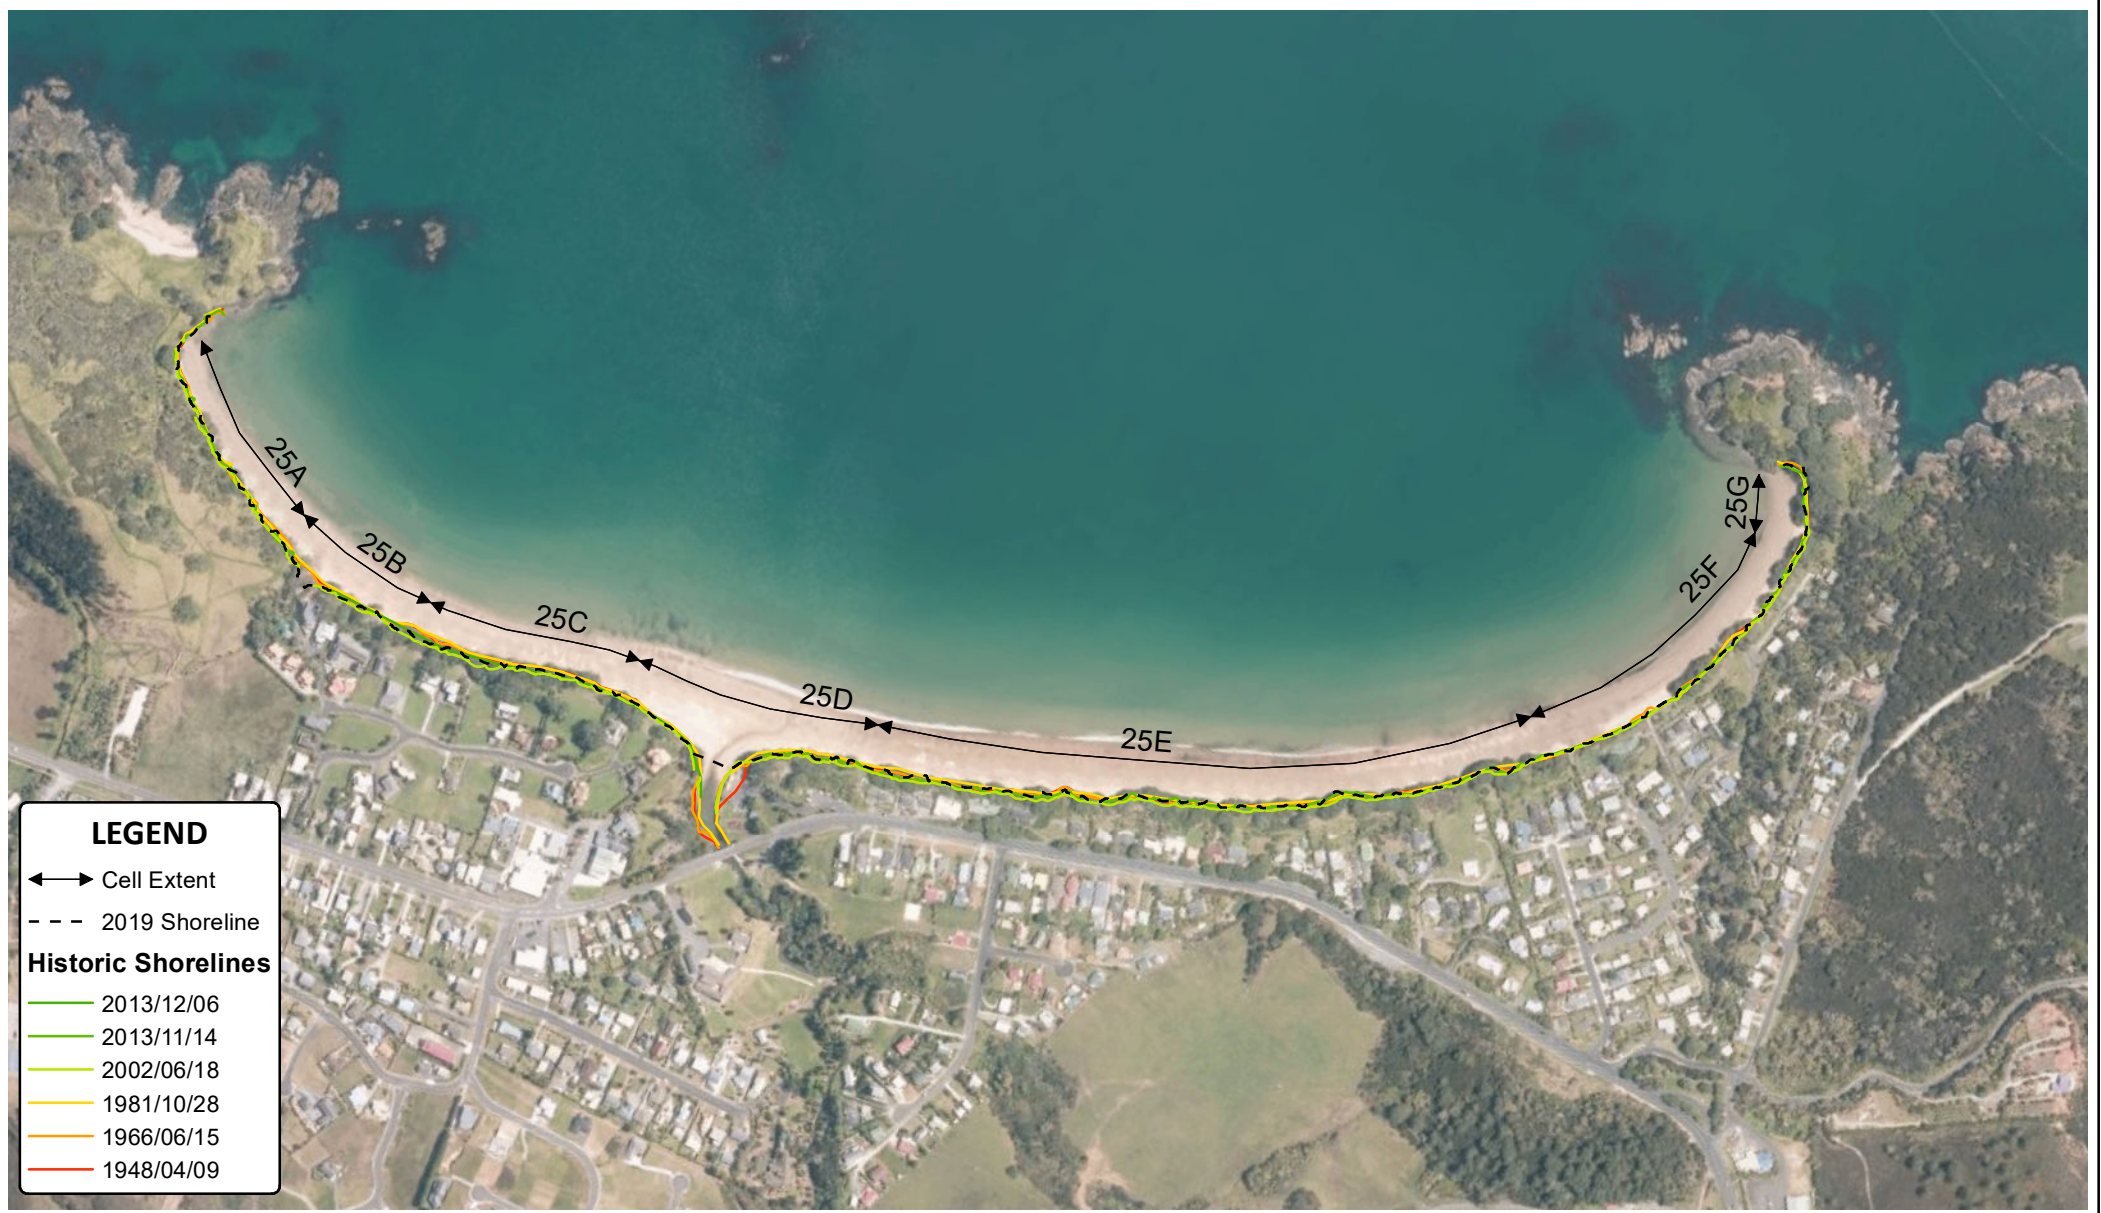
FIGURE No.	Figure 25-9	Rev.	1
------------	-------------	------	---

NORTHLAND REGIONAL COUNCIL
 Historic Shorelines
 Coopers Beach
 Site: 25

Figure 25-9 shows the available historic shorelines for Coopers Beach.
