Recreational Swimming Water Quality in Northland

Summer 2016-2017

1. Executive Summary

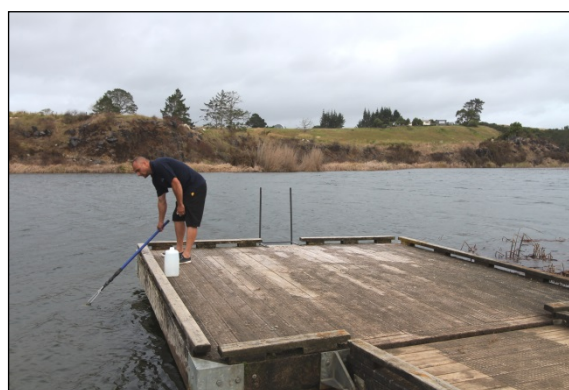
Photo 4: Council staff taking water sample at Lake Waro, Hikurangi

Each sample is collected following the methods described in the MfE and MoH (2003) guidelines. Coastal water samples are taken from the shore using a sampling pole at about 0.5 metre depth, from approximately 15 centimetres below the surface. Freshwater samples are taken at approximately 30 centimetres below the surface, at approximately one metre depth. All samples are collected during

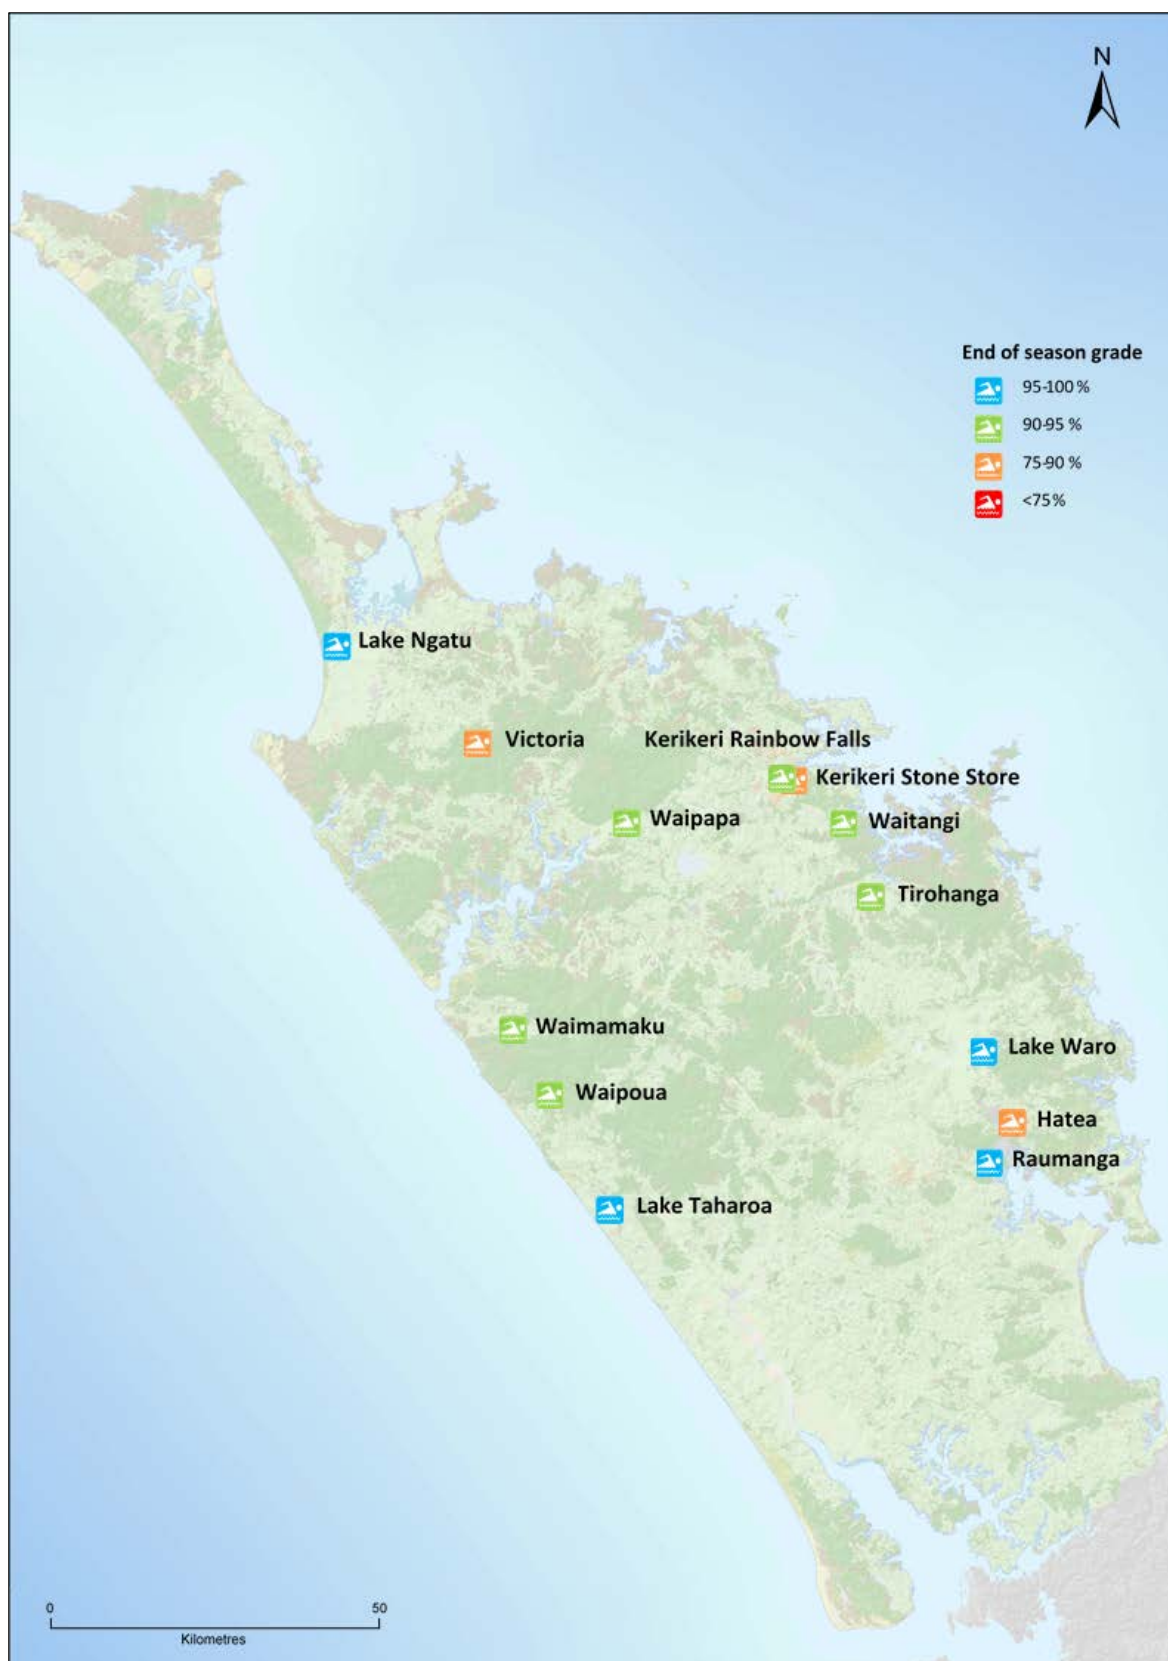
Figure 3: Freshwater end of season grading 2016-17

The map above summarises the end of season grading for samples taken from each of the 13 freshwater sites monitored in Northland during the 2016-17 sampling season (21 November 2016 to the 21 February 2017). The grades indicate the percentage of results below 'Action' level recorded at each site.
