5 Marsden Cove

Coastal Erosion Hazard Assessment

NORTHLAND REGIONAL COUNCIL

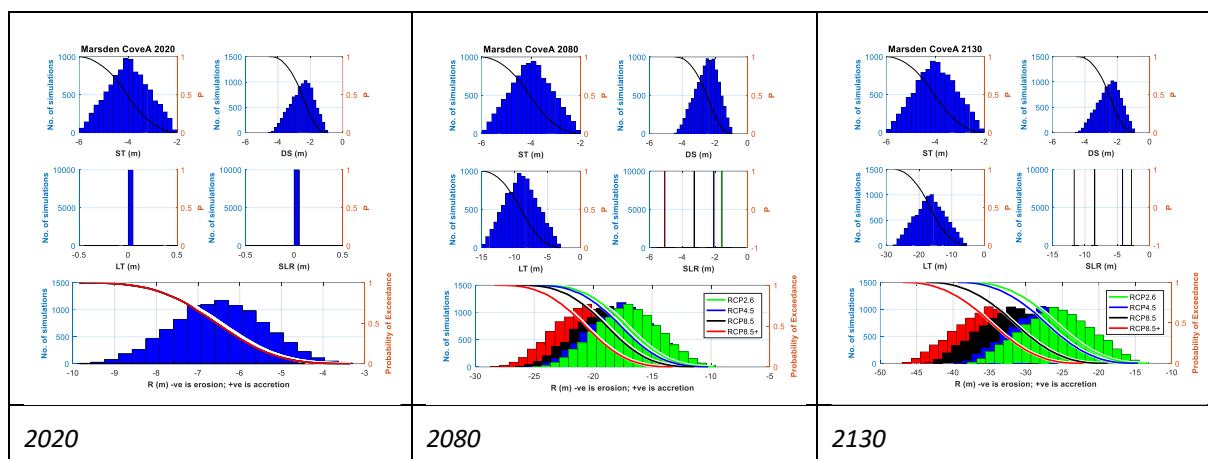
Figure 5-1 Histograms of parameter samples and the resultant shoreline distances for 2020, 2080 and 2130 timeframes for cell 5A

Histograms of individual components and resultant CEHZ distances using a Monte Carlo technique are shown in Figure 5-1 to Figure 5-3. Coastal Erosion Hazard Zone widths are presented within Table 5-2 to 5-4 and Figure 5-5.

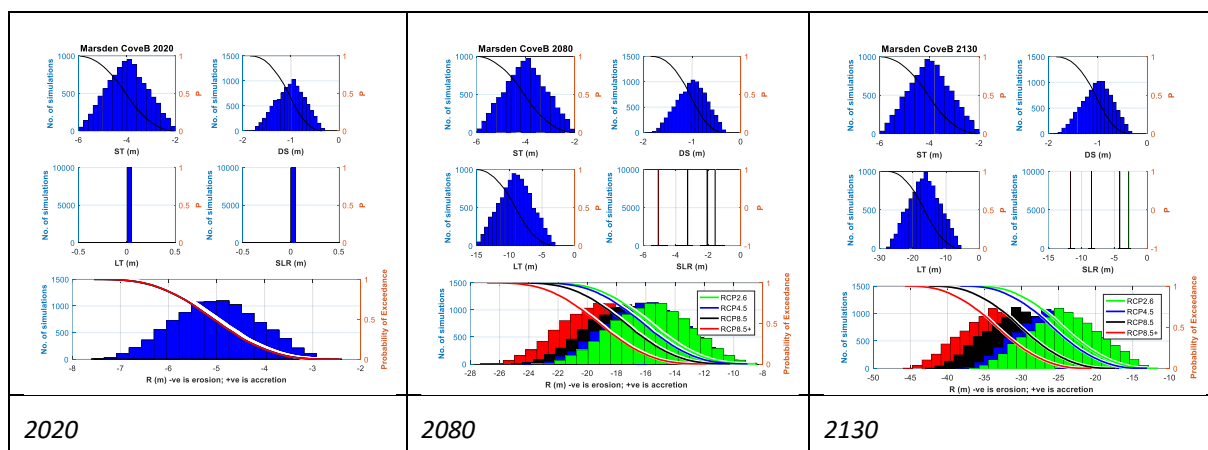
Figure 5-2 Histograms of parameter samples and the resultant shoreline distances for 2020, 2080 and 2130 timeframes for cell 5B

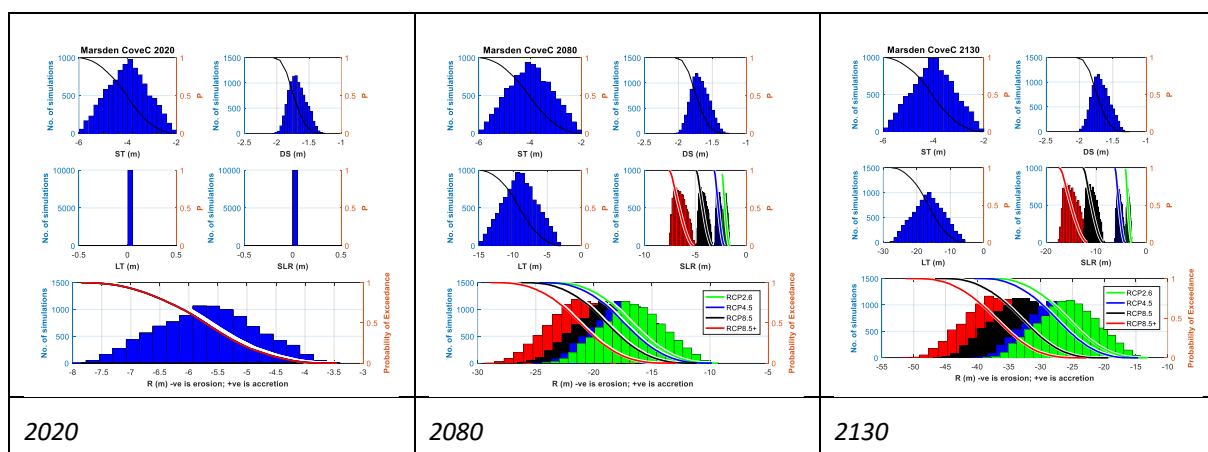
Figure 5-3 Histograms of parameter samples and the resultant shoreline distances for 2020, 2080 and 2130 timeframes for cell 5C

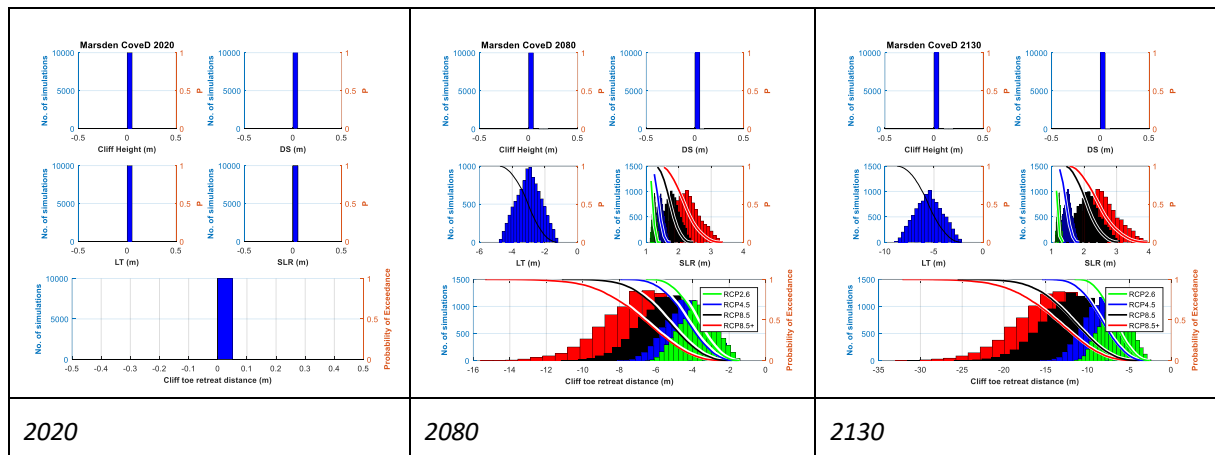
Figure 5-4 Histograms of parameter samples and the resultant shoreline distances for 2020, 2080 and 2130 timeframes for cell 5D

For cell 5D the cliff projection method has been adopted with future shoreline distances shown

in Figure 5-4 and Table 5-2 instead of CEHZ distances.

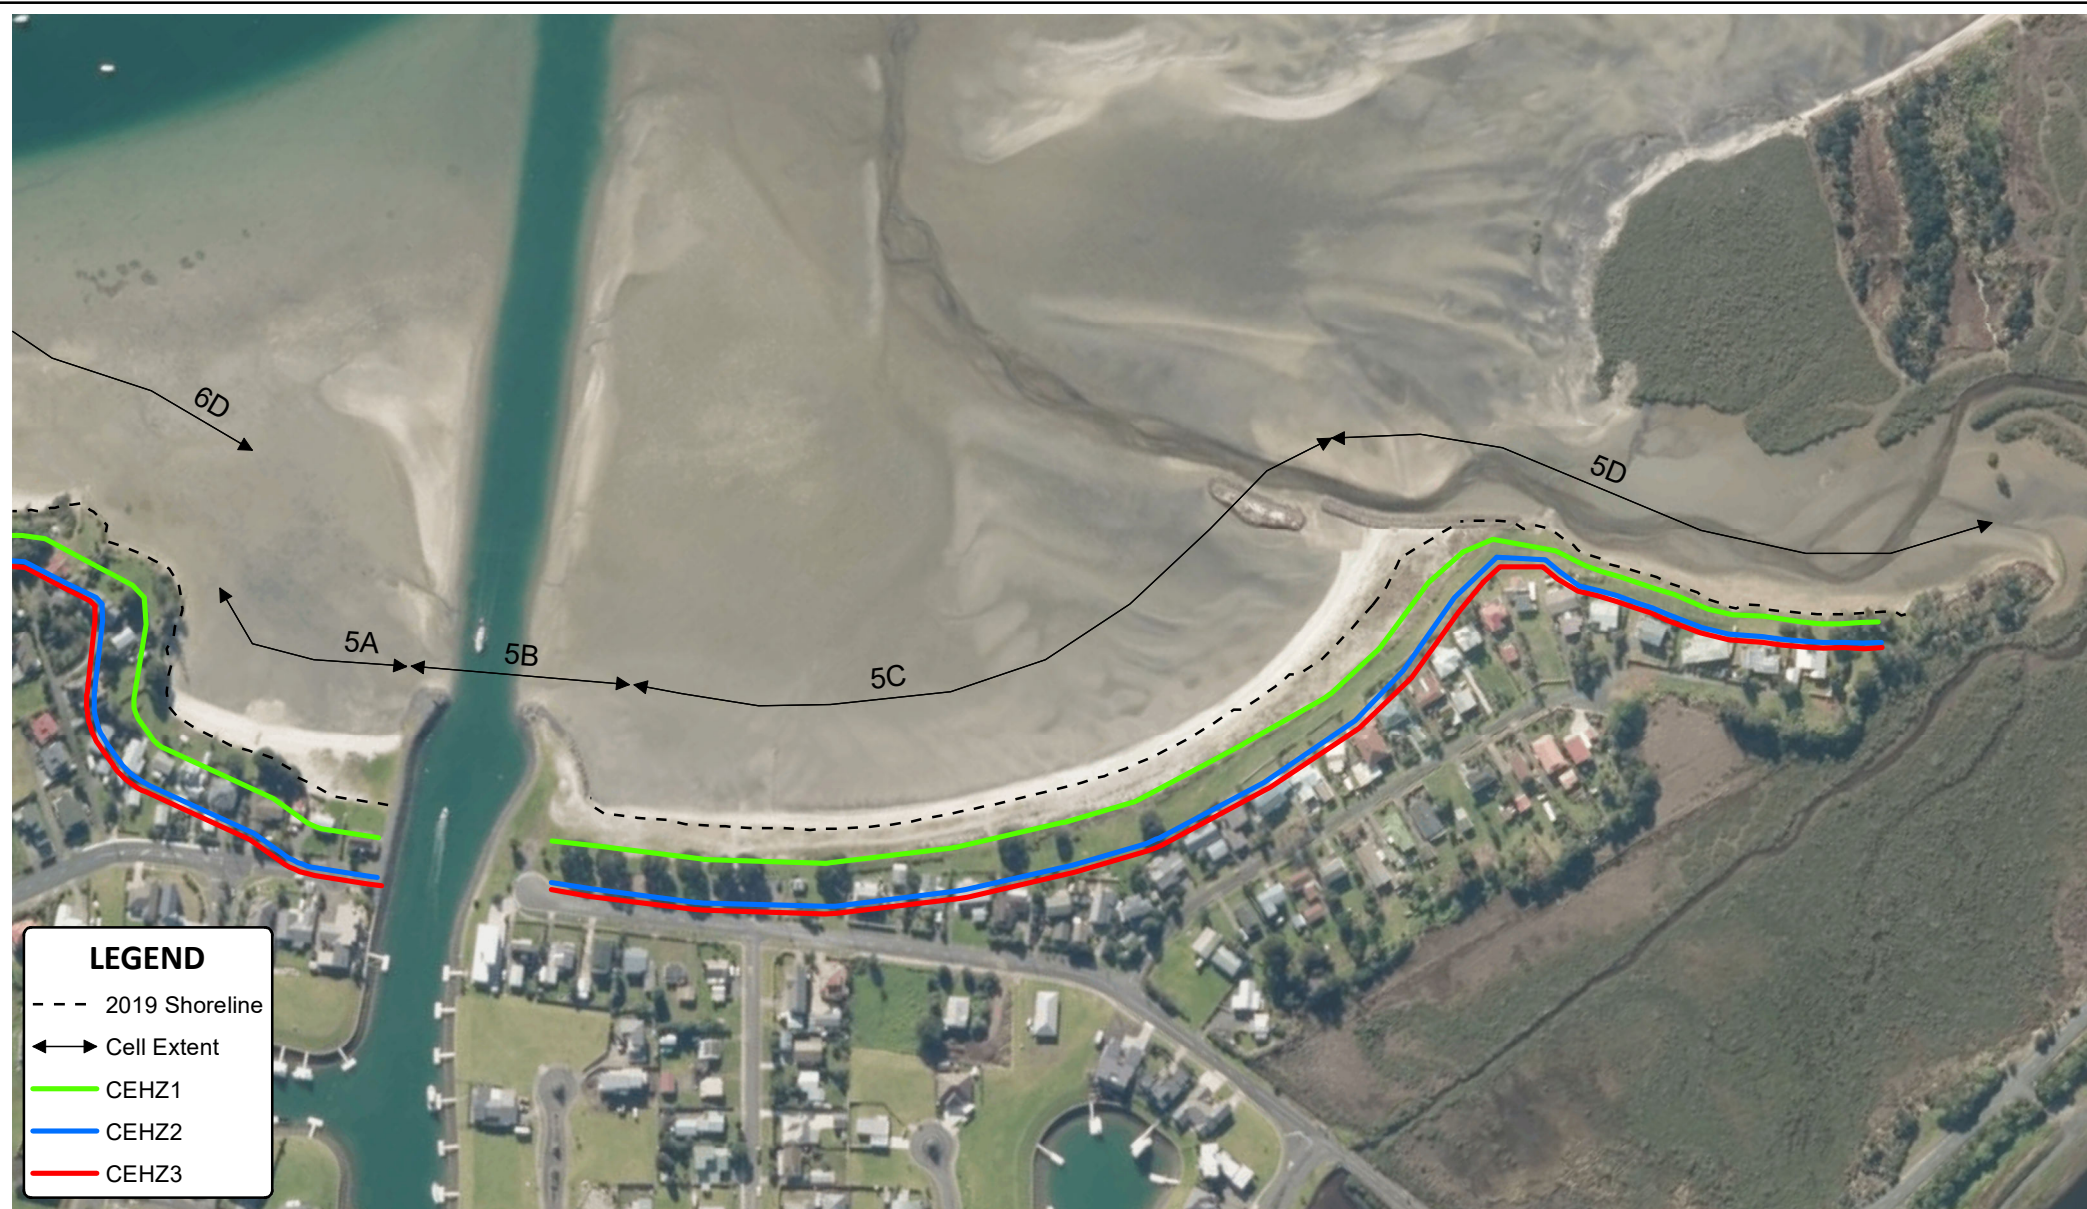
Figure 5-5

Notes: Dashed CEHZ indicates greater uncertainty around stream mouths and backshore topography.
Northland 0.4m Rural Aerial Photos (2014-2016).

CEHZ1 values range from 16 to 18 m. CEHZ2 values range from 38 to 41 m and CEHZ3 values range from 41 to 45 m. CEHZs have been mapped in agreement with the calculated values. Note that cell 5C has experienced accretion since about 1985 over approximately 500 m, with CEHZs offset from the accreted most recent shoreline.

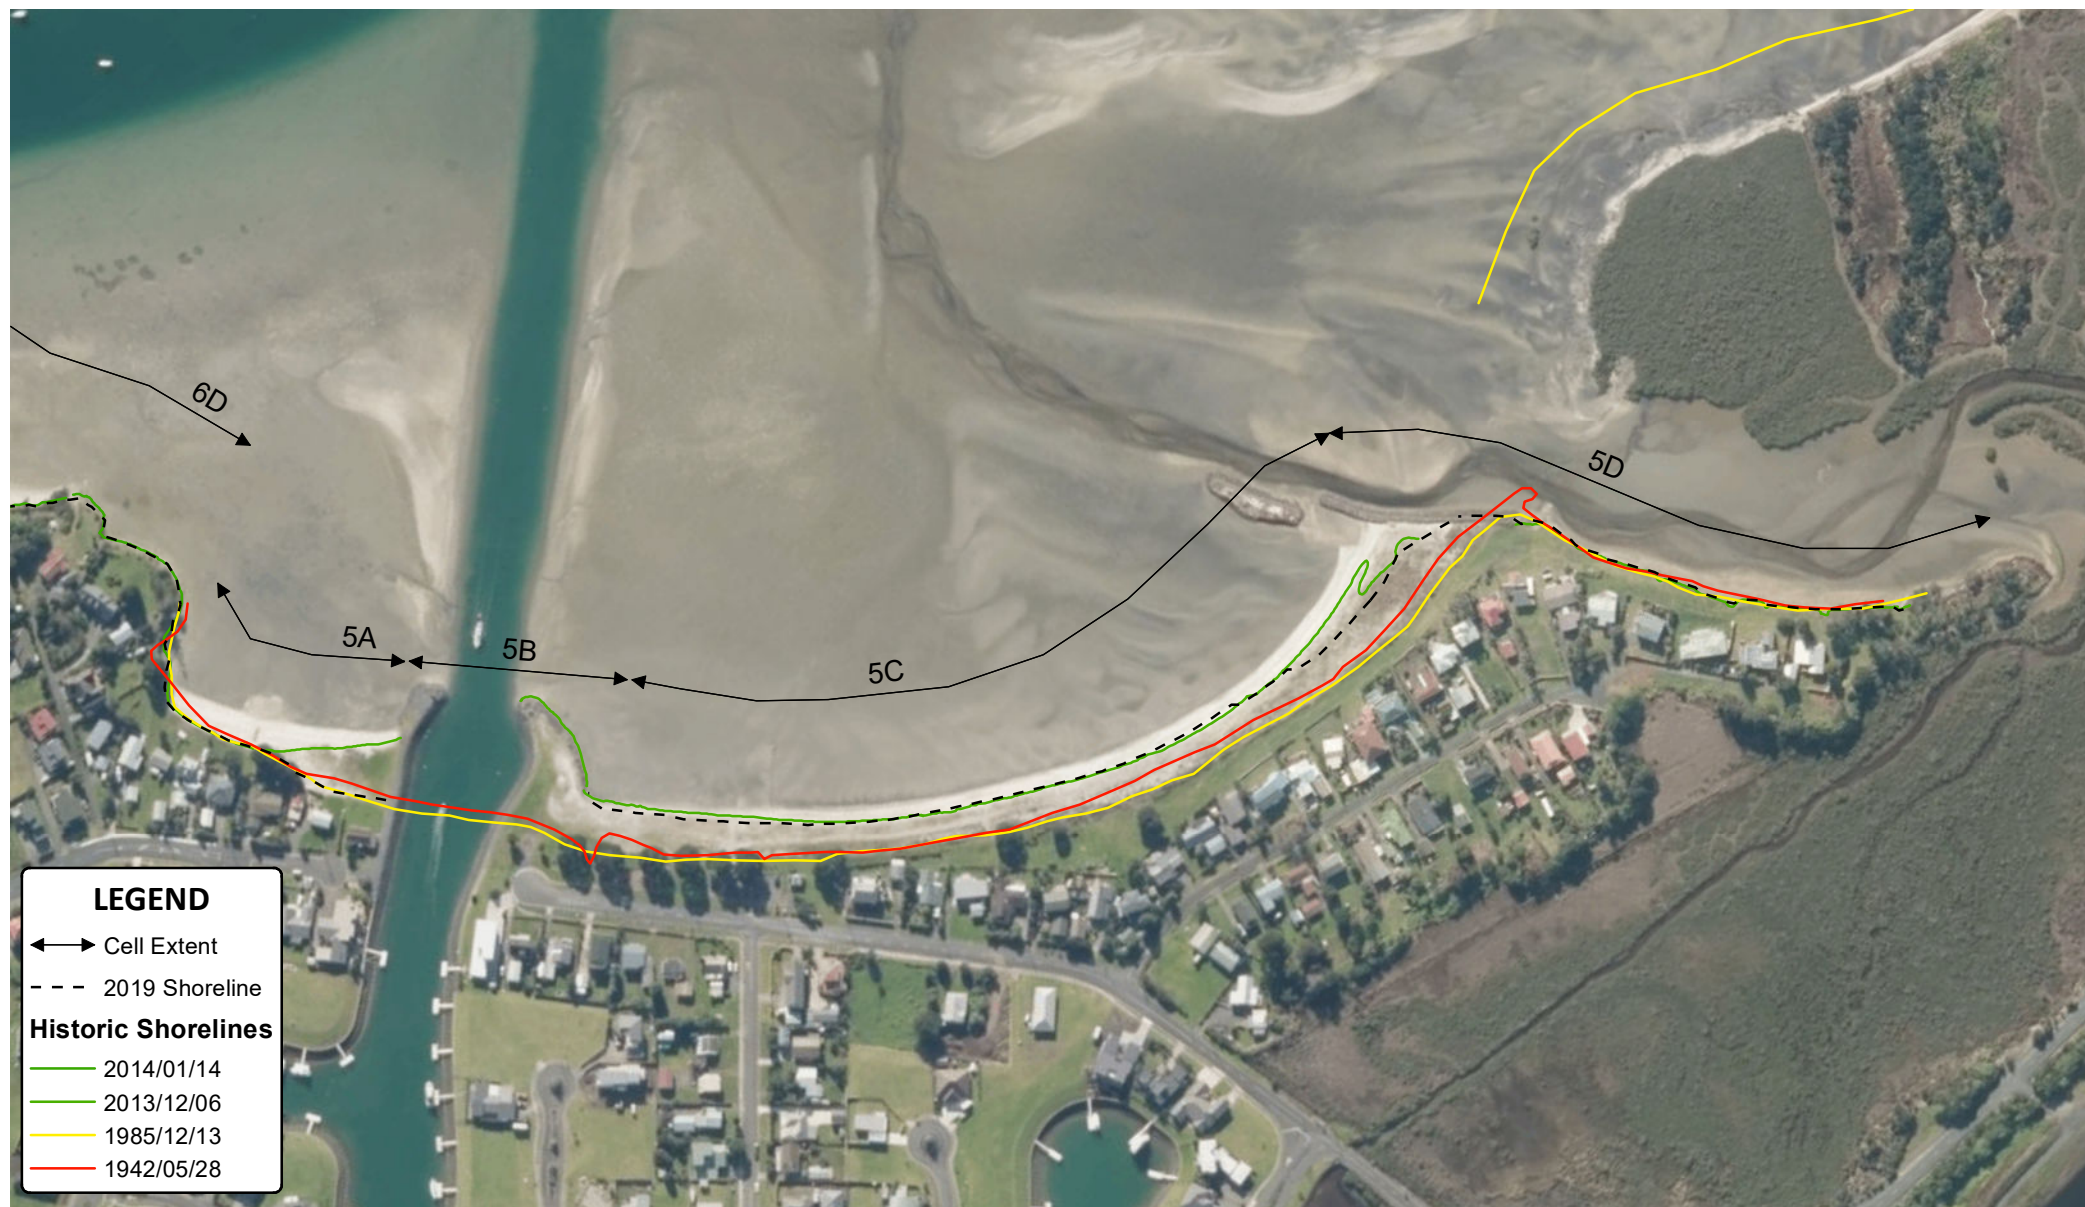
NORTHLAND REGIONAL COUNCIL		
Historic Shorelines		
Marsden Cove		
Site: 5		
FIGURE No.	Figure 5-6	Rev.
		1

Figure 5-6 shows the available historic shorelines for Marsden Cove.
