4. Karikari Peninsula, central and east

4.1 Horahora Dune lake (central and east Northland), NRC Lake No. 199A; visited in 2008

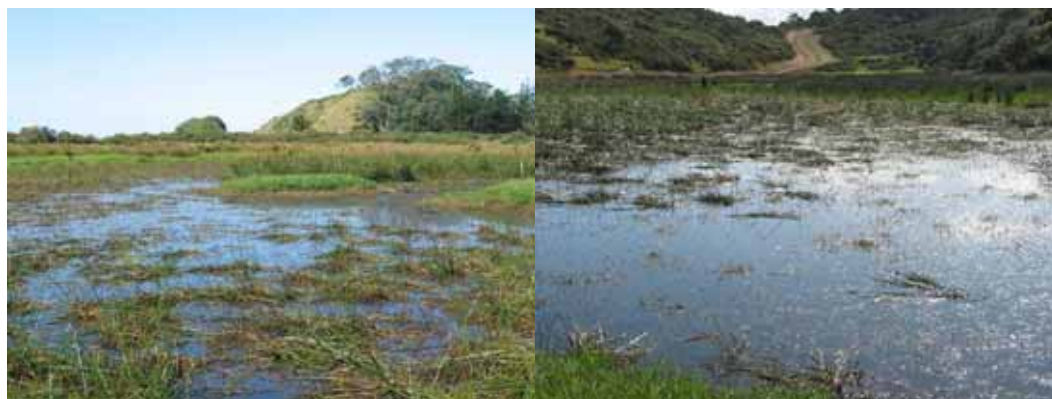
Plate: Horahora Dune Lake, Ngunguru

Horahora Dune lake (1736048E, 6051806N) was almost dry when visited, with two shallow (0.5 m deep) ponds <1ha in area. The lake is situated on the northern side of the Horahora River mouth accessed through private Maori land. The catchment was rough pasture and scrub, with a 3 ha wetland fringe around some of the lake.

No further monitoring.

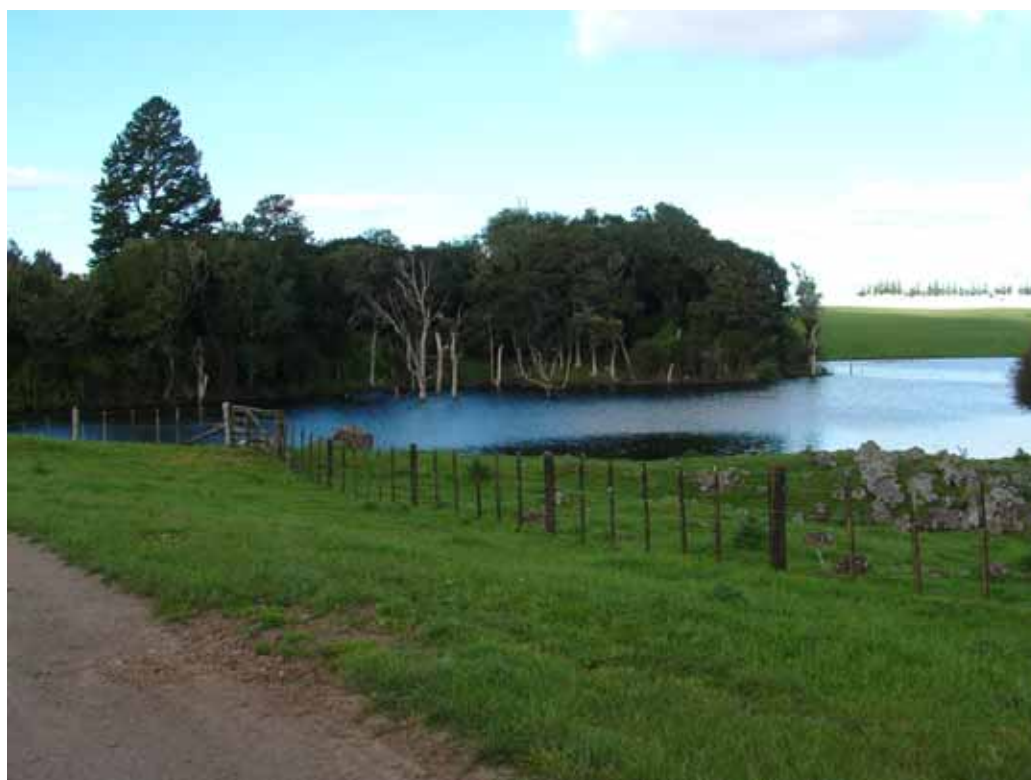
Plate: Access point showing forest remnant at the northern end of Jack's Lake.

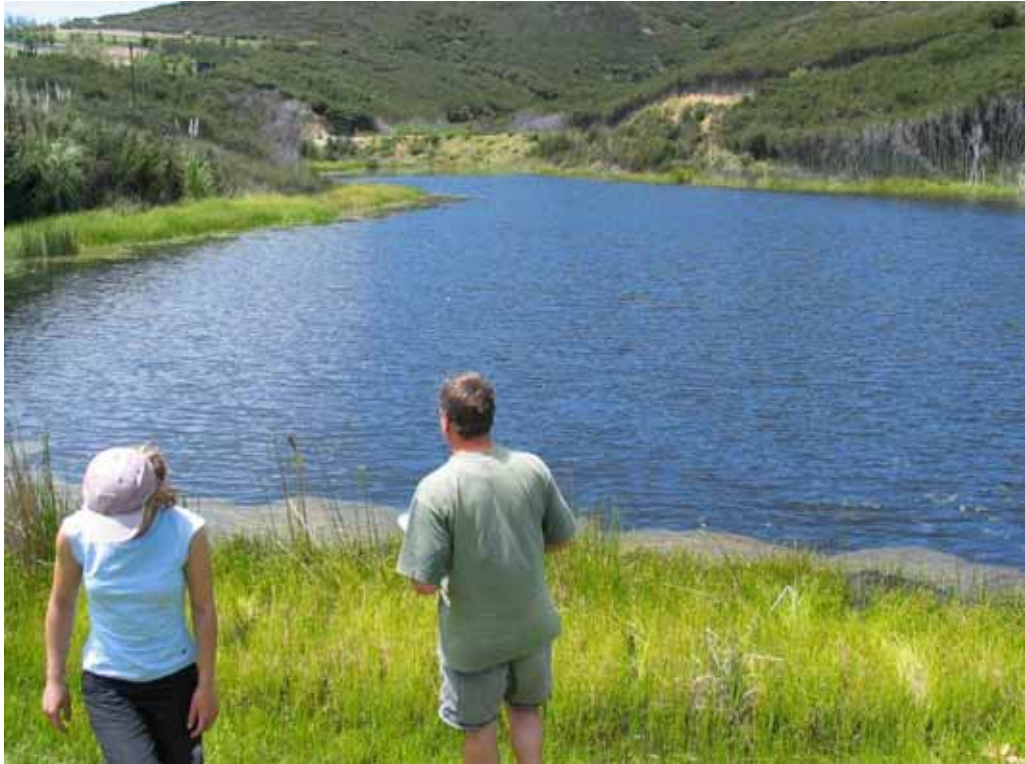
Plate: Roadside pond at Matai, note the sprawling *Isolepis prolifer* margin (light green), contiguous mat floating mats of *Utricularia gibba* around the pond (pale brown) and floating leaves of swamp lily (*Ottelia ovalifolia*).

Utricularia gibba is abundant, the only known site on the Karikari Peninsula.

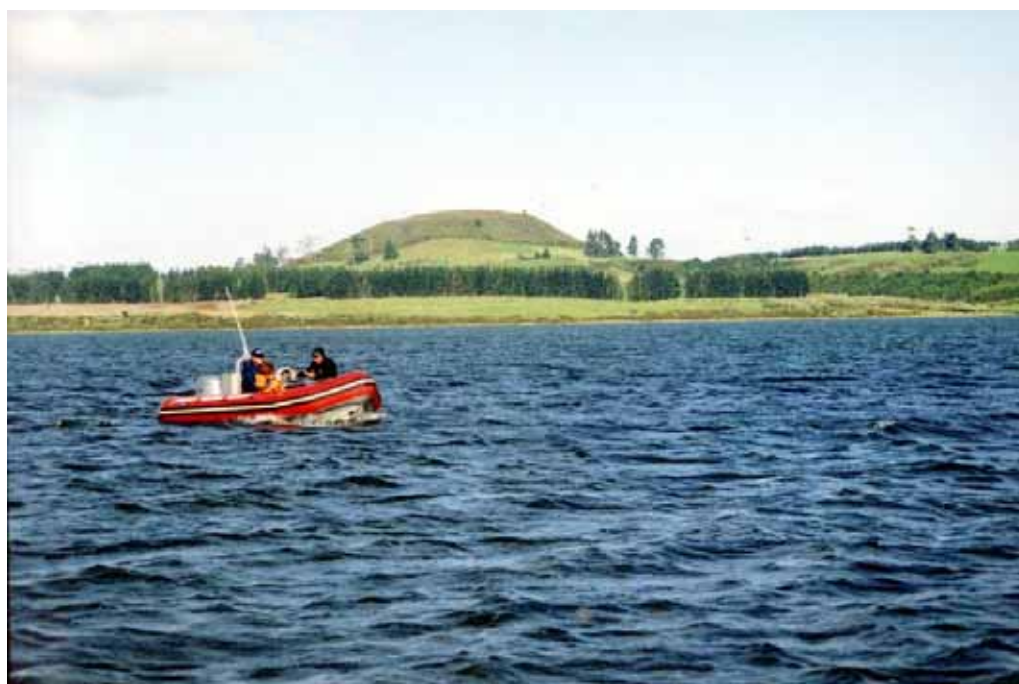
Plate: Lake Omapere showing the mostly pastoral catchment.

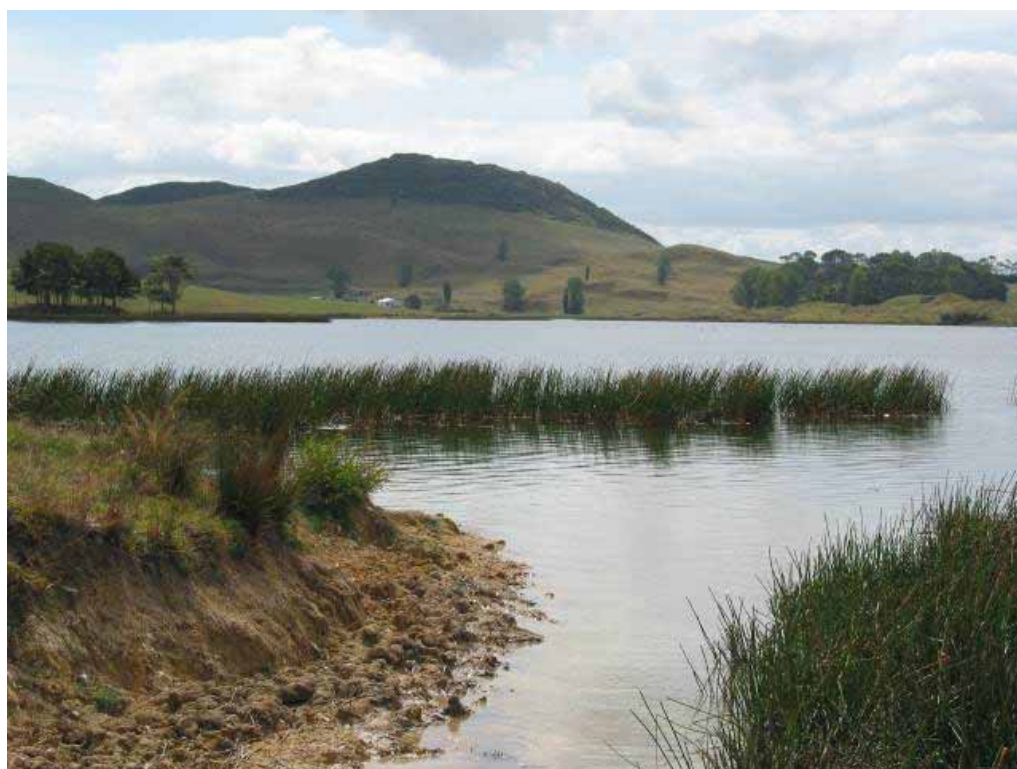
Plate: Lake Owhareiti margin showing pasture margins and emergent beds of *Eleocharis sphacelata*.

There was a fringe of emergent vegetation around much of the lake, 5-10 m across to 2.5 m deep. It was dominated by *Eleocharis sphacelata* with lesser amounts of *Baumea articulata*. There is cattle access to much of the lake.

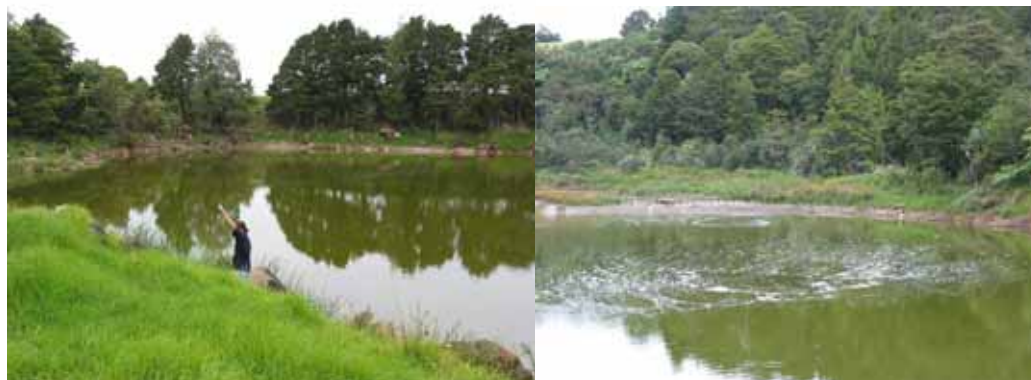
Plate: A lake with few submerged and emergent plants.

Low: Very low water clarity prevents submerged vegetation establishing and there was little marginal vegetation.

No monitoring. Consider marginal planting and lake restoration.

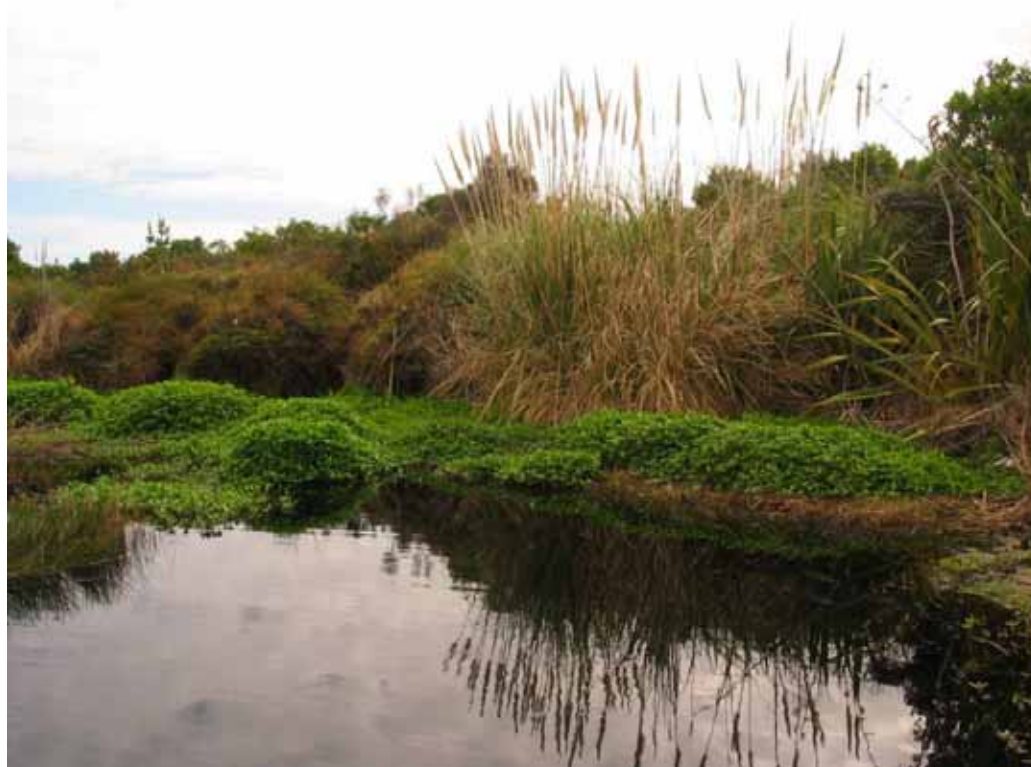
Plate: Margin of Lake Rotokawau East showing floating mats of the pest plant alligator weed (*Alternanthera philoxeroides*) with clumps of wire rush (*Empodisma minus*) (left), pampas (*Cortaderia selloana*) (mid-right) and flax (*Phormium tenax*) (right) in the marginal vegetation behind this. Note the humic-stained water.

There was a narrow fringe of emergent vegetation around much of the lake, mostly < 5 m across. Large floating rafts of the exotic alligator weed (*Alternanthera philoxeroides*) were noted around the access point. These were interspersed with clumps of *Eleocharis acuta*, *Baumea juncea*, *Schoenoplectus tabernaemontani*, *Typha orientalis*, *E. sphacelata* and *Phormium tenax*. Immediately adjacent to this was bog/heath vegetation dominated by the regionally significant *Empodisma minus*, *Gleichenia dicarpa*, *Schoenus brevifolius* and the scrub weeds, gorse and pampas. The endangered ferns and fern ally, *Todea barbara*, *Cyclosorus interruptus* and *Lycopodiella serpentina* were reported from this marginal area.

Conditions would not favour the establishment of other pest plants. Alligator weed is well established and beyond control.

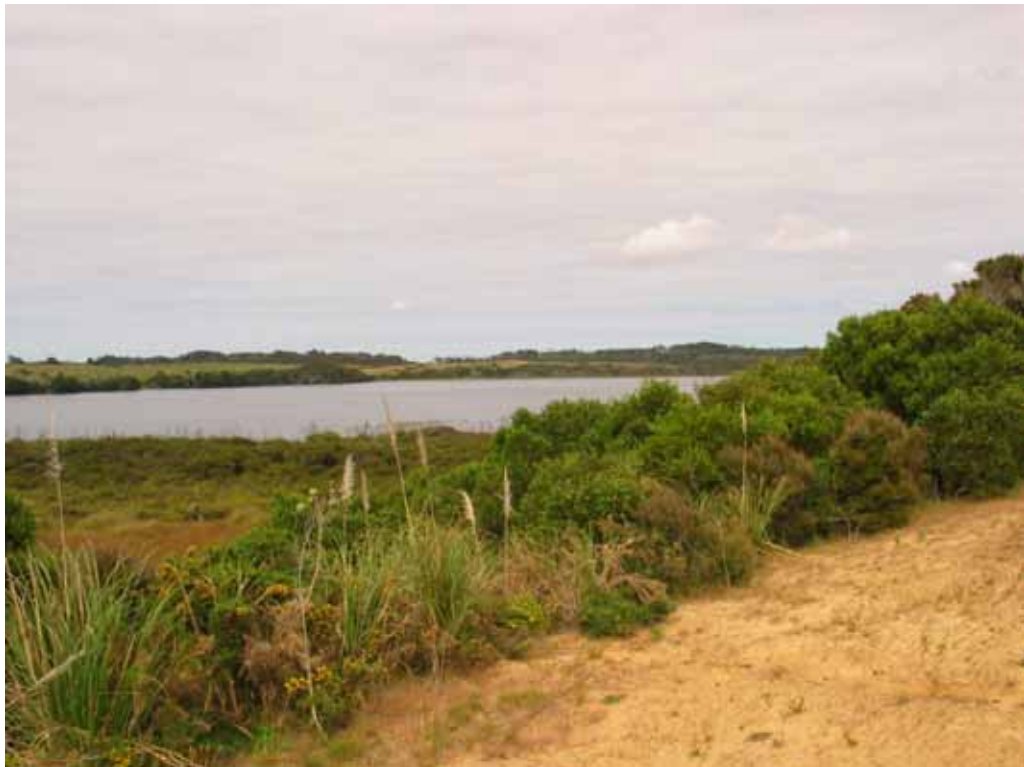
Plate: Lake Rotokawau West from the north-east. Note the beach ridge with scrub vegetation (right) and wetland area separating the two Rotokawau lakes.

There was a narrow fringe of emergent vegetation around much of the lake, mostly < 5 m across. Large floating rafts of the exotic alligator weed (*Alternanthera philoxeroides*) were noted. These were interspersed with clumps of *Eleocharis sphacelata*, *Baumea juncea*, *B. arthrophylla* and *Phormium tenax*. *Sphagnum* sp. formed a wetland area on the landward side of the emergent zone.

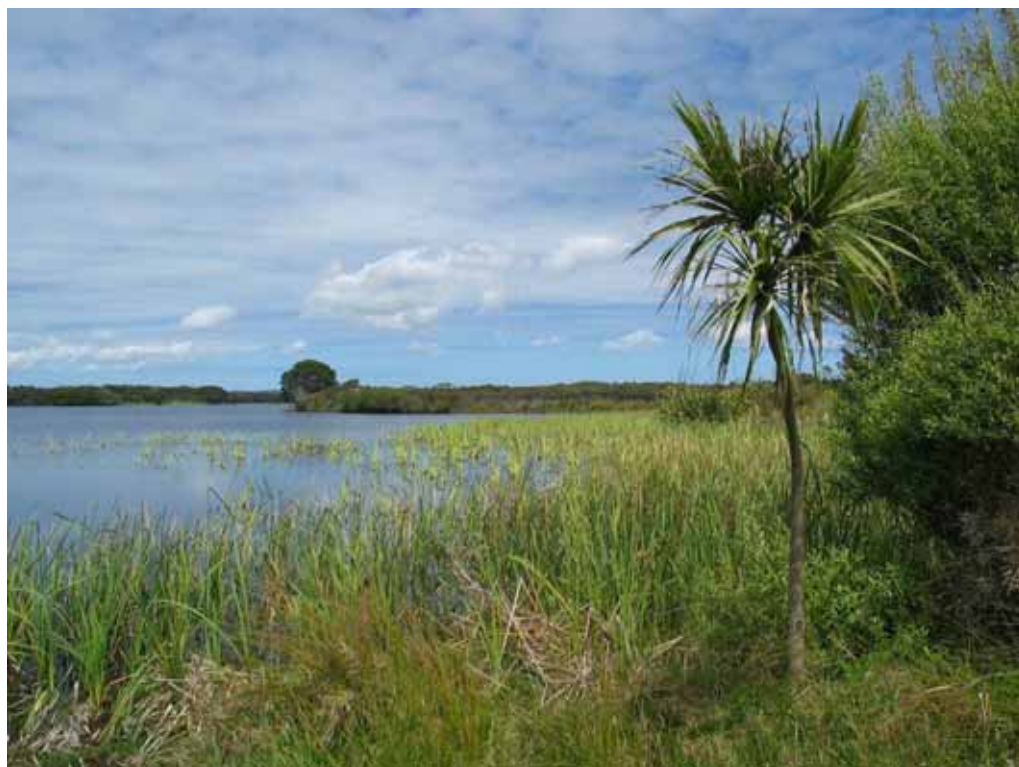
Plate: Lake Rotopokaka. Note *Typha orientalis* dominated emergent vegetation with manuka scrub in the background.

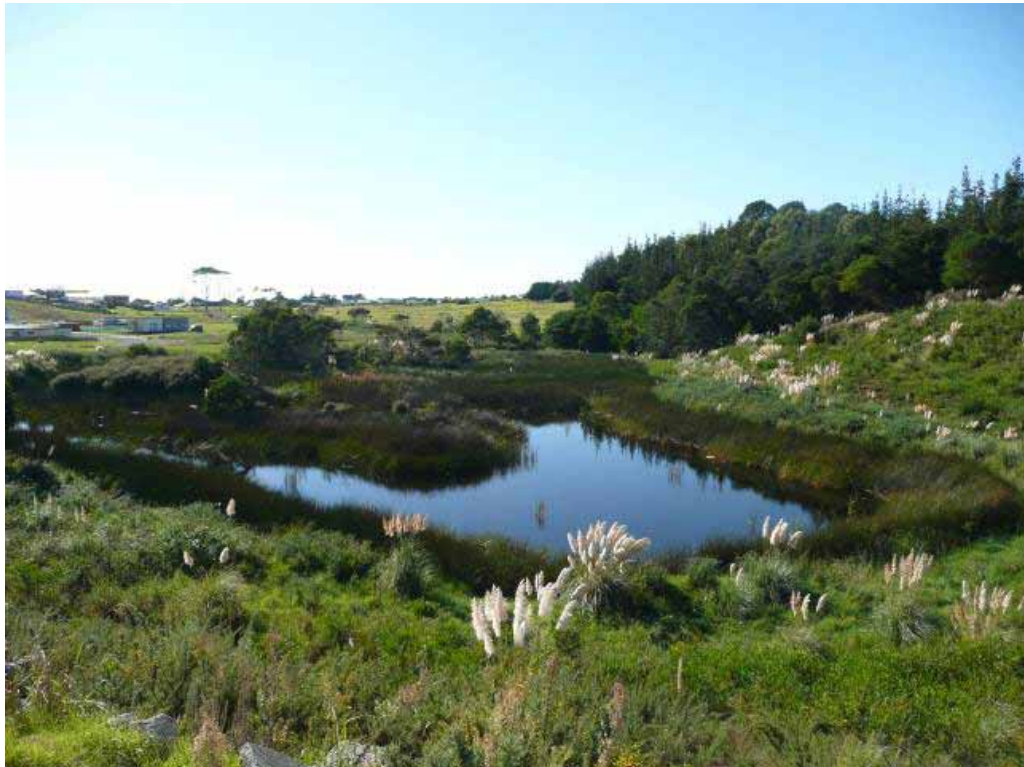
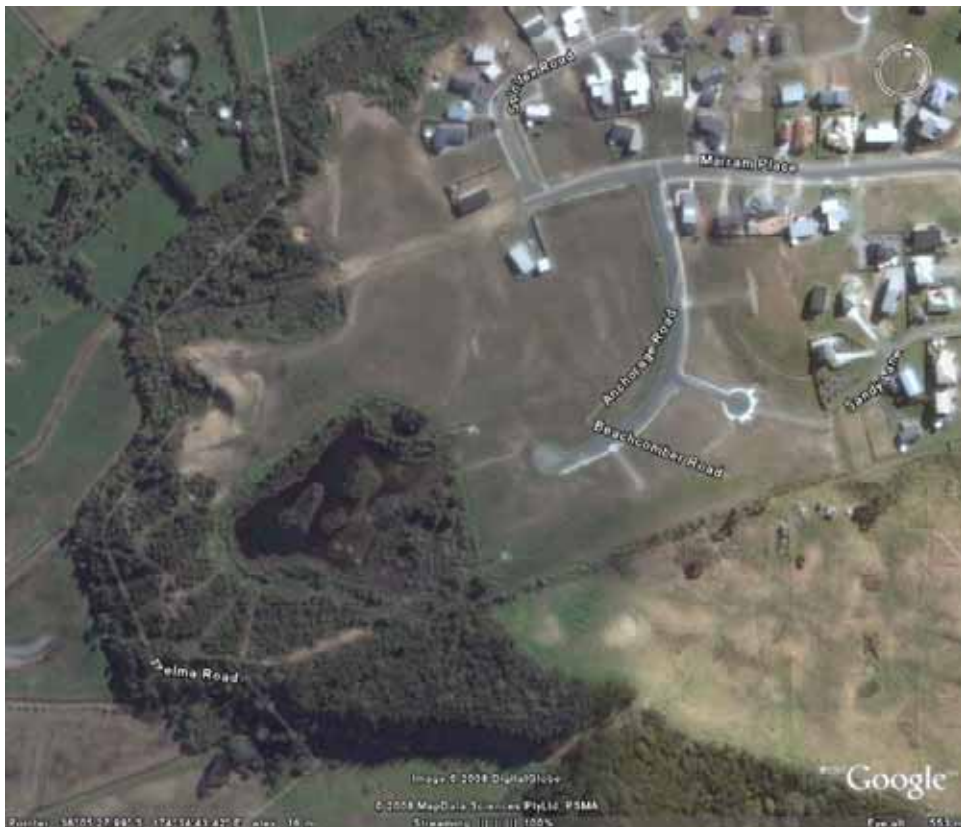
Plate: Lake Sands is a dune lake now within an area for which residential development is planned.

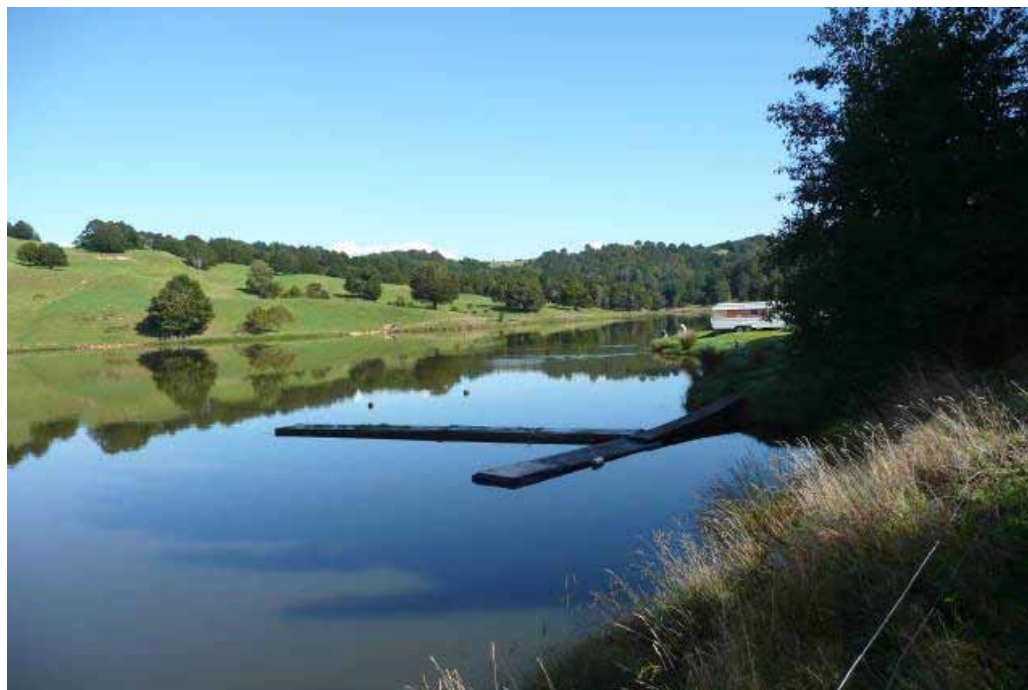
Plate: Smiths Dam, Hikurangi.

Very poor water clarity prevented visual assessment, and insufficient light would prevent plant growth if sustained for several months. No submerged plants were found by dragging the bottom with a grapnel.

The dam was of very low ecological value and is unlikely to deteriorate further.

No further monitoring.

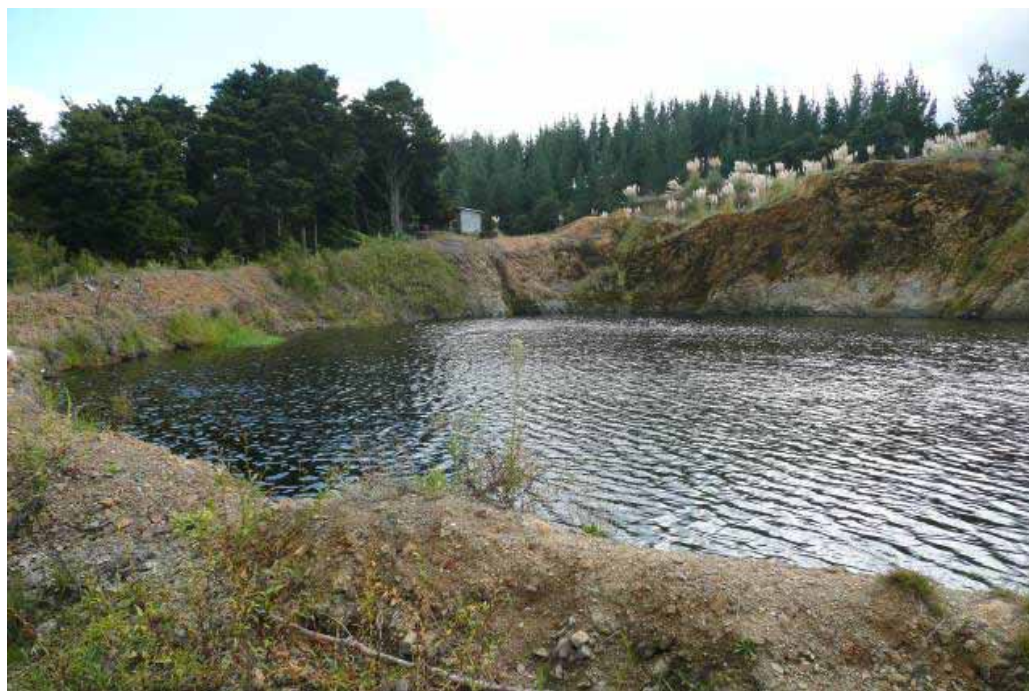
Plate: The Taupiri Rd quarry lake with minimal marginal vegetation and no inflow or outflow.

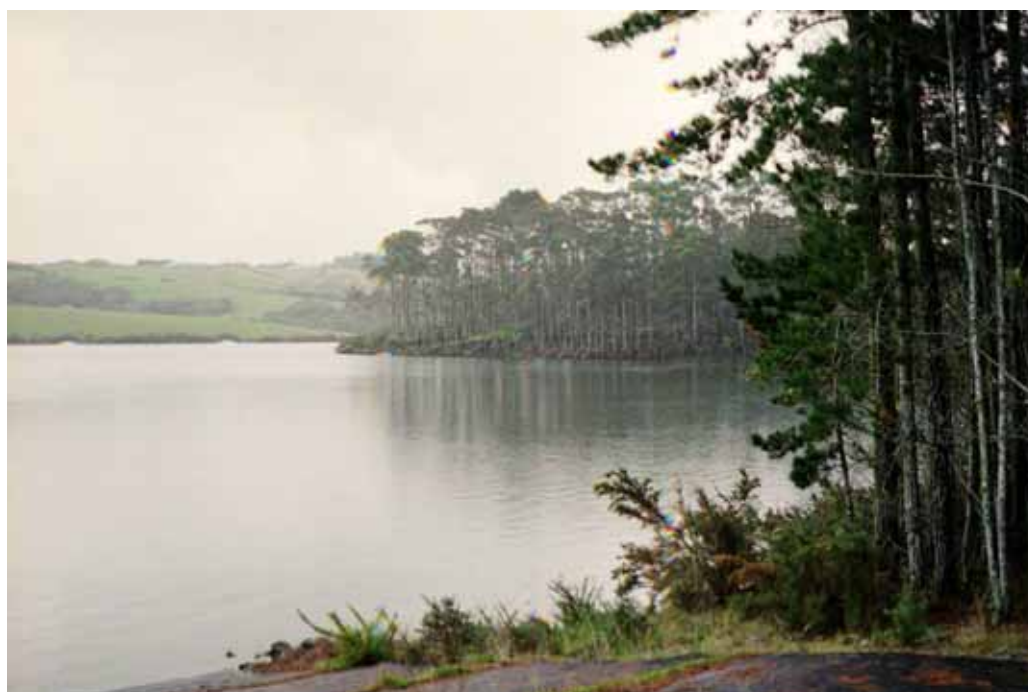
Plate: Lake Waingaro showing the dam edge and planted pines.

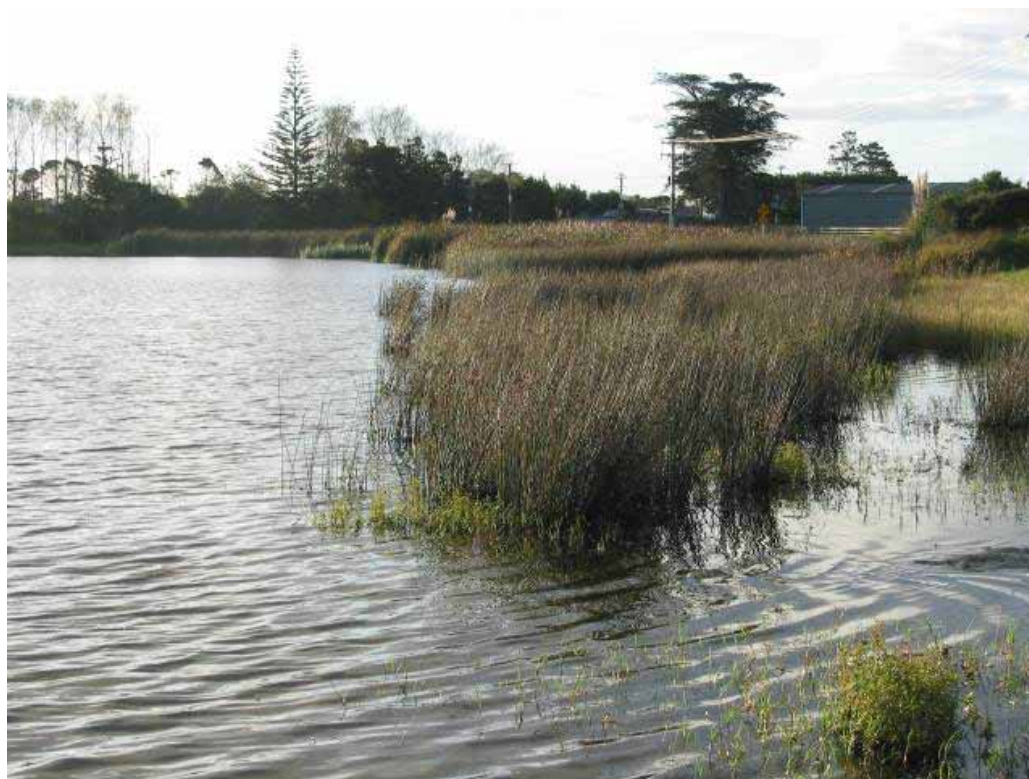
Plate: Lake Waiporohita showing emergent communities on the east side of the lake accessible from the road.

A 2 m² patch of alligator weed (*Alternanthera philoxeroides*) was noted in 2005 at the north end where there was an access point. In 2010 this area had increased and it was also found amongst the marginal emergent vegetation at the north-east edge of the lake.

Attempt eradication of alligator weed.

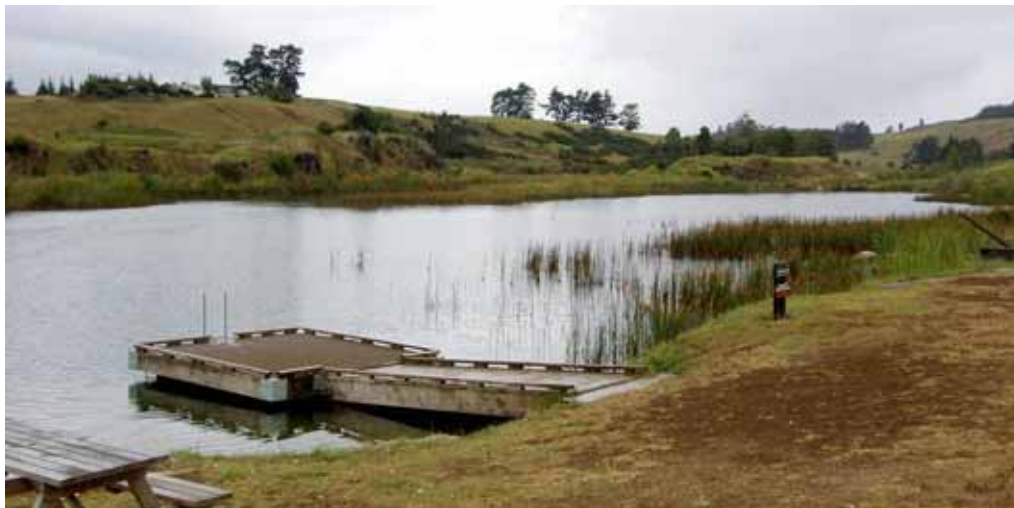
Plate A: Lake Waro is a recreational park and used for contact recreation, particularly swimming. It is not used for boating, but would be a prime site for further alien pest liberations.

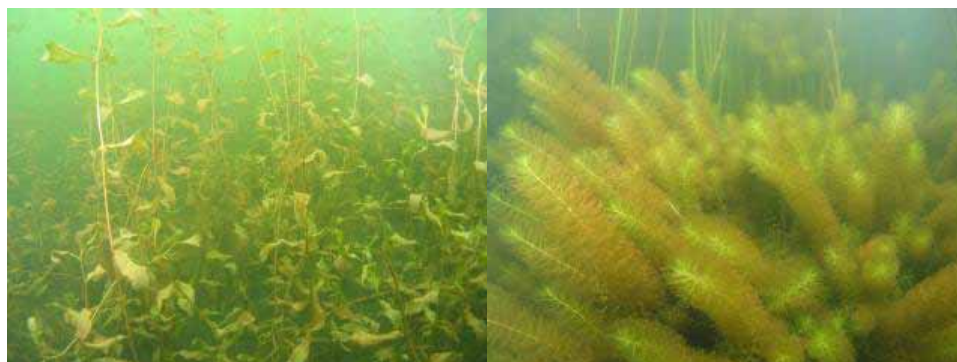
The plants were large-leaved and quite robust, probably reflecting the higher calcium content of the water in this limestone quarry.

Plate B: The plants were large-leaved and quite robust looking; *Potamogeton cheesemanii* left and *Myriophyllum propinquum* on the right.

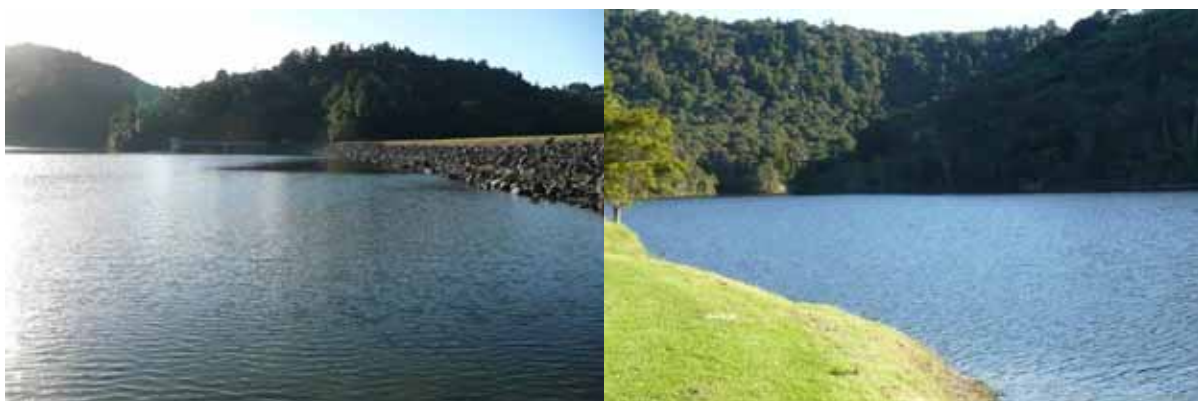
Plate: The Whau Dam (left) and looking away from the dam (right).
