24 Hihi

Coastal Erosion Hazard Assessment

NORTHLAND REGIONAL COUNCIL
 Coastal Erosion Hazard Assessment
 Hihi
 Site: 24

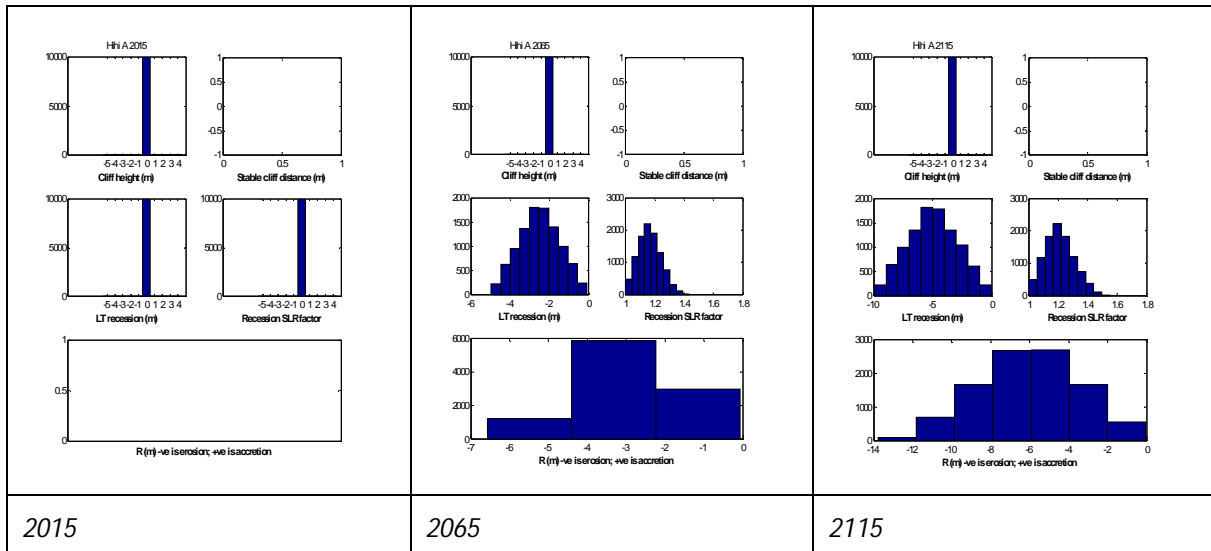
Figure 24-1 Histograms of parameter samples and the resultant shoreline distances for 2015, 2065 and 2115 timeframes for cell 24A

For cell 24A, 24B and 24F the cliff projection method has been adopted with future shoreline distances shown in Figure 24-1, Figure 24-2, Figure 24-6 and Table 24-2 instead of CEHZ distances. The future cliff toe distances range from 2 to 19 m to 2065 and 10 to 81 m to 2115.

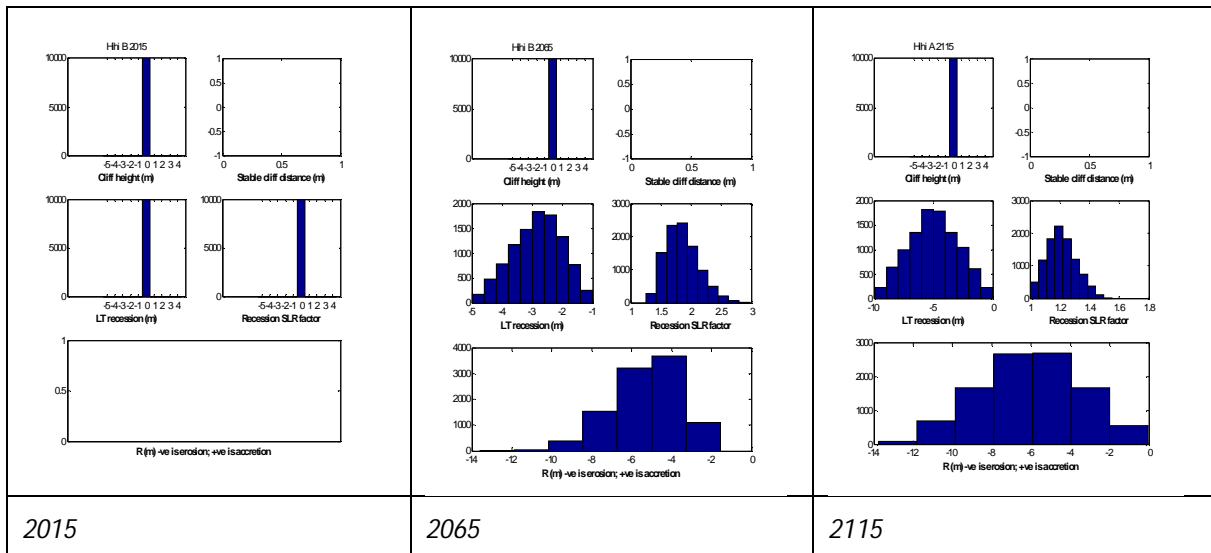
Figure 24-2 Histograms of parameter samples and the resultant shoreline distances for 2015, 2065 and 2115 timeframes for cell 24B

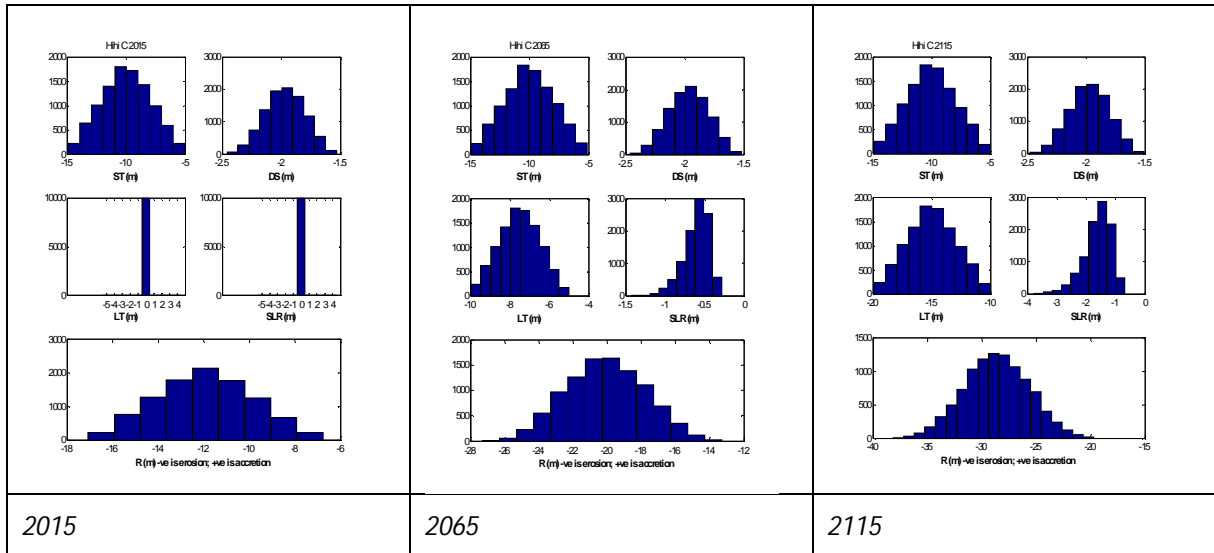
Figure 24-3 Histograms of parameter samples and the resultant shoreline distances for 2015, 2065 and 2115 timeframes for cell 24C

Histograms of individual components and resultant CEHZ distances using a Monte Carlo technique are shown in Figure 24-3 to Figure 24-5. Coastal Erosion Hazard Zone widths are presented within Table 24-2 and Figure 24-7.

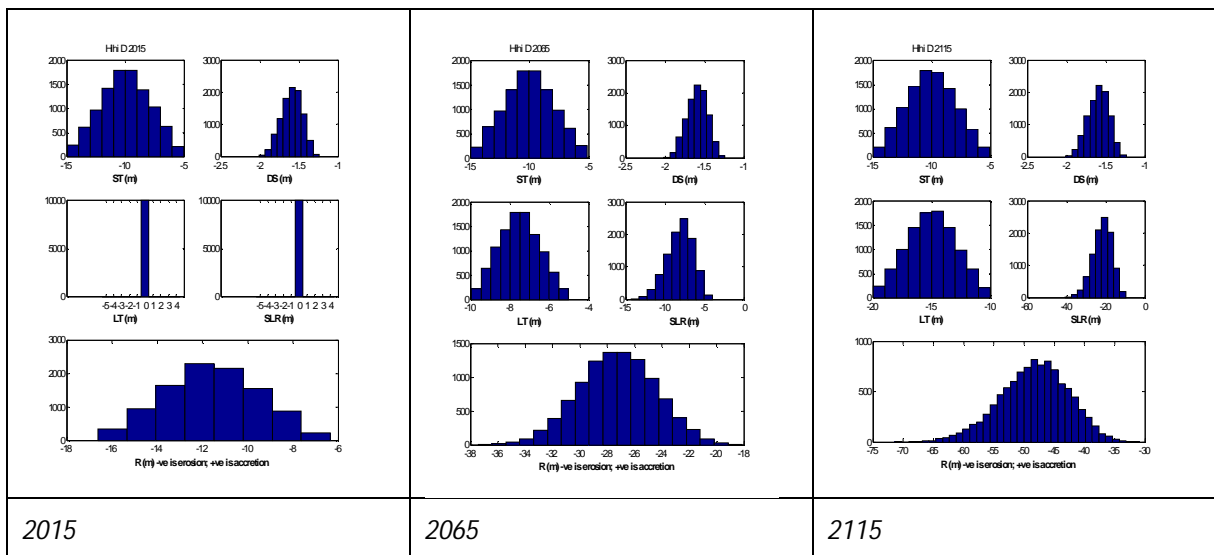
Figure 24-4 Histograms of parameter samples and the resultant shoreline distances for 2015, 2065 and 2115 timeframes for cell 24D

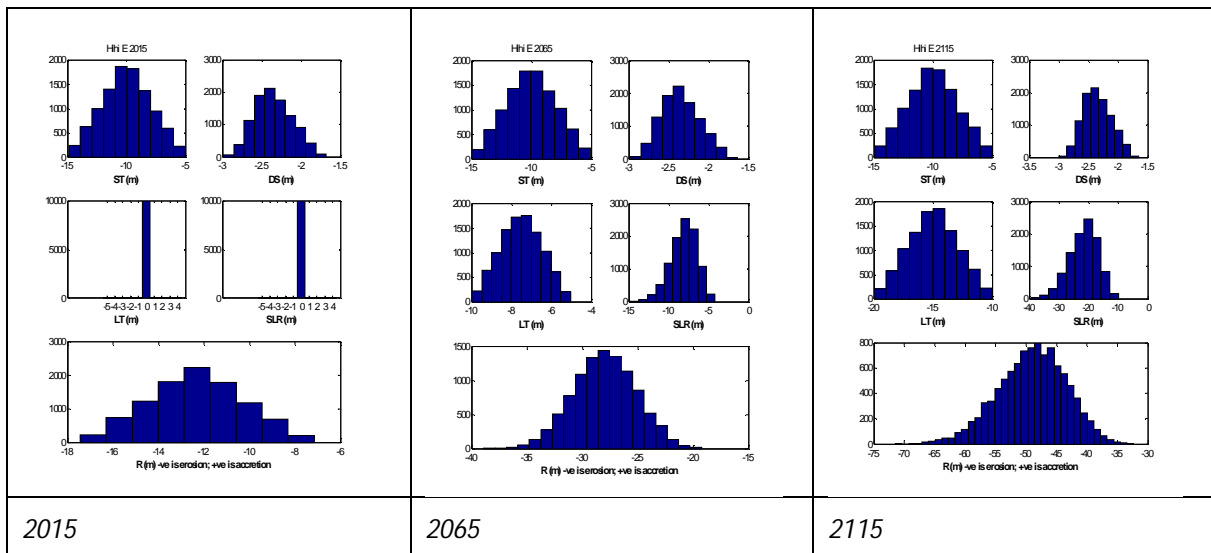
Figure 24-5 Histograms of parameter samples and the resultant shoreline distances for 2015, 2065 and 2115 timeframes for cell 24E

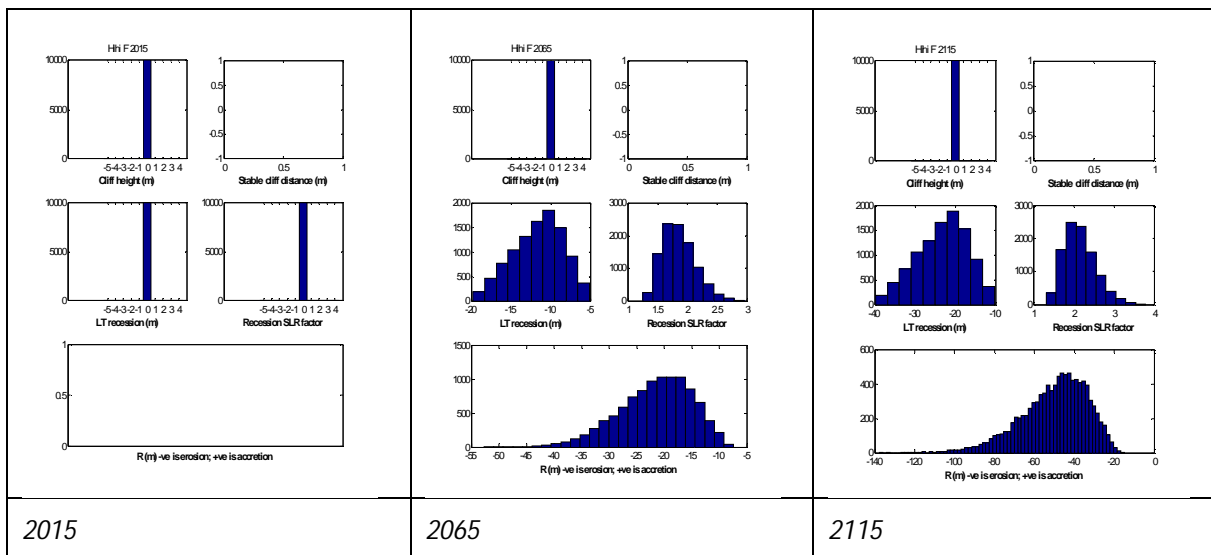
Figure 24-6 Histograms of parameter samples and the resultant shoreline distances for 2015, 2065 and 2115 timeframes for cell 24F

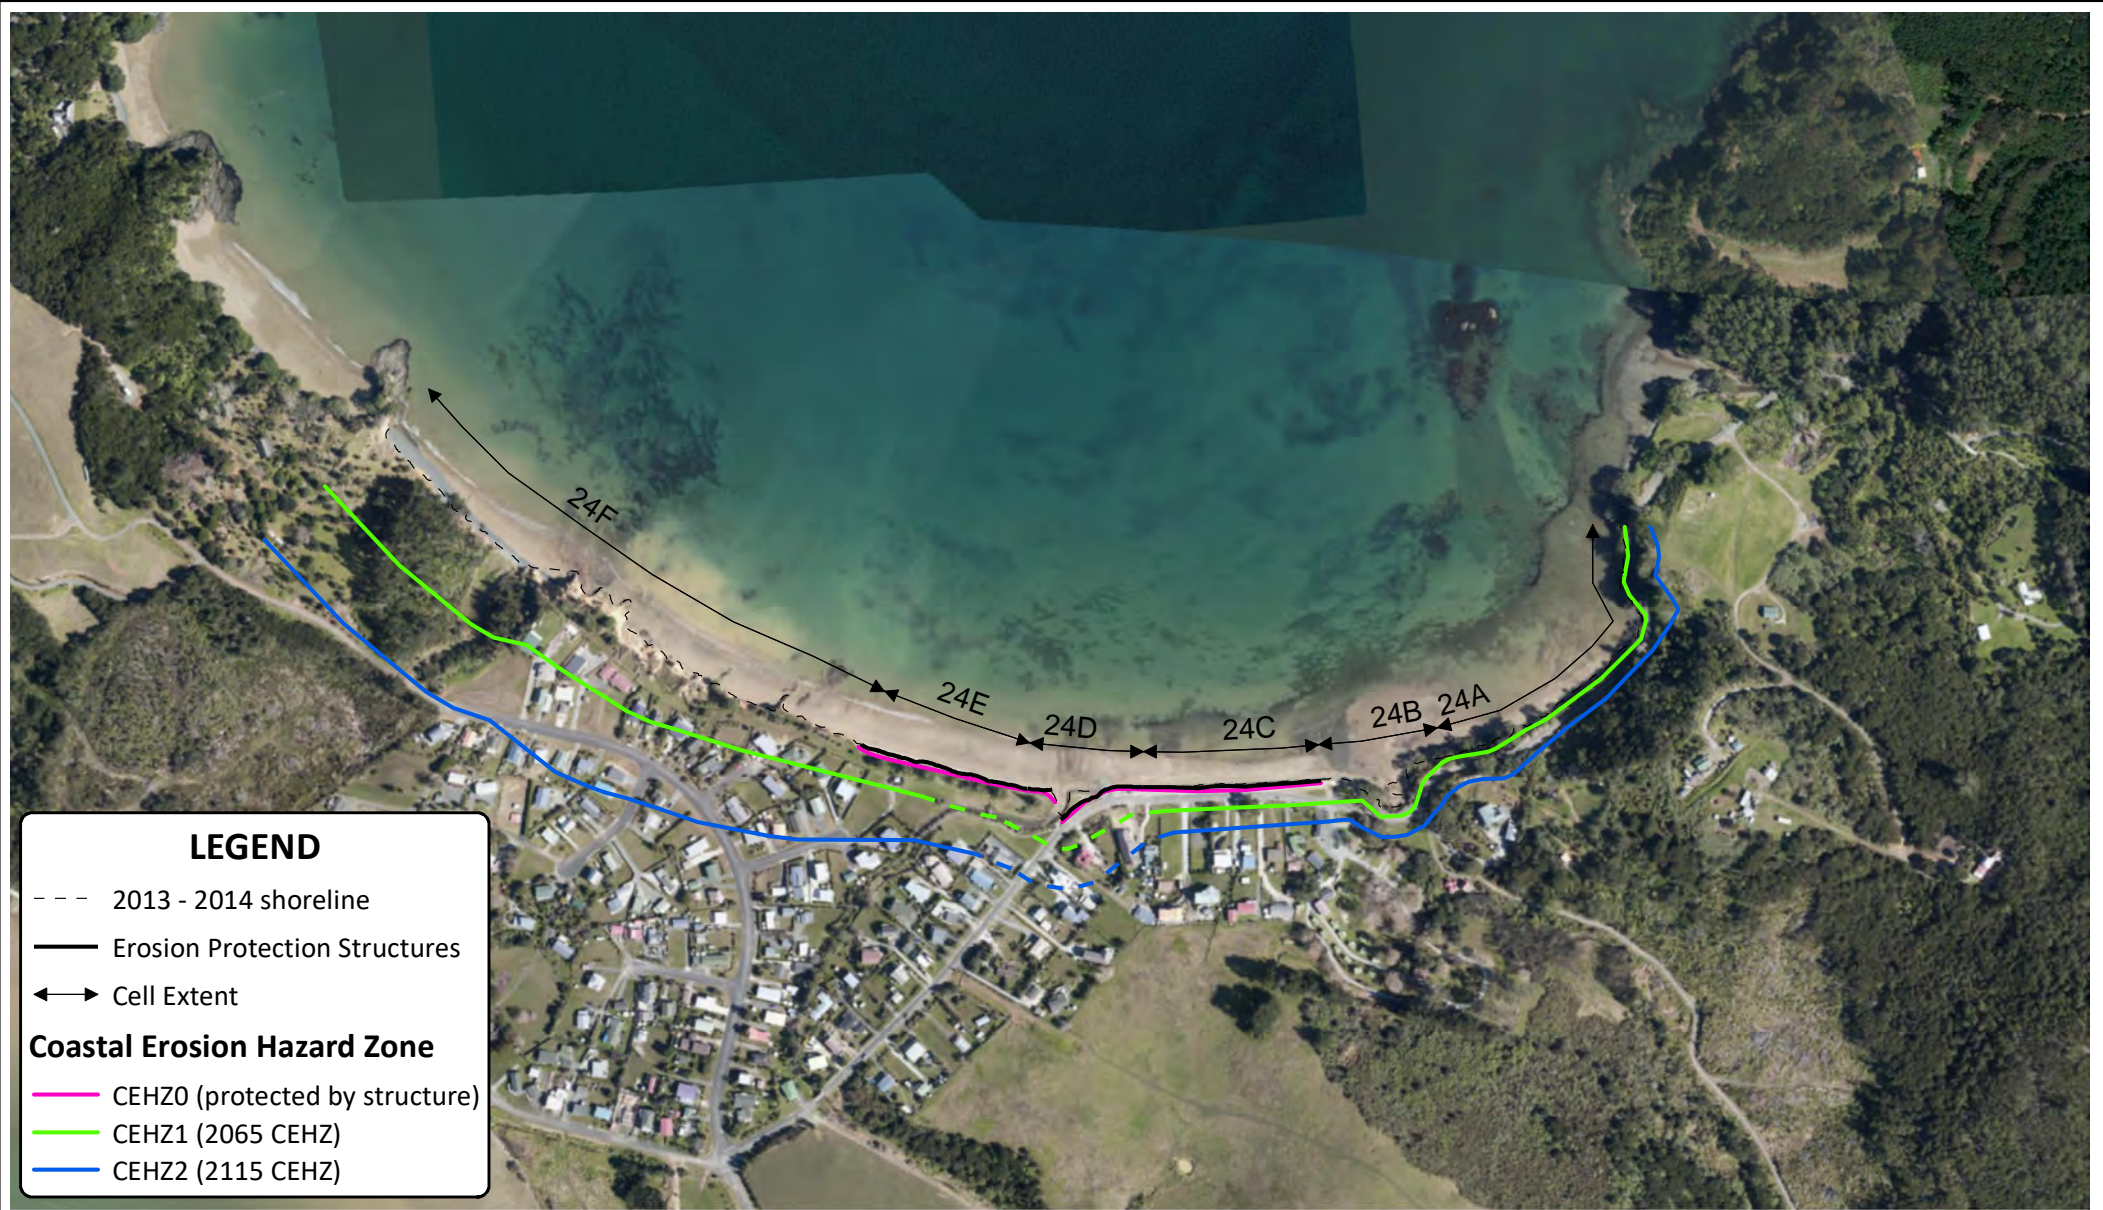
FIGURE No. Figure 24-7

Notes: Dashed CEHZ indicates greater uncertainty around stream mouths and backshore topography. Northland 0.1m Rural Aerial Photos (2014-2015).

CEHZ1 values range from 19 to 27 m. CEHZ2 values range from 34 to 59 m. CEHZ's have been

mapped in agreement with the calculated values. Note that at cell 24D an area with a length of 25 m have likely been reclaimed, with CEHZ offset from the most recent shoreline.

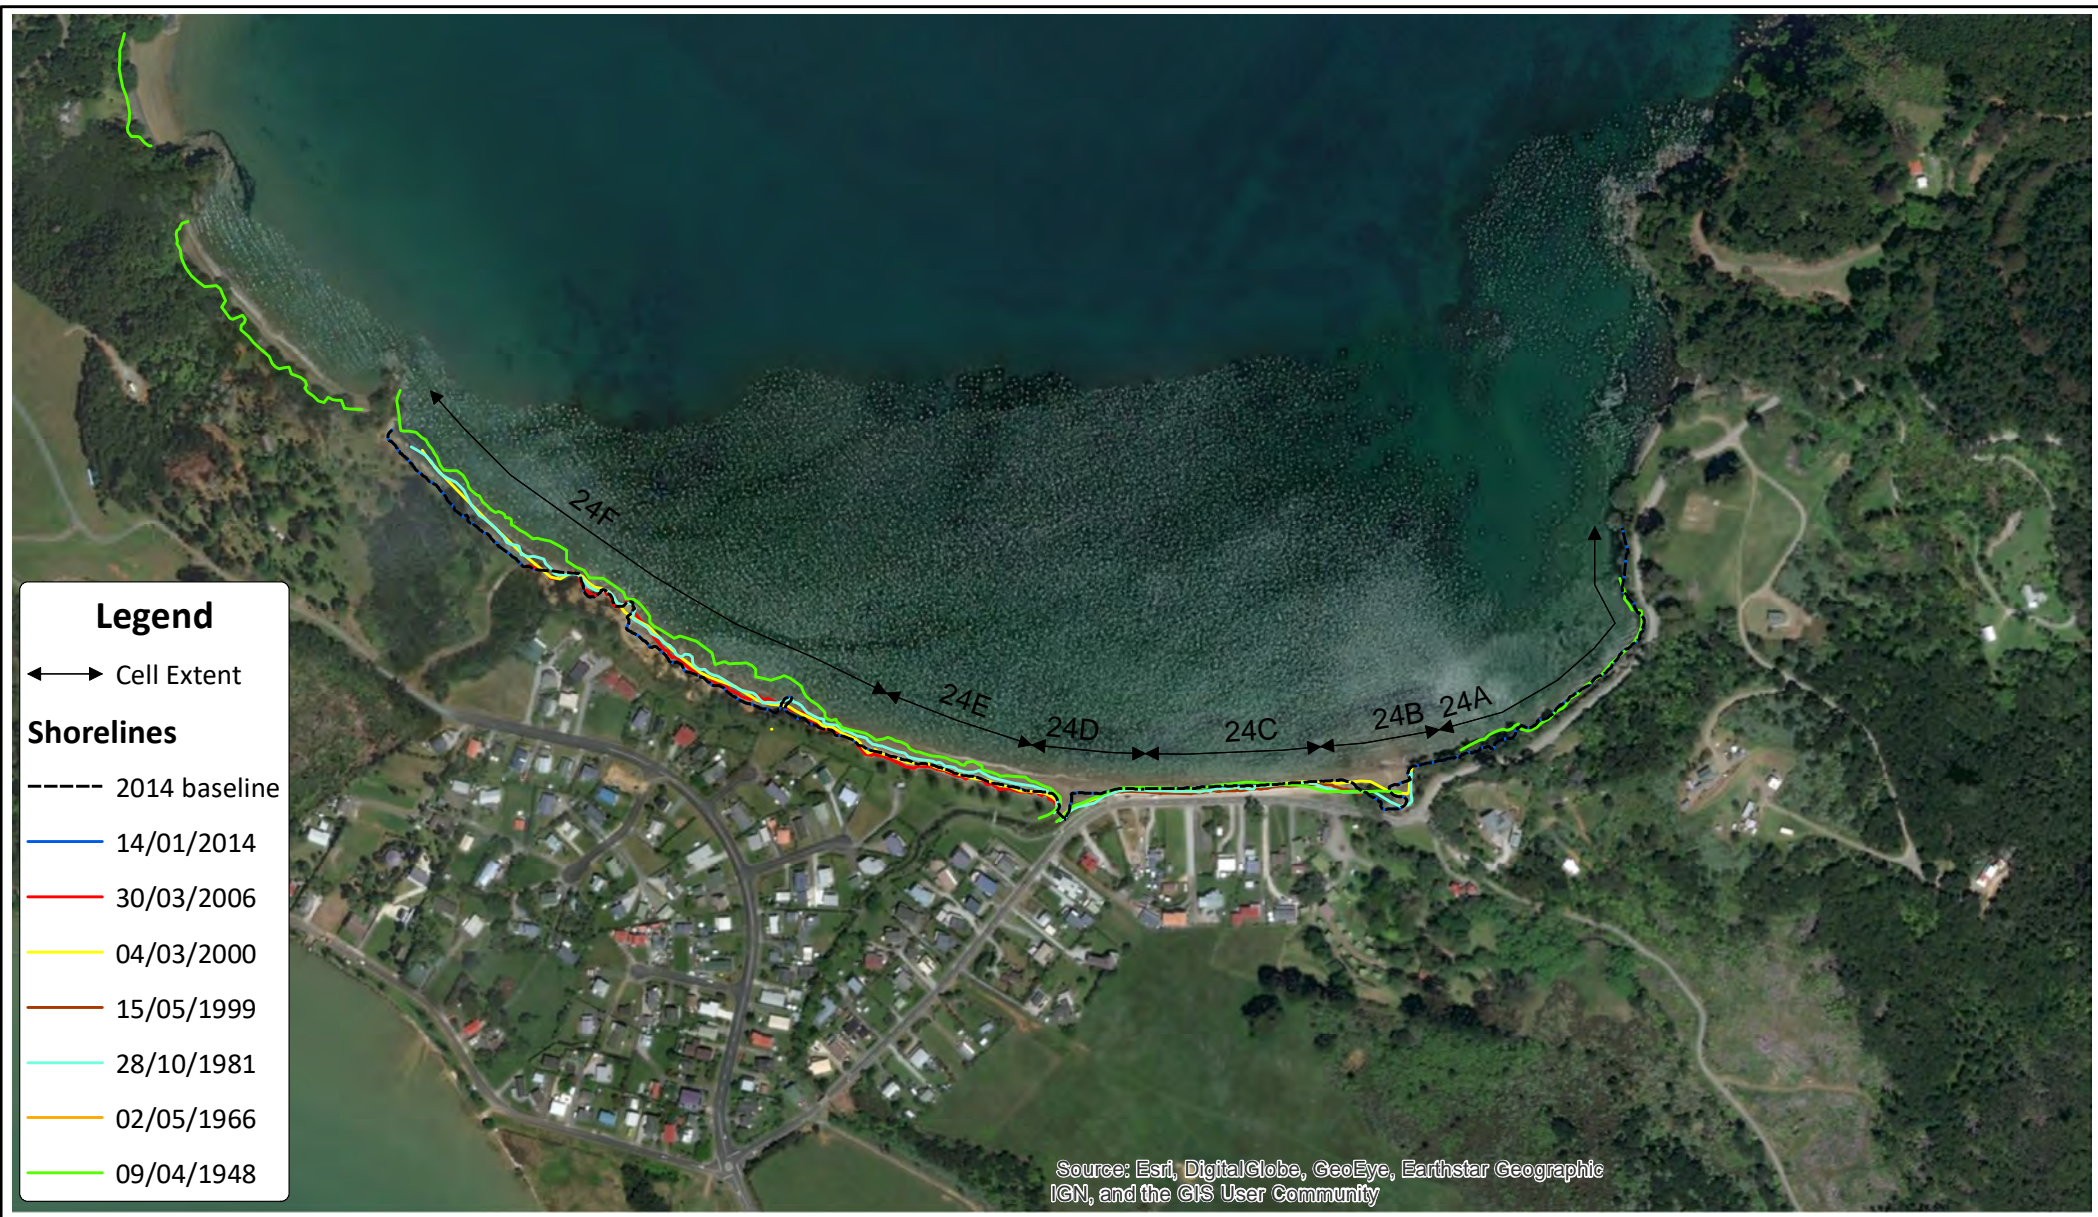
FIGURE No. Figure 24-8	Rev. 2
------------------------	--------

NORTHLAND REGIONAL COUNCIL
Historic shorelines
Hihi
Site: 24

Figure 24-8 shows the available historic shorelines for Hihi.
