Northland Lakes – Pouto Annual Report 2014

Prepared for Northland Regional Council

June 2014

NIWA Client Report No:	HAM2014-081
Report date:	June 2014
NIWA Project:	NRC14205

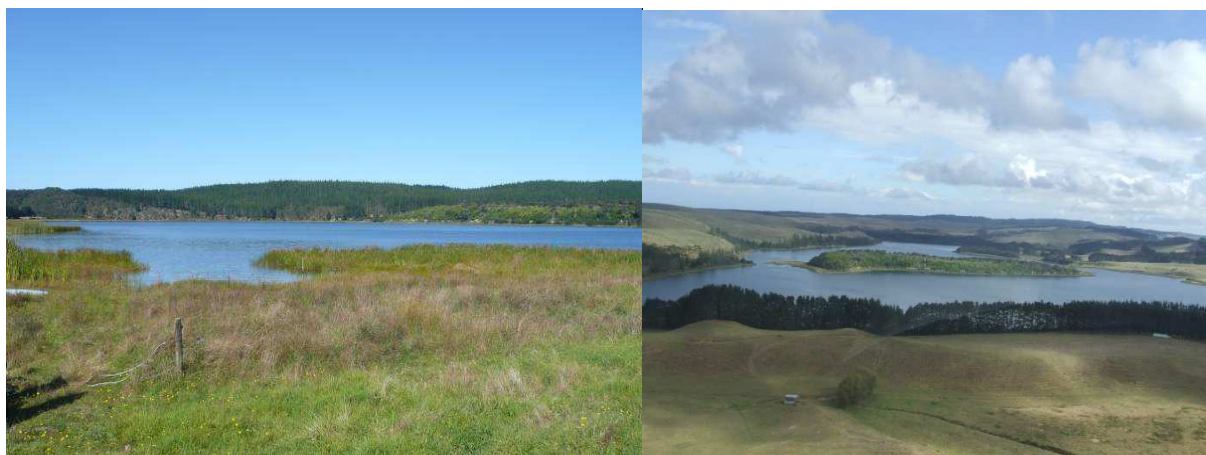
Plate A: Lake Humuhumu showing pastoral catchment in foreground, pine forest in background (Left photo) and harvested (Right photo) left side of lake to the west.

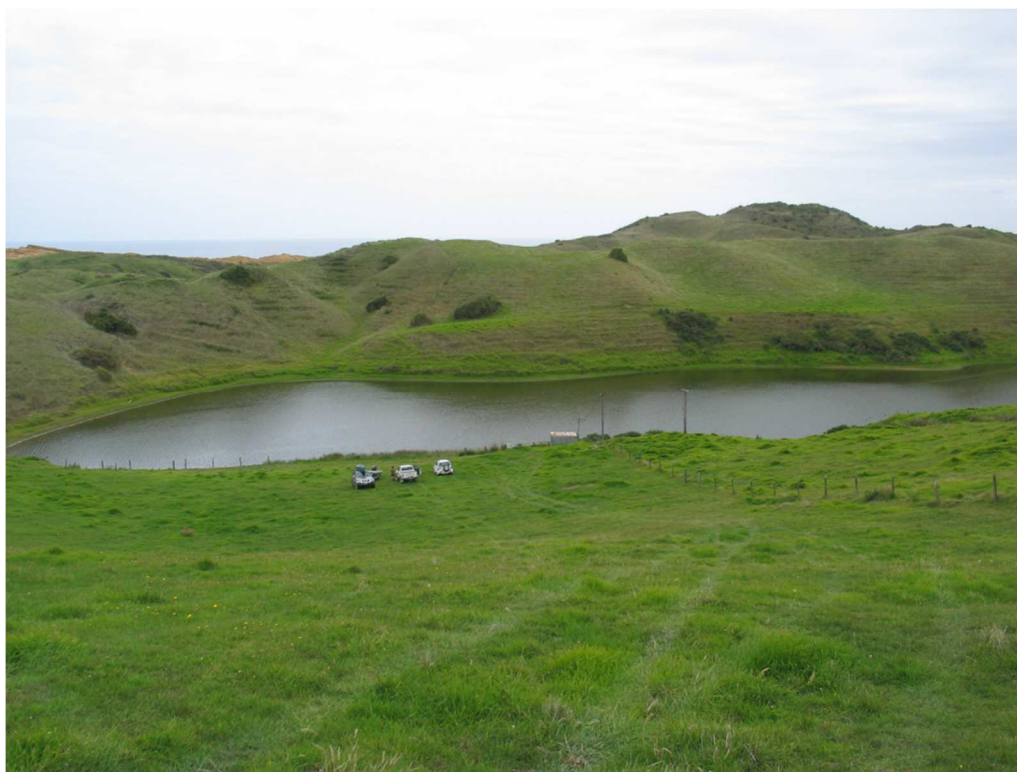
Plate A: Lake Kapoai set in a pastoral catchment.

Complete fencing the lake and consider planting options around the margins.

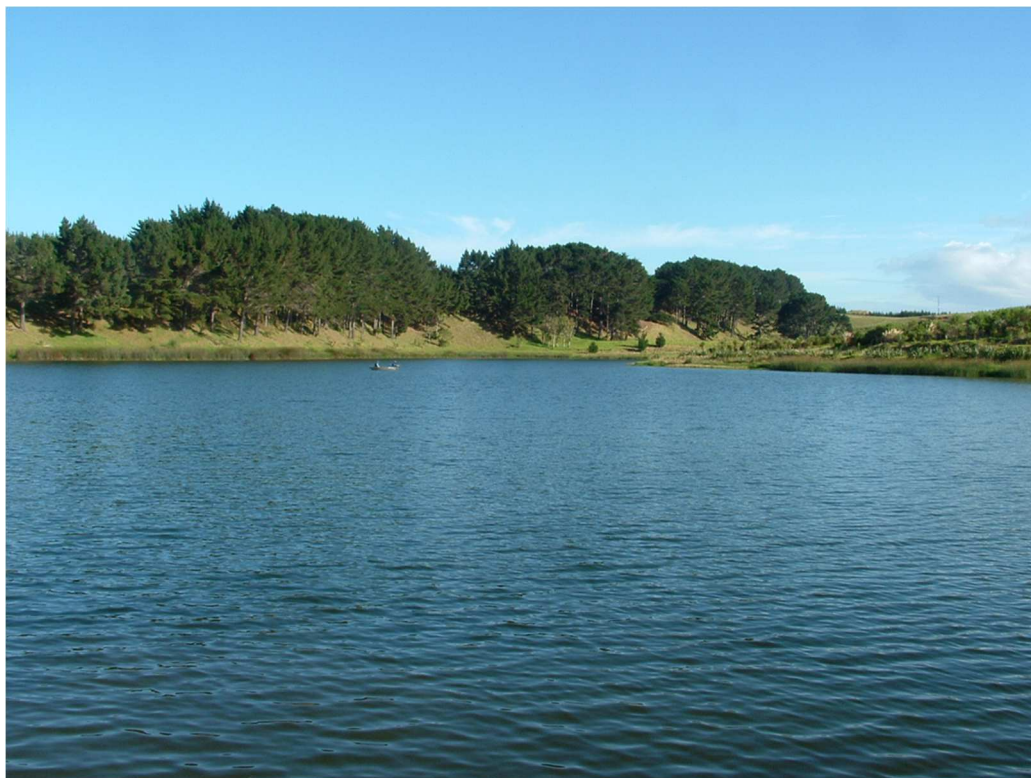
Plate A: Lake Rototuna has a pastoral catchment with a lot of pines in the wider catchment.

Investigate hydrology, the reduction of lake levels and sources of nutrients.

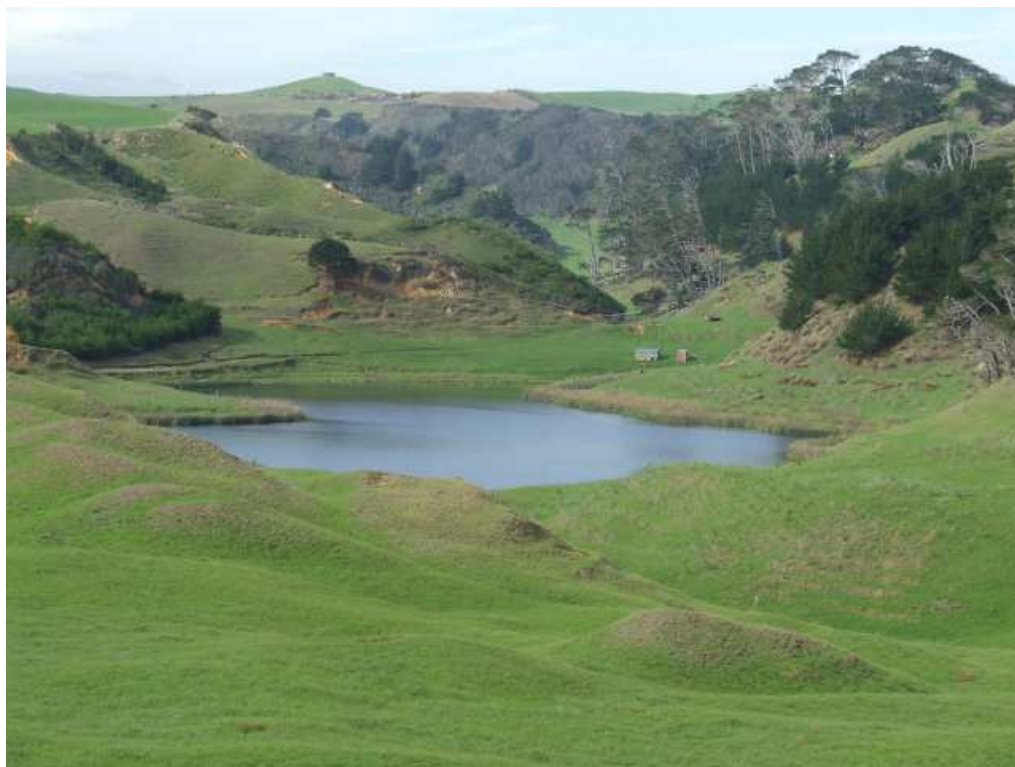
Plate A: Lake Wainui viewed from the north (access point south end by sheds). Note the steep sided pasture catchment. Photo Lisa Forester 2010.

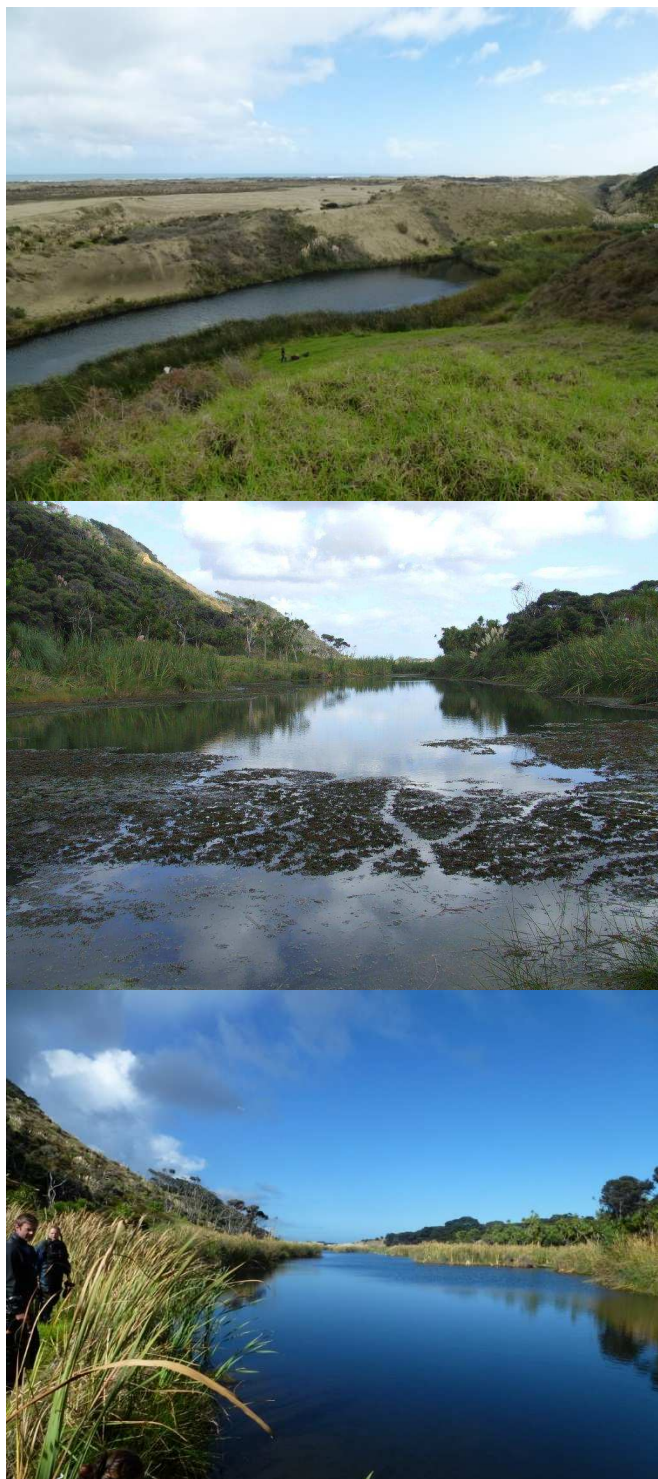
Plate A: Round Hill Lake 2 (top), and Lake Wairere north end (middle) and Lake Wairere further south (bottom). Raupo (*Typha orientalis*) dominated emergent vegetation.

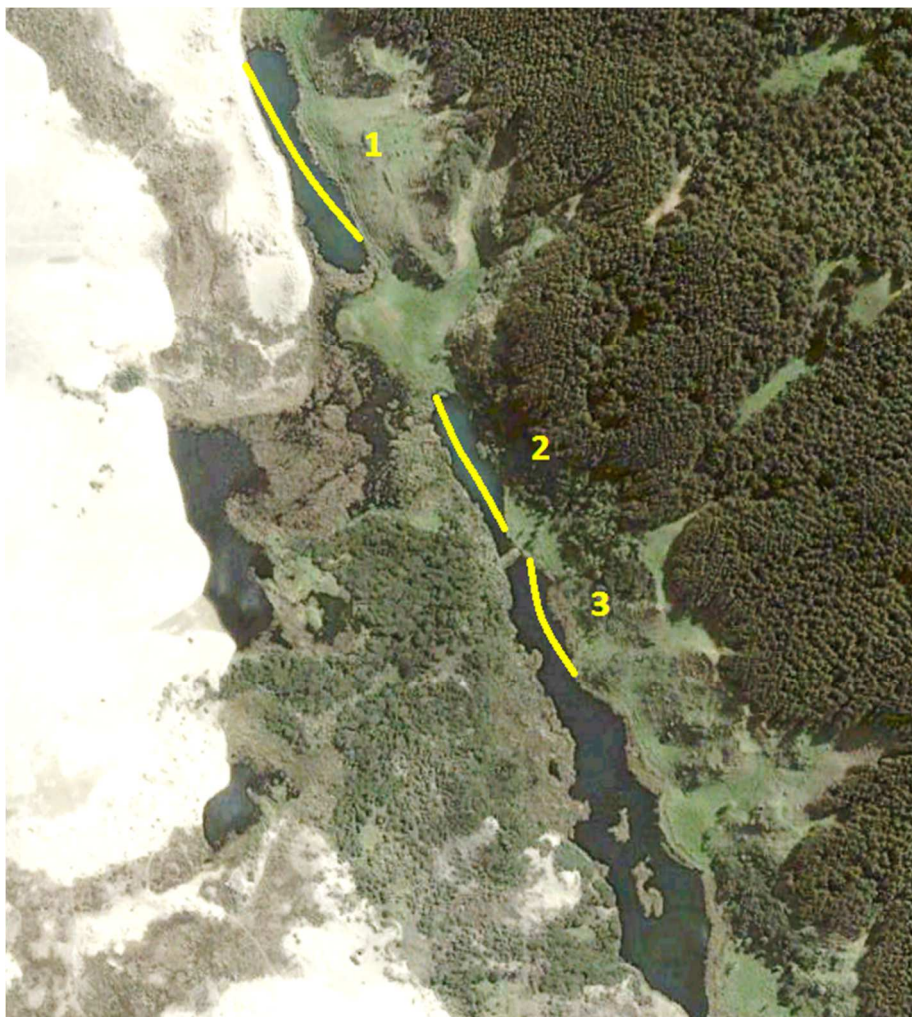
Plate B: Yellow lines indicate path swum. Line 1 is Round Hill Lake 2, and lines 2 & 3 are paths swum in Lake Wairere (north end).

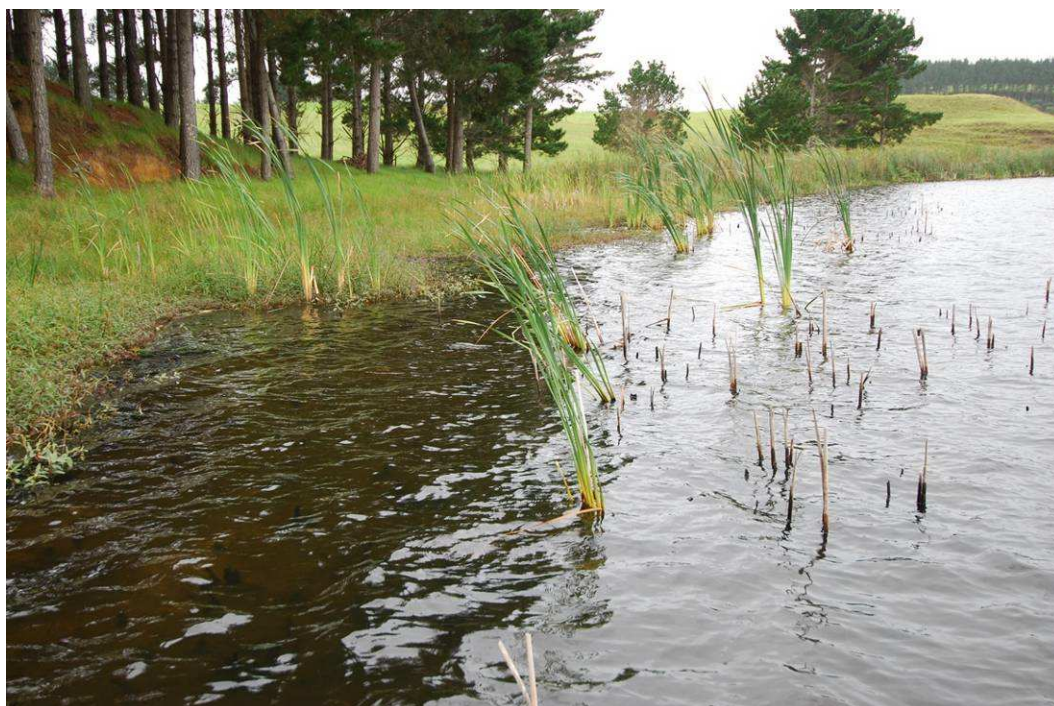
In March 2011 only a few pieces of hornwort were found floating amongst the emergent species on the lake margin and the lake basin was de-vegetated. The marginal emergent species were also reduced considerably in extent with only remnants of raupo (*Typha orientalis*) stands left (Plate B). The area least grazed was in the arm at the north end of the lake where the lake extends into a wetland. Low growing turf species were not affected by grass carp grazing.

Plate B: Lake Swan margins. Grass carp were introduced in May 2009 and by 2011 had removed significant amounts of the raupo (*Typha orientalis*) from the margins.

No evidence of either hornwort or egeria has been found for three years. It is appropriate to begin removal of grass carp using netting.

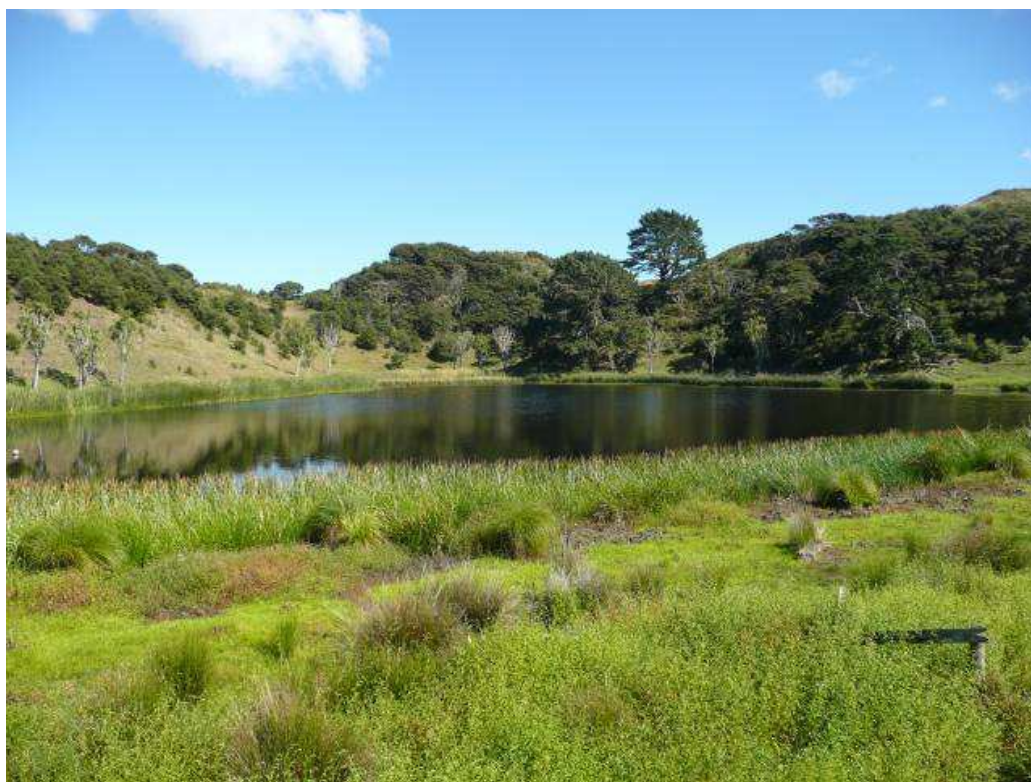
Plate A: Phoebe's Lake with a dense margin of *Eleocharis sphacelata*.
