## Te Hiku

Wairauo (formerly lake north of Ngakeketa) NRC Lake No. 13

Summary	Lake Wairauo
<b>Surveyed:</b>	2004, 2006, 2009 and 2021
<b>Overall ranking:</b>	<b>Moderate:</b> The invasive weed egeria has spread throughout the lake with little indigenous aquatic vegetation. Lake margins are surrounded by native scrub/forest, with mostly fenced pasture or mobile dunes surrounding this vegetation.
<b>Threats:</b>	The lake is isolated, so further human-mediated incursions seem unlikely. However, the egeria incursion is likely a consequence of eel fishing. There are indications of nutrient enrichment and benthic oxygen depletion.  Cows were observed in the lake during 2021.
<b>Management recommendations:</b>	Advocate the exclusion of cattle from the lake, with alternative water supply provided.  No monitoring recommended.

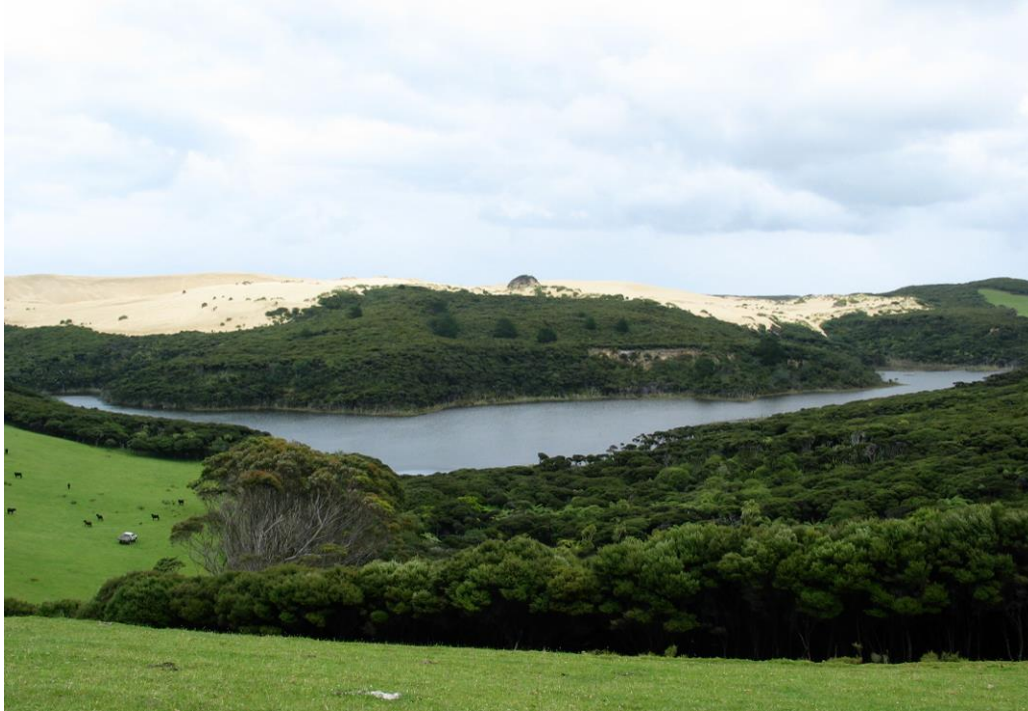
Wairauo (head of Kauaeparaoa Stream), showing the forested surrounds, with pasture and mobile dunes also in the catchment.

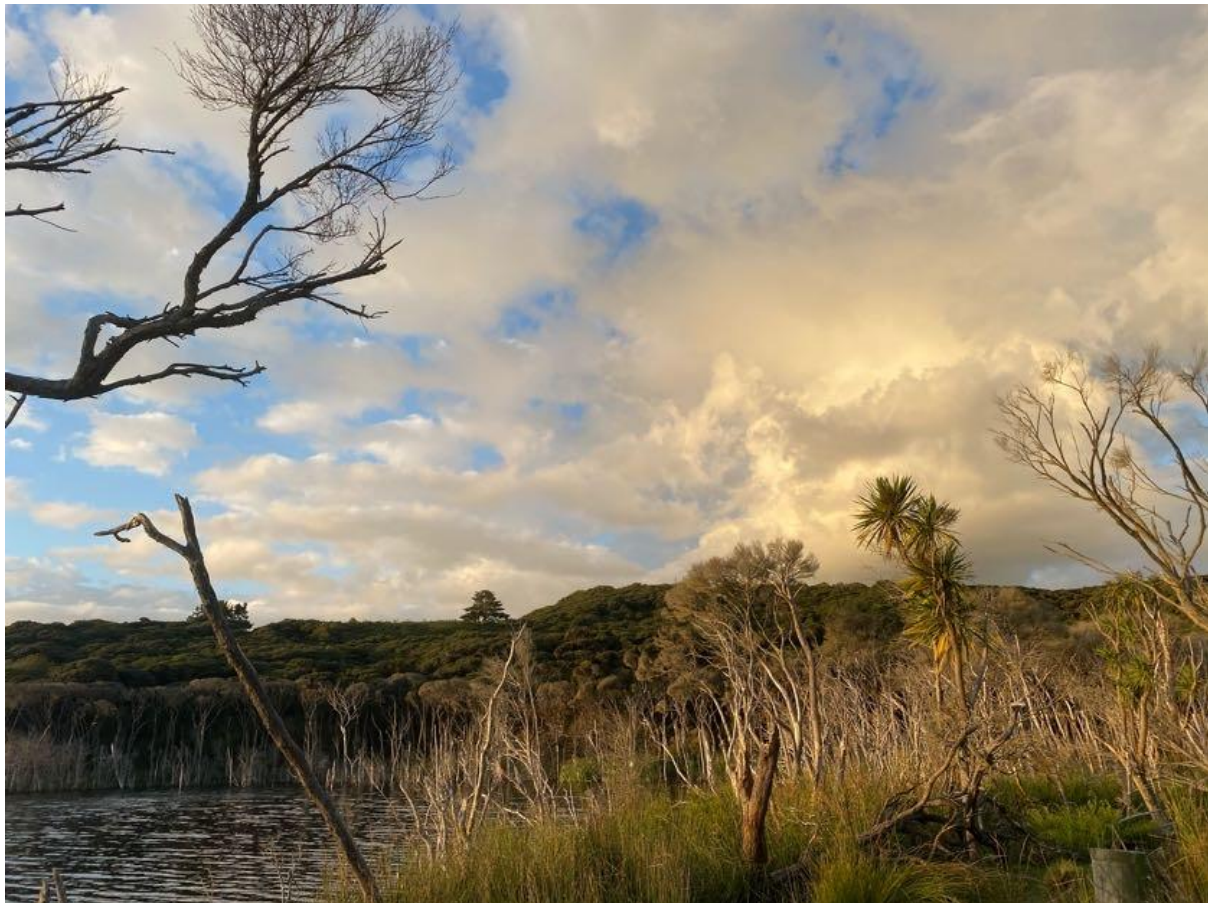
This lake (1577791E, 6180590N) is situated north of Ngakeketo and is 12.7 ha in area with a depth >7 m. It was formed by a stream system impounded by dunes. The lake level has continued to rise as evident by the flooding and death of trees (mostly kanuka – *Kunzea linearis*) on the margins. The

There was an almost complete fringe of emergent vegetation (apart from the dune face), mostly narrow, about 1 m across due to the steep sided lake edges, apart from the northern area where a larger emergent band was present. Vegetation was dominated by kuta (*Eleocharis sphacelata*) or raupo (*Typha orientalis*) which both grew to depths of up to 2 m. Swamp millet (*Isachne globosa*) was also common amongst the emergent species. In 2009, the lake level was assessed as higher than in 2007 with some marginal plants such as harakeke (*Phormium tenax*) and ti kouka (*Cordyline australis*) being partially submerged and dying. Further increase in water level from 2009 to 2021 was evident, with deeper emergent vegetation and dead woody vegetation at several sites.

**Wairau, at the access point showing the dead woodland, caused by water level rise [Susie Elcock, 2021].**

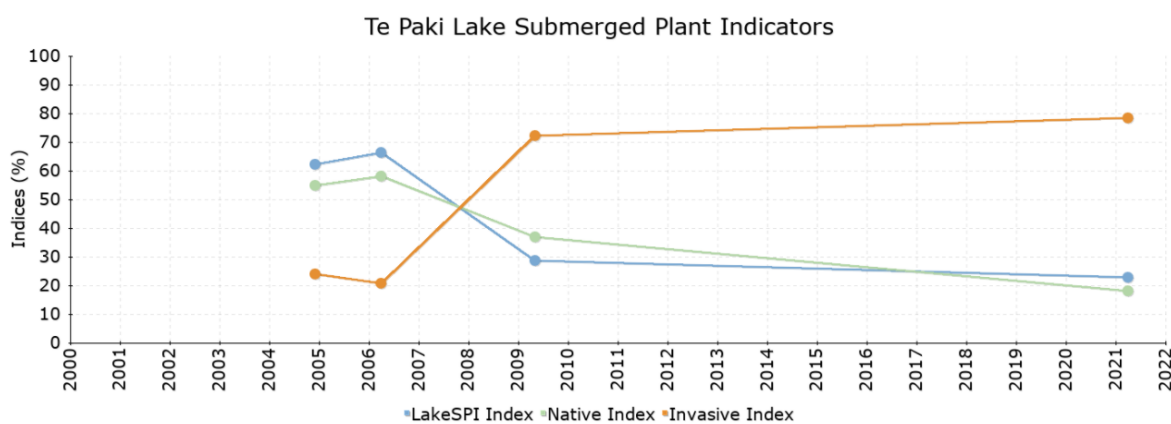
Survey Date	Status	LakeSPI %	Native Condition %	Invasive Impact %
March 2021	Moderate	22.9%	18.1%	78.5%
April 2009	Moderate	28.7%	36.9%	72.2%
March 2006	High	66.3%	58.1%	20.7%
November 2004	High	62.2%	54.8%	24.1%

**LakeSPI Index for Wairau.** Four LakeSPI surveys are recorded between 2004 and 2021.

The LakeSPI score of 23% has reduced markedly from 62% in 2004 reflecting the increasing impact of the invasive egeria. Despite a small reduction in LakeSPI and Invasive Impact Index from 2009 to 2021, the Native Condition index has halved from 37 to 18%.

Advocate the exclusion of cattle from the lake, with alternative water supply provided. No monitoring recommended.
