Recreational Swimming Water Quality in Northland

Summer 2012-2013

NORTHLAND
REGIONAL
COUNCIL

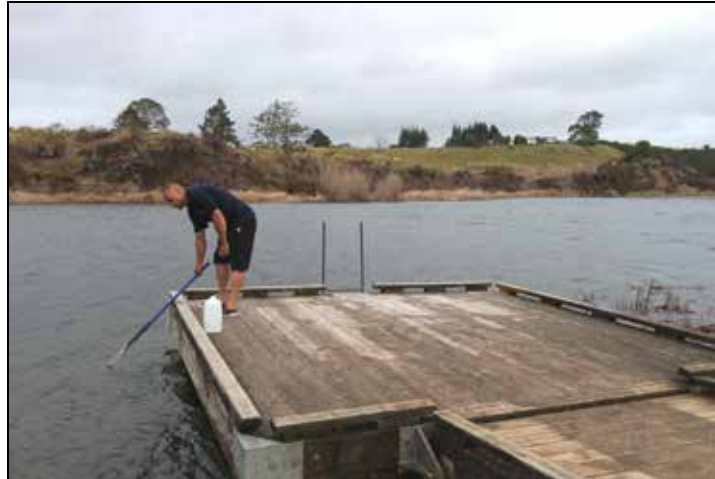
Photo 4: Council staff member taking a water quality sample at Lake Waro

Each sample is collected following the methods described in the *Microbiological Water Quality Guidelines for Freshwater and Marine Recreational Bathing Areas* (MfE 2003). Coastal water samples are taken from the shore using a sampling pole at about 0.5 metre depth, from approximately 15 centimetres below the surface. Freshwater samples are taken at approximately 30 centimetres below the surface, at approximately one metre depth. All samples are collected during daylight hours and sites are sampled in the same order each week. This ensures that, where practicable, samples are collected at around the same time each week.

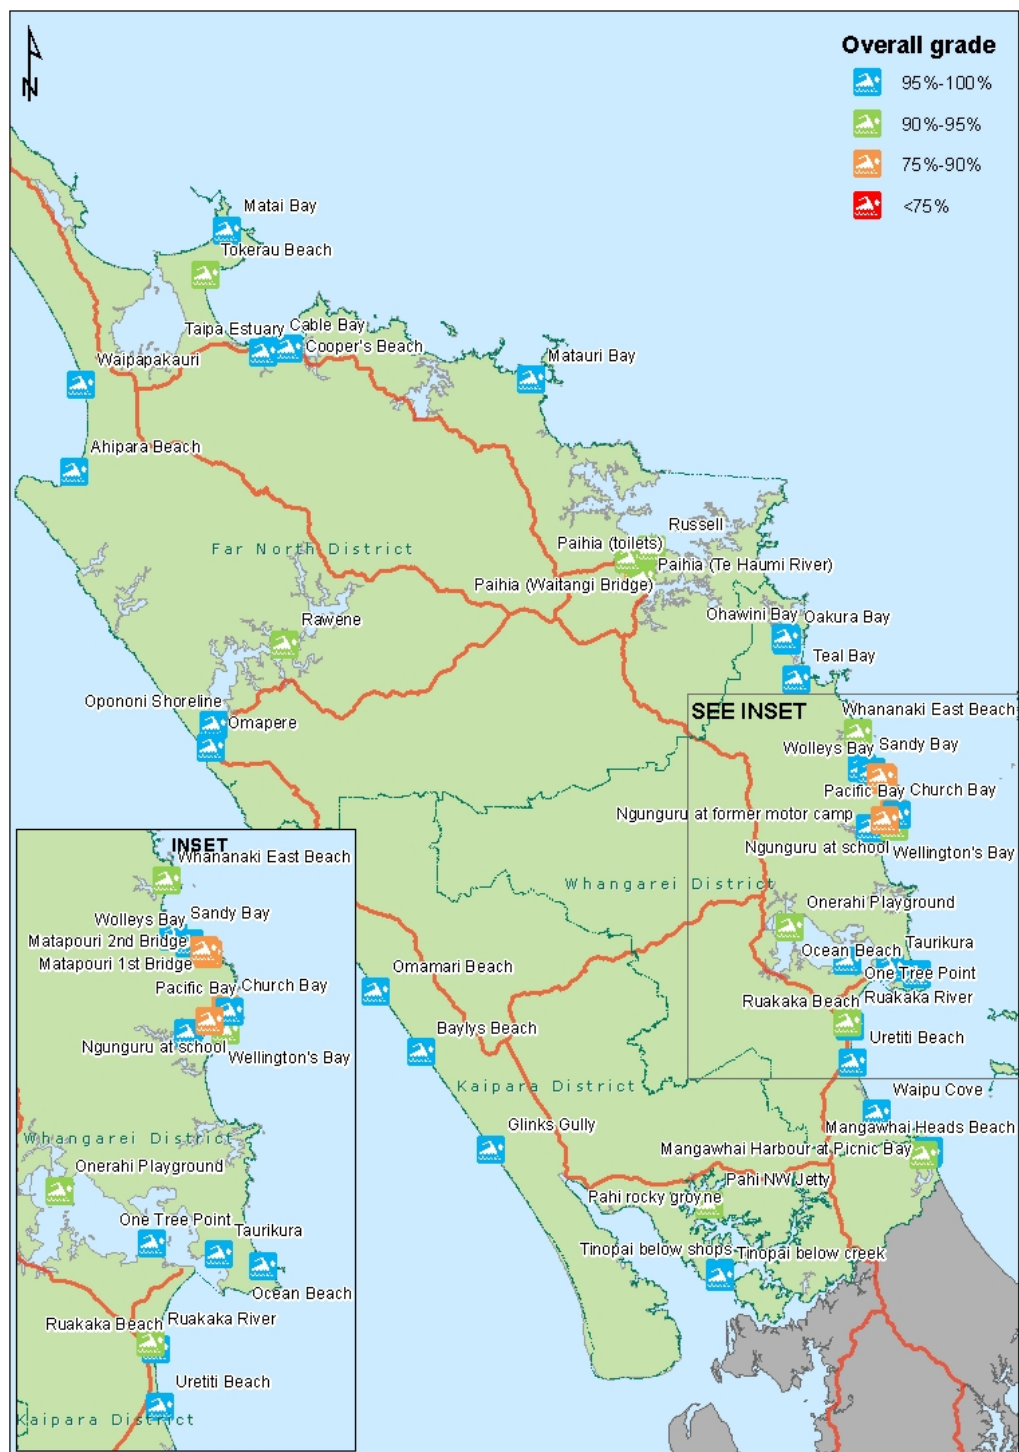
Figure 1: Coastal end of season grading 2012-13

The map above summarises the end of season grading for samples taken from each of the 47 coastal sites monitored in Northland during the 2012-13 sampling season (26 November 2012 to the 26 March 2013). The grades indicate the percentage of results below 'Action' level recorded at each site.

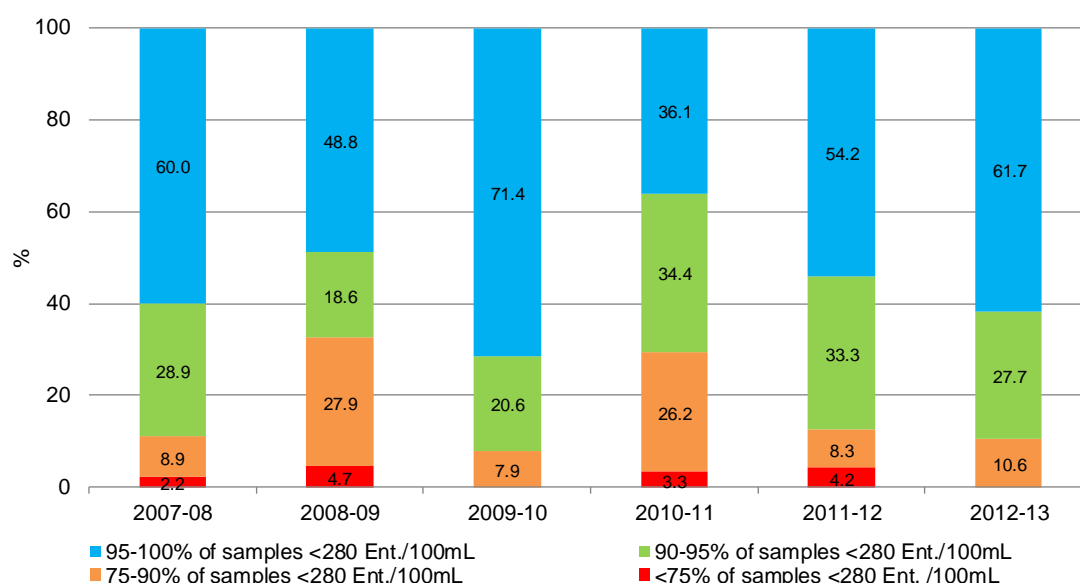
Figure 2: Yearly overall percentage of coastal sites with corresponding percentage of samples within each category from 2007 to 2013

The results from faecal indicator bacteria testing in 2012-13 were slightly improved compared to the 2011-12 season. No site recorded less than 75 percent of samples below the 'Action' level, i.e. 280 *Enterococci* per 100 millilitres. About 62 percent of coastal sites had more than 95 percent of samples below the 'Action level. Similar grades were recorded in summer 2009-10 as shown in Figure 2 above.

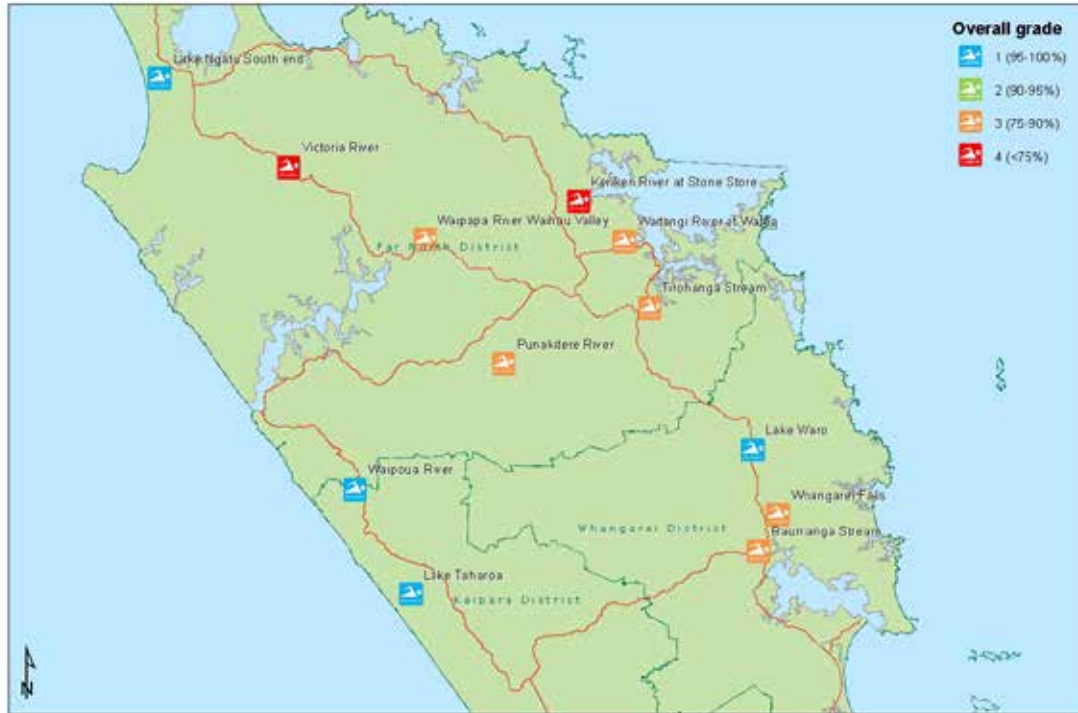
Figure 3: Freshwater end of season grading 2012-13

The map above summarises the end of season grading for samples taken from each of the 12 freshwater sites monitored in Northland during the 2012-13 sampling season (26 November 2012 to the 26 March 2013). The grades indicate the percentage of results below 'Action' level recorded at each site.
