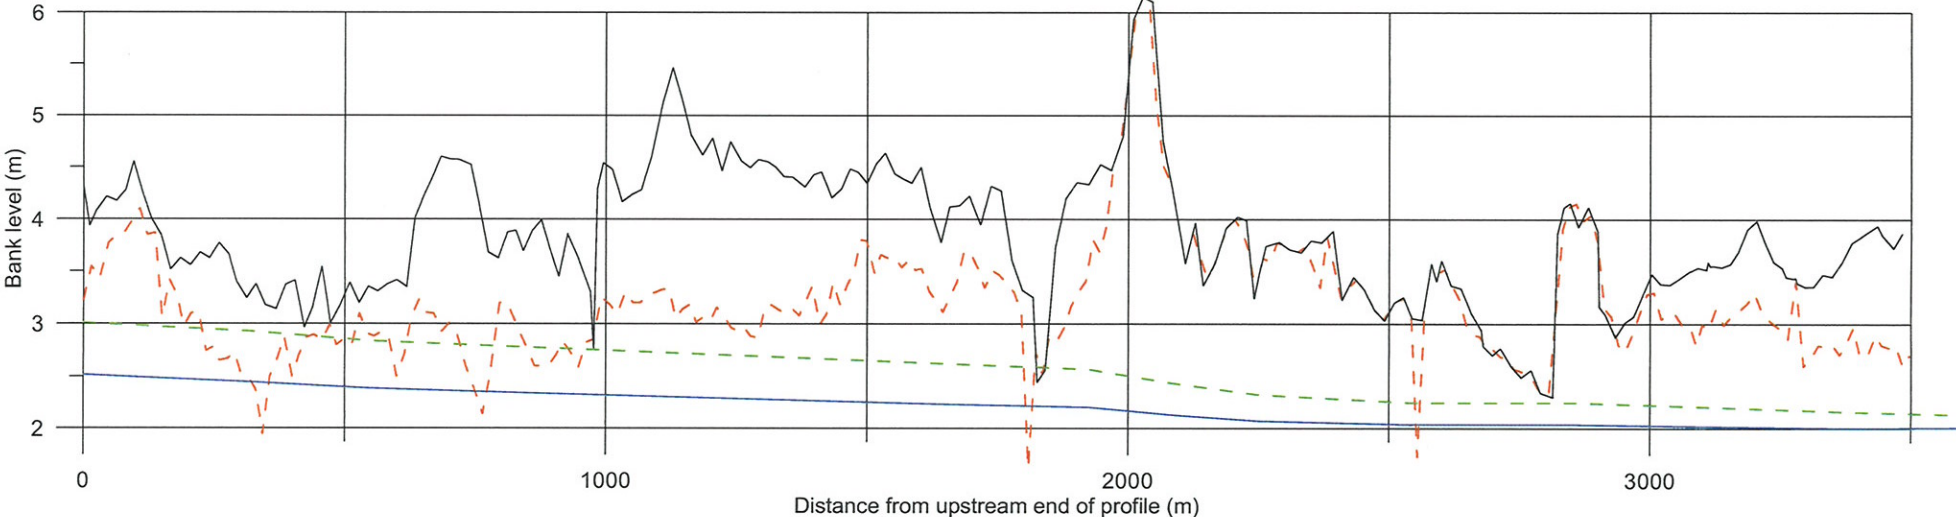
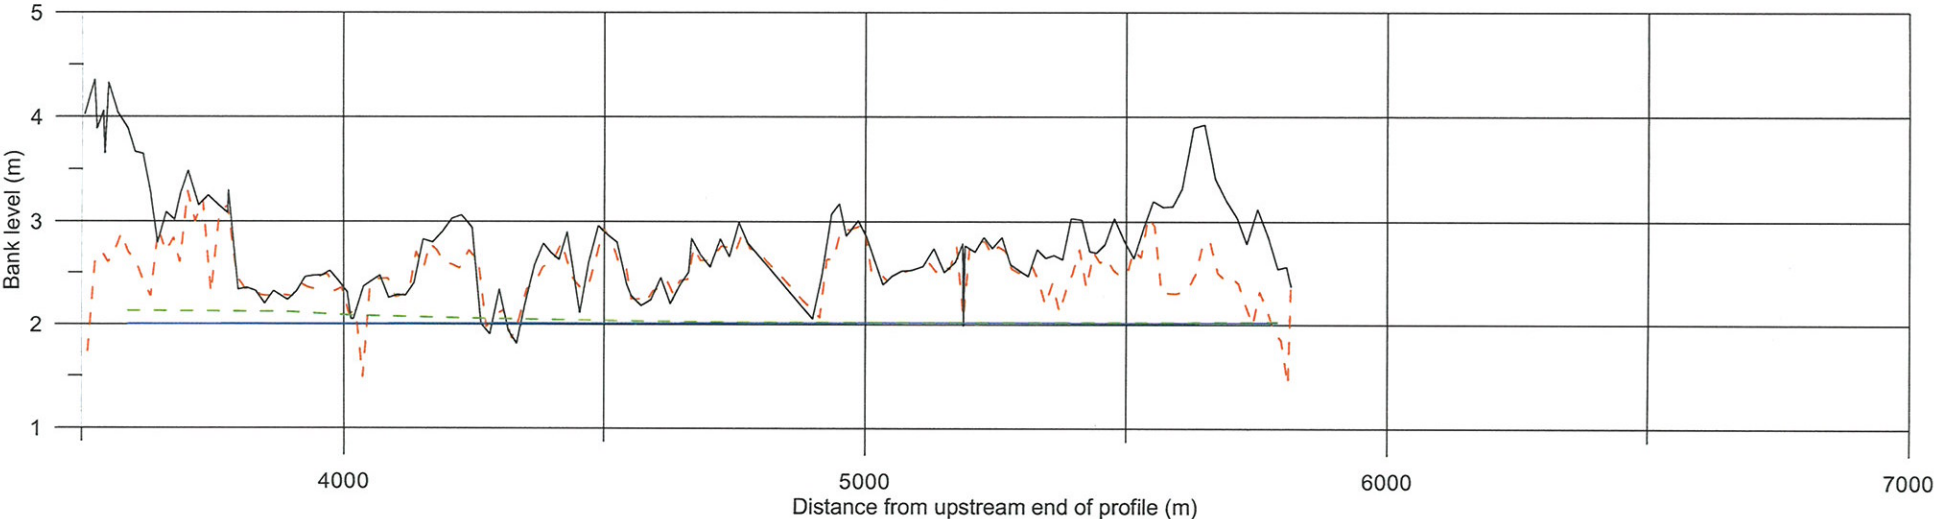
Left bank from Bottleneck to high ground upstream of Rotu Stream confluence (survey LB4)

- Estimated natural unmodified bank level
- Bank crest surveyed 2010
- Maximum water level in 6 month ARI flood, with no bank overtopping
- Maximum water level in 1 year ARI flood, with no bank overtopping

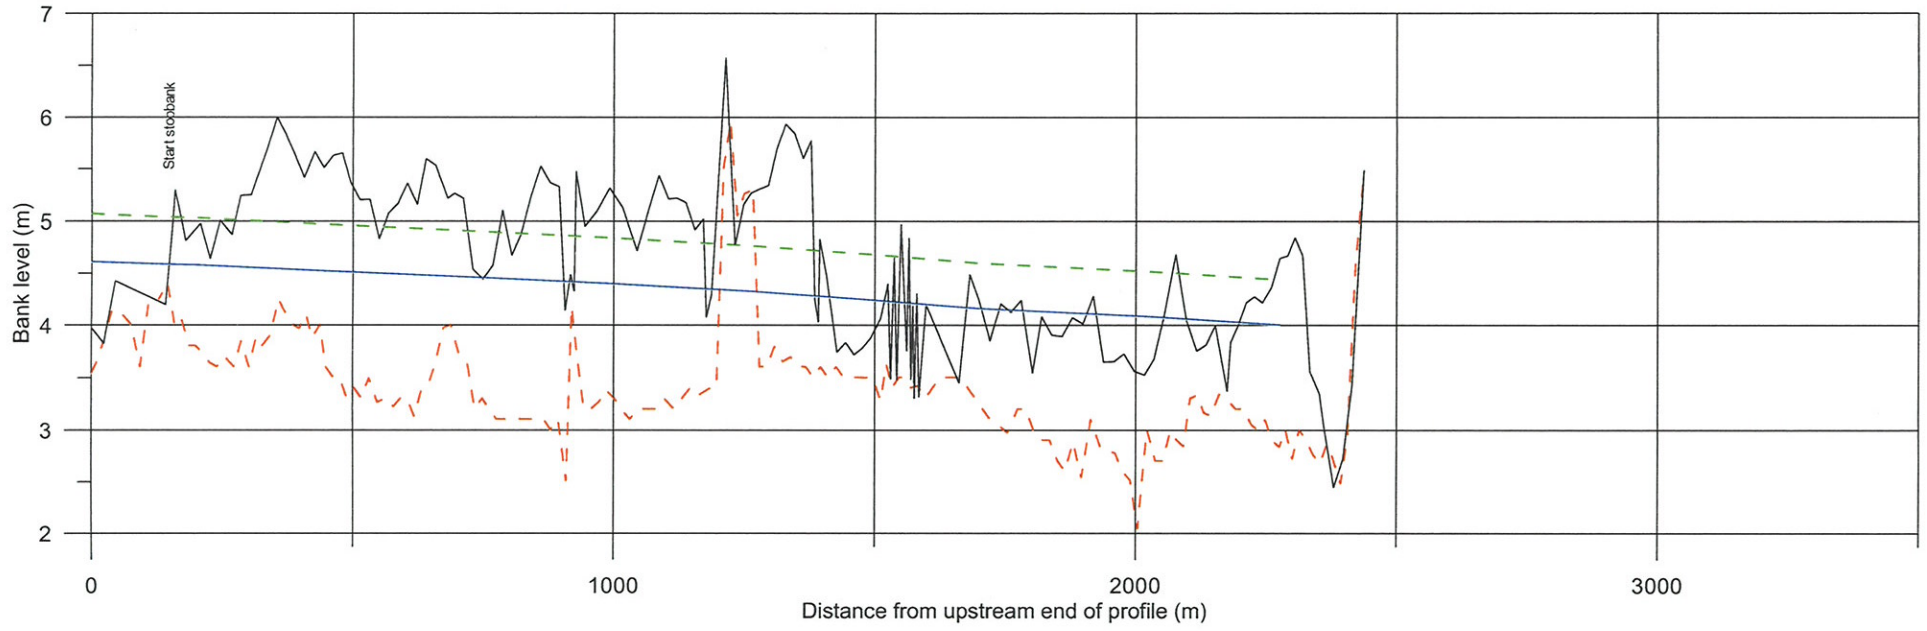
Left bank from high ground upstream of Taita Stream confluence to high ground upstream of Bottleneck (survey LB6)

- - - Estimated natural unmodified bank level
- Bank crest surveyed 2010
- Maximum water level in 6 month ARI flood, with no bank overtopping
- - - Maximum water level in 1 year ARI flood, with no bank overtopping

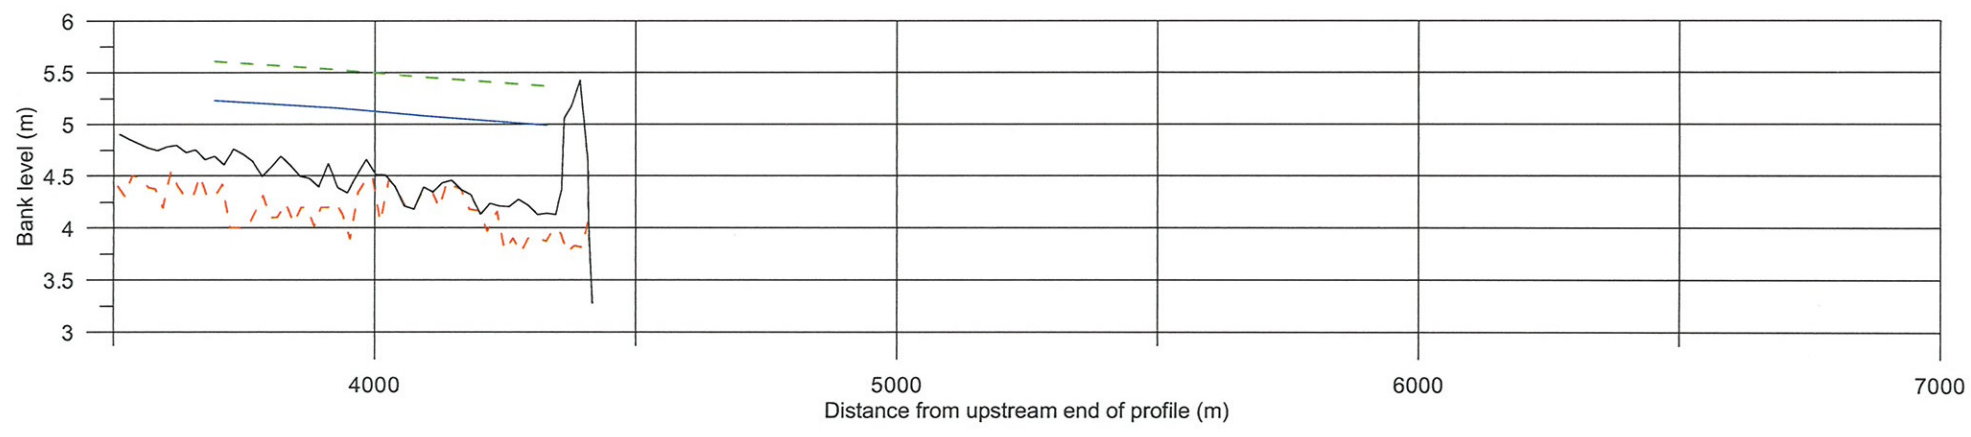
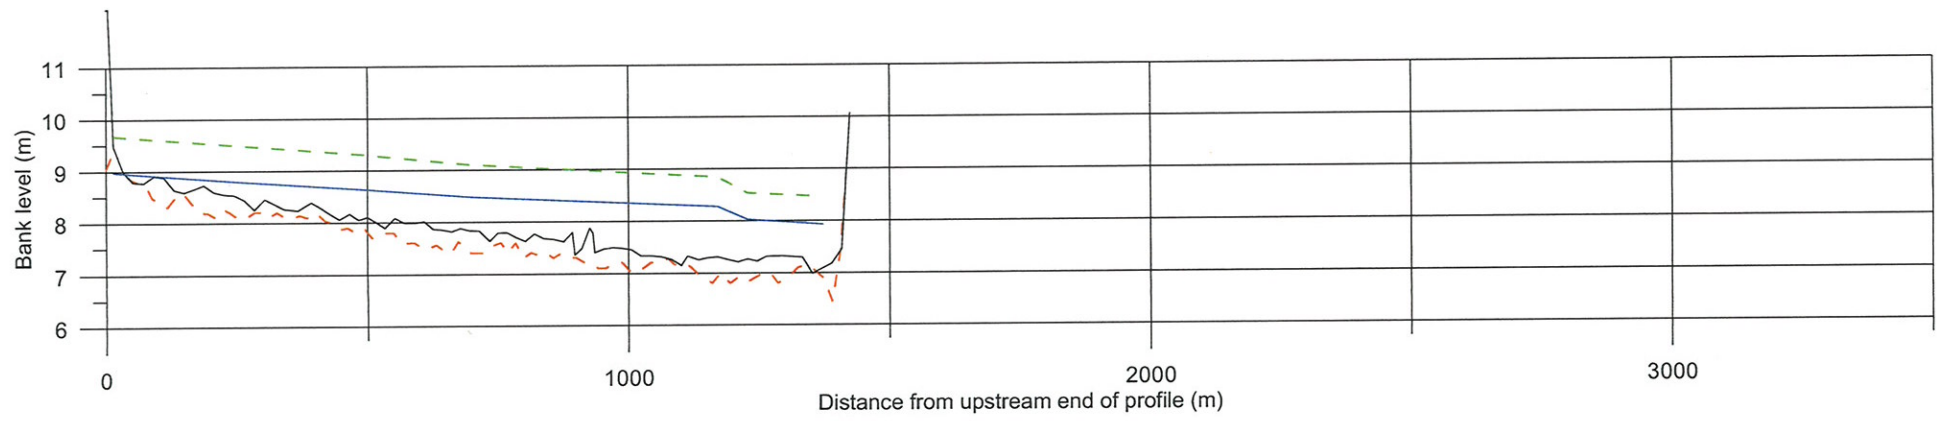
Left bank Waihue Road to high ground upstream of Taita Stream confluence (survey LB9)

- - - Estimated natural unmodified bank level
- Bank crest surveyed 2010
- Maximum water level in 6 month ARI flood, with no bank overtopping
- - - Maximum water level in 1 year ARI flood, with no bank overtopping
